NC School District/040 Anson County/Elementary School

# Lilesville Elementary

## Campus Assessment Report

March 11, 2017

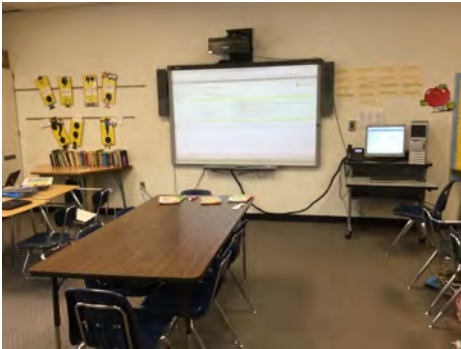
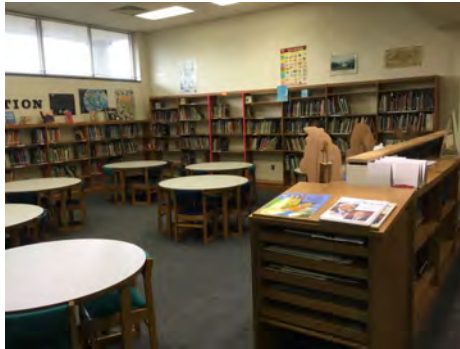
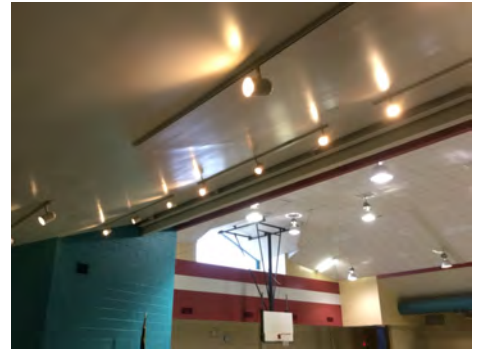
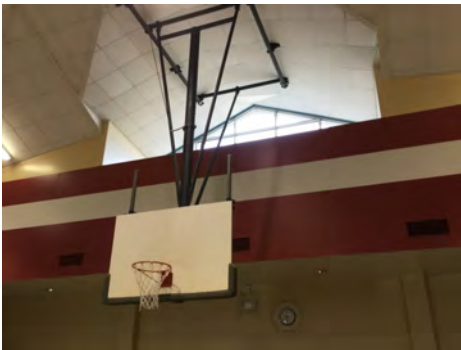
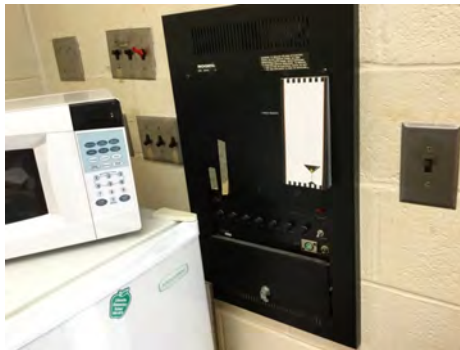
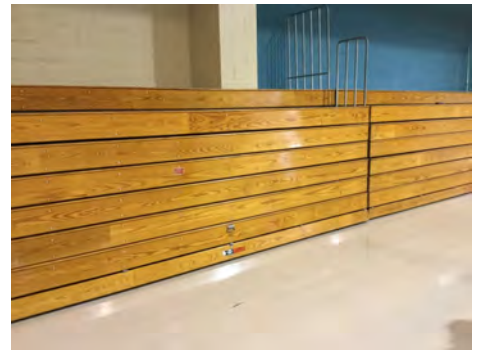
**System:** E1020 - Institutional Equipment

**Note:** Some newer equipment is installed. Original equipment is functional. System renewal date pushed to reflect no immediate need for replacements/upgrades.

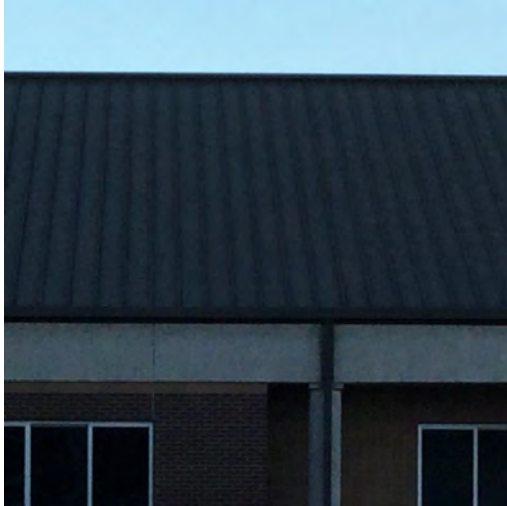
#### **System: B3010130 - Prefomed Metal Roofing**

**Location:** Roof  
**Distress:** Failing  
**Category:** Deferred Maintenance  
**Priority:** 2 - Potentially Critical (Year 1)  
**Correction:** Renew System  
**Qty:** 63,168.00  
**Unit of Measure:** S.F.  
**Estimate:** \$842,080.00  
**Assessor Name:** Eduardo Lopez  
**Date Created:** 02/09/2017

**Notes:** Despite major repairs in 2014, roofs continue to leak, particularly in wind driven conditions around ridge vents. As a result water damaged ceiling tile replacement is a continual maintenance task. Gutters are in poor condition. Consider proper ventilation and insulation in redesign to mitigate humidity problems. System redesign and replacement is recommended.

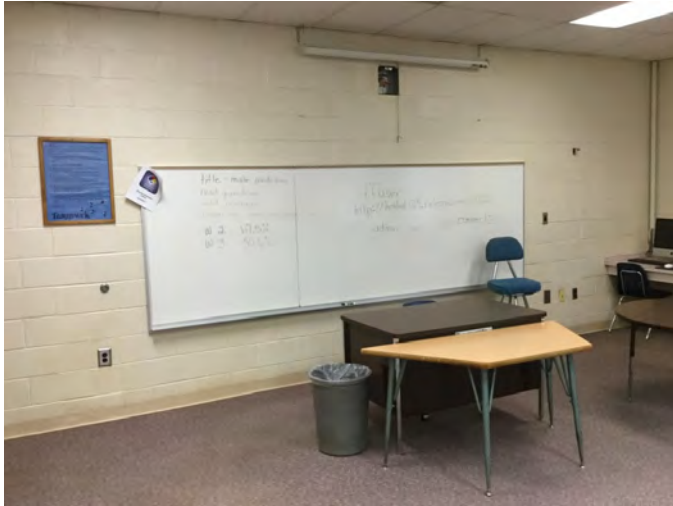
**System: C1030 - Fittings**

**Location:** Throughout the building  
**Distress:** Beyond Service Life  
**Category:** Deferred Maintenance  
**Priority:** 3 - Necessary/Not Yet Critical (Years 2-5)  
**Correction:** Renew System  
**Qty:** 63,168.00  
**Unit of Measure:** S.F.  
**Estimate:** \$662,885.00  
**Assessor Name:** Eduardo Lopez  
**Date Created:** 12/16/2016

**Notes:** Building fittings are typically original and beyond their expected life. Whiteboards in particular are noted by district staff to be in need of replacement. System renewal is recommended.

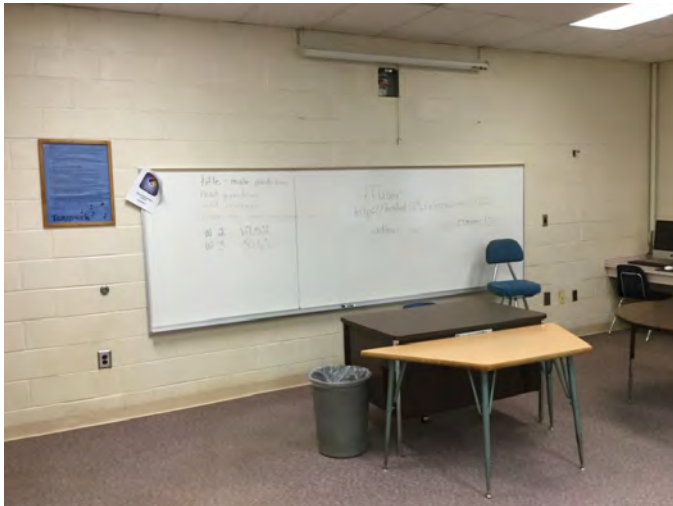
**System: C3010 - Wall Finishes**

**Location:** Throughout the building  
**Distress:** Beyond Service Life  
**Category:** Deferred Maintenance  
**Priority:** 3 - Necessary/Not Yet Critical (Years 2-5)  
**Correction:** Renew System  
**Qty:** 63,168.00  
**Unit of Measure:** S.F.  
**Estimate:** \$189,694.00  
**Assessor Name:** Eduardo Lopez  
**Date Created:** 12/16/2016

**Notes:** A comprehensive painting program is not implemented in this building. Repainting throughout is recommended.

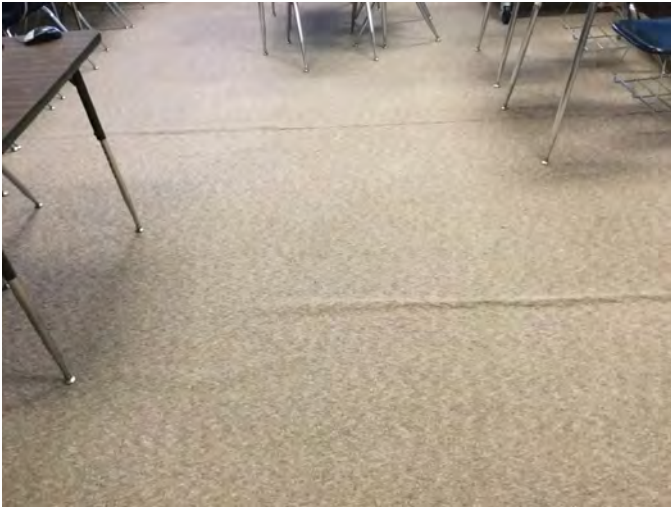
**System: C3020 - Floor Finishes**

**Location:** Throughout the building  
**Distress:** Beyond Service Life  
**Category:** Deferred Maintenance  
**Priority:** 3 - Necessary/Not Yet Critical (Years 2-5)  
**Correction:** Renew System  
**Qty:** 63,168.00  
**Unit of Measure:** S.F.  
**Estimate:** \$774,756.00  
**Assessor Name:** Eduardo Lopez  
**Date Created:** 12/16/2016

**Notes:** While some classrooms have had carpet replaced with VCT, there is still a considerable amount of carpet in poor condition in classrooms. Original VCT is generally beyond its expected useful life. System renewal is recommended.

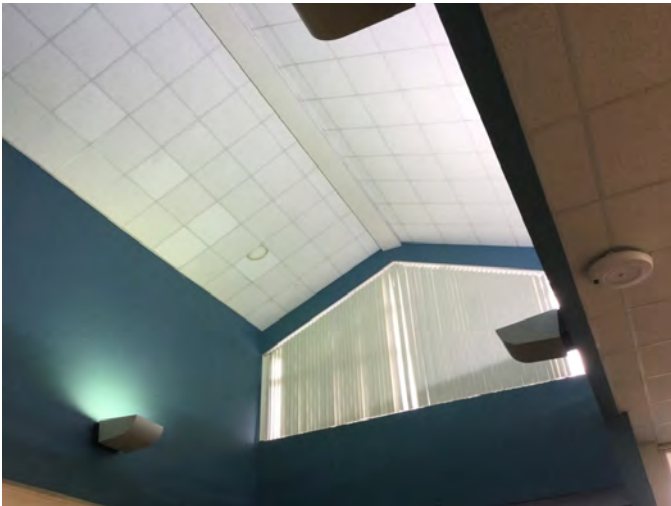
**System: C3030 - Ceiling Finishes**

**Location:** Throughout the building  
**Distress:** Beyond Service Life  
**Category:** Deferred Maintenance  
**Priority:** 3 - Necessary/Not Yet Critical (Years 2-5)  
**Correction:** Renew System  
**Qty:** 63,168.00  
**Unit of Measure:** S.F.  
**Estimate:** \$746,267.00  
**Assessor Name:** Eduardo Lopez  
**Date Created:** 12/16/2016

**Notes:** Although well maintained without broken or missing tile, ceilings are in aged condition. Frequent tile replacements due to roof leaks and condensation have resulted in mismatched tile throughout the building. Grids are starting to yellow. It is recommended that system renewal follow roof replacement.

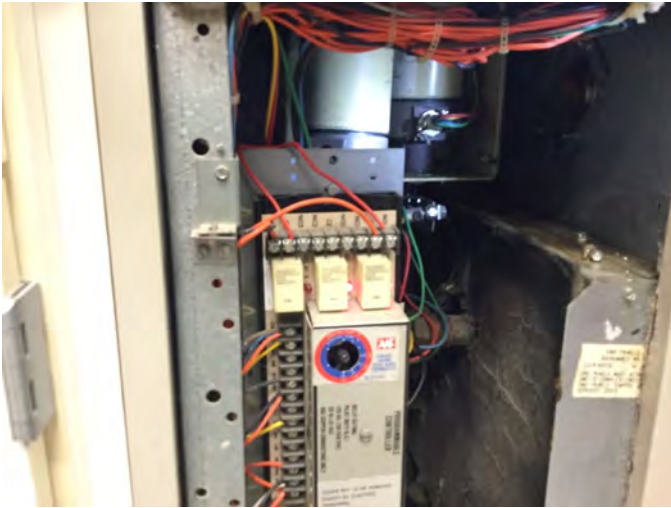
**System: D3050 - Terminal & Package Units**

**Location:** Throughout the building  
**Distress:** Beyond Service Life  
**Category:** Deferred Maintenance  
**Priority:** 3 - Necessary/Not Yet Critical (Years 2-5)  
**Correction:** Renew System  
**Qty:** 63,168.00  
**Unit of Measure:** S.F.  
**Estimate:** \$564,217.00  
**Assessor Name:** Eduardo Lopez  
**Date Created:** 12/16/2016

**Notes:** Terminal and package units, mostly ground mounted condensers for the split systems and cabinet unit ventilators with compressors, have exceeded their expected useful life. Parts for the unit ventilators are difficult to obtain and valves are not functioning. Outside air dampers do not function correctly. Refrigeration lines to newer ground mount units are poorly routed. System renewal is recommended.

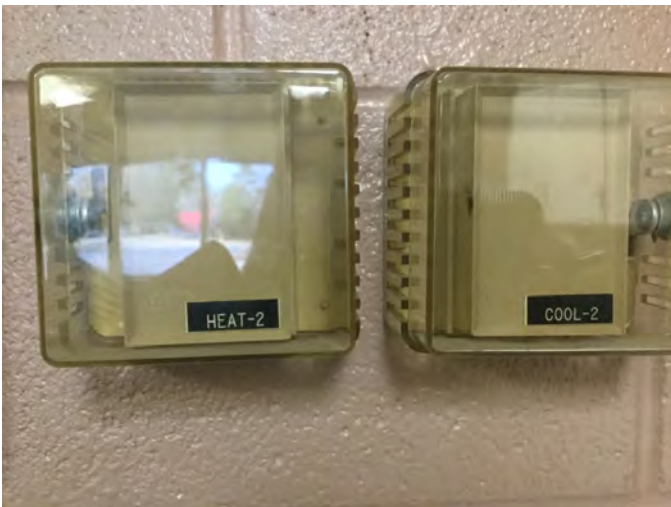
**System: D3060 - Controls & Instrumentation**

**Location:** Throughout the building  
**Distress:** Beyond Service Life  
**Category:** Deferred Maintenance  
**Priority:** 3 - Necessary/Not Yet Critical (Years 2-5)  
**Correction:** Renew System  
**Qty:** 63,168.00  
**Unit of Measure:** S.F.  
**Estimate:** \$132,716.00  
**Assessor Name:** Eduardo Lopez  
**Date Created:** 12/16/2016

**Notes:** Building controls are typically original pneumatics. They are locally controlled. Installation of a modern digital system with remote monitoring and control capability for energy conservation is recommended.

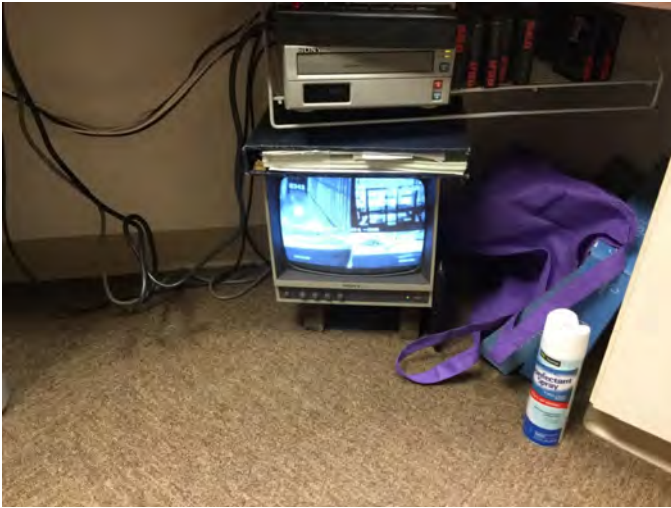
**System: D5030810 - Security & Detection Systems**

**Location:** Throughout the building  
**Distress:** Beyond Service Life  
**Category:** Deferred Maintenance  
**Priority:** 3 - Necessary/Not Yet Critical (Years 2-5)  
**Correction:** Renew System  
**Qty:** 63,168.00  
**Unit of Measure:** S.F.  
**Estimate:** \$127,157.00  
**Assessor Name:** Eduardo Lopez  
**Date Created:** 12/16/2016

**Notes:** The security system is mostly original and beyond its expected life. There are areas inside and outside the building that aren't monitored. System renewal is recommended.

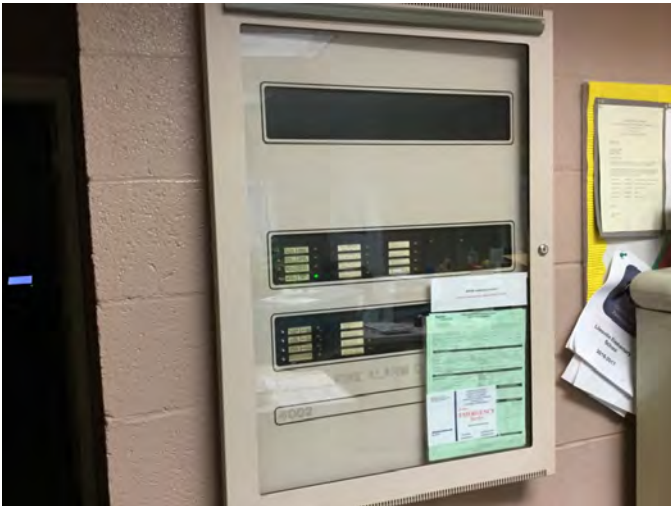
**System: D5030910 - Fire Alarm Systems**

**Location:** Throughout the building  
**Distress:** Beyond Service Life  
**Category:** Deferred Maintenance  
**Priority:** 3 - Necessary/Not Yet Critical (Years 2-5)  
**Correction:** Renew System  
**Qty:** 63,168.00  
**Unit of Measure:** S.F.  
**Estimate:** \$229,995.00  
**Assessor Name:** Eduardo Lopez  
**Date Created:** 12/16/2016

**Notes:** The fire alarm system is original and beyond its expected life. System renewal is recommended to ensure reliability of this life safety system.

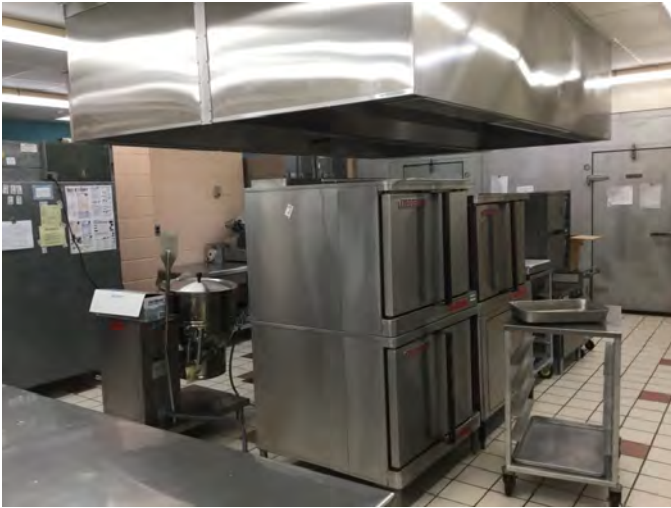
**System: E1090 - Other Equipment**

**Location:** Kitchen  
**Distress:** Beyond Service Life  
**Category:** Deferred Maintenance  
**Priority:** 3 - Necessary/Not Yet Critical (Years 2-5)  
**Correction:** Renew System  
**Qty:** 63,168.00  
**Unit of Measure:** S.F.  
**Estimate:** \$129,242.00  
**Assessor Name:** Eduardo Lopez  
**Date Created:** 12/16/2016

**Notes:** Kitchen equipment is typically original and beyond its expected life. System renewal is recommended.

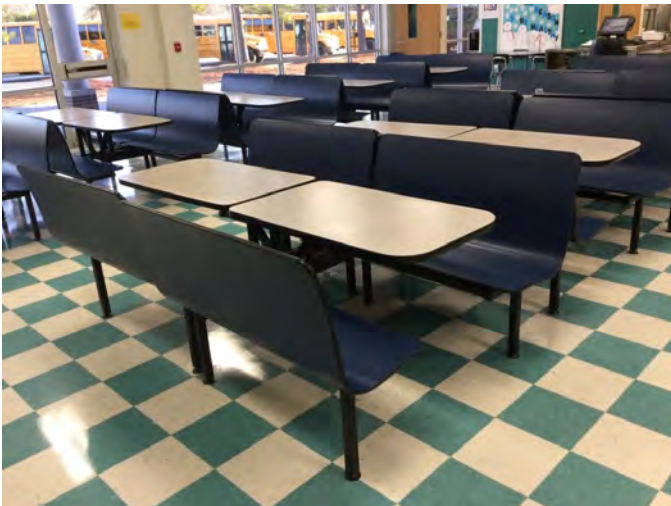
**System: E2010 - Fixed Furnishings**

**Location:** Classrooms, cafeteria.  
**Distress:** Beyond Service Life  
**Category:** Deferred Maintenance  
**Priority:** 3 - Necessary/Not Yet Critical (Years 2-5)  
**Correction:** Renew System  
**Qty:** 63,168.00  
**Unit of Measure:** S.F.  
**Estimate:** \$397,453.00  
**Assessor Name:** Eduardo Lopez  
**Date Created:** 12/16/2016

**Notes:** Interior furnishings are beyond their expected life and are showing signs of wear and tear. Most classrooms do not have window blinds. System renewal is recommended.

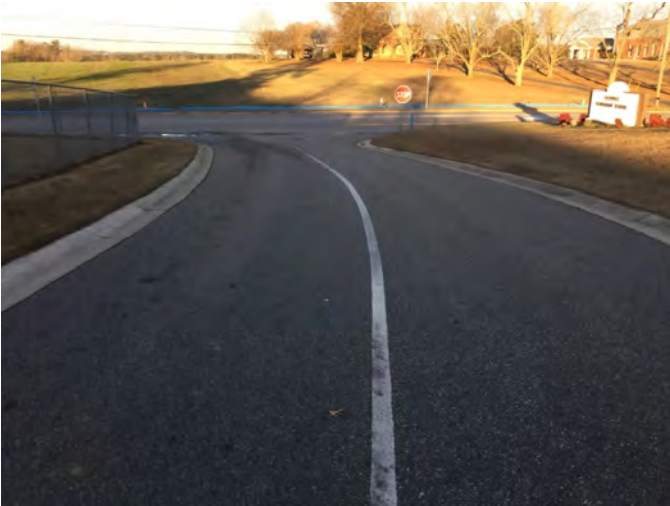
#### System: G2010 - Roadways

**Location:** Site  
**Distress:** Beyond Service Life  
**Category:** Deferred Maintenance  
**Priority:** 3 - Necessary/Not Yet Critical (Years 2-5)  
**Correction:** Renew System  
**Qty:** 63,744.00  
**Unit of Measure:** S.F.  
**Estimate:** \$267,151.00  
**Assessor Name:** Ann Buerger Linden  
**Date Created:** 02/22/2017

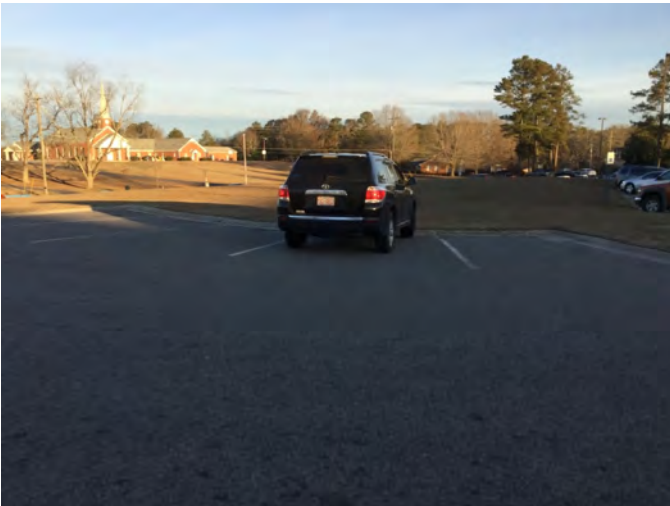
#### System: G2020 - Parking Lots

**Location:** Parking lots  
**Distress:** Beyond Service Life  
**Category:** Deferred Maintenance  
**Priority:** 3 - Necessary/Not Yet Critical (Years 2-5)  
**Correction:** Renew System  
**Qty:** 63,744.00  
**Unit of Measure:** S.F.  
**Estimate:** \$93,257.00  
**Assessor Name:** Ann Buerger Linden  
**Date Created:** 02/22/2017

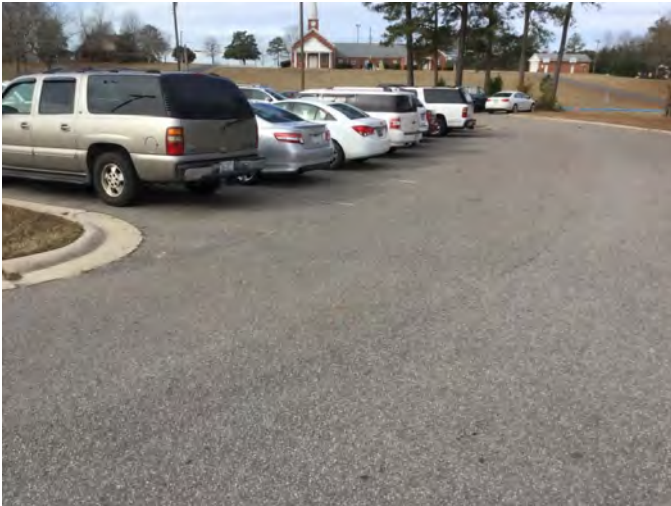
**System: G2020 - Parking Lots**

**Location:** Site  
**Distress:** Inadequate  
**Category:** Safety  
**Priority:** 3 - Necessary/Not Yet Critical (Years 2-5)  
**Correction:** Add more parking spaces  
**Qty:** 20.00  
**Unit of Measure:** Ea.  
**Estimate:** \$41,712.00  
**Assessor Name:** Ann Buerger Linden  
**Date Created:** 02/09/2017

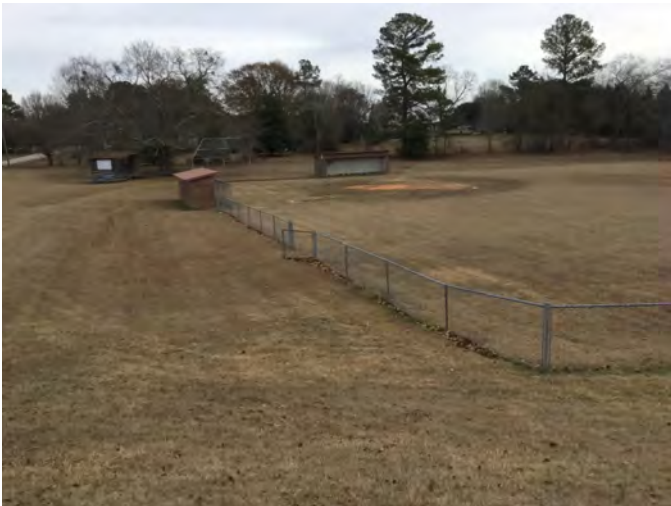
**System: G2040950 - Playing Field**

**Location:** East end of site  
**Distress:** Beyond Service Life  
**Category:** Deferred Maintenance  
**Priority:** 3 - Necessary/Not Yet Critical (Years 2-5)  
**Correction:** Renew System  
**Qty:** 63,744.00  
**Unit of Measure:** S.F.  
**Estimate:** \$318,338.00  
**Assessor Name:** Ann Buerger Linden  
**Date Created:** 02/22/2017
