NC School District/040 Anson County/Elementary School

# Morven Elementary

## Campus Assessment Report

March 11, 2017

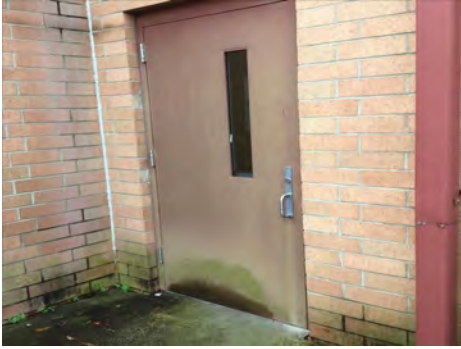
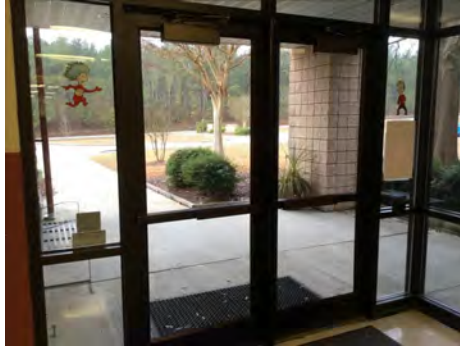
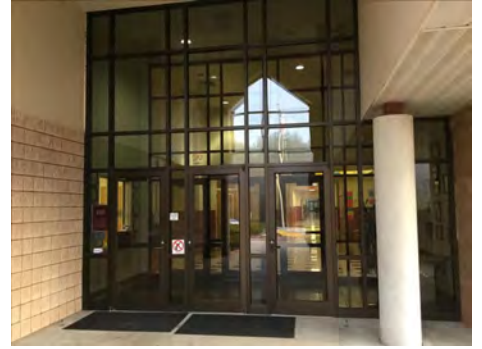
**System:** B2030 - Exterior Doors

**Note:** Exterior doors are generally functional. Some maintenance repairs are required. System renewal at scheduled expiration is recommended.

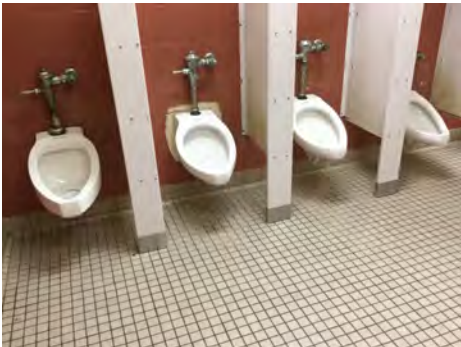
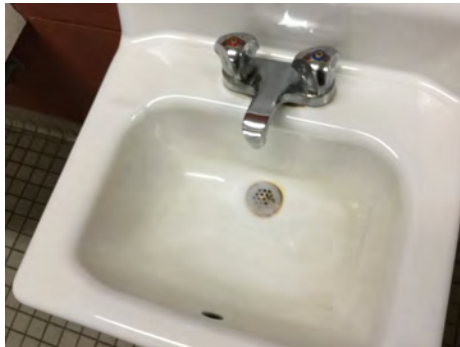
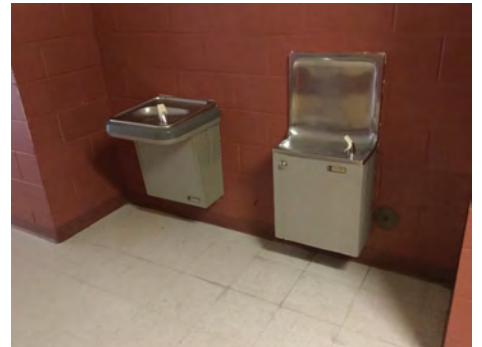
**System:** D2010 - Plumbing Fixtures

**Note:** System renewal at the scheduled 30 year time frame is recommended. Water heaters have been recently updated.

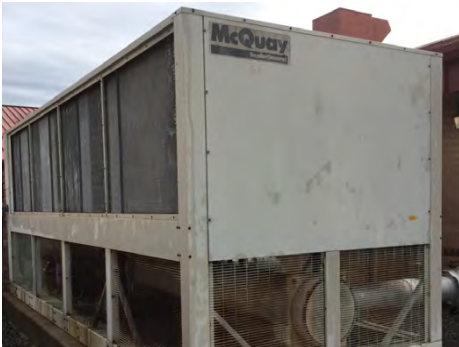
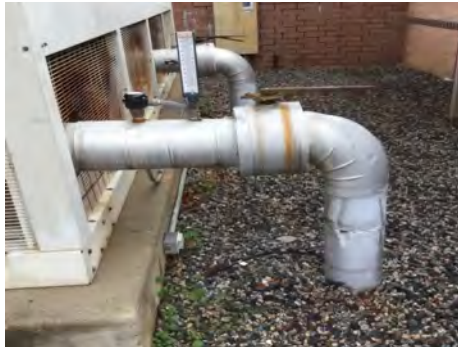
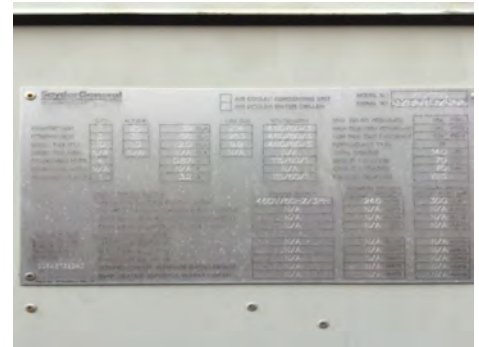
## System: D3030 - Cooling Generating Systems

**Note:** System will expire within one year of FCA. Chiller replacement is recommended along with other recommended HVAC replacements/upgrades for a complete system renovation.

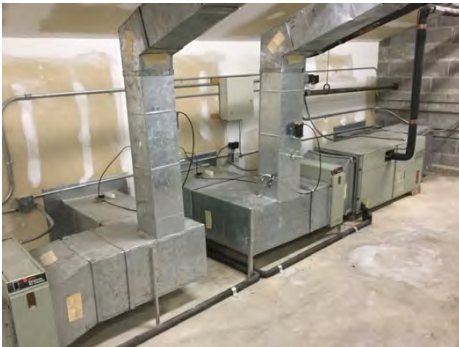
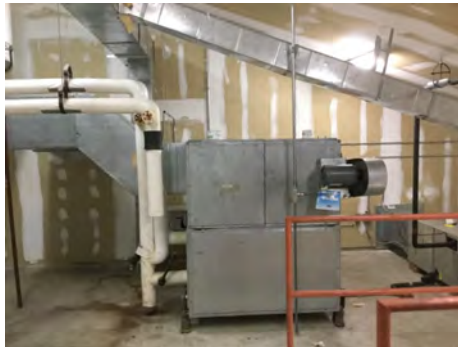
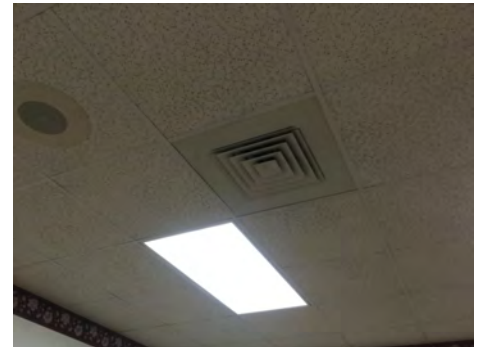
## System: D3040 - Distribution Systems

**Note:** Internally insulated ductwork.

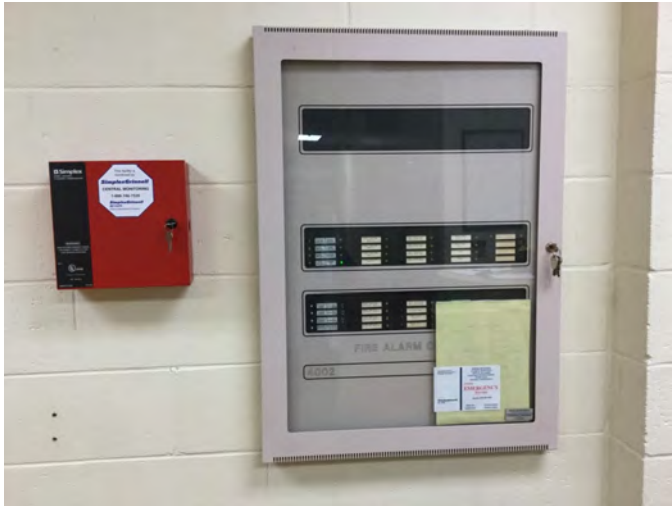
#### System: D5030910 - Fire Alarm Systems

**Location:** Throughout the building  
**Distress:** Failing  
**Category:** Deferred Maintenance / Life Safety Code Compliance  
**Priority:** 2 - Potentially Critical (Year 1)  
**Correction:** Renew System  
**Qty:** 58,823.00  
**Unit of Measure:** S.F.  
**Estimate:** \$214,175.00  
**Assessor Name:** Somnath Das  
**Date Created:** 01/09/2017

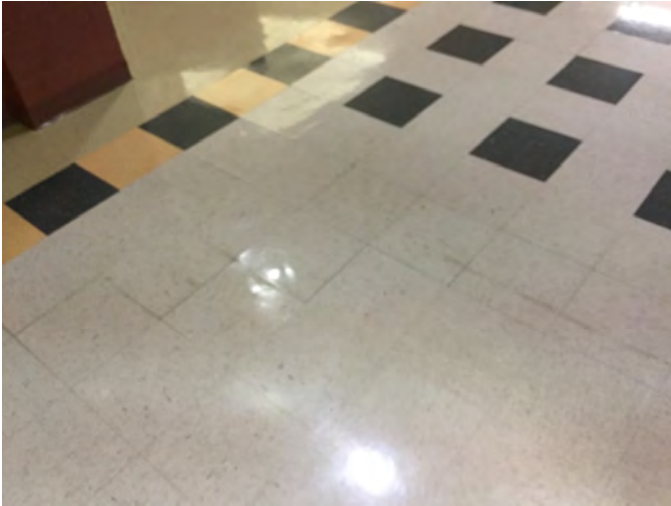
**System: A1010 - Standard Foundations**

**Location:** Throughout the school  
**Distress:** Damaged  
**Category:** Deferred Maintenance  
**Priority:** 3 - Necessary/Not Yet Critical (Years 2-5)  
**Correction:** Engineering Study  
**Qty:** 1.00  
**Unit of Measure:** Ea.  
**Estimate:** \$10,560.00  
**Assessor Name:** Somnath Das  
**Date Created:** 01/12/2017

**Notes:** Slabs on grade show some signs of minor separation; observed throughout the building. Some minor cracks in walls seen. An engineering study is recommended to determine the cause. Pricing does not include remediation measures.

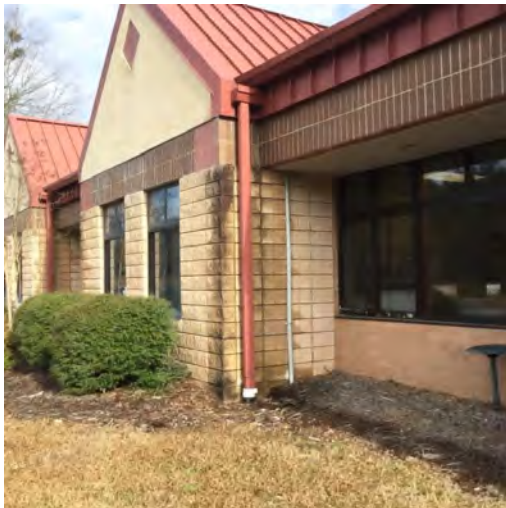
**System: B2010 - Exterior Walls**

**Location:** Exterior walls  
**Distress:** Damaged  
**Category:** Deferred Maintenance / Appearance  
**Priority:** 3 - Necessary/Not Yet Critical (Years 2-5)  
**Correction:** Spray refinish exterior walls  
**Qty:** 30,000.00  
**Unit of Measure:** S.F.  
**Estimate:** \$132,303.60  
**Assessor Name:** Somnath Das  
**Date Created:** 01/12/2017

**Notes:** Exterior walls are excessively stained, primarily due to roof/gutter conditions. Power washing of exterior walls is recommended to be scheduled after roof replacement is completed.

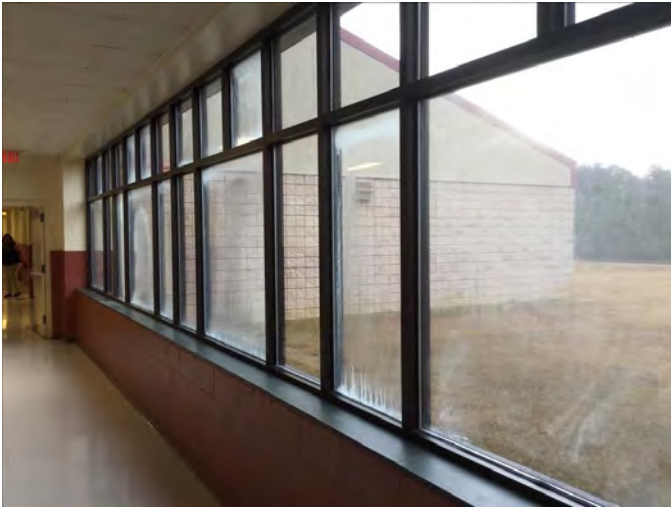
**System: B2020 - Exterior Windows**

**Location:** Exterior windows  
**Distress:** Failing  
**Category:** Deferred Maintenance  
**Priority:** 3 - Necessary/Not Yet Critical (Years 2-5)  
**Correction:** Renew System  
**Qty:** 58,823.00  
**Unit of Measure:** S.F.  
**Estimate:** \$595,289.00  
**Assessor Name:** Somnath Das  
**Date Created:** 01/11/2017

**Notes:** Exterior windows are failing prematurely throughout the school with loss of seals between dual panes. Operable windows (designated for emergency egress) are difficult to operate and may constitute a safety hazard in an evacuation situation. System renewal is recommended.

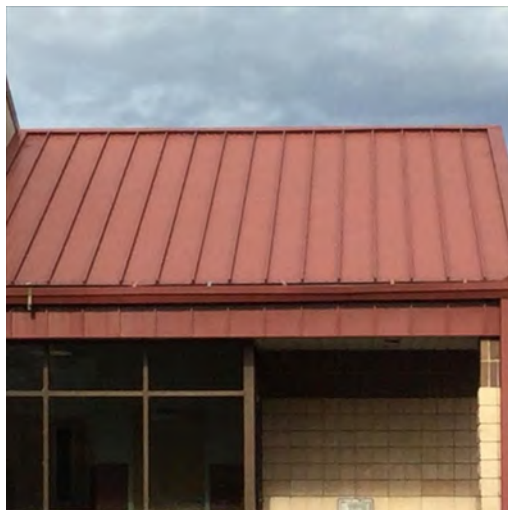
**System: B3010130 - Preformed Metal Roofing**

**Location:** Roof  
**Distress:** Failing  
**Category:** Deferred Maintenance  
**Priority:** 3 - Necessary/Not Yet Critical (Years 2-5)  
**Correction:** Renew System  
**Qty:** 58,823.00  
**Unit of Measure:** S.F.  
**Estimate:** \$784,158.00  
**Assessor Name:** Somnath Das  
**Date Created:** 01/11/2017

**Notes:** Metal roofing is leaking throughout the building, notably at the gym peak, but also in numerous other places, possibly due to faulty original design or installation. High maintenance costs for replacement of ceiling tile. The roof system is not adequately ventilated or insulated, resulting in moisture problems in the building. Gutters leak at seams, and are bent in many places due to ice. System replacement is recommended.

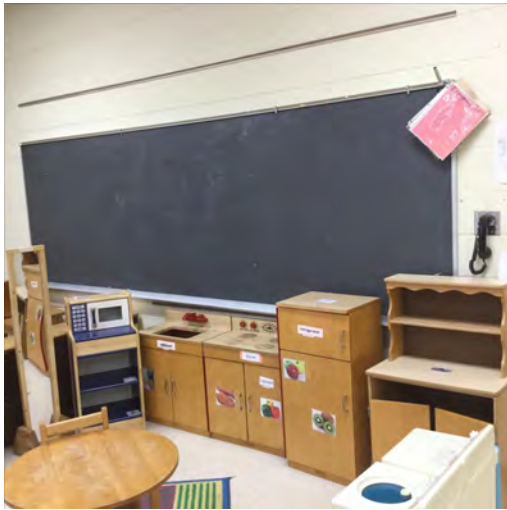
**System: C1030 - Fittings**

**Location:** Throughout the building  
**Distress:** Beyond Service Life  
**Category:** Deferred Maintenance  
**Priority:** 3 - Necessary/Not Yet Critical (Years 2-5)  
**Correction:** Renew System  
**Qty:** 58,823.00  
**Unit of Measure:** S.F.  
**Estimate:** \$617,289.00  
**Assessor Name:** Somnath Das  
**Date Created:** 01/09/2017

**Notes:** Building fittings are typically original and beyond their expected life. In particular, there are still some chalkboards in the school, and many whiteboards are stained beyond cleaning. Lockers at the kitchen are beginning to rust. Signage is original.

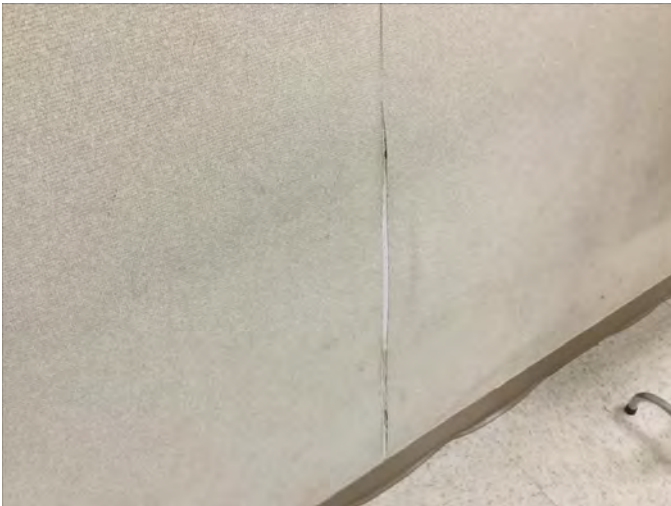
**System: C3010 - Wall Finishes**

**Location:** Throughout the building  
**Distress:** Beyond Service Life  
**Category:** Deferred Maintenance / Appearance  
**Priority:** 3 - Necessary/Not Yet Critical (Years 2-5)  
**Correction:** Renew System  
**Qty:** 58,823.00  
**Unit of Measure:** S.F.  
**Estimate:** \$176,645.00  
**Assessor Name:** Somnath Das  
**Date Created:** 01/09/2017

**Notes:** Painted walls are maintained on an ad hoc basis with no regularly scheduled repainting. Many areas of the building are in need of re-painting. Humidity has caused some peeling. Vinyl wall coverings in classrooms is original and in poor condition with scuffs and peeling wall coverings. System renewal is recommended.

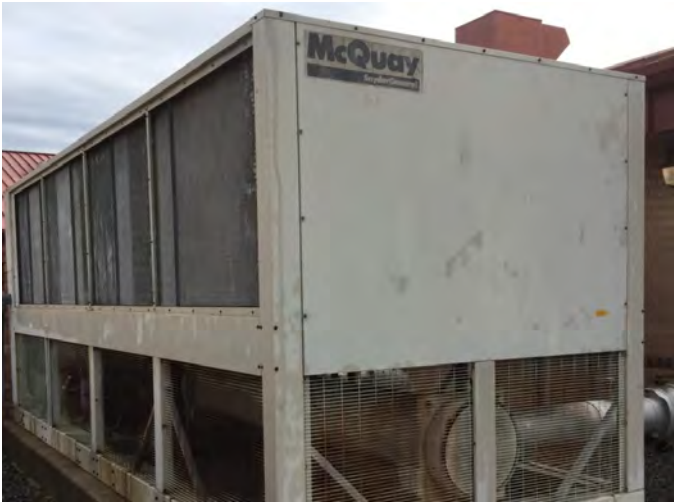
**System: D3030 - Cooling Generating Systems**

**Location:** Mechanical equipment yard  
**Distress:** Beyond Service Life  
**Category:** Deferred Maintenance  
**Priority:** 3 - Necessary/Not Yet Critical (Years 2-5)  
**Correction:** Renew System  
**Qty:** 58,823.00  
**Unit of Measure:** S.F.  
**Estimate:** \$333,879.00  
**Assessor Name:** Somnath Das  
**Date Created:** 01/11/2017

**Notes:** The air cooled chiller is nearing the end of its expected life and should be replaced to ensure cooling capacity for the school.

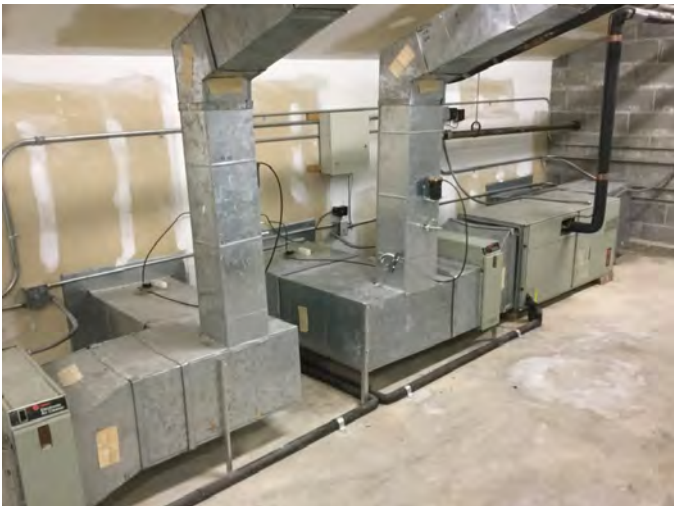
**System: D3040 - Distribution Systems**

**Location:** Throughout the building  
**Distress:** Inadequate  
**Category:** Deferred Maintenance / Energy  
**Priority:** 3 - Necessary/Not Yet Critical (Years 2-5)  
**Correction:** Renew System  
**Qty:** 58,823.00  
**Unit of Measure:** S.F.  
**Estimate:** \$389,526.00  
**Assessor Name:** Somnath Das  
**Date Created:** 01/11/2017

**Notes:** Internally insulated ductwork is used throughout the building. Air handlers are original and need balancing. System renewal is recommended.

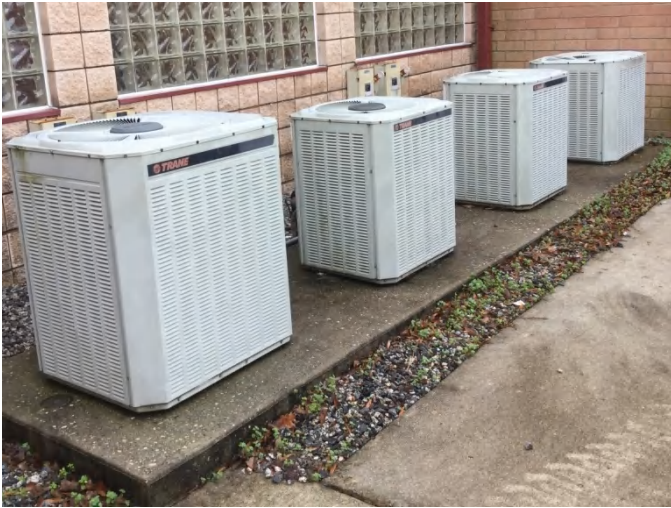
**System: D3050 - Terminal & Package Units**

**Location:** Front office  
**Distress:** Beyond Service Life  
**Category:** Deferred Maintenance / Energy  
**Priority:** 3 - Necessary/Not Yet Critical (Years 2-5)  
**Correction:** Renew System  
**Qty:** 58,823.00  
**Unit of Measure:** S.F.  
**Estimate:** \$191,528.00  
**Assessor Name:** Somnath Das  
**Date Created:** 01/09/2017

**Notes:** Split system heat pumps used at front office areas are original and well beyond their expected life. Closets / rooms converted to data rooms do not typically have adequate cooling/ventilation. System renewal with modern energy efficient equipment is recommended.

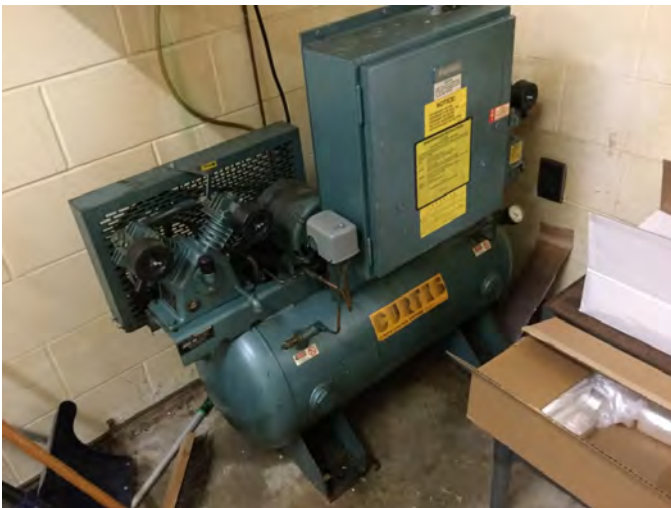
**System: D3060 - Controls & Instrumentation**

**Location:** Throughout the building  
**Distress:** Beyond Service Life  
**Category:** Deferred Maintenance / Energy  
**Priority:** 3 - Necessary/Not Yet Critical (Years 2-5)  
**Correction:** Renew System  
**Qty:** 58,823.00  
**Unit of Measure:** S.F.  
**Estimate:** \$123,587.00  
**Assessor Name:** Somnath Das  
**Date Created:** 01/09/2017

**Notes:** Building controls are typically original pneumatics. They are locally controlled. Installation of a modern digital system with remote monitoring and control capability for energy conservation is recommended.

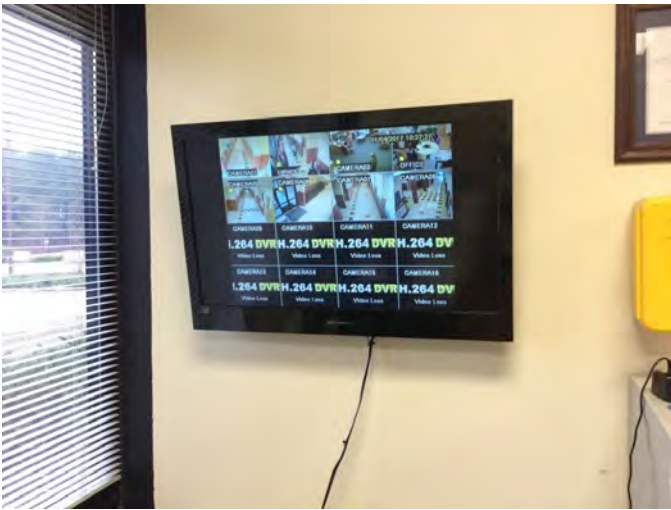
**System: D5030810 - Security & Detection Systems**

**Location:** Throughout the building  
**Distress:** Inadequate  
**Category:** Deferred Maintenance / Safety  
**Priority:** 3 - Necessary/Not Yet Critical (Years 2-5)  
**Correction:** Renew System  
**Qty:** 58,823.00  
**Unit of Measure:** S.F.  
**Estimate:** \$118,411.00  
**Assessor Name:** Somnath Das  
**Date Created:** 01/09/2017

**Notes:** The security system is mostly original and beyond its expected life. There are areas inside and outside the building that aren't monitored. Addition of magnetic locks at exterior doors is suggested. System renewal is recommended.

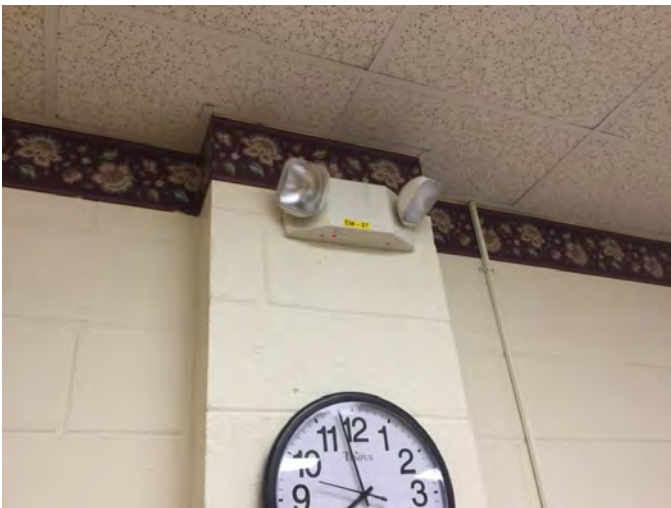
**System: D5090 - Other Electrical Systems**

**Location:** Throughout the building  
**Distress:** Beyond Service Life  
**Category:** Deferred Maintenance / Life Safety Code Compliance  
**Priority:** 3 - Necessary/Not Yet Critical (Years 2-5)  
**Correction:** Renew System  
**Qty:** 58,823.00  
**Unit of Measure:** S.F.  
**Estimate:** \$7,765.00  
**Assessor Name:** Somnath Das  
**Date Created:** 01/11/2017

**Notes:** Emergency lighting systems are believed to be original and are beyond their expected service life. As this is a Life Safety concern, system renewal is recommended.

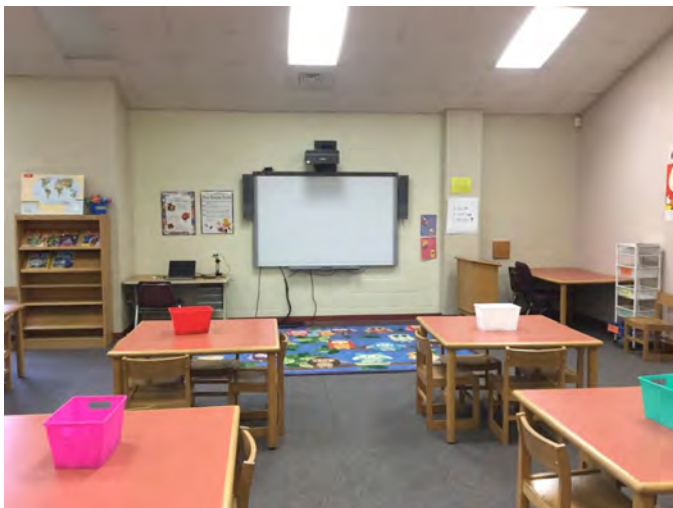
**System: E1020 - Institutional Equipment**

**Location:** Throughout the school  
**Distress:** Beyond Service Life  
**Category:** Deferred Maintenance  
**Priority:** 3 - Necessary/Not Yet Critical (Years 2-5)  
**Correction:** Renew System  
**Qty:** 58,823.00  
**Unit of Measure:** S.F.  
**Estimate:** \$19,412.00  
**Assessor Name:** Somnath Das  
**Date Created:** 01/11/2017

**Notes:** Institutional equipment as a system is generally beyond its expected life. In particular, the number of Smartboards is inadequate. System renewal is recommended.

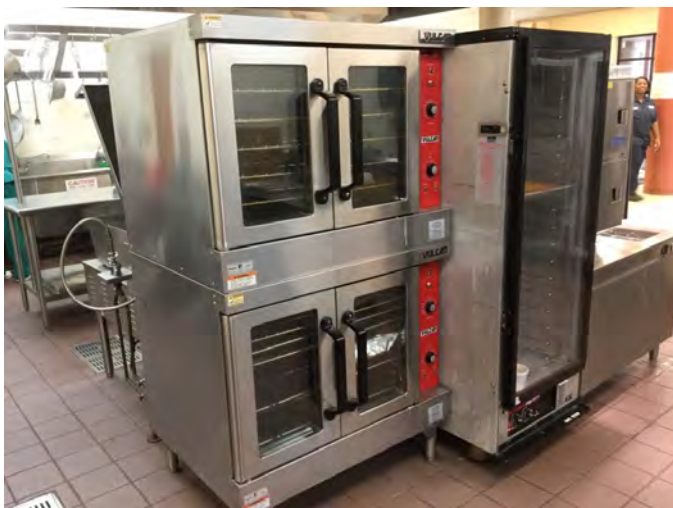
**System: E1090 - Other Equipment**

**Location:** Kitchen  
**Distress:** Beyond Service Life  
**Category:** Deferred Maintenance  
**Priority:** 3 - Necessary/Not Yet Critical (Years 2-5)  
**Correction:** Renew System  
**Qty:** 58,823.00  
**Unit of Measure:** S.F.  
**Estimate:** \$120,352.00  
**Assessor Name:** Somnath Das  
**Date Created:** 01/09/2017

**Notes:** The original kitchen hood and exhaust system is operating but is beyond its expected life, and should be replaced.

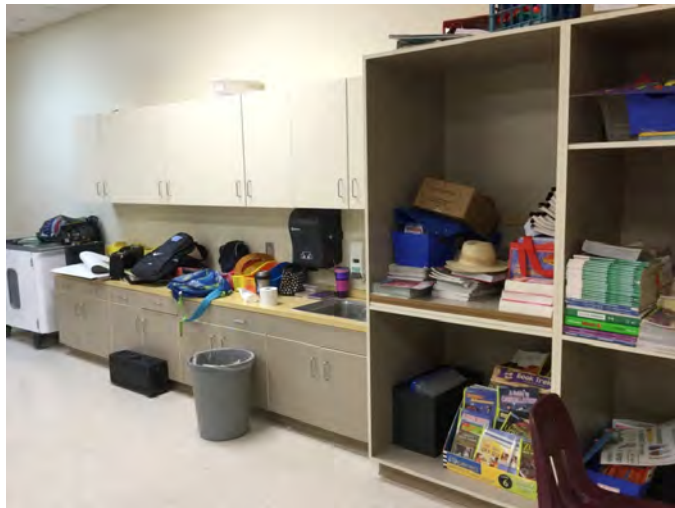
**System: E2010 - Fixed Furnishings**

**Location:** Throughout the building.  
**Distress:** Beyond Service Life  
**Category:** Deferred Maintenance  
**Priority:** 3 - Necessary/Not Yet Critical (Years 2-5)  
**Correction:** Renew System  
**Qty:** 58,823.00  
**Unit of Measure:** S.F.  
**Estimate:** \$370,114.00  
**Assessor Name:** Somnath Das  
**Date Created:** 01/09/2017

**Notes:** Fixed furnishings including classroom cabinetry and window treatments are beyond their expected useful life and are showing some signs of wear and tear. Window treatments are missing at many spaces, creating glare. System renewal is recommended.

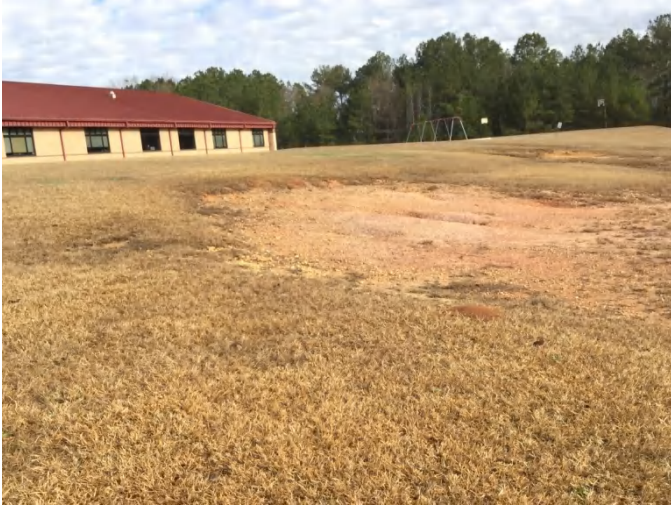
#### **System: G2050 - Landscaping**

**Location:** Site, south side  
**Distress:** Failing  
**Category:** Deferred Maintenance / Safety  
**Priority:** 2 - Potentially Critical (Year 1)  
**Correction:** Erosion control; incl. soil preparation, topsoil and sodding  
**Qty:** 10,000.00  
**Unit of Measure:** S.F.  
**Estimate:** \$270,498.36  
**Assessor Name:** Terence Davis  
**Date Created:** 01/12/2017

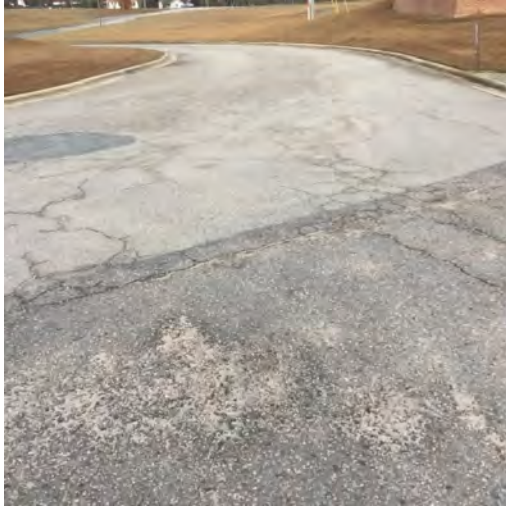
**System: G2010 - Roadways**

**Location:** Site  
**Distress:** Beyond Service Life  
**Category:** Deferred Maintenance  
**Priority:** 3 - Necessary/Not Yet Critical (Years 2-5)  
**Correction:** Renew System  
**Qty:** 59,399.00  
**Unit of Measure:** S.F.  
**Estimate:** \$248,941.00  
**Assessor Name:** Terence Davis  
**Date Created:** 12/19/2016

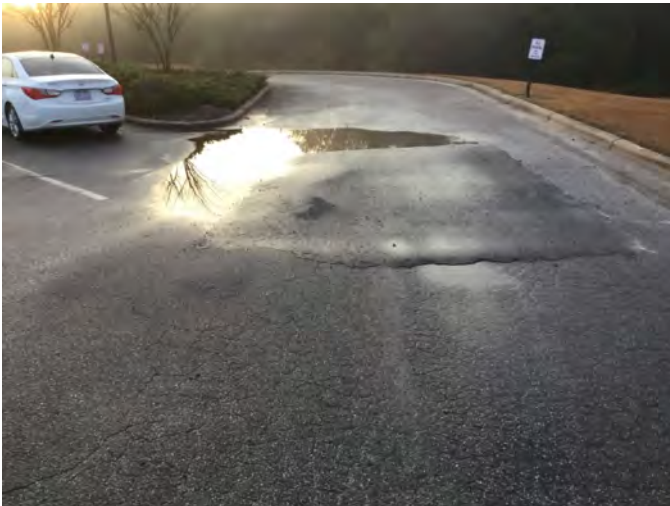
**System: G2020 - Parking Lots**

**Location:** Site  
**Distress:** Beyond Service Life  
**Category:** Deferred Maintenance  
**Priority:** 3 - Necessary/Not Yet Critical (Years 2-5)  
**Correction:** Renew System  
**Qty:** 59,399.00  
**Unit of Measure:** S.F.  
**Estimate:** \$86,901.00  
**Assessor Name:** Terence Davis  
**Date Created:** 12/19/2016

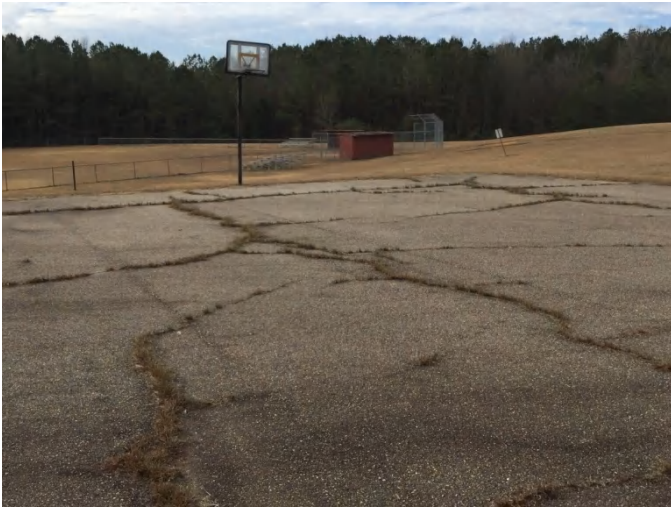
**System: G2040950 - Hard Surface Play Area**

**Location:** Site  
**Distress:** Beyond Service Life  
**Category:** Deferred Maintenance  
**Priority:** 3 - Necessary/Not Yet Critical (Years 2-5)  
**Correction:** Renew System  
**Qty:** 59,399.00  
**Unit of Measure:** S.F.  
**Estimate:** \$49,004.00  
**Assessor Name:** Terence Davis  
**Date Created:** 12/19/2016

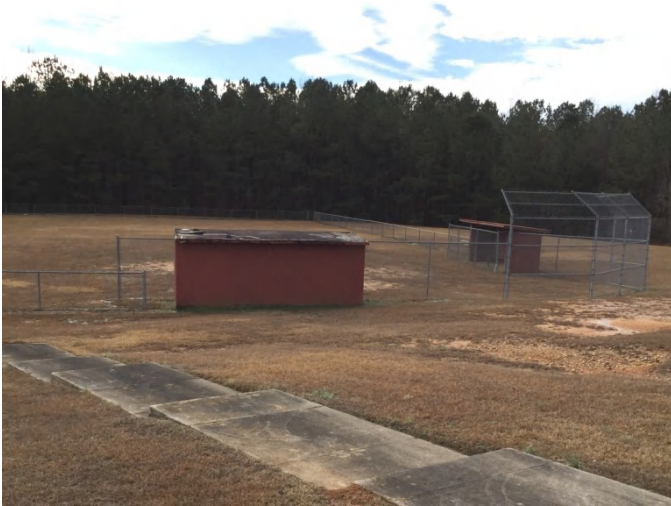
**System: G2040950 - Playing Field**

**Location:** Site  
**Distress:** Beyond Service Life  
**Category:** Deferred Maintenance  
**Priority:** 3 - Necessary/Not Yet Critical (Years 2-5)  
**Correction:** Renew System  
**Qty:** 59,399.00  
**Unit of Measure:** S.F.  
**Estimate:** \$296,639.00  
**Assessor Name:** Terence Davis  
**Date Created:** 12/19/2016
