NC School District/040 Anson County/Elementary School

Peachland-Polkton Elementary

Campus Assessment Report

March 11, 2017

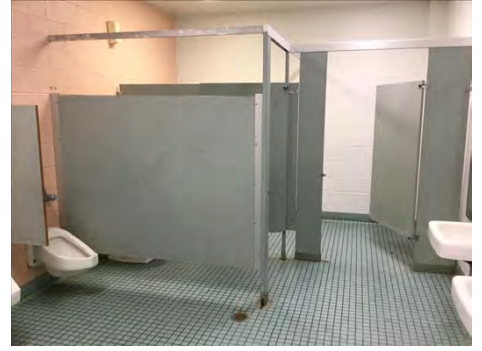
System: C1030 - Fittings

Note: The toilet partition and the signages throughout the school needs to be replaced.

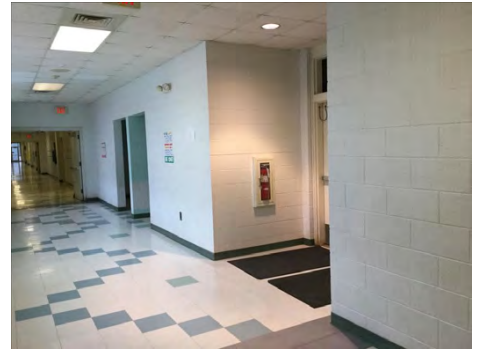
System: C3010 - Wall Finishes

Note: The paint is beyond its service life and should be replaced.

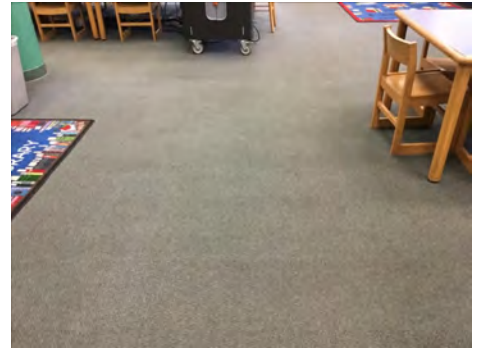
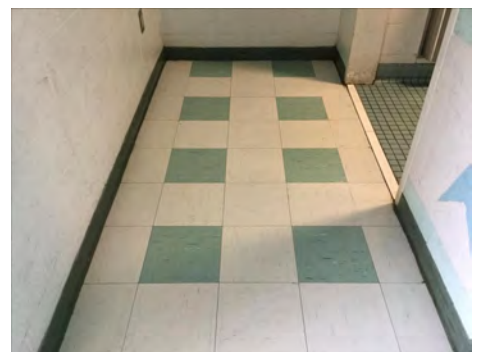
System: C3020 - Floor Finishes

Note: The carpet and portion of the VCT needs to be replaced.

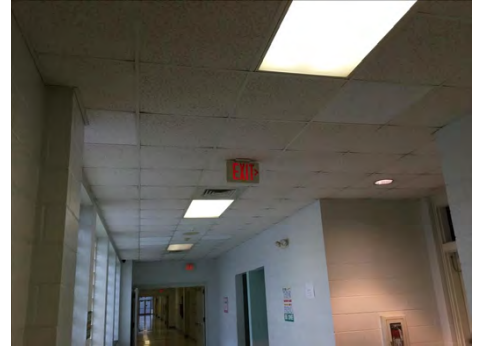
System: C3030 - Ceiling Finishes

Note: The acoustical ceiling tiles are beyond their service life and should be replaced.

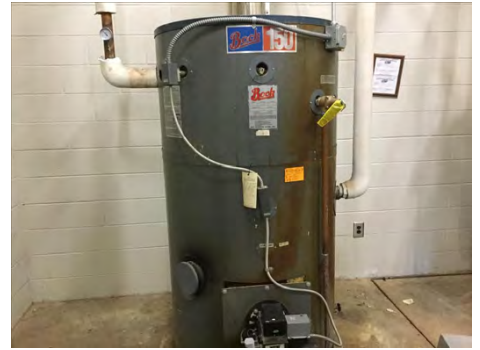
System: D2020 - Domestic Water Distribution

Note: The domestic water distribution system is beyond its service life and should be replaced.

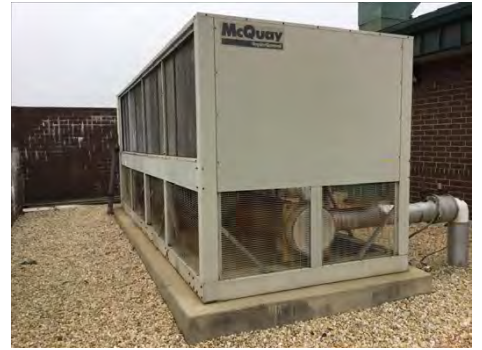
System: D3030 - Cooling Generating Systems

Note: The cooling system is beyond its service life and should be replaced.

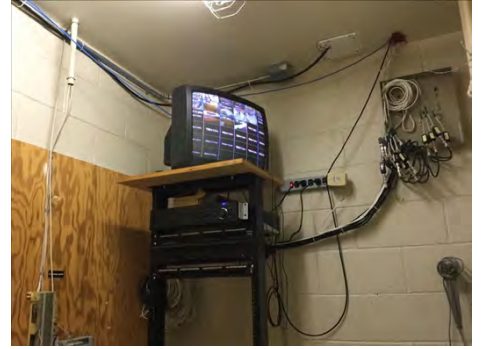
System: D5030810 - Security & Detection Systems

Note: The security and detection system is beyond its service life and should be replaced.

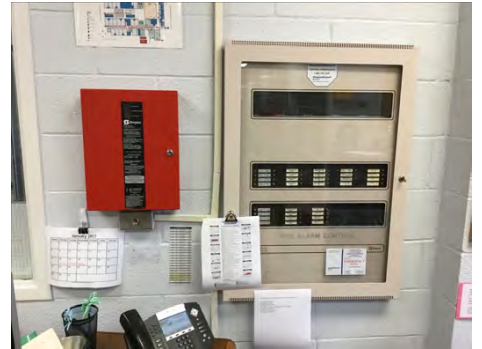
System: D5030910 - Fire Alarm Systems

Note: The fire alarm system is beyond its service life and should be replaced.

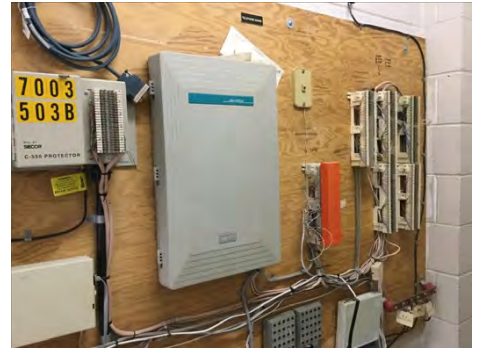
System: D5030920 - Data Communication

Note: The data communication is beyond its service life and should be replaced.

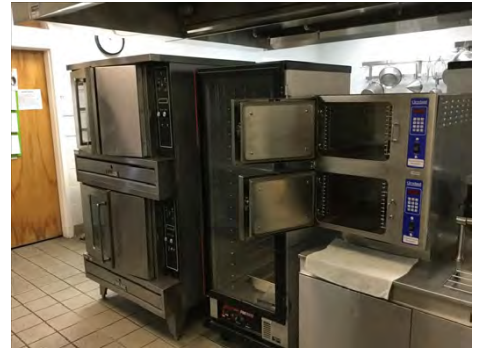
System: E1090 - Other Equipment

Note: The kitchen equipment is beyond its service life and should be replaced.

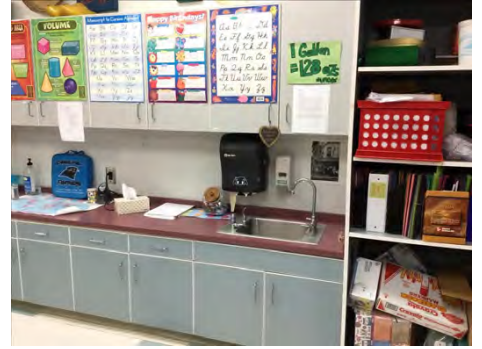
System: E2010 - Fixed Furnishings

Note: The fixed furnishings are beyond their service life and should be replaced.

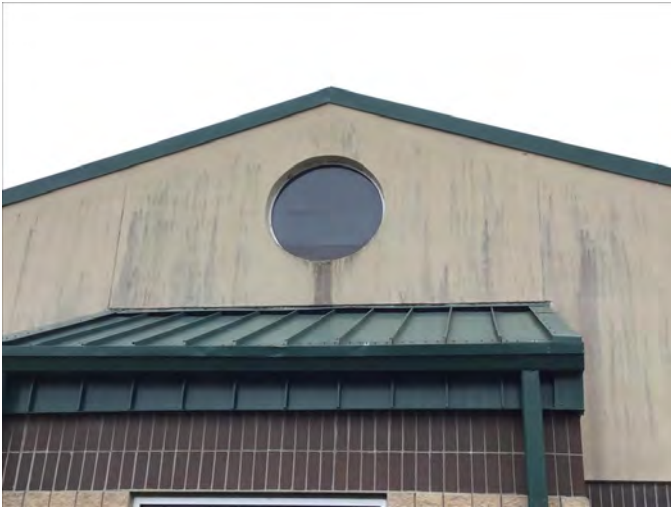
System: B2020 - Exterior Windows

Location: Exterior Walls
Distress: Failing
Category: Deferred Maintenance / Energy
Priority: 3 - Necessary/Not Yet Critical (Years 2-5)
Correction: Repair 3' x 4' aluminum window - 1st floor
Qty: 20.00
Unit of Measure: Ea.
Estimate: \$9,474.96
Assessor Name: Eduardo Lopez
Date Created: 01/18/2017

Notes: The exterior windows need to be resealed as the sealing is in poor condition.

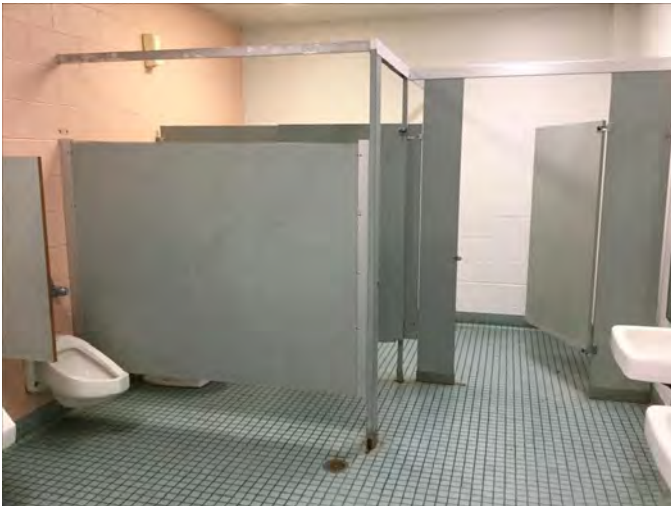
System: C1030 - Fittings

Location: Throughout Building
Distress: Beyond Service Life
Category: Deferred Maintenance
Priority: 3 - Necessary/Not Yet Critical (Years 2-5)
Correction: Renew System
Qty: 65,259.00
Unit of Measure: S.F.
Estimate: \$684,828.00
Assessor Name: Eduardo Lopez
Date Created: 01/16/2017

Notes: The toilet partition and the signages throughout the school needs to be replaced.

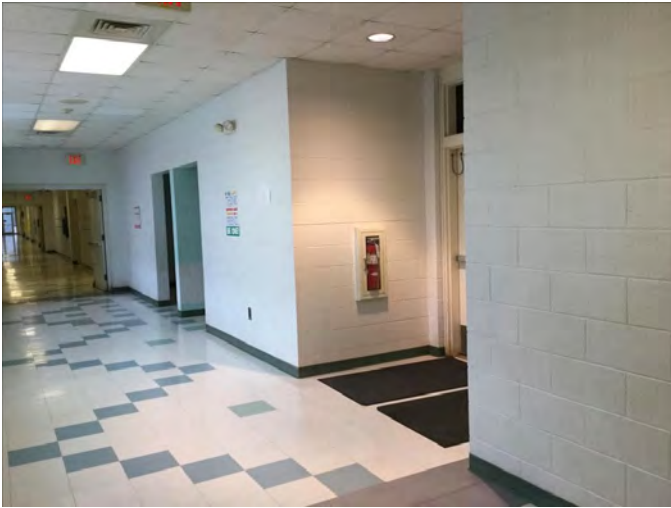
System: C3010 - Wall Finishes

Location: Throughout Building
Distress: Beyond Service Life
Category: Deferred Maintenance
Priority: 3 - Necessary/Not Yet Critical (Years 2-5)
Correction: Renew System
Qty: 65,259.00
Unit of Measure: S.F.
Estimate: \$195,973.00
Assessor Name: Eduardo Lopez
Date Created: 01/16/2017

Notes: The paint is beyond its service life and should be replaced.

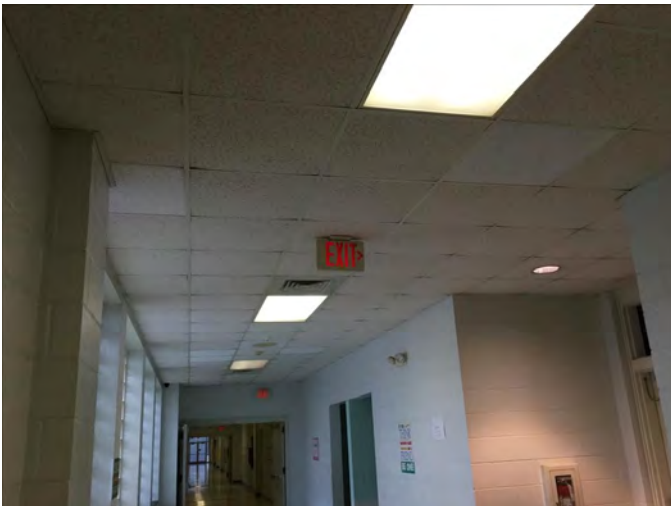
System: C3030 - Ceiling Finishes

Location: Throughout Building
Distress: Beyond Service Life
Category: Deferred Maintenance
Priority: 3 - Necessary/Not Yet Critical (Years 2-5)
Correction: Renew System
Qty: 65,259.00
Unit of Measure: S.F.
Estimate: \$770,970.00
Assessor Name: Eduardo Lopez
Date Created: 01/19/2017

Notes: The acoustical ceiling tiles are beyond their service life and should be replaced.

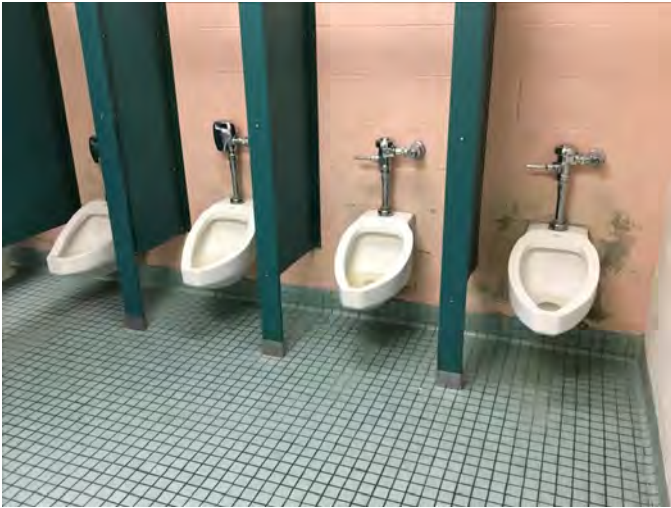
System: D2010 - Plumbing Fixtures

Location: Throughout Building
Distress: Beyond Service Life
Category: Deferred Maintenance
Priority: 3 - Necessary/Not Yet Critical (Years 2-5)
Correction: Renew System
Qty: 65,259.00
Unit of Measure: S.F.
Estimate: \$808,298.00
Assessor Name: Eduardo Lopez
Date Created: 01/19/2017

Notes: The plumbing fixtures are beyond their service life and should be replaced.

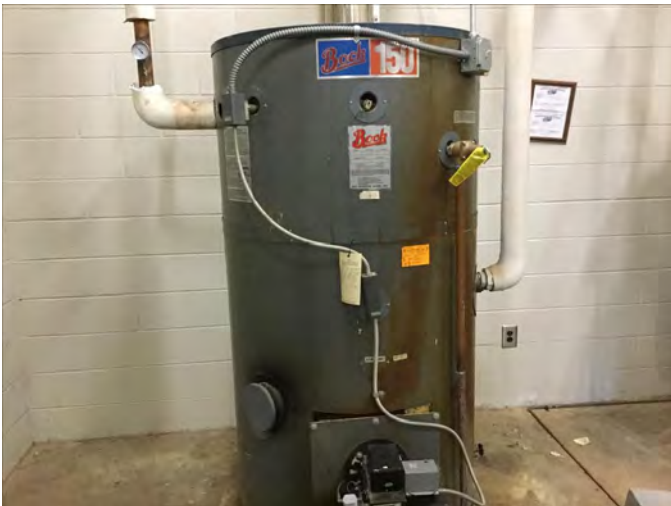
System: D2020 - Domestic Water Distribution

Location: Throughout Building
Distress: Beyond Service Life
Category: Deferred Maintenance
Priority: 3 - Necessary/Not Yet Critical (Years 2-5)
Correction: Renew System
Qty: 65,259.00
Unit of Measure: S.F.
Estimate: \$68,914.00
Assessor Name: Eduardo Lopez
Date Created: 01/19/2017

Notes: The domestic water distribution system is beyond its service life and should be replaced.

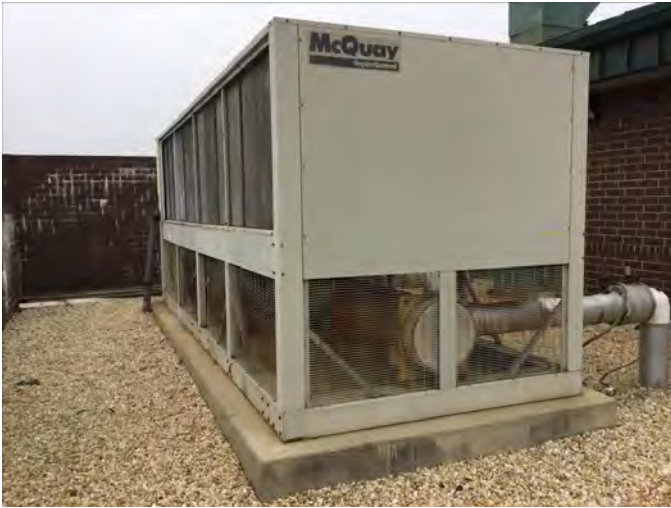
System: D3030 - Cooling Generating Systems

Location: Throughout Building
Distress: Beyond Service Life
Category: Deferred Maintenance
Priority: 3 - Necessary/Not Yet Critical (Years 2-5)
Correction: Renew System
Qty: 65,259.00
Unit of Measure: S.F.
Estimate: \$370,410.00
Assessor Name: Eduardo Lopez
Date Created: 01/19/2017

Notes: The cooling system is beyond its service life and should be replaced.

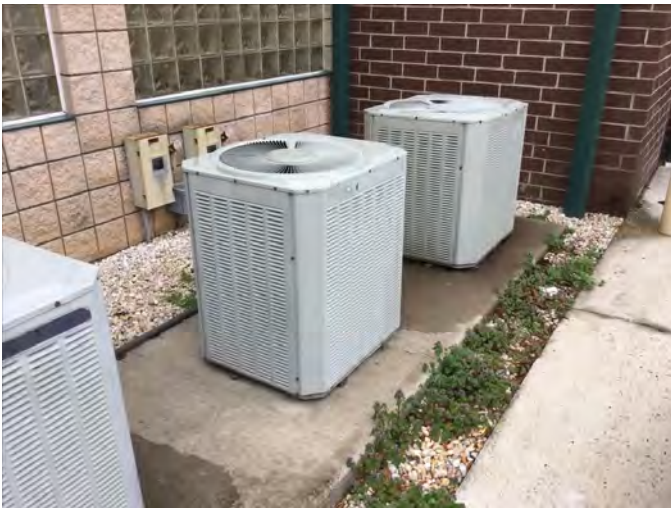
System: D3050 - Terminal & Package Units

Location: Throughout Building
Distress: Beyond Service Life
Category: Deferred Maintenance
Priority: 3 - Necessary/Not Yet Critical (Years 2-5)
Correction: Renew System
Qty: 65,259.00
Unit of Measure: S.F.
Estimate: \$212,483.00
Assessor Name: Eduardo Lopez
Date Created: 01/16/2017

Notes: The terminal and package units are beyond their service life and should be replaced.

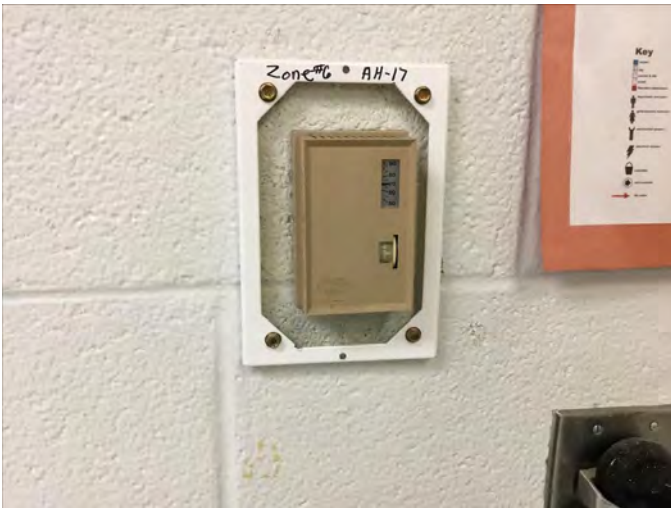
System: D3060 - Controls & Instrumentation

Location: Throughout Building
Distress: Beyond Service Life
Category: Deferred Maintenance
Priority: 3 - Necessary/Not Yet Critical (Years 2-5)
Correction: Renew System
Qty: 65,259.00
Unit of Measure: S.F.
Estimate: \$137,109.00
Assessor Name: Eduardo Lopez
Date Created: 01/16/2017

Notes: The controls and instrumentation are beyond its service life and should be replaced.

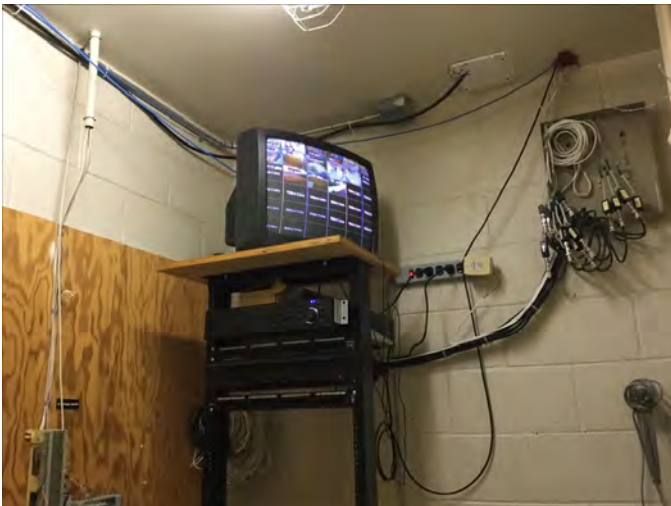
System: D5030810 - Security & Detection Systems

Location: Throughout Building
Distress: Beyond Service Life
Category: Deferred Maintenance
Priority: 3 - Necessary/Not Yet Critical (Years 2-5)
Correction: Renew System
Qty: 65,259.00
Unit of Measure: S.F.
Estimate: \$131,366.00
Assessor Name: Eduardo Lopez
Date Created: 01/16/2017

Notes: The security and detection system is beyond its service life and should be replaced.

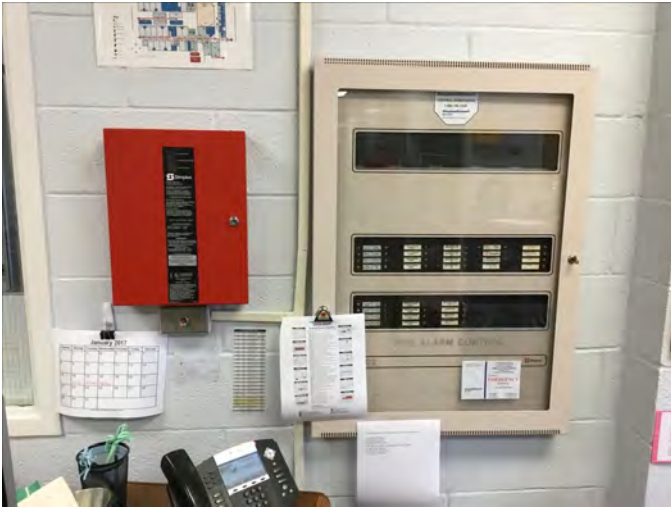
System: D5030910 - Fire Alarm Systems

Location: Throughout Building
Distress: Beyond Service Life
Category: Deferred Maintenance
Priority: 3 - Necessary/Not Yet Critical (Years 2-5)
Correction: Renew System
Qty: 65,259.00
Unit of Measure: S.F.
Estimate: \$237,608.00
Assessor Name: Eduardo Lopez
Date Created: 01/16/2017

Notes: The fire alarm system is beyond its service life and should be replaced.

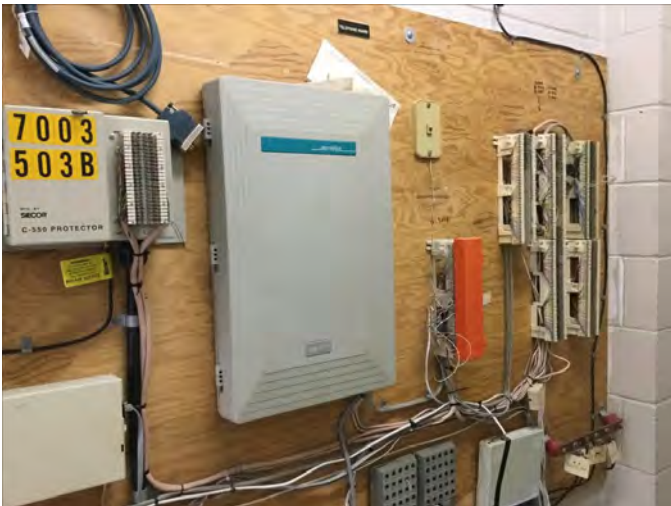
System: D5030920 - Data Communication

Location: Throughout Building
Distress: Beyond Service Life
Category: Deferred Maintenance
Priority: 3 - Necessary/Not Yet Critical (Years 2-5)
Correction: Renew System
Qty: 65,259.00
Unit of Measure: S.F.
Estimate: \$308,675.00
Assessor Name: Eduardo Lopez
Date Created: 01/16/2017

Notes: The data communication is beyond its service life and should be replaced.

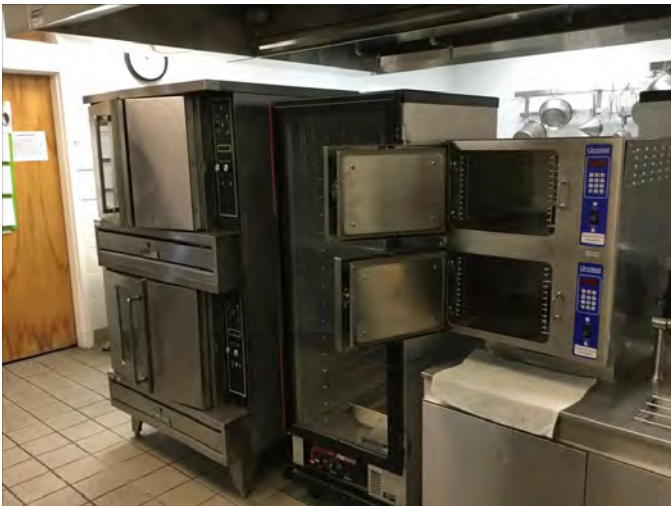
System: E1090 - Other Equipment

Location: Kitchen
Distress: Beyond Service Life
Category: Deferred Maintenance
Priority: 3 - Necessary/Not Yet Critical (Years 2-5)
Correction: Renew System
Qty: 65,259.00
Unit of Measure: S.F.
Estimate: \$133,520.00
Assessor Name: Eduardo Lopez
Date Created: 01/16/2017

Notes: The kitchen equipment is beyond its service life and should be replaced.

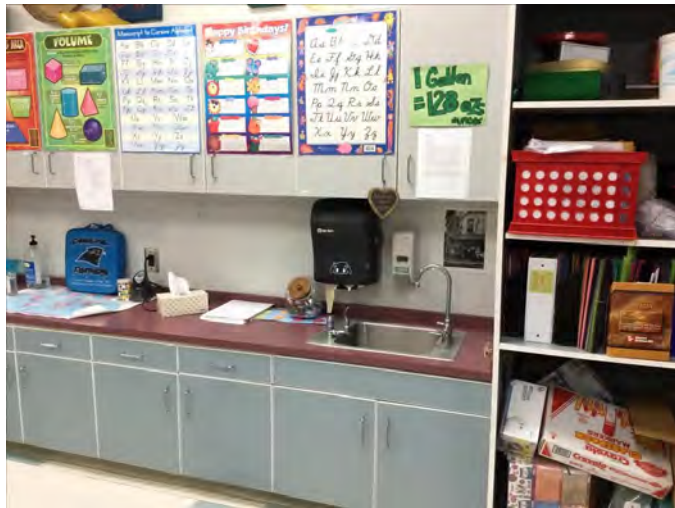
System: E2010 - Fixed Furnishings

Location: Throughout Building
Distress: Beyond Service Life
Category: Deferred Maintenance
Priority: 3 - Necessary/Not Yet Critical (Years 2-5)
Correction: Renew System
Qty: 65,259.00
Unit of Measure: S.F.
Estimate: \$410,610.00
Assessor Name: Eduardo Lopez
Date Created: 01/16/2017

Notes: The fixed furnishings are beyond their service life and should be replaced.

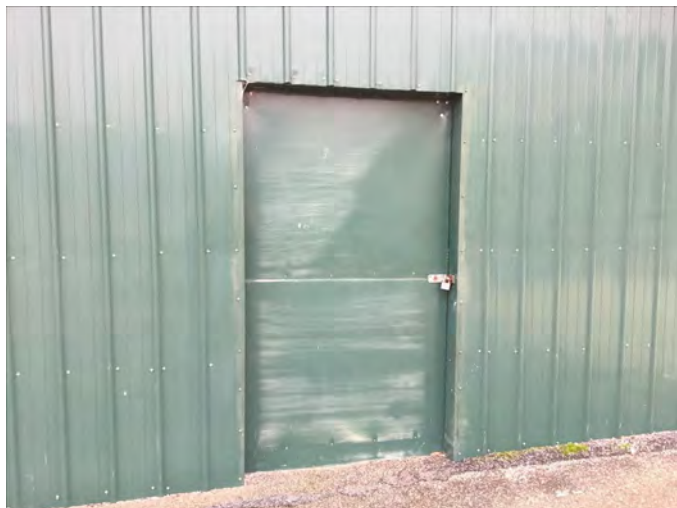
System: B2030 - Exterior Doors

Location: Exterior Walls
Distress: Damaged
Category: Deferred Maintenance / Appearance
Priority: 3 - Necessary/Not Yet Critical (Years 2-5)
Correction: Refinish 3'-0" x 7'-0" steel sliding painted door
Qty: 3.00
Unit of Measure: Ea.
Estimate: \$447.48
Assessor Name: Eduardo Lopez
Date Created: 01/18/2017

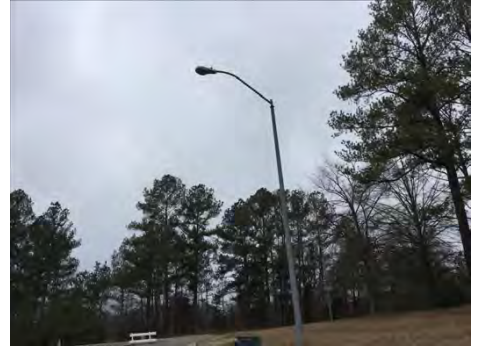
System: G4020 - Site Lighting

Note: The exterior lighting is considered inadequate and more lighting should be installed.

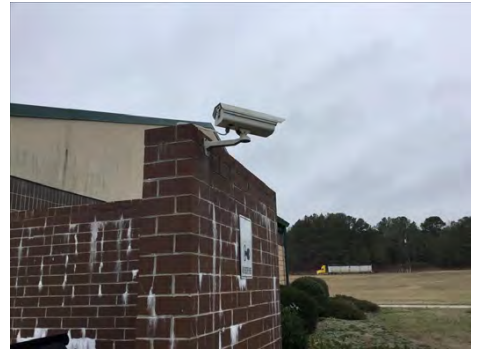
System: G4030 - Site Communications & Security

Note: The site security system is beyond its service life and should be replaced.

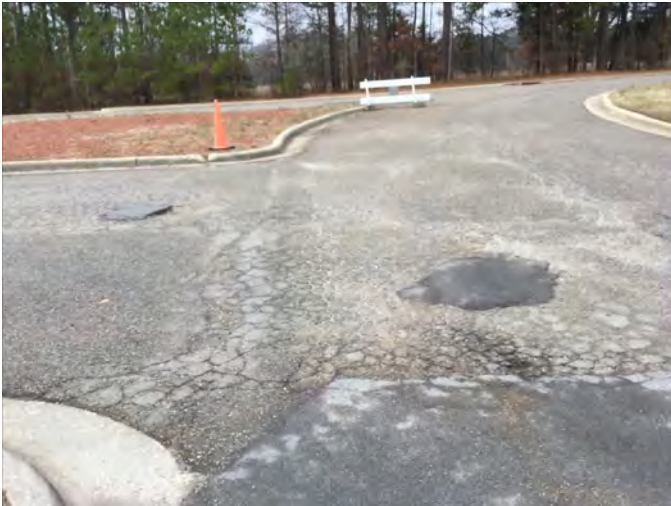
Location: Site
Distress: Beyond Service Life
Category: Deferred Maintenance
Priority: 3 - Necessary/Not Yet Critical (Years 2-5)
Correction: Renew System
Qty: 66,179.00
Unit of Measure: S.F.
Estimate: \$277,356.00
Assessor Name: Eduardo Lopez
Date Created: 01/19/2017

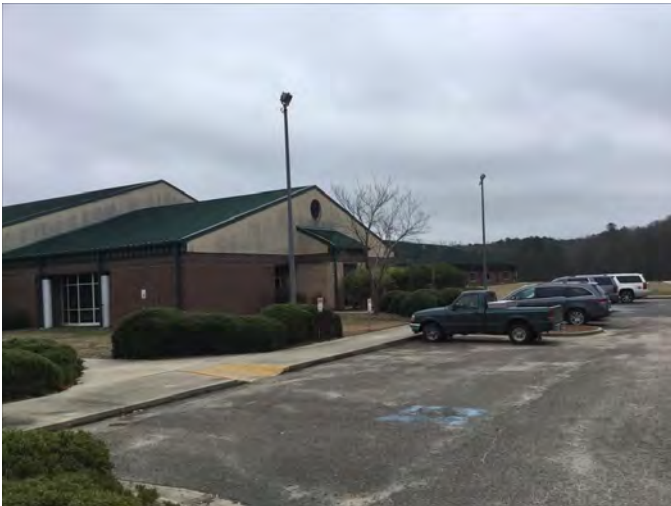
Location: Site
Distress: Beyond Service Life
Category: Deferred Maintenance
Priority: 3 - Necessary/Not Yet Critical (Years 2-5)
Correction: Renew System
Qty: 66,179.00
Unit of Measure: S.F.
Estimate: \$96,820.00
Assessor Name: Eduardo Lopez
Date Created: 01/19/2017

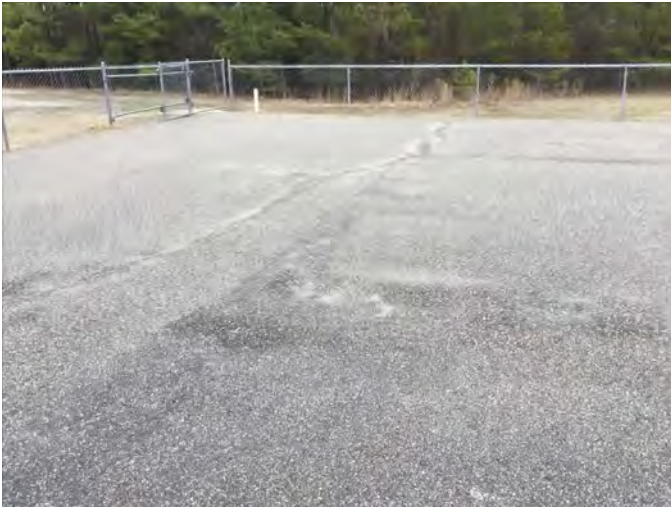
Location: Site
Distress: Beyond Service Life
Category: Deferred Maintenance
Priority: 3 - Necessary/Not Yet Critical (Years 2-5)
Correction: Renew System
Qty: 66,179.00
Unit of Measure: S.F.
Estimate: \$54,598.00
Assessor Name: Eduardo Lopez
Date Created: 01/16/2017

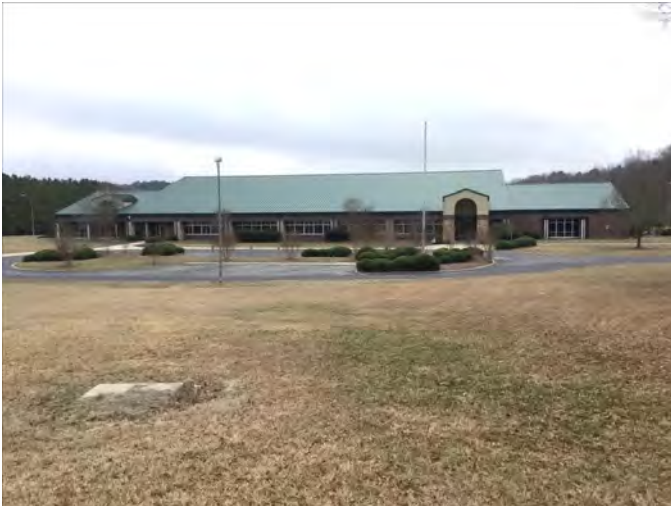
Location: Site
Distress: Failing
Category: Life Safety Code Compliance
Priority: 3 - Necessary/Not Yet Critical (Years 2-5)
Correction: Grading study
Qty: 1.00
Unit of Measure: Ea.
Estimate: \$6,600.00
Assessor Name: Eduardo Lopez
Date Created: 01/18/2017

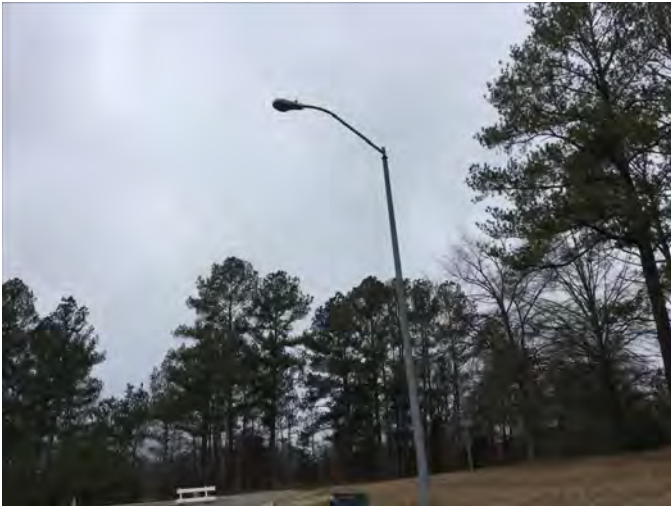
Location: Site
Distress: Inadequate
Category: Safety
Priority: 3 - Necessary/Not Yet Critical (Years 2-5)
Correction: Renew System
Qty: 66,179.00
Unit of Measure: S.F.
Estimate: \$107,011.00
Assessor Name: Eduardo Lopez
Date Created: 01/19/2017

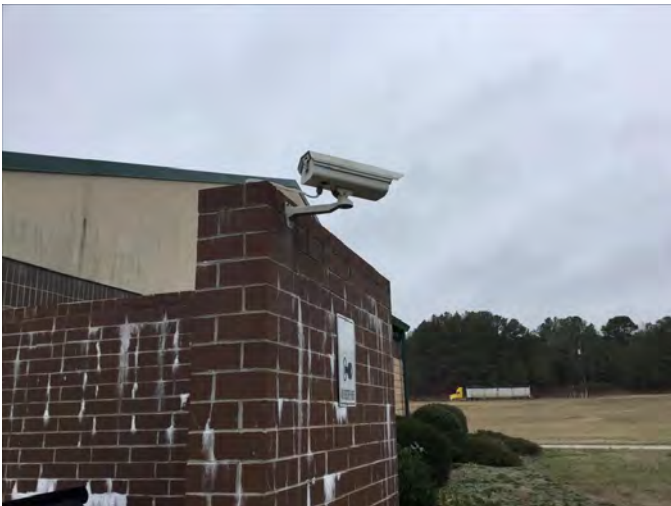
Location: Site
Distress: Beyond Service Life
Category: Deferred Maintenance
Priority: 3 - Necessary/Not Yet Critical (Years 2-5)
Correction: Renew System
Qty: 66,179.00
Unit of Measure: S.F.
Estimate: \$61,149.00
Assessor Name: Eduardo Lopez
Date Created: 01/19/2017
