NC School District/040 Anson County/Elementary School

Wadesboro Elementary

Campus Assessment Report

March 11, 2017

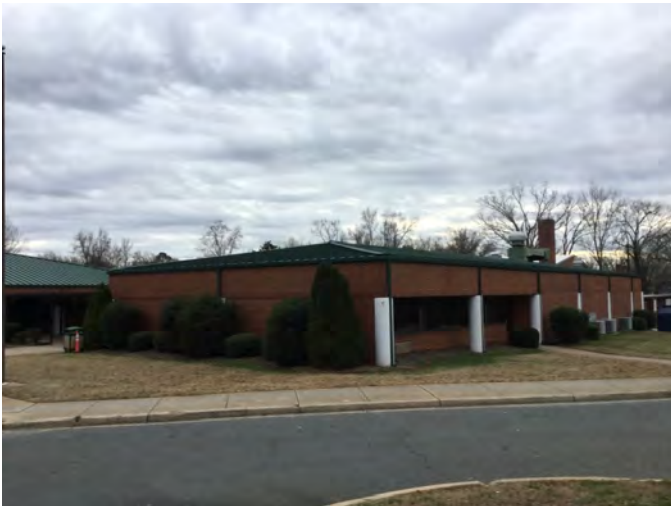
System: B3010130 - Preformed Metal Roofing

Location: Roof
Distress: Beyond Service Life
Category: Deferred Maintenance
Priority: 3 - Necessary/Not Yet Critical (Years 2-5)
Correction: Renew System
Qty: 6,685.00
Unit of Measure: S.F.
Estimate: \$89,116.00
Assessor Name: Somnath Das
Date Created: 12/19/2016

Notes: The roof has exceeded its expected life. System renewal is recommended.

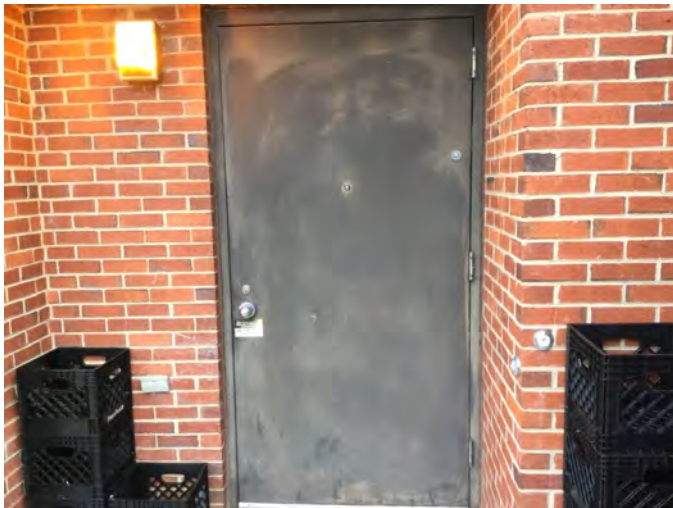
System: C1020 - Interior Doors

Location: Exterior doors
Distress: Beyond Service Life
Category: Deferred Maintenance
Priority: 3 - Necessary/Not Yet Critical (Years 2-5)
Correction: Renew System
Qty: 6,685.00
Unit of Measure: S.F.
Estimate: \$18,237.00
Assessor Name: Somnath Das
Date Created: 12/19/2016

Notes: Exterior doors are beyond their expected service life. System renewal is recommended.

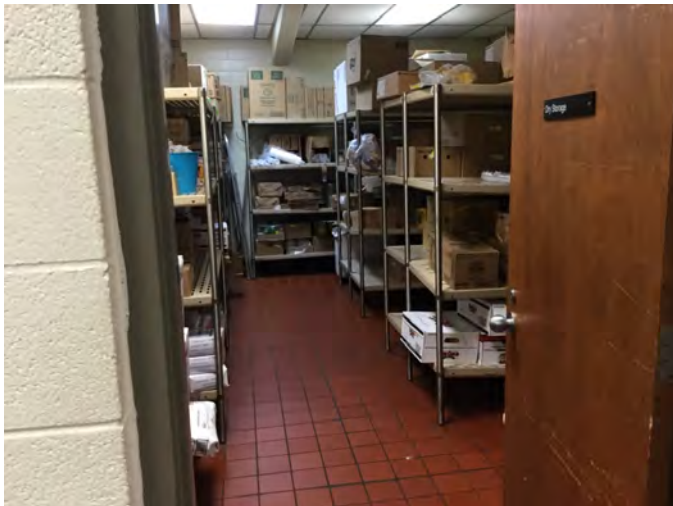
Location: Throughout the building
Distress: Beyond Service Life
Category: Deferred Maintenance
Priority: 3 - Necessary/Not Yet Critical (Years 2-5)
Correction: Renew System
Qty: 6,685.00
Unit of Measure: S.F.
Estimate: \$70,152.00
Assessor Name: Somnath Das
Date Created: 12/19/2016

Notes: Fittings have exceed their expected useful life. Signage s not up to code. Toilet room is not ADA compliant. System renewal is recommended.

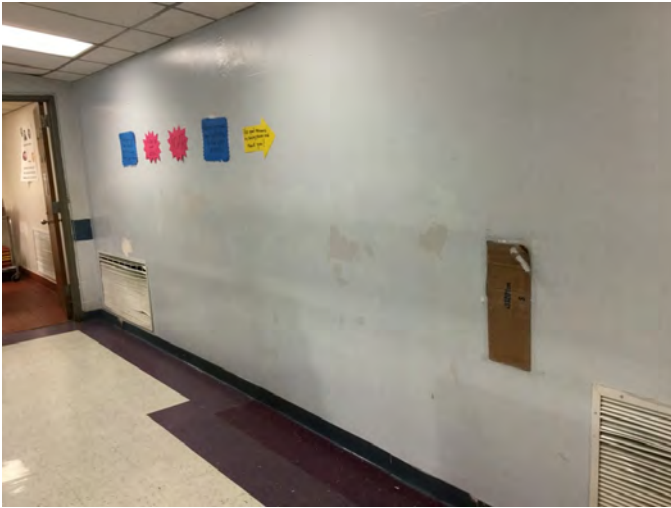
Location: Interiors
Distress: Beyond Service Life
Category: Deferred Maintenance
Priority: 3 - Necessary/Not Yet Critical (Years 2-5)
Correction: Renew System
Qty: 6,685.00
Unit of Measure: S.F.
Estimate: \$20,075.00
Assessor Name: Somnath Das
Date Created: 12/19/2016

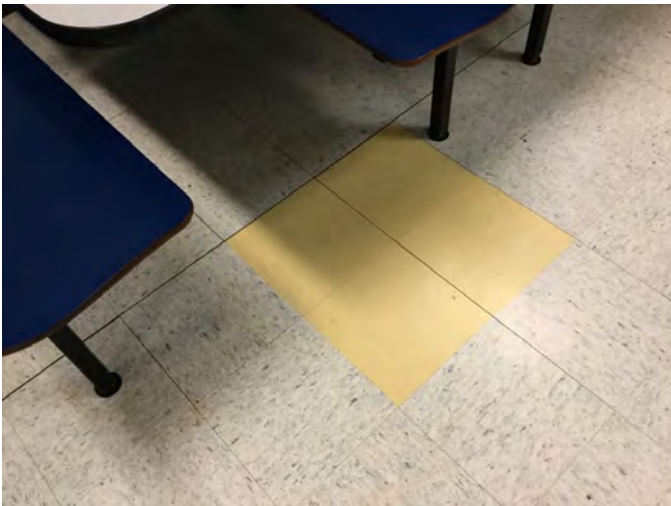
Location: Throughout the building
Distress: Beyond Service Life
Category: Deferred Maintenance
Priority: 3 - Necessary/Not Yet Critical (Years 2-5)
Correction: Renew System
Qty: 6,685.00
Unit of Measure: S.F.
Estimate: \$81,992.00
Assessor Name: Somnath Das
Date Created: 12/19/2016

Notes: Floor finishes are beyond their expected life throughout the building. Renewal is recommended.

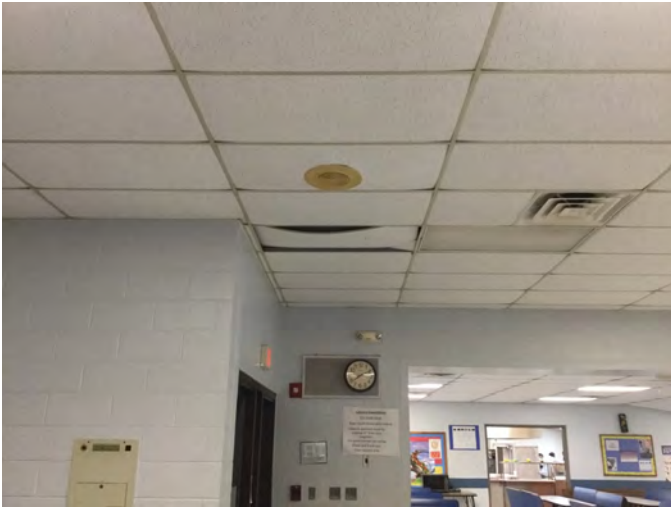
Location: Throughout the building
Distress: Beyond Service Life
Category: Deferred Maintenance
Priority: 3 - Necessary/Not Yet Critical (Years 2-5)
Correction: Renew System
Qty: 6,685.00
Unit of Measure: S.F.
Estimate: \$78,977.00
Assessor Name: Somnath Das
Date Created: 12/19/2016

Notes: Ceiling finishes are expired and in fair condition. Renewal is recommended.

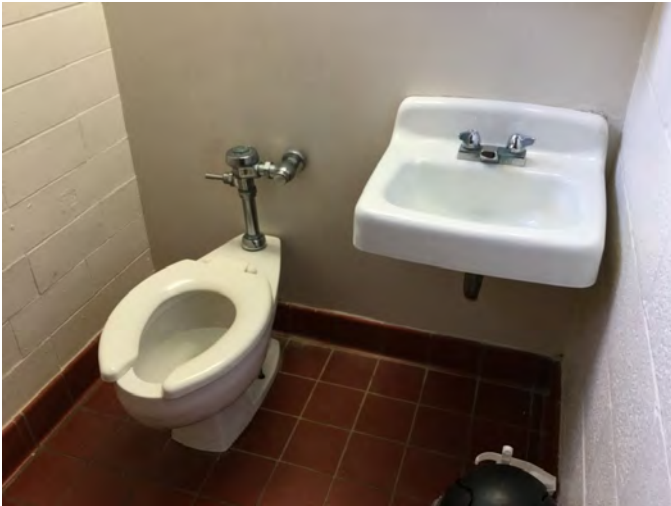
Location: Toilet room
Distress: Beyond Service Life
Category: Deferred Maintenance / Accessibility Code Compliance
Priority: 3 - Necessary/Not Yet Critical (Years 2-5)
Correction: Renew System
Qty: 6,685.00
Unit of Measure: S.F.
Estimate: \$82,800.00
Assessor Name: Somnath Das
Date Created: 12/19/2016

Notes: Fixtures are beyond their expected life. Toilet room is not ADA compliant. System renewal is recommended.

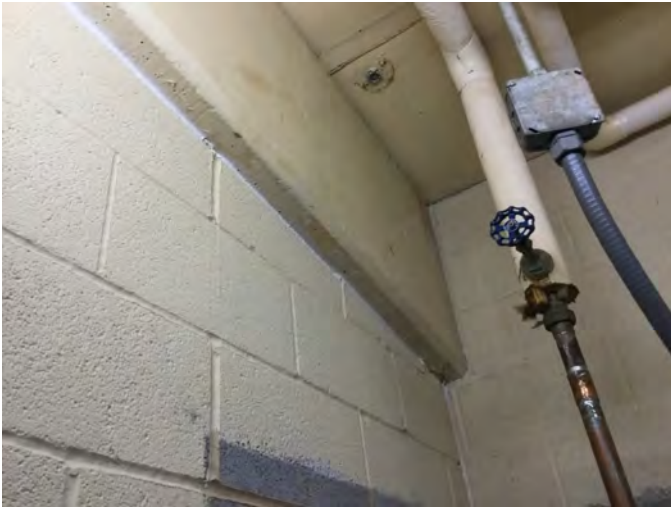
Location: Throughout the building
Distress: Beyond Service Life
Category: Deferred Maintenance
Priority: 3 - Necessary/Not Yet Critical (Years 2-5)
Correction: Renew System
Qty: 6,685.00
Unit of Measure: S.F.
Estimate: \$7,059.00
Assessor Name: Somnath Das
Date Created: 12/19/2016

Notes: The domestic water system has exceeded its useful life. There is no backflow prevention on the water supply. system renewal is recommended.

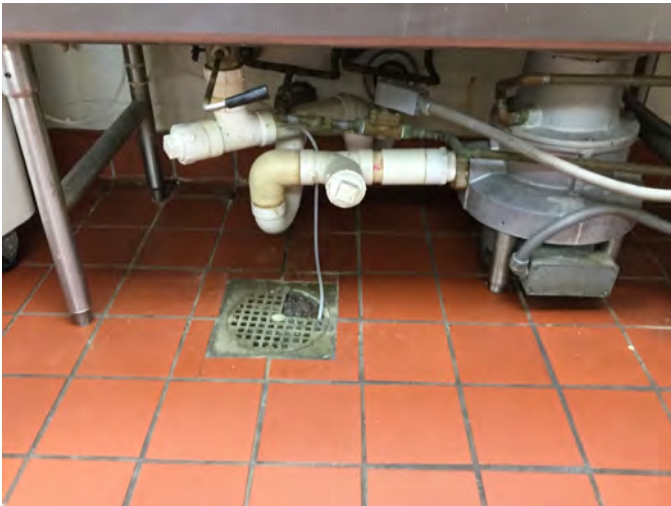
Location: Kitchen and support spaces
Distress: Beyond Service Life
Category: Deferred Maintenance
Priority: 3 - Necessary/Not Yet Critical (Years 2-5)
Correction: Renew System
Qty: 6,685.00
Unit of Measure: S.F.
Estimate: \$11,177.00
Assessor Name: Somnath Das
Date Created: 12/19/2016

Notes: The sanitary sewer system has exceeded its expected useful life. System renewal is recommended.

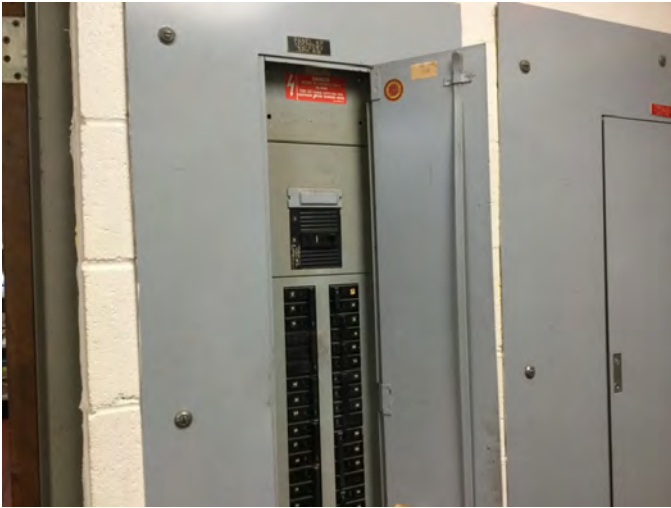
Location: Throughout the building
Distress: Beyond Service Life
Category: Deferred Maintenance
Priority: 3 - Necessary/Not Yet Critical (Years 2-5)
Correction: Renew System
Qty: 6,685.00
Unit of Measure: S.F.
Estimate: \$36,694.00
Assessor Name: Somnath Das
Date Created: 12/19/2016

Notes: The branch wiring system has exceeded its useful life. System renewal is recommended.

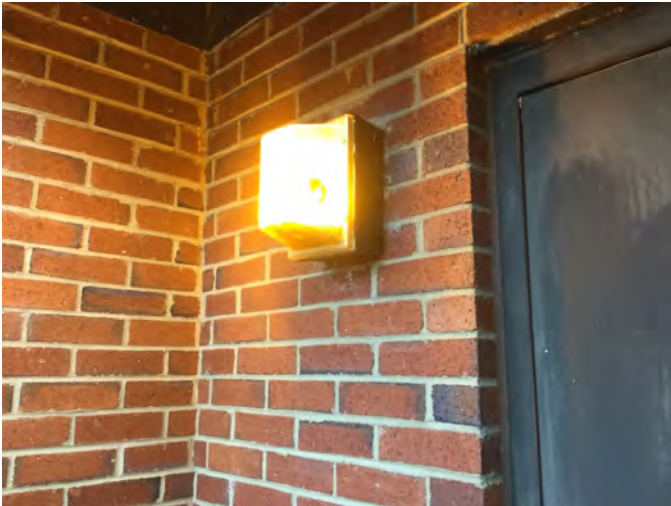
Location: Throughout the building
Distress: Beyond Service Life
Category: Deferred Maintenance
Priority: 3 - Necessary/Not Yet Critical (Years 2-5)
Correction: Renew System
Qty: 6,685.00
Unit of Measure: S.F.
Estimate: \$85,595.00
Assessor Name: Somnath Das
Date Created: 12/19/2016

Notes: Lighting systems in the building are beyond their expected life and should be replaced.

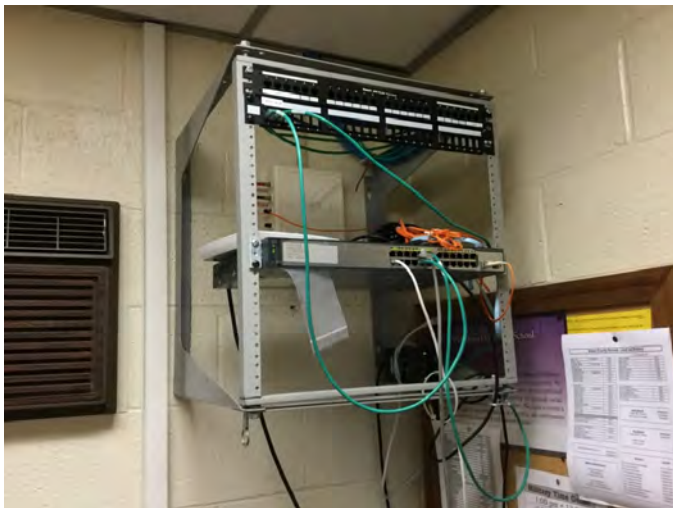
Location: Throughout the building
Distress: Beyond Service Life
Category: Deferred Maintenance
Priority: 3 - Necessary/Not Yet Critical (Years 2-5)
Correction: Renew System
Qty: 6,685.00
Unit of Measure: S.F.
Estimate: \$31,620.00
Assessor Name: Somnath Das
Date Created: 12/19/2016

Notes: Data and communications systems are beyond their expected life. System renewal is recommended.

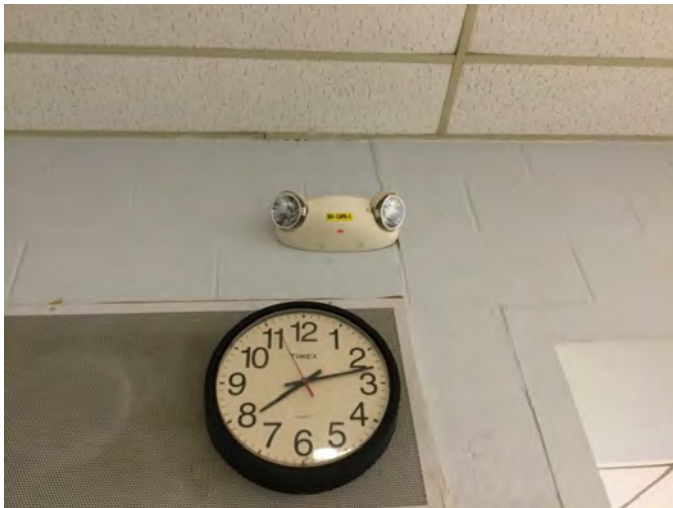
Location: Throughout the building
Distress: Beyond Service Life
Category: Deferred Maintenance / Life Safety Code Compliance
Priority: 3 - Necessary/Not Yet Critical (Years 2-5)
Correction: Renew System
Qty: 6,685.00
Unit of Measure: S.F.
Estimate: \$882.00
Assessor Name: Somnath Das
Date Created: 12/19/2016

Notes: Emergency lighting and illuminated exit signage is beyond its expected useful life. System renewal is recommended.

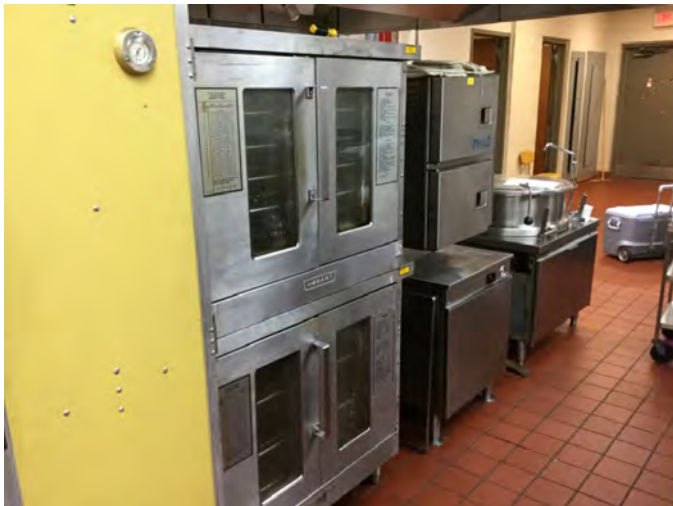
Location: Kitchen
Distress: Beyond Service Life
Category: Deferred Maintenance
Priority: 3 - Necessary/Not Yet Critical (Years 2-5)
Correction: Renew System
Qty: 6,685.00
Unit of Measure: S.F.
Estimate: \$15,884.00
Assessor Name: Somnath Das
Date Created: 12/19/2016

Notes: Kitchen equipment is generally well beyond its expected useful life. System renewal is recommended.

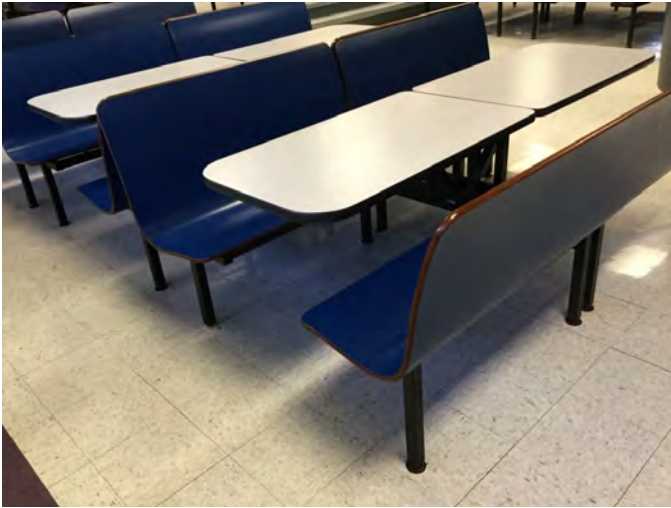
Location: Dining room
Distress: Beyond Service Life
Category: Deferred Maintenance
Priority: 4 - Recommended (Years 6-10)
Correction: Renew System
Qty: 6,685.00
Unit of Measure: S.F.
Estimate: \$42,062.00
Assessor Name: Somnath Das
Date Created: 12/19/2016

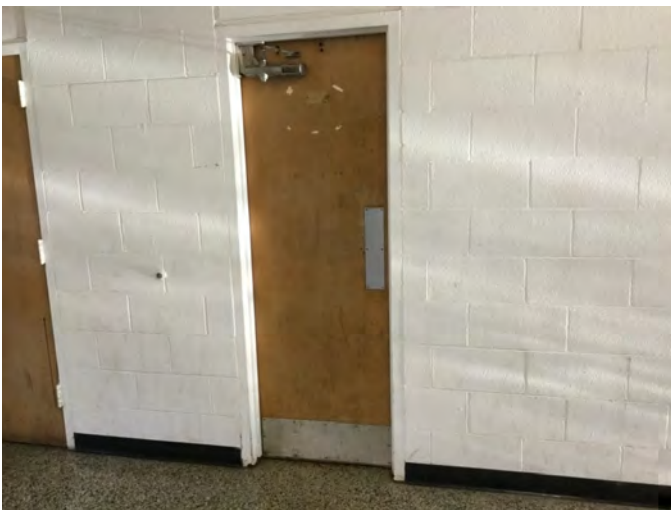
Location: Original portions of building
Distress: Beyond Service Life
Category: Deferred Maintenance
Priority: 3 - Necessary/Not Yet Critical (Years 2-5)
Correction: Renew System
Qty: 24,682.00
Unit of Measure: S.F.
Estimate: \$67,333.00
Assessor Name: Somnath Das
Date Created: 12/20/2016

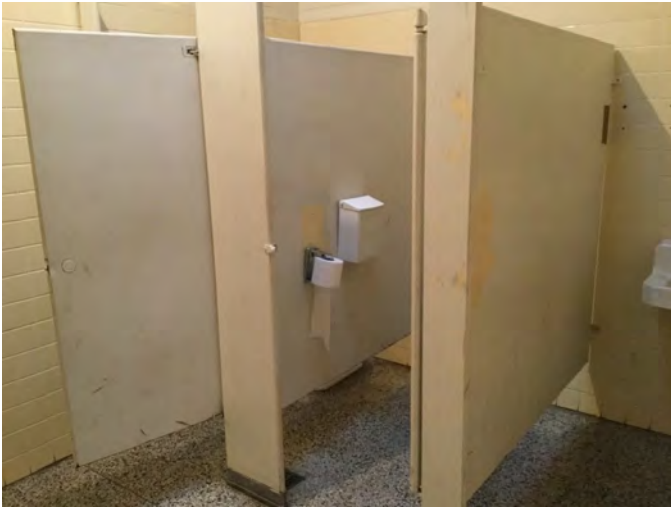
Location: Original portion of building
Distress: Beyond Service Life
Category: Deferred Maintenance
Priority: 3 - Necessary/Not Yet Critical (Years 2-5)
Correction: Renew System
Qty: 24,682.00
Unit of Measure: S.F.
Estimate: \$259,013.00
Assessor Name: Somnath Das
Date Created: 12/20/2016

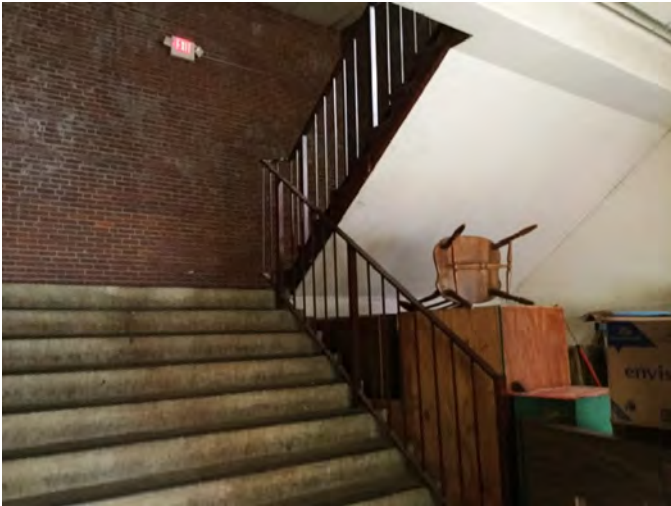
Location: Southeast exit stairs
Distress: Inadequate
Category: Safety / Building Code Compliance
Priority: 3 - Necessary/Not Yet Critical (Years 2-5)
Correction: Replace Stair Rails
Qty: 60.00
Unit of Measure: L.F.
Estimate: \$12,385.30
Assessor Name: Somnath Das
Date Created: 02/09/2017

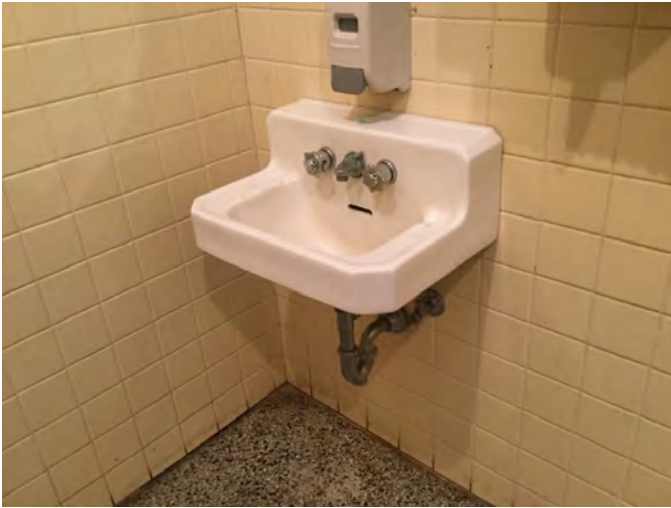
Location: Lobby restrooms and old restrooms
Distress: Beyond Service Life
Category: Deferred Maintenance
Priority: 3 - Necessary/Not Yet Critical (Years 2-5)
Correction: Renew System
Qty: 24,682.00
Unit of Measure: S.F.
Estimate: \$305,711.00
Assessor Name: Somnath Das
Date Created: 12/20/2016

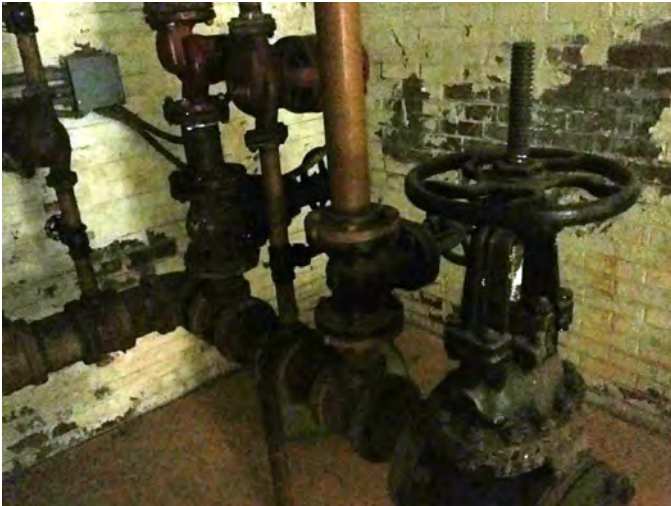
Location: Original portion of building
Distress: Beyond Service Life
Category: Deferred Maintenance
Priority: 3 - Necessary/Not Yet Critical (Years 2-5)
Correction: Renew System
Qty: 24,682.00
Unit of Measure: S.F.
Estimate: \$26,064.00
Assessor Name: Somnath Das
Date Created: 12/20/2016

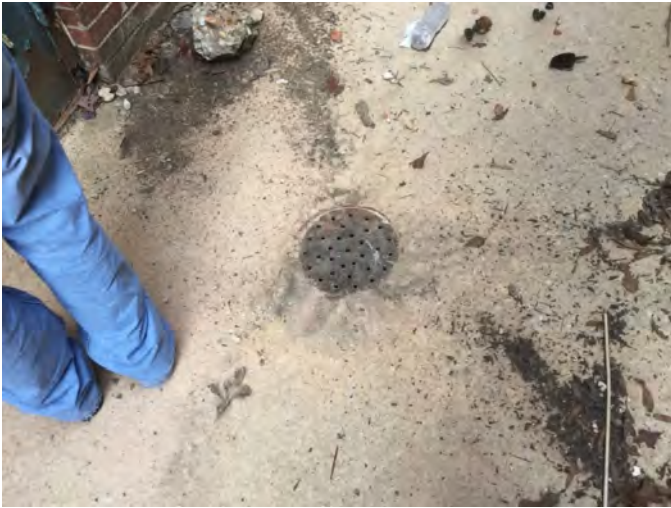
Location: Throughout the building
Distress: Beyond Service Life
Category: Deferred Maintenance
Priority: 3 - Necessary/Not Yet Critical (Years 2-5)
Correction: Renew System
Qty: 24,682.00
Unit of Measure: S.F.
Estimate: \$41,268.00
Assessor Name: Somnath Das
Date Created: 12/20/2016

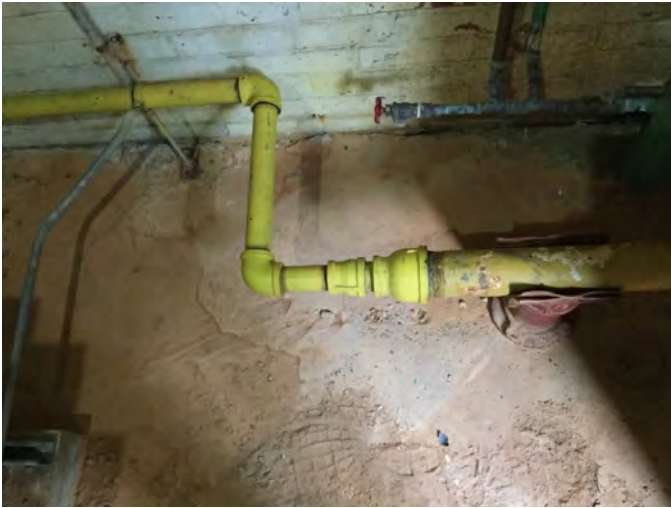
Location: Boiler room
Distress: Beyond Service Life
Category: Deferred Maintenance
Priority: 3 - Necessary/Not Yet Critical (Years 2-5)
Correction: Renew System
Qty: 24,682.00
Unit of Measure: S.F.
Estimate: \$4,616.00
Assessor Name: Somnath Das
Date Created: 12/20/2016

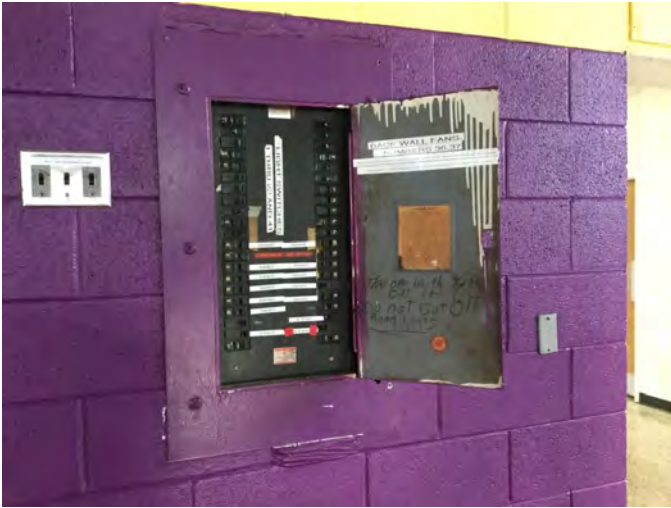
Location: Throughout the building
Distress: Beyond Service Life
Category: Deferred Maintenance
Priority: 3 - Necessary/Not Yet Critical (Years 2-5)
Correction: Renew System
Qty: 24,682.00
Unit of Measure: S.F.
Estimate: \$135,480.00
Assessor Name: Somnath Das
Date Created: 12/20/2016

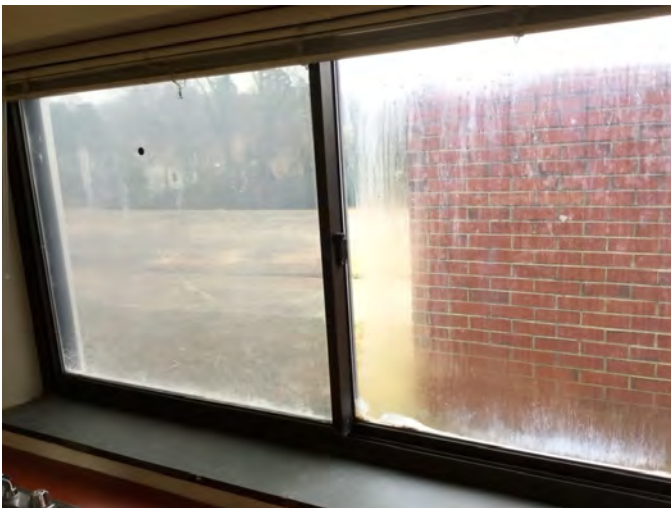
Location: Exterior windows throughout
Distress: Beyond Service Life
Category: Deferred Maintenance
Priority: 3 - Necessary/Not Yet Critical (Years 2-5)
Correction: Renew System
Qty: 41,625.00
Unit of Measure: S.F.
Estimate: \$421,245.00
Assessor Name: Eduardo Lopez
Date Created: 12/19/2016

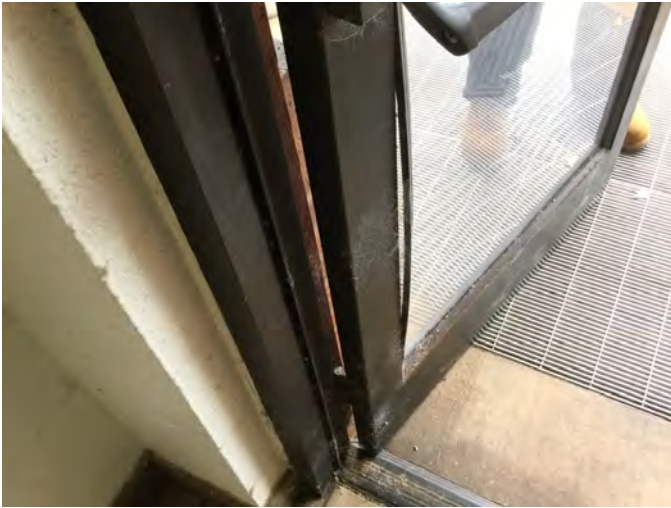
Location: Exterior doors
Distress: Beyond Service Life
Category: Deferred Maintenance
Priority: 3 - Necessary/Not Yet Critical (Years 2-5)
Correction: Renew System
Qty: 41,625.00
Unit of Measure: S.F.
Estimate: \$46,703.00
Assessor Name: Eduardo Lopez
Date Created: 12/19/2016

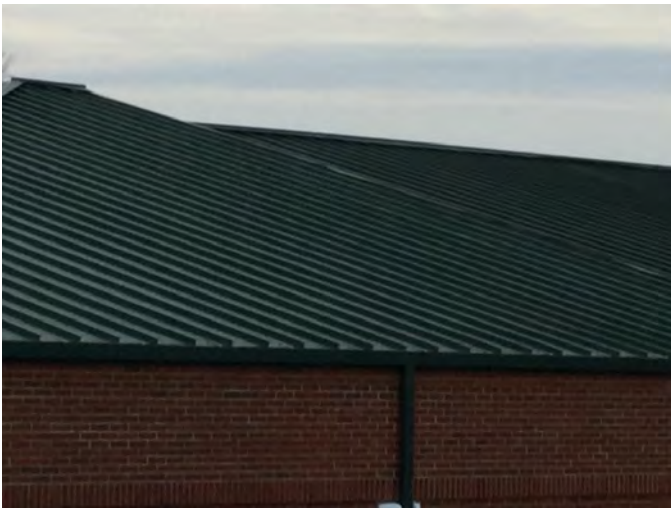
Location: Roof
Distress: Beyond Service Life
Category: Deferred Maintenance
Priority: 3 - Necessary/Not Yet Critical (Years 2-5)
Correction: Renew System
Qty: 41,625.00
Unit of Measure: S.F.
Estimate: \$554,895.00
Assessor Name: Eduardo Lopez
Date Created: 12/19/2016

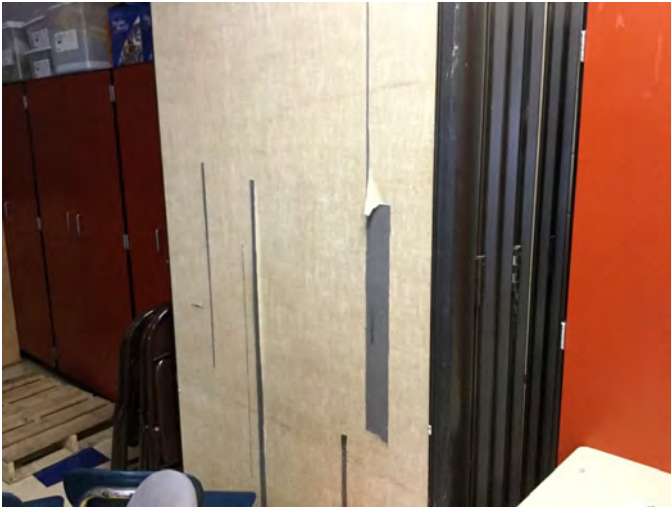
Location: Three Classrooms
Distress: Beyond Service Life
Category: Deferred Maintenance
Priority: 3 - Necessary/Not Yet Critical (Years 2-5)
Correction: Remove and reinstall demountable partitions
Qty: 3.00
Unit of Measure: C.L.F.
Estimate: \$26,332.02
Assessor Name: Eduardo Lopez
Date Created: 02/11/2017

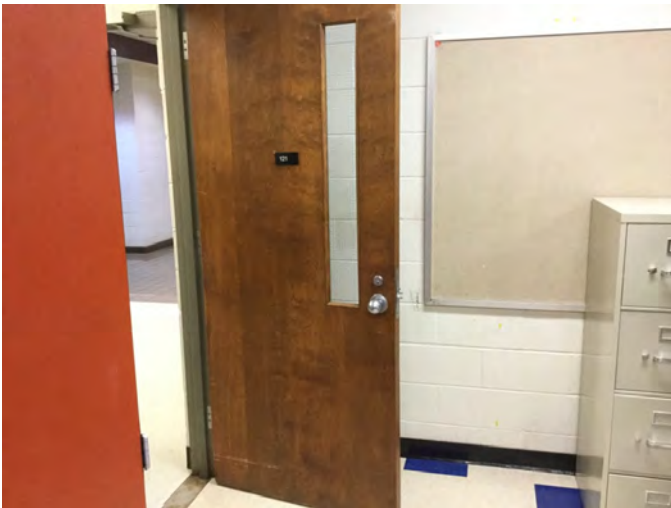
Location: Throughout the building
Distress: Beyond Service Life
Category: Deferred Maintenance
Priority: 3 - Necessary/Not Yet Critical (Years 2-5)
Correction: Renew System
Qty: 41,625.00
Unit of Measure: S.F.
Estimate: \$113,553.00
Assessor Name: Eduardo Lopez
Date Created: 12/19/2016

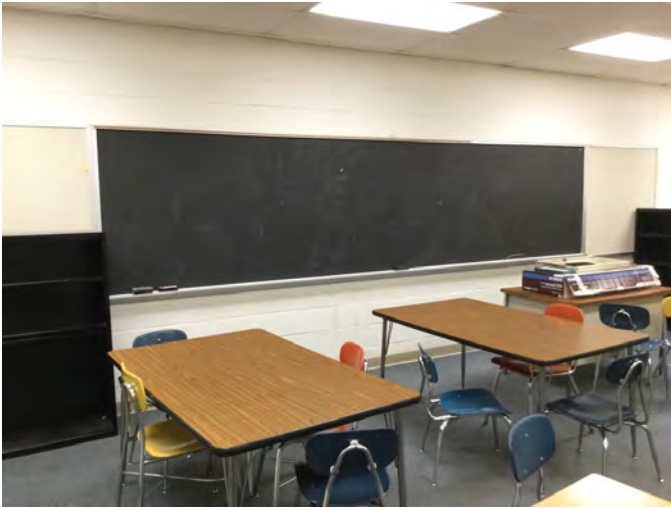
Location: Throughout the building
Distress: Beyond Service Life
Category: Deferred Maintenance
Priority: 3 - Necessary/Not Yet Critical (Years 2-5)
Correction: Renew System
Qty: 41,625.00
Unit of Measure: S.F.
Estimate: \$436,813.00
Assessor Name: Eduardo Lopez
Date Created: 12/19/2016

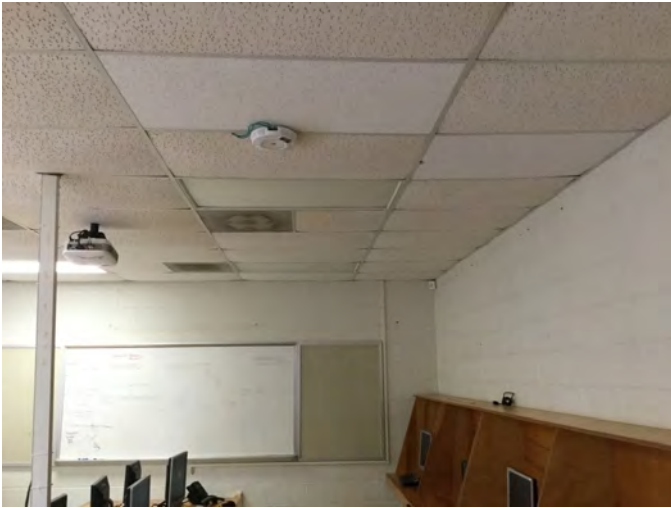
Location: Throughout the building
Distress: Beyond Service Life
Category: Deferred Maintenance
Priority: 3 - Necessary/Not Yet Critical (Years 2-5)
Correction: Renew System
Qty: 41,625.00
Unit of Measure: S.F.
Estimate: \$491,758.00
Assessor Name: Eduardo Lopez
Date Created: 12/19/2016

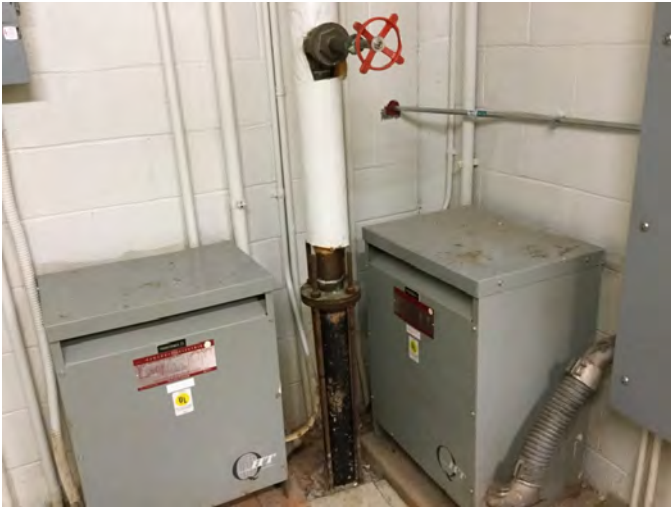
Location: Throughout the building
Distress: Beyond Service Life
Category: Deferred Maintenance / Building Code Compliance
Priority: 3 - Necessary/Not Yet Critical (Years 2-5)
Correction: Renew System
Qty: 41,625.00
Unit of Measure: S.F.
Estimate: \$43,956.00
Assessor Name: Eduardo Lopez
Date Created: 12/19/2016

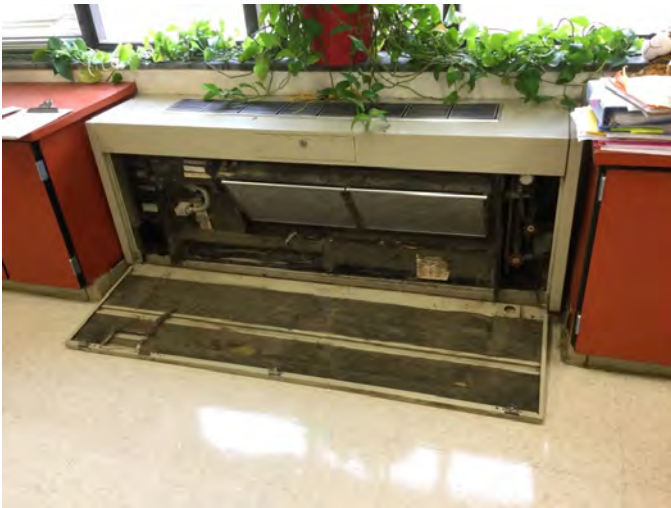
Location: Throughout the building
Distress: Beyond Service Life
Category: Deferred Maintenance
Priority: 3 - Necessary/Not Yet Critical (Years 2-5)
Correction: Renew System
Qty: 41,625.00
Unit of Measure: S.F.
Estimate: \$275,641.00
Assessor Name: Eduardo Lopez
Date Created: 12/19/2016

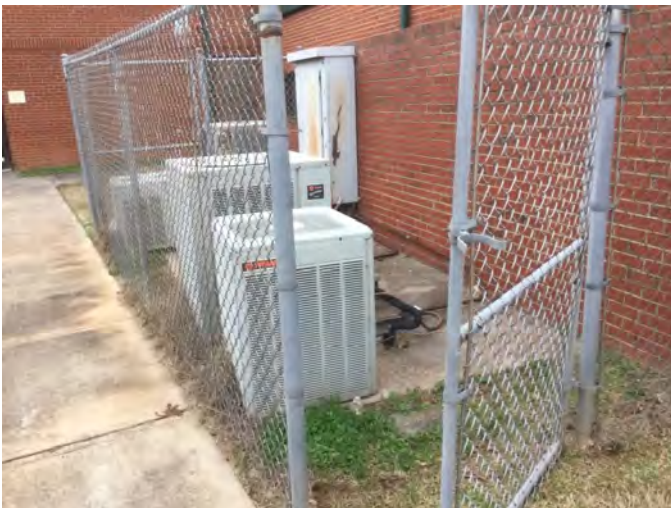
Location: Throughout the building
Distress: Beyond Service Life
Category: Deferred Maintenance
Priority: 3 - Necessary/Not Yet Critical (Years 2-5)
Correction: Renew System
Qty: 41,625.00
Unit of Measure: S.F.
Estimate: \$371,795.00
Assessor Name: Eduardo Lopez
Date Created: 12/19/2016

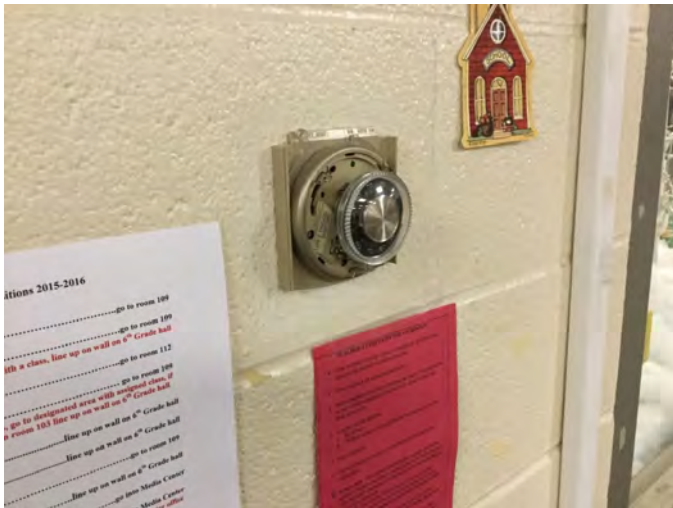
Location: Throughout the building
Distress: Beyond Service Life
Category: Deferred Maintenance
Priority: 3 - Necessary/Not Yet Critical (Years 2-5)
Correction: Renew System
Qty: 41,625.00
Unit of Measure: S.F.
Estimate: \$87,454.00
Assessor Name: Eduardo Lopez
Date Created: 12/19/2016

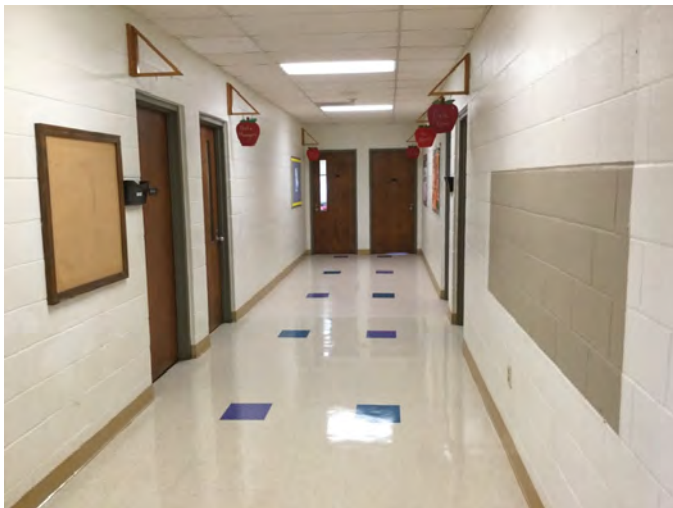
Location: Throughout the building
Distress: Missing
Category: Building Code Compliance
Priority: 3 - Necessary/Not Yet Critical (Years 2-5)
Correction: Renew System
Qty: 41,625.00
Unit of Measure: S.F.
Estimate: \$193,223.00
Assessor Name: Eduardo Lopez
Date Created: 12/19/2016

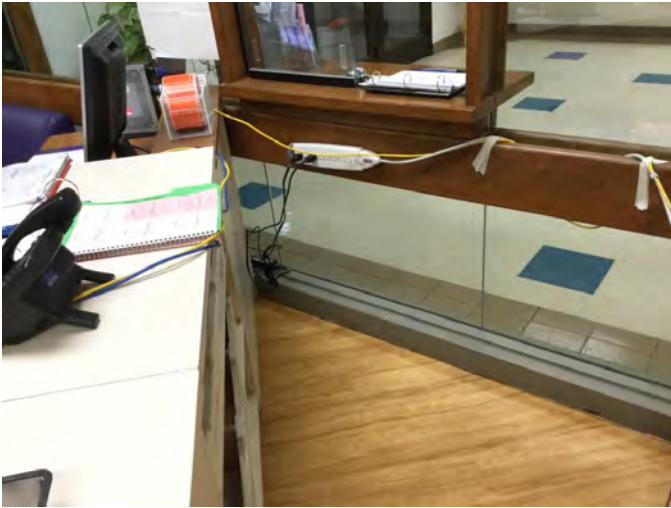
Location: Throughout the building
Distress: Beyond Service Life
Category: Deferred Maintenance
Priority: 3 - Necessary/Not Yet Critical (Years 2-5)
Correction: Renew System
Qty: 41,625.00
Unit of Measure: S.F.
Estimate: \$228,480.00
Assessor Name: Eduardo Lopez
Date Created: 12/19/2016

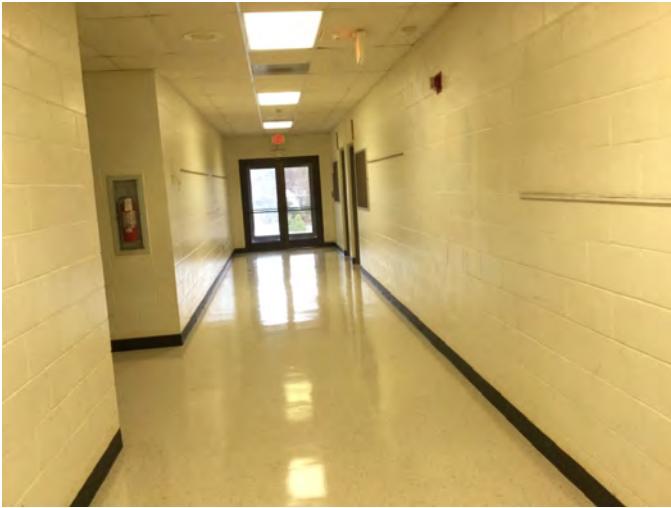
Location: Throughout the building
Distress: Beyond Service Life
Category: Deferred Maintenance
Priority: 3 - Necessary/Not Yet Critical (Years 2-5)
Correction: Renew System
Qty: 41,625.00
Unit of Measure: S.F.
Estimate: \$83,791.00
Assessor Name: Eduardo Lopez
Date Created: 12/19/2016

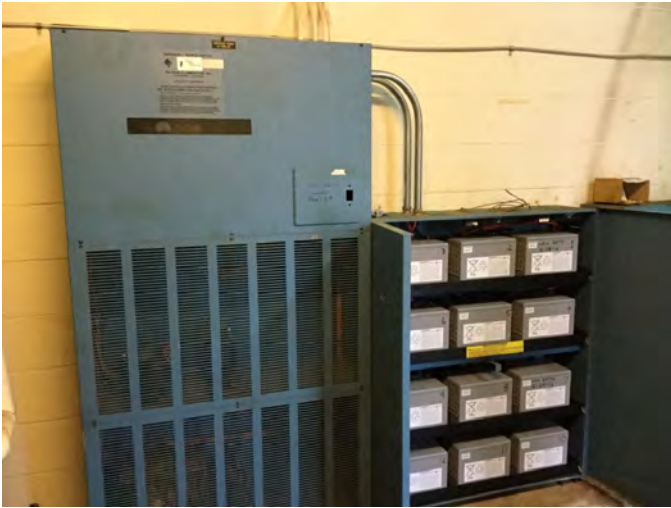
Location: Throughout the building
Distress: Beyond Service Life
Category: Deferred Maintenance
Priority: 3 - Necessary/Not Yet Critical (Years 2-5)
Correction: Renew System
Qty: 41,625.00
Unit of Measure: S.F.
Estimate: \$5,495.00
Assessor Name: Eduardo Lopez
Date Created: 12/19/2016

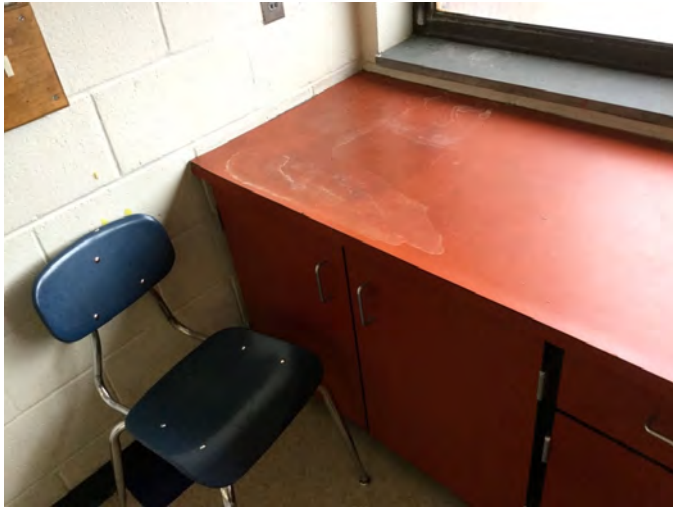
Location: Throughout the building
Distress: Beyond Service Life
Category: Deferred Maintenance
Priority: 3 - Necessary/Not Yet Critical (Years 2-5)
Correction: Renew System
Qty: 41,625.00
Unit of Measure: S.F.
Estimate: \$261,905.00
Assessor Name: Eduardo Lopez
Date Created: 12/19/2016

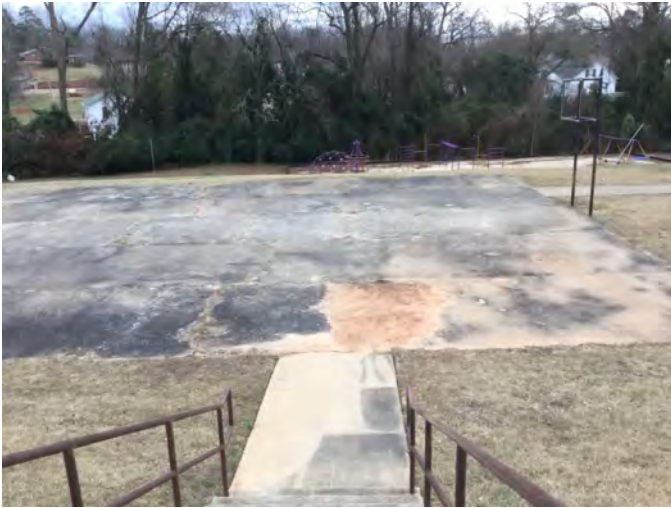
Location: On site east of building
Distress: Beyond Service Life
Category: Deferred Maintenance
Priority: 3 - Necessary/Not Yet Critical (Years 2-5)
Correction: Renew System
Qty: 72,992.00
Unit of Measure: S.F.
Estimate: \$60,218.00
Assessor Name: Ann Buerger Linden
Date Created: 02/09/2017
