NC School District/040 Anson County/Elementary School

Wadesboro Primary

Campus Assessment Report

March 10, 2017

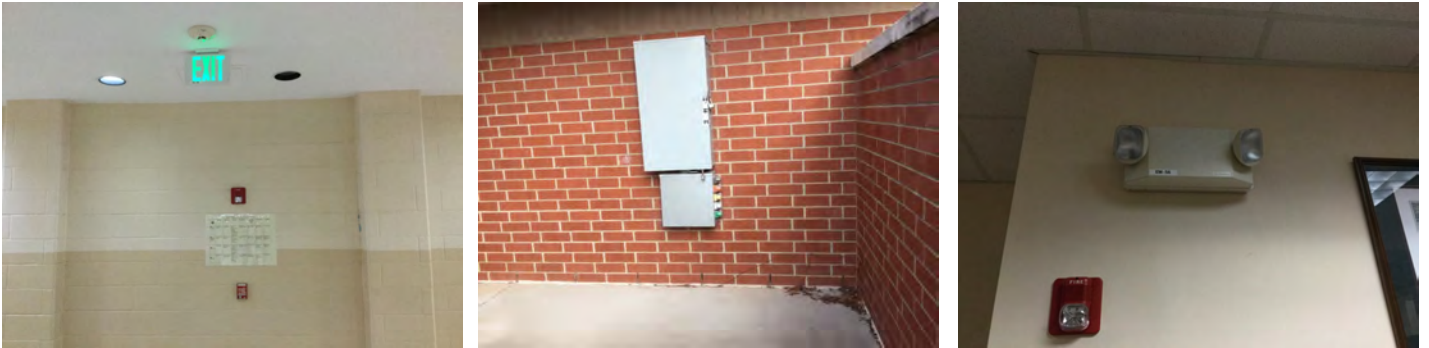
System: D5090 - Other Electrical Systems

Note: School has transfer switch for emergency generator. Portable generator supplied by local emergency response team as needed. School was previously a designated emergency shelter site.

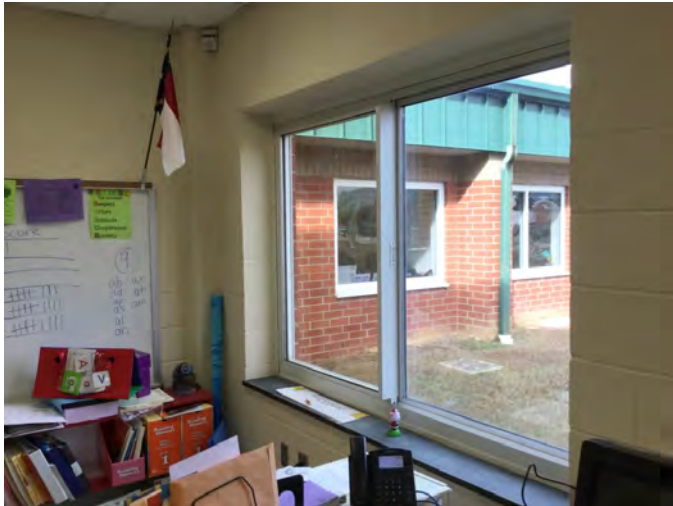
System: E2010 - Fixed Furnishings

Location: Classrooms and offices

Distress: Missing

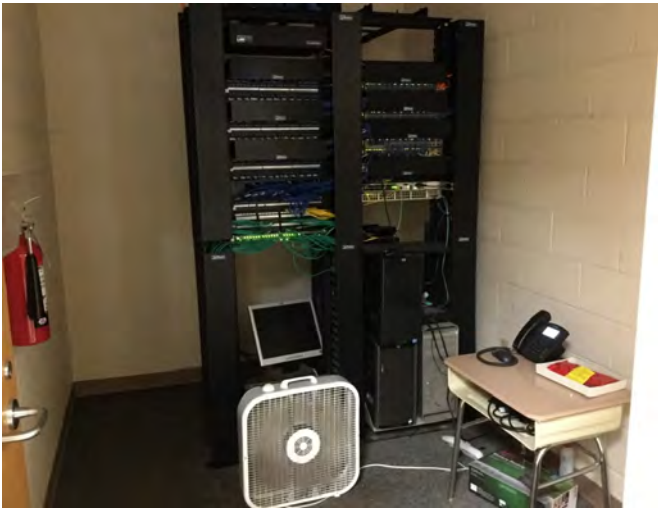
System: D3050 - Terminal & Package Units

Location: Data rooms
Distress: Inadequate
Category: Deferred Maintenance
Priority: 2 - Potentially Critical (Year 1)
Correction: Renew System
Qty: 66,866.00
Unit of Measure: S.F.
Estimate: \$46,338.00
Assessor Name: Somnath Das
Date Created: 12/16/2016

Notes: Data rooms do not have independent cooling. The building system is inadequate for these spaces. Provide mini-split systems.

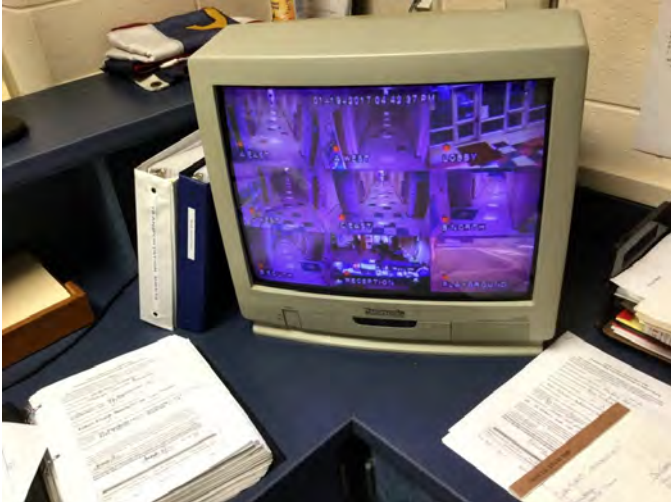
System: D5030810 - Security & Detection Systems

Location: Throughout the building
Distress: Beyond Service Life
Category: Deferred Maintenance
Priority: 2 - Potentially Critical (Year 1)
Correction: Renew System
Qty: 66,866.00
Unit of Measure: S.F.
Estimate: \$134,601.00
Assessor Name: Somnath Das
Date Created: 12/16/2016

Notes: The original security system is obsolete and does not function well. A digital system is requested. Additional cameras needed at bus lot and front of building.

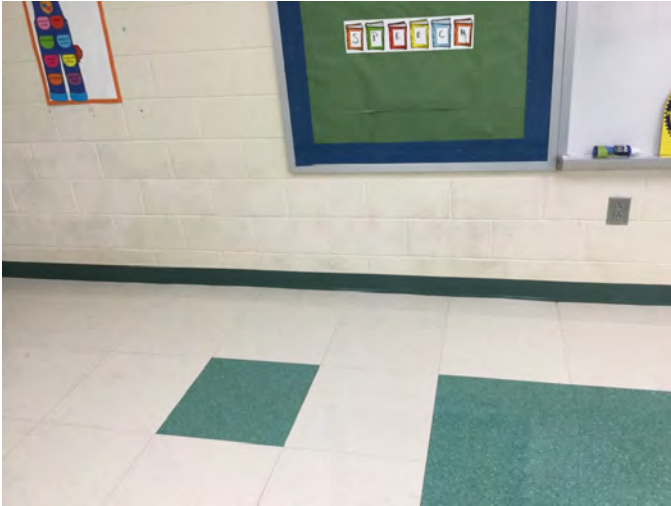
System: C3010 - Wall Finishes

Location: Throughout the building.
Distress: Beyond Service Life
Category: Deferred Maintenance
Priority: 3 - Necessary/Not Yet Critical (Years 2-5)
Correction: Renew System
Qty: 66,866.00
Unit of Measure: S.F.
Estimate: \$200,799.00
Assessor Name: Somnath Das
Date Created: 12/16/2016

Notes: Painted walls are maintained on an ad hoc basis with no regularly scheduled repainting. Many areas of the building are in need of re-painting. System renewal is recommended

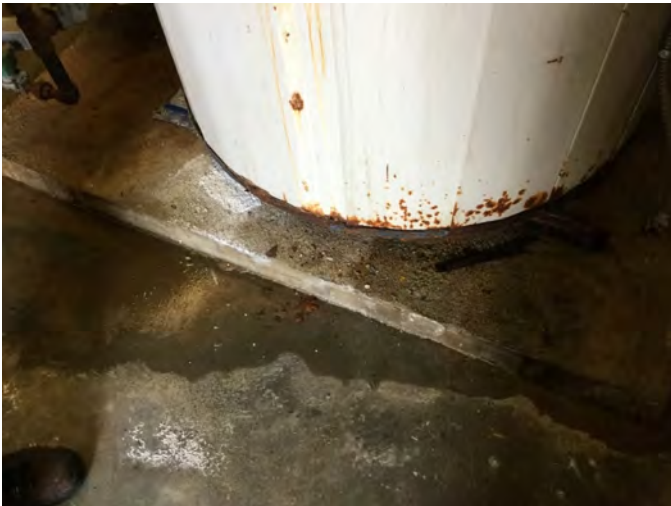
System: D2020 - Domestic Water Distribution

Location: Mechanical room
Distress: Beyond Service Life
Category: Deferred Maintenance
Priority: 3 - Necessary/Not Yet Critical (Years 2-5)
Correction: Replace water heater, gas / oil, 70 gallon
Qty: 2.00
Unit of Measure: Ea.
Estimate: \$40,497.60
Assessor Name: Somnath Das
Date Created: 02/08/2017

Notes: Water heaters are beyond their expected service life. Replacement is recommended.

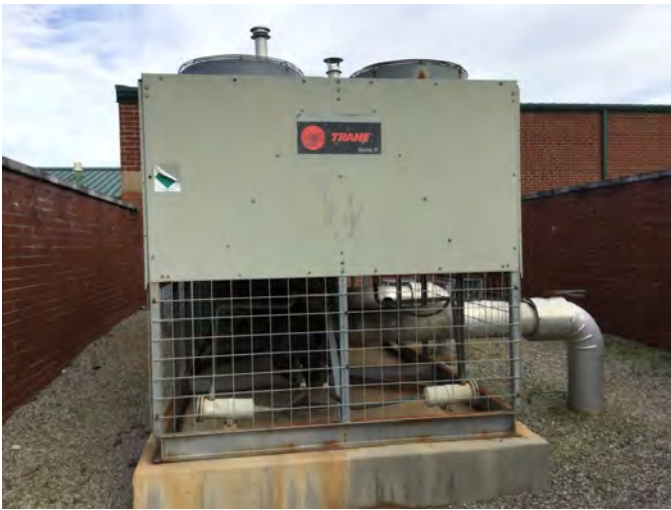
System: D3030 - Cooling Generating Systems

Location: Air cooled chiller
Distress: Beyond Service Life
Category: Deferred Maintenance
Priority: 3 - Necessary/Not Yet Critical (Years 2-5)
Correction: Renew System
Qty: 66,866.00
Unit of Measure: S.F.
Estimate: \$573,710.00
Assessor Name: Somnath Das
Date Created: 02/08/2017

Notes: The original chiller has had 2 major failures. System renewal for reliability is recommended.

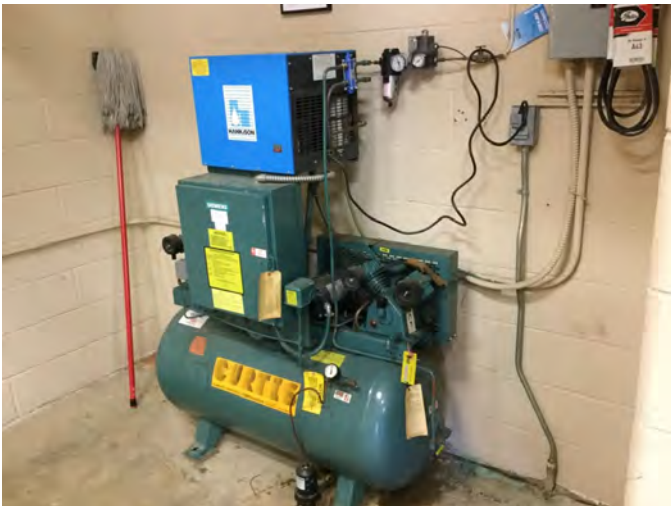
System: D3060 - Controls & Instrumentation

Location: Throughout the building
Distress: Inadequate
Category: Energy
Priority: 3 - Necessary/Not Yet Critical (Years 2-5)
Correction: Renew System
Qty: 66,866.00
Unit of Measure: S.F.
Estimate: \$334,664.00
Assessor Name: Somnath Das
Date Created: 02/08/2017

Notes: The original pneumatic controls system was obsolete at the time of construction. Replacement with a digital controls system that allows remote monitoring and control is recommended for system efficiency and reliability.

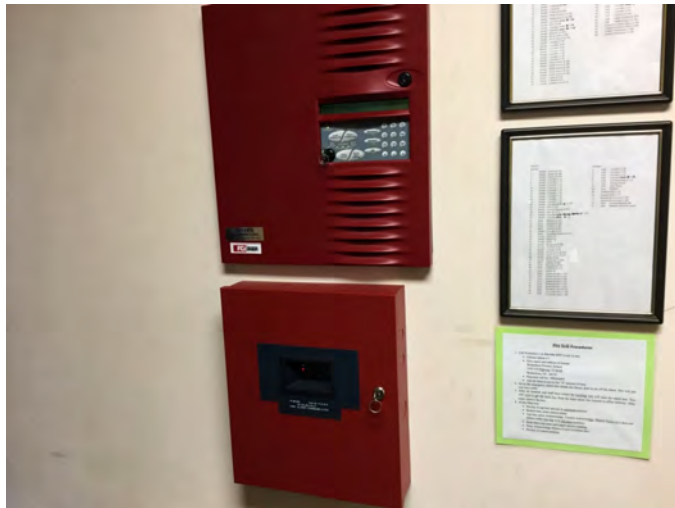
System: D5030910 - Fire Alarm Systems

Location: Throughout the building
Distress: Beyond Service Life
Category: Deferred Maintenance
Priority: 3 - Necessary/Not Yet Critical (Years 2-5)
Correction: Renew System
Qty: 66,866.00
Unit of Measure: S.F.
Estimate: \$243,459.00
Assessor Name: Somnath Das
Date Created: 12/16/2016

Notes: The fire alarm system is original and beyond its expected life. Replacement parts are difficult to obtain. System renewal is recommended to ensure reliability of this life safety system.

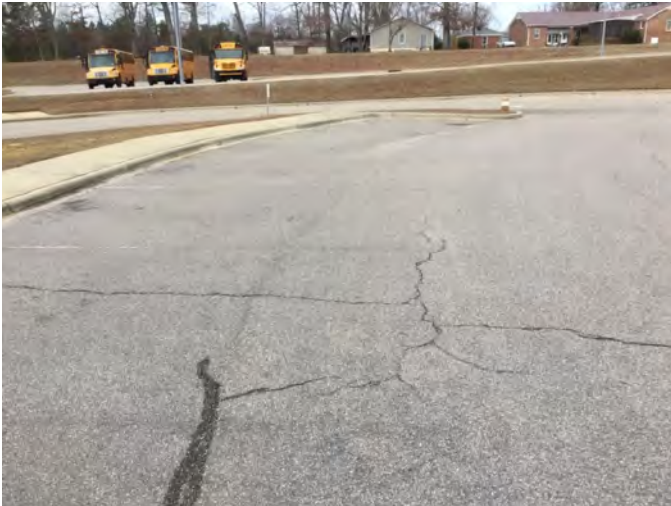
System: G2010 - Roadways

Location: Site roadways
Distress: Failing
Category: Deferred Maintenance
Priority: 3 - Necessary/Not Yet Critical (Years 2-5)
Correction: Resurface the roadway
Qty: 2,500.00
Unit of Measure: L.F.
Estimate: \$106,128.00
Assessor Name: Somnath Das
Date Created: 02/08/2017

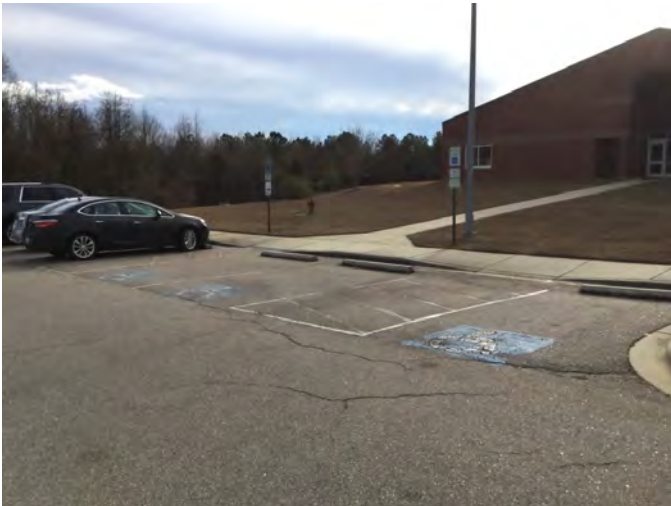
System: G2020 - Parking Lots

Location: Parking lots
Distress: Failing
Category: Deferred Maintenance
Priority: 3 - Necessary/Not Yet Critical (Years 2-5)
Correction: Parking lot repair and sealcoating
Qty: 35.00
Unit of Measure: M.S.F.
Estimate: \$30,906.41
Assessor Name: Somnath Das
Date Created: 02/08/2017

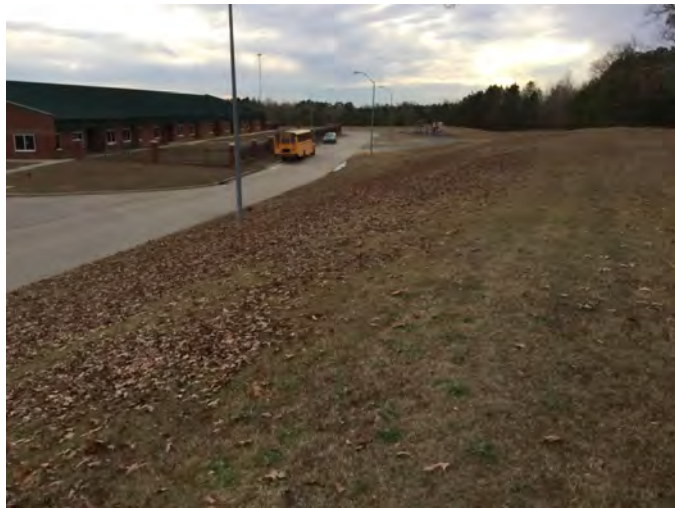
System: G2050 - Landscaping

Location: Near bus driveway
Distress: Inadequate
Category: Deferred Maintenance / Safety
Priority: 3 - Necessary/Not Yet Critical (Years 2-5)
Correction: Grading study
Qty: 1.00
Unit of Measure: Ea.
Estimate: \$6,600.00
Assessor Name: Somnath Das
Date Created: 02/09/2017
