NC School District/040 Anson County/High School

Anson County Early College High

Final
Campus Assessment Report

March 11, 2017

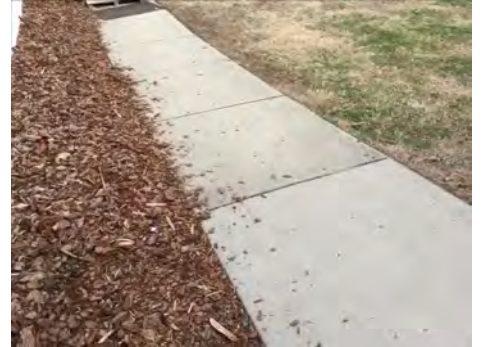
System: G2030 - Pedestrian Paving

Notes: The pedestrian paving is in poor condition and it should be repaved.

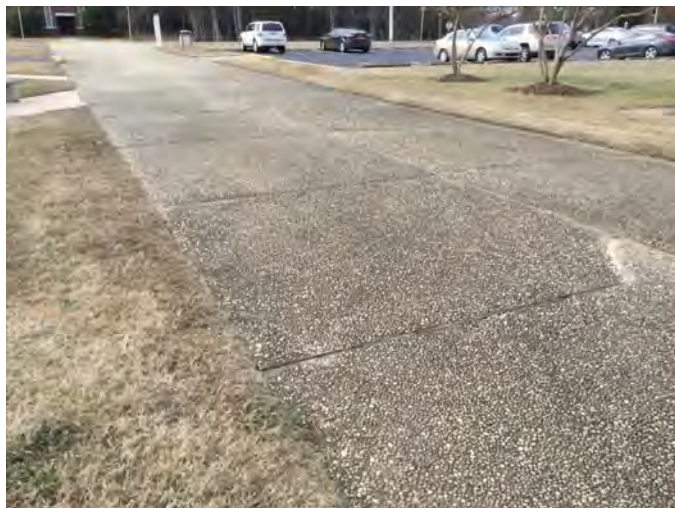
System: G2030 - Pedestrian Paving

Location: Site
Distress: Failing
Category: Deferred Maintenance
Priority: 3 - Necessary/Not Yet Critical (Years 2-5)
Correction: Remove and replace asphalt sidewalk, 4' wide
Qty: 400.00
Unit of Measure: L.F.
Estimate: \$9,065.03
Assessor Name: Eduardo Lopez
Date Created: 01/18/2017
