NC School District/220 Clay County/Elementary School

# Hayesville Elementary

## Campus Assessment Report

March 13, 2017

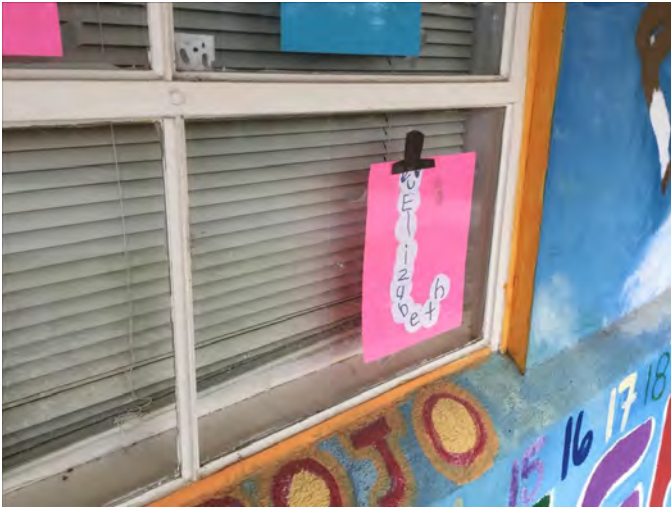
#### System: B2020 - Exterior Windows

**Location:** Exterior  
**Distress:** Failing  
**Category:** Deferred Maintenance  
**Priority:** 3 - Necessary/Not Yet Critical (Years 2-5)  
**Correction:** Renew System  
**Qty:** 23,963.00  
**Unit of Measure:** S.F.  
**Estimate:** \$252,259.00  
**Assessor Name:** Eduardo Lopez  
**Date Created:** 02/09/2017

**Notes:** The original metal frame, single pane, operable windows are aged, worn, inefficient and should be replaced.

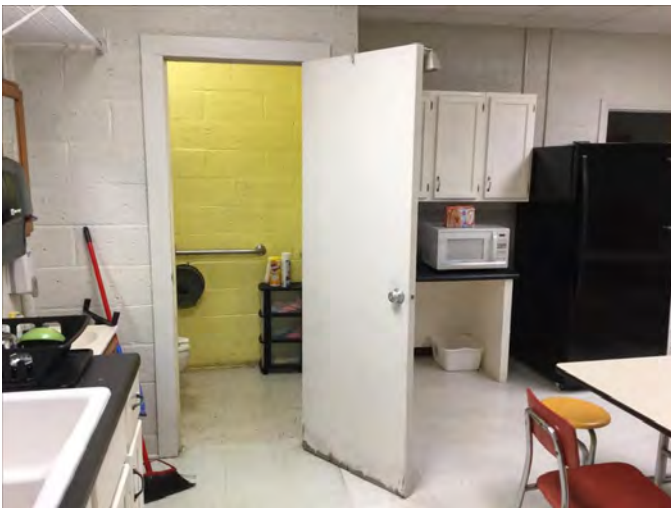
#### System: C1020 - Interior Doors

**Location:** Classroom Restrooms  
**Distress:** Damaged  
**Category:** Deferred Maintenance / Accessibility Code Compliance  
**Priority:** 3 - Necessary/Not Yet Critical (Years 2-5)  
**Correction:** Renew System  
**Qty:** 23,963.00  
**Unit of Measure:** S.F.  
**Estimate:** \$68,271.00  
**Assessor Name:** Eduardo Lopez  
**Date Created:** 02/09/2017

**Notes:** The interior doors are aged, frames are rusting and damaged, and the hardware is not ADA compliant and should be replaced.

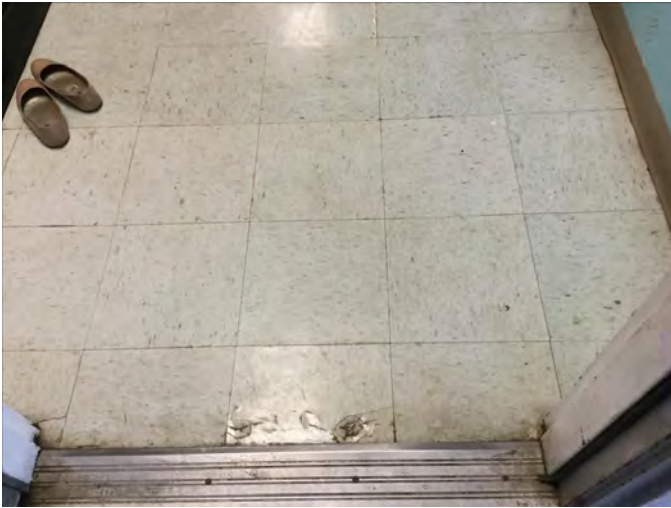
**System: C3020 - Floor Finishes**

**Location:** Throughout the building  
**Distress:** Damaged  
**Category:** Deferred Maintenance / Environmental  
**Priority:** 3 - Necessary/Not Yet Critical (Years 2-5)  
**Correction:** Renew System  
**Qty:** 23,963.00  
**Unit of Measure:** S.F.  
**Estimate:** \$305,768.00  
**Assessor Name:** Eduardo Lopez  
**Date Created:** 02/09/2017

**Notes:** The floor covering is aged, damaged in some areas and beyond its service life.

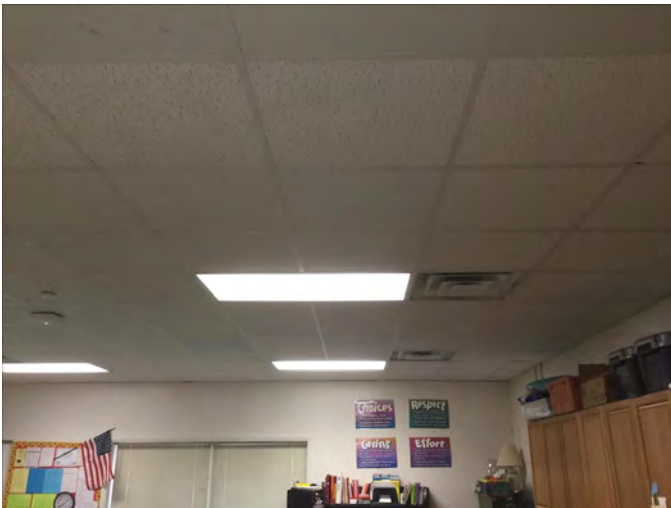
**System: C3030 - Ceiling Finishes**

**Location:** Throughout the building  
**Distress:** Damaged  
**Category:** Deferred Maintenance  
**Priority:** 3 - Necessary/Not Yet Critical (Years 2-5)  
**Correction:** Renew System  
**Qty:** 23,963.00  
**Unit of Measure:** S.F.  
**Estimate:** \$294,961.00  
**Assessor Name:** Eduardo Lopez  
**Date Created:** 02/09/2017

**Notes:** The original ceiling finishes are aged, tiles are sagging or damaged and should be replaced.

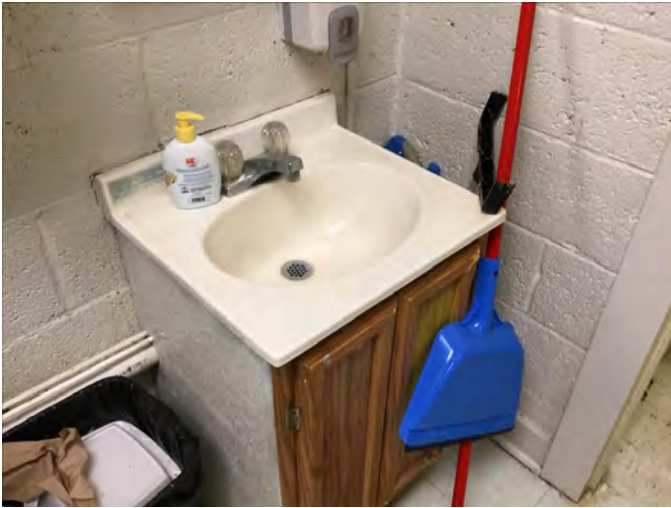
**System: D2010 - Plumbing Fixtures**

**Location:** Classrooms  
**Distress:** Inadequate  
**Category:** Accessibility Code Compliance  
**Priority:** 3 - Necessary/Not Yet Critical (Years 2-5)  
**Correction:** Renew System  
**Qty:** 23,963.00  
**Unit of Measure:** S.F.  
**Estimate:** \$308,667.00  
**Assessor Name:** Eduardo Lopez  
**Date Created:** 02/09/2017

**Notes:** Plumbing fixtures are in operational conditions. However, they are aged, not ADA compliant and should be replaced with a low-flow water fixtures.

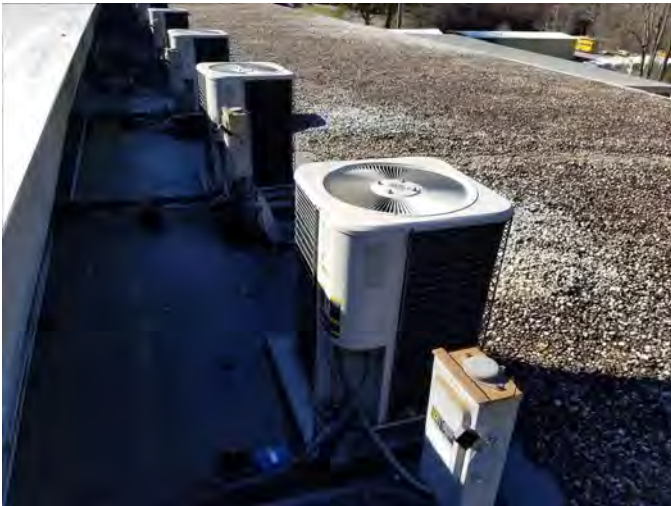
**System: D3050 - Terminal & Package Units**

**Location:** Roof  
**Distress:** Beyond Service Life  
**Category:** Deferred Maintenance  
**Priority:** 3 - Necessary/Not Yet Critical (Years 2-5)  
**Correction:** Renew System  
**Qty:** 23,963.00  
**Unit of Measure:** S.F.  
**Estimate:** \$223,000.00  
**Assessor Name:** Eduardo Lopez  
**Date Created:** 02/09/2017

**Notes:** The AC units are beyond their expected service life, requires extensive maintenance and should be scheduled for replacement.

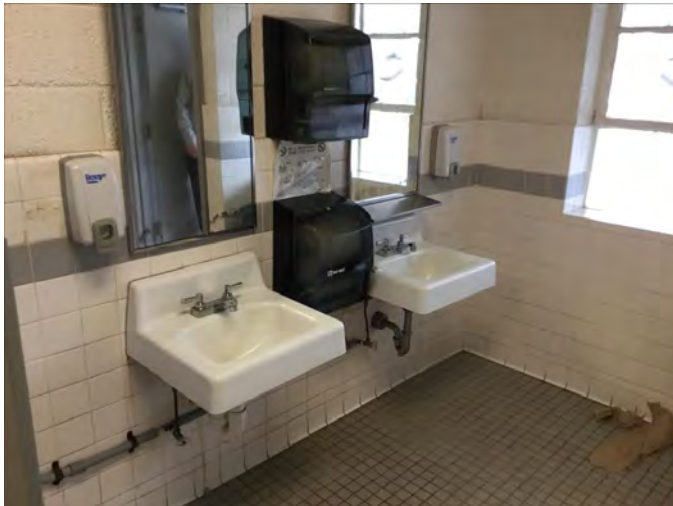
**System: D2020 - Domestic Water Distribution**

**Location:** Throughout the building  
**Distress:** Beyond Service Life  
**Category:** Deferred Maintenance  
**Priority:** 4 - Recommended (Years 6-10)  
**Correction:** Renew System  
**Qty:** 23,963.00  
**Unit of Measure:** S.F.  
**Estimate:** \$26,096.00  
**Assessor Name:** Eduardo Lopez  
**Date Created:** 02/09/2017

**Notes:** There are no reported issues or observed deficiencies with the domestic water piping. Due to the age of the copper pipe there can be internal pitting corrosion that may be a costly problem that leads to the formation of pinhole leaks and possible water contamination. Corrosion can build-up on the inside walls of the pipes and create the potential for lead to accumulate over time.

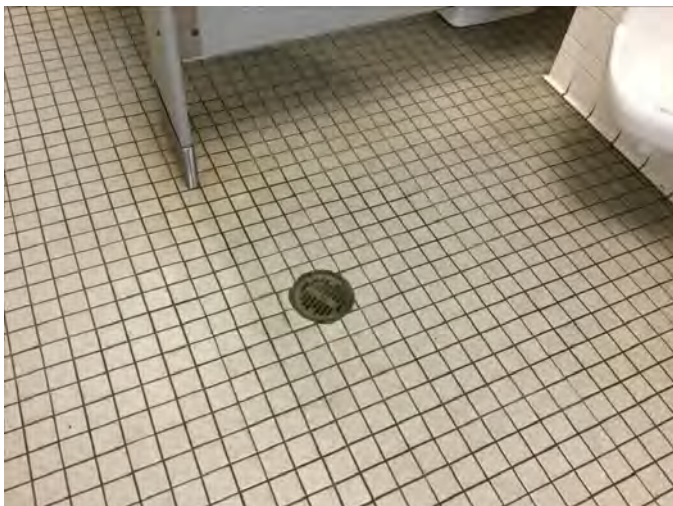
**System: D2030 - Sanitary Waste**

**Location:** Throughout the building  
**Distress:** Beyond Service Life  
**Category:** Deferred Maintenance  
**Priority:** 4 - Recommended (Years 6-10)  
**Correction:** Renew System  
**Qty:** 23,963.00  
**Unit of Measure:** S.F.  
**Estimate:** \$41,384.00  
**Assessor Name:** Eduardo Lopez  
**Date Created:** 02/09/2017

**Notes:** There are no reported issues or observed deficiencies with the sanitary waste piping. The aging sanitary sewer piping is subject to leaks, infiltration, and it can even collapse in the interior walls. The system should be inspected with cameras to ensure that none of these deficiencies exist.

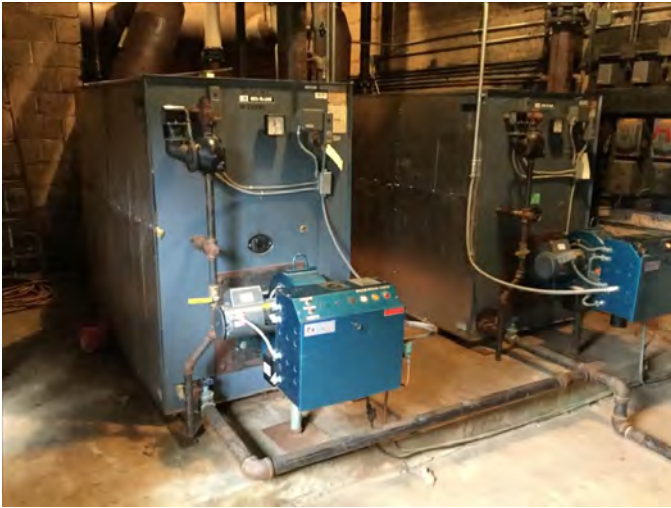
**System: D3020 - Heat Generating Systems**

**Location:** Boiler Room  
**Distress:** Beyond Service Life  
**Category:** Deferred Maintenance  
**Priority:** 4 - Recommended (Years 6-10)  
**Correction:** Renew System  
**Qty:** 23,963.00  
**Unit of Measure:** S.F.  
**Estimate:** \$136,805.00  
**Assessor Name:** Eduardo Lopez  
**Date Created:** 02/09/2017

**Notes:** The boilers are well maintained and functions as designed, but are beyond their service life and should be considered for replacement.

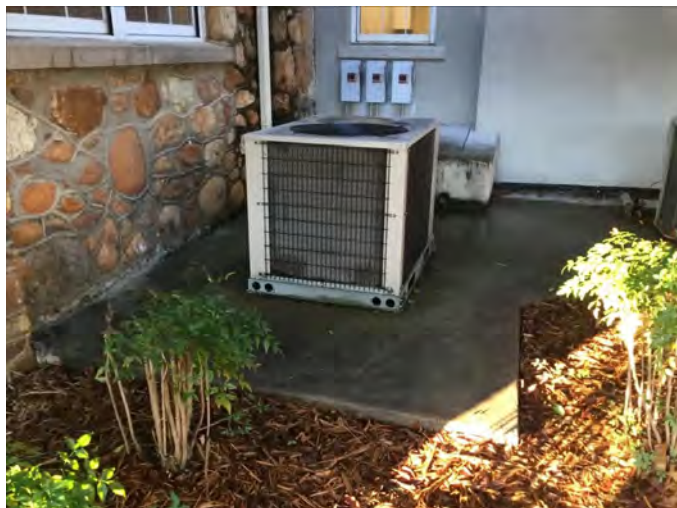
#### System: D3050 - Terminal & Package Units

**Location:** Exterior  
**Distress:** Beyond Service Life  
**Category:** Deferred Maintenance  
**Priority:** 3 - Necessary/Not Yet Critical (Years 2-5)  
**Correction:** Renew System  
**Qty:** 10,413.00  
**Unit of Measure:** S.F.  
**Estimate:** \$156,351.00  
**Assessor Name:** Eduardo Lopez  
**Date Created:** 02/09/2017

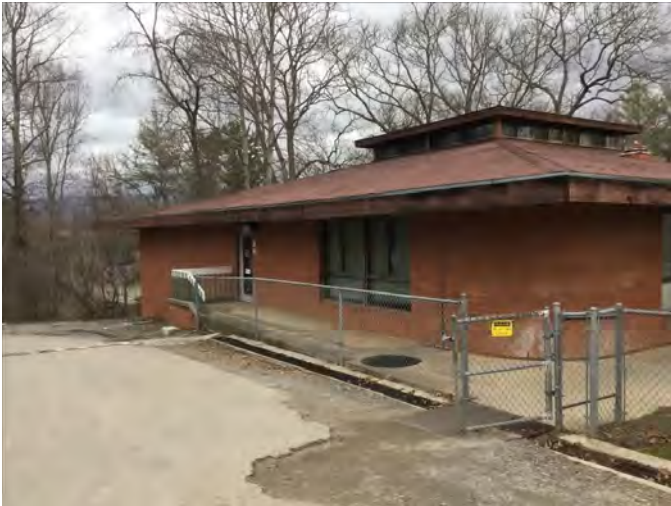
#### System: B3010140 - Asphalt Shingles

**Location:** Roof  
**Distress:** Beyond Service Life  
**Category:** Deferred Maintenance  
**Priority:** 3 - Necessary/Not Yet Critical (Years 2-5)  
**Correction:** Renew System  
**Qty:** 5,051.00  
**Unit of Measure:** S.F.  
**Estimate:** \$31,858.00  
**Assessor Name:** Eduardo Lopez  
**Date Created:** 01/18/2017

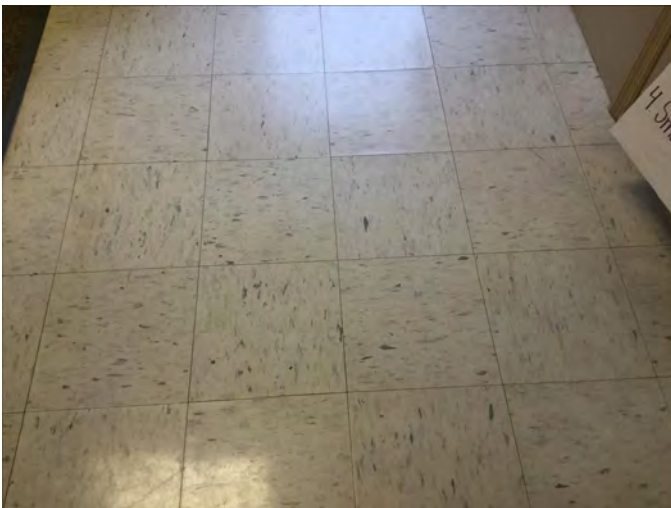
#### System: C3020 - Floor Finishes

**Location:** Throughout the building  
**Distress:** Beyond Service Life  
**Category:** Deferred Maintenance  
**Priority:** 3 - Necessary/Not Yet Critical (Years 2-5)  
**Correction:** Renew System  
**Qty:** 5,051.00  
**Unit of Measure:** S.F.  
**Estimate:** \$64,451.00  
**Assessor Name:** Eduardo Lopez  
**Date Created:** 01/18/2017

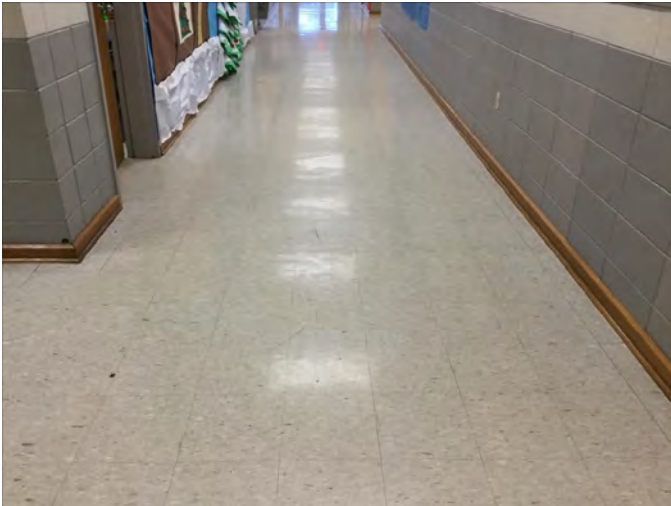
#### System: C3020 - Floor Finishes

**Location:** Throughout the building  
**Distress:** Beyond Service Life  
**Category:** Deferred Maintenance  
**Priority:** 4 - Recommended (Years 6-10)  
**Correction:** Renew System  
**Qty:** 22,016.00  
**Unit of Measure:** S.F.  
**Estimate:** \$280,924.00  
**Assessor Name:** Eduardo Lopez  
**Date Created:** 01/18/2017

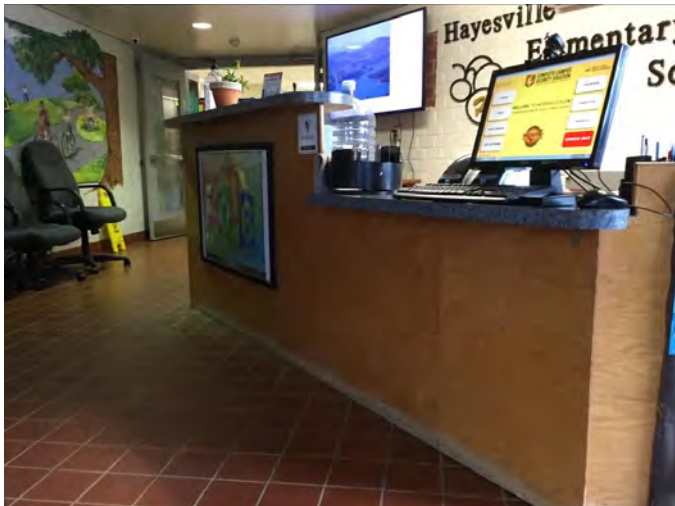
**System: E2010 - Fixed Furnishings**

**Location:** Throughout the building  
**Distress:** Beyond Service Life  
**Category:** Deferred Maintenance  
**Priority:** 4 - Recommended (Years 6-10)  
**Correction:** Renew System  
**Qty:** 22,016.00  
**Unit of Measure:** S.F.  
**Estimate:** \$144,095.00  
**Assessor Name:** Eduardo Lopez  
**Date Created:** 01/18/2017

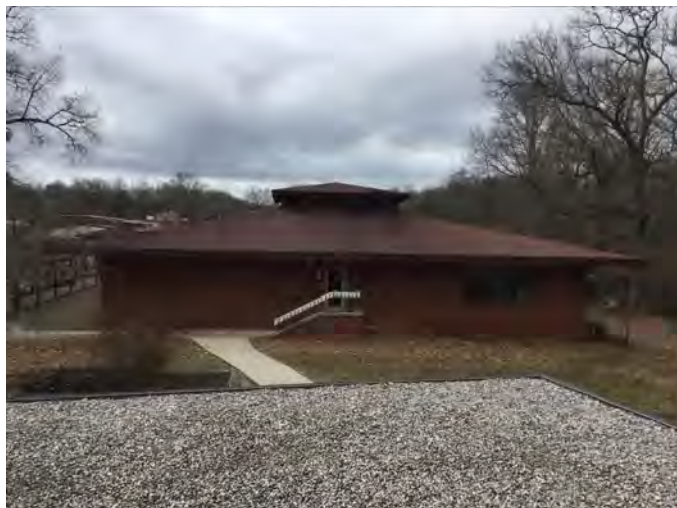
#### System: B3010140 - Asphalt Shingles

**Location:** Roof  
**Distress:** Damaged  
**Category:** Deferred Maintenance  
**Priority:** 3 - Necessary/Not Yet Critical (Years 2-5)  
**Correction:** Renew System  
**Qty:** 5,041.00  
**Unit of Measure:** S.F.  
**Estimate:** \$31,795.00  
**Assessor Name:** Eduardo Lopez  
**Date Created:** 01/18/2017

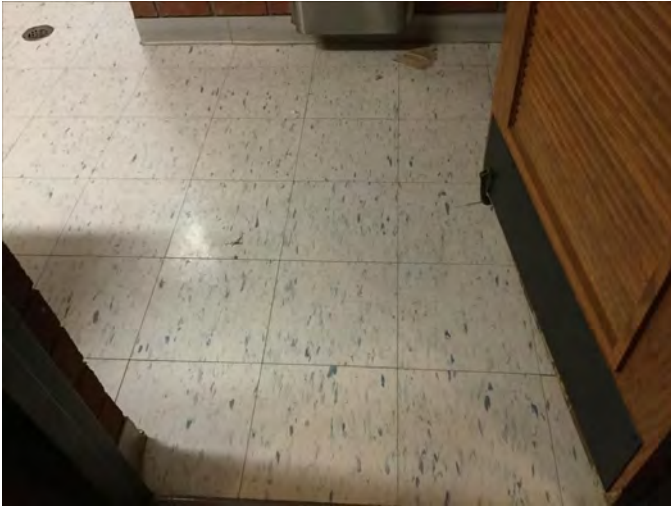
**System: C3020 - Floor Finishes**

**Location:** Throughout the building  
**Distress:** Damaged  
**Category:** Deferred Maintenance  
**Priority:** 4 - Recommended (Years 6-10)  
**Correction:** Renew System  
**Qty:** 5,041.00  
**Unit of Measure:** S.F.  
**Estimate:** \$64,323.00  
**Assessor Name:** Eduardo Lopez  
**Date Created:** 01/18/2017
