NC School District/300 Davie County/High School

Central Davie Academy

Campus Assessment Report

March 10, 2017

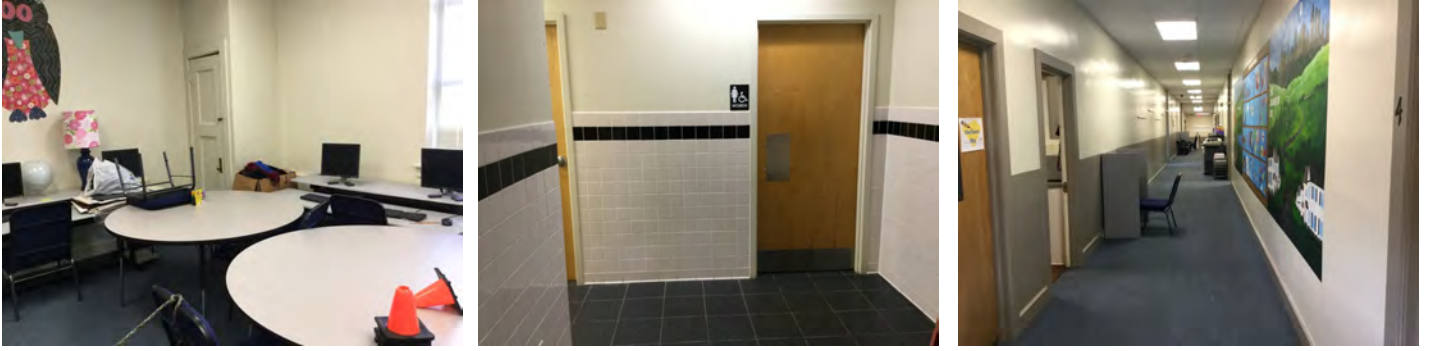
System: C3010 - Wall Finishes

Note: Interior wall finishes are well maintained. No deficiencies found. System renewal pushed 5 years.

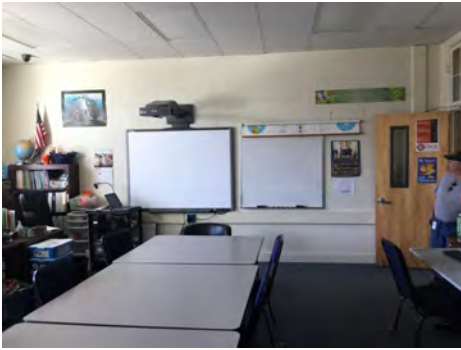
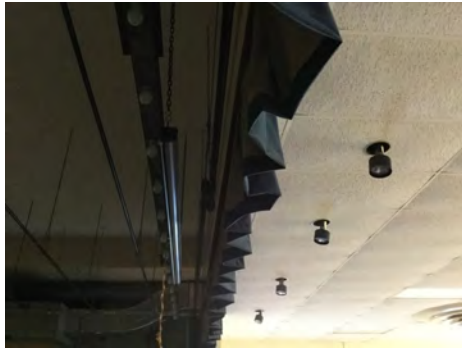
System: E1020 - Institutional Equipment

Note: Smartboards are up to date. Auditorium seating is old, but in well maintained condition. Year installed date set to 2004.

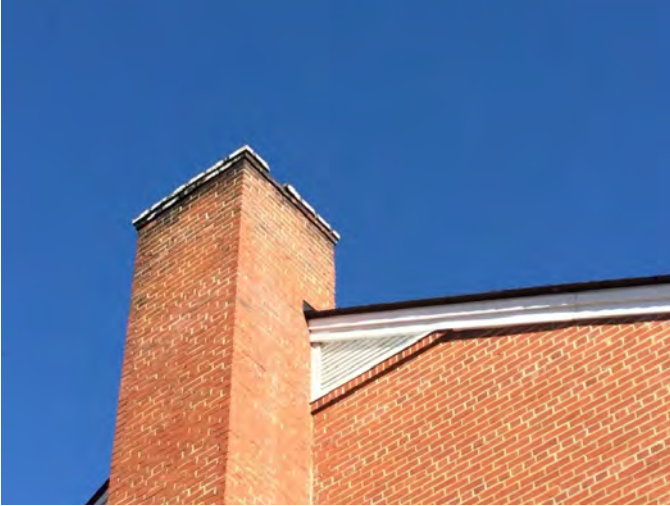
System: B2010 - Exterior Walls

Location: West wall, chimney
Distress: Damaged
Category: Deferred Maintenance
Priority: 3 - Necessary/Not Yet Critical (Years 2-5)
Correction: Point clay brick wall, 2nd floor
Qty: 12.00
Unit of Measure: C.S.F.
Estimate: \$17,170.56
Assessor Name: Eduardo Lopez
Date Created: 02/18/2017

Notes: Some pointing/repair of brick is recommended. Chimney top is deteriorating.

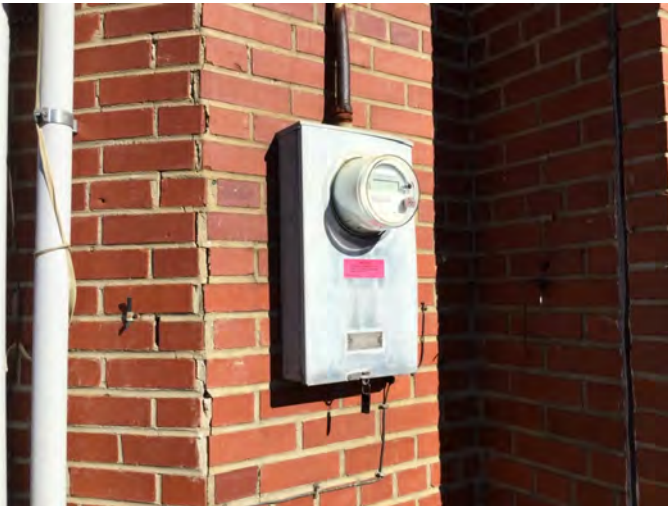
System: B2010 - Exterior Walls

Location: South, east end of building
Distress: Failing
Category: Deferred Maintenance
Priority: 3 - Necessary/Not Yet Critical (Years 2-5)
Correction: Engineering Study-2016-11-15 17:41:59
Qty: 1.00
Unit of Measure: Ea.
Estimate: \$13,200.00
Assessor Name: Eduardo Lopez
Date Created: 02/18/2017

Notes: Some settlement cracking is observed. An Engineering study to determine the seriousness of the condition is recommended.

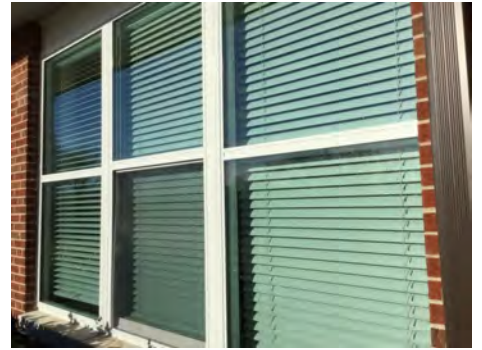
System: B2020 - Exterior Windows

Note: New windows designed with removable panel to readily accommodate new wall mounted heat pumps to be installed summer 2017.

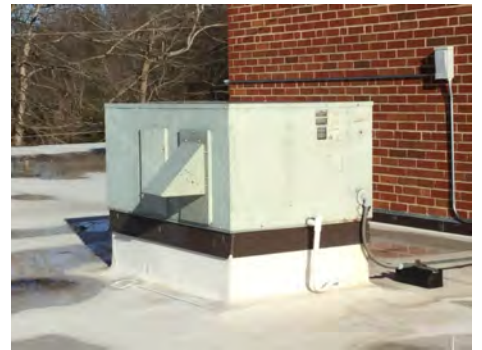
System: D3050 - Terminal & Package Units

Note: Wall mounted heat pumps being installed Summer 2017.

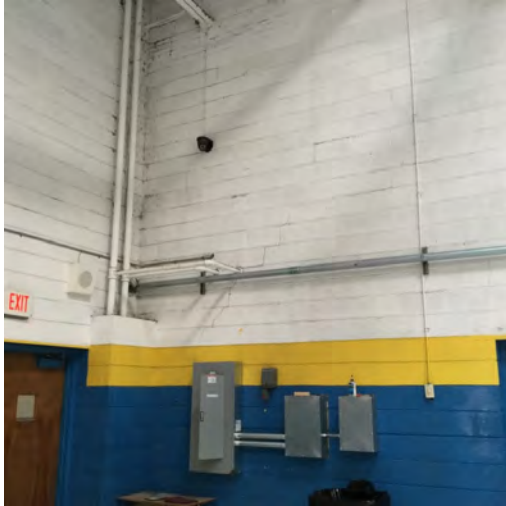
System: B2010 - Exterior Walls

Location: Gym walls
Distress: Failing
Category: Safety
Priority: 2 - Potentially Critical (Year 1)
Correction: Engineering Study-2016-11-15 17:41:59
Qty: 1.00
Unit of Measure: Ea.
Estimate: \$13,200.00
Assessor Name: Ann Buerger Linden
Date Created: 02/14/2017

Notes: Stairstep and vertical cracking was observed at the interior of exterior walls in the gymnasium. An engineering study to determine the cause and to make repair proposals is recommended.

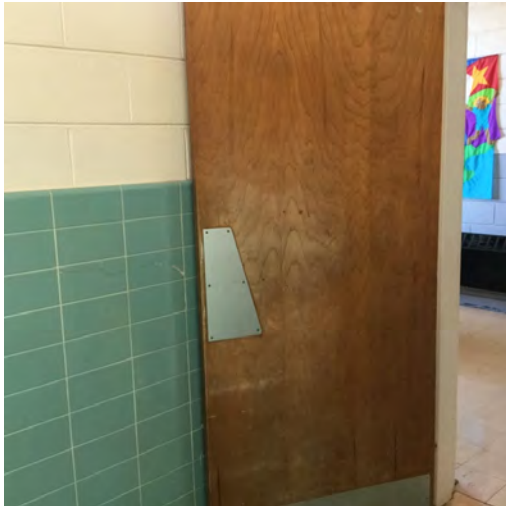
System: C1020 - Interior Doors

Location: Throughout the building
Distress: Beyond Service Life
Category: Deferred Maintenance
Priority: 3 - Necessary/Not Yet Critical (Years 2-5)
Correction: Renew System
Qty: 27,371.00
Unit of Measure: S.F.
Estimate: \$78,582.00
Assessor Name: Ann Buerger Linden
Date Created: 02/17/2017

Notes: Interior doors are typically original slab doors and are worn. Hardware is mostly not ADA compliant. System renewal is recommended.

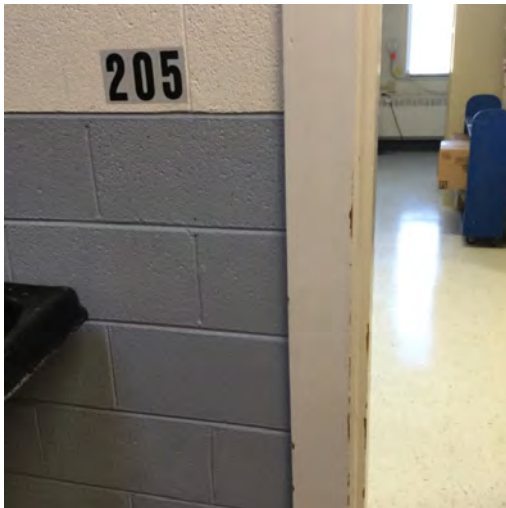
System: C1030 - Fittings

Location: Throughout the building
Distress: Beyond Service Life
Category: Deferred Maintenance
Priority: 3 - Necessary/Not Yet Critical (Years 2-5)
Correction: Renew System
Qty: 27,371.00
Unit of Measure: S.F.
Estimate: \$47,571.00
Assessor Name: Ann Buerger Linden
Date Created: 02/17/2017

Notes: The fittings throughout the building are aged and in fair condition. Room signage and toilet room fittings are not ADA compliant. Locker rooms are cannibalized. System renewal is recommended.

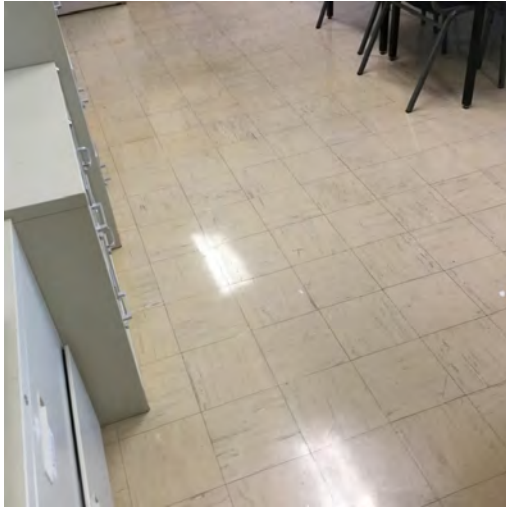
System: C3020 - Floor Finishes

Location: Throughout the building
Distress: Beyond Service Life
Category: Deferred Maintenance
Priority: 3 - Necessary/Not Yet Critical (Years 2-5)
Correction: Renew System
Qty: 27,371.00
Unit of Measure: S.F.
Estimate: \$352,867.00
Assessor Name: Ann Buerger Linden
Date Created: 02/17/2017

Notes: Although some floor finishes have been updated, in general floor finishes are beyond their expected life. VAT was seen in the building and should be fully abated in the system renewal.

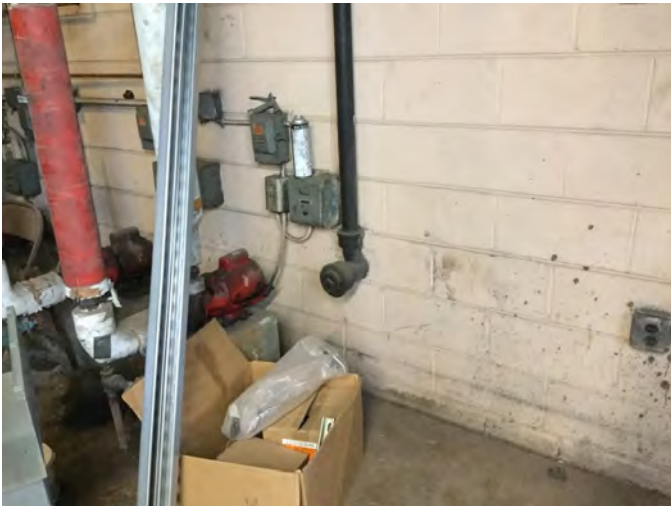
System: D2030 - Sanitary Waste

Location: Throughout the building
Distress: Beyond Service Life
Category: Deferred Maintenance
Priority: 3 - Necessary/Not Yet Critical (Years 2-5)
Correction: Renew System
Qty: 27,371.00
Unit of Measure: S.F.
Estimate: \$83,399.00
Assessor Name: Ann Buerger Linden
Date Created: 02/17/2017

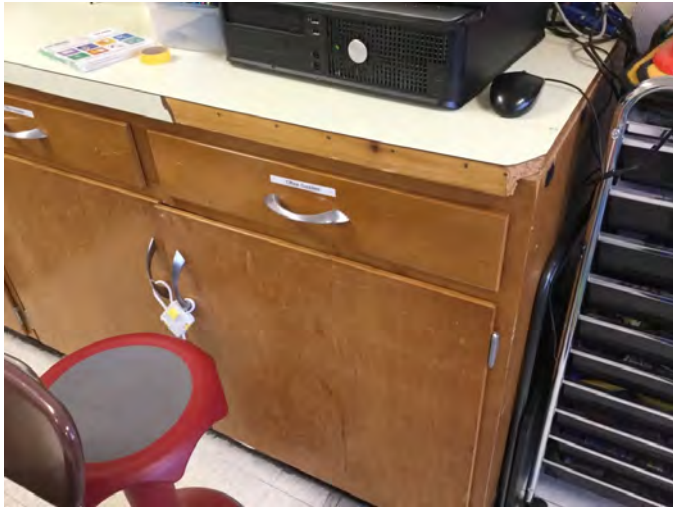
System: E2010 - Fixed Furnishings

Location: Throughout the building
Distress: Beyond Service Life
Category: Deferred Maintenance
Priority: 3 - Necessary/Not Yet Critical (Years 2-5)
Correction: Renew System
Qty: 27,371.00
Unit of Measure: S.F.
Estimate: \$160,476.00
Assessor Name: Ann Buerger Linden
Date Created: 02/17/2017

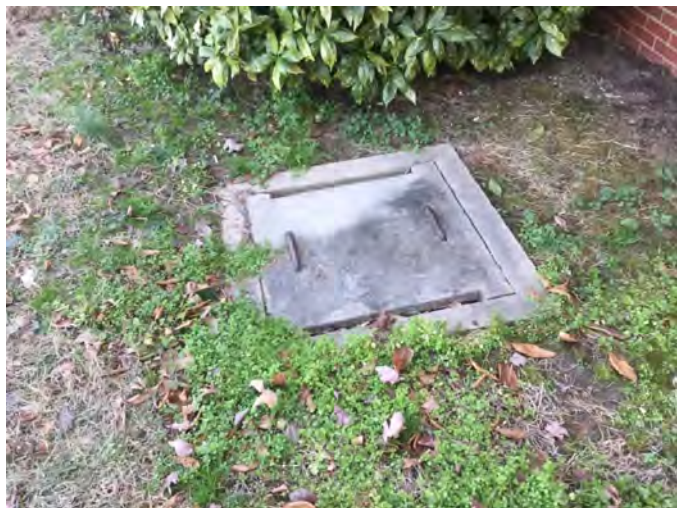
System: G3020 - Sanitary Sewer

Location: Site
Distress: Beyond Service Life
Category: Deferred Maintenance
Priority: 3 - Necessary/Not Yet Critical (Years 2-5)
Correction: Renew System
Qty: 44,558.00
Unit of Measure: S.F.
Estimate: \$74,501.00
Assessor Name: Eduardo Lopez
Date Created: 02/28/2017
