NC School District/300 Davie County/High School

Davie County Early College High

Campus Assessment Report

March 10, 2017

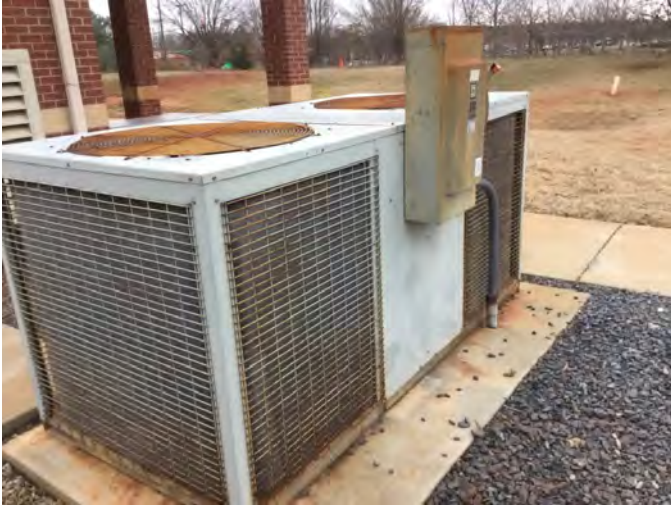
System: D3050 - Terminal & Package Units

Location: Southwest side of building
Distress: Beyond Service Life
Category: Deferred Maintenance
Priority: 3 - Necessary/Not Yet Critical (Years 2-5)
Correction: Renew System
Qty: 6,259.00
Unit of Measure: S.F.
Estimate: \$83,514.00
Assessor Name: Ann Buerger Linden
Date Created: 02/14/2017

Notes: The ground mounted compressor unit for this building is beyond its expected life. System renewal to ensure system performance and for energy conservation is recommended.
