NC School District/300 Davie County/Middle School

William Ellis Middle

Campus Assessment Report

March 10, 2017

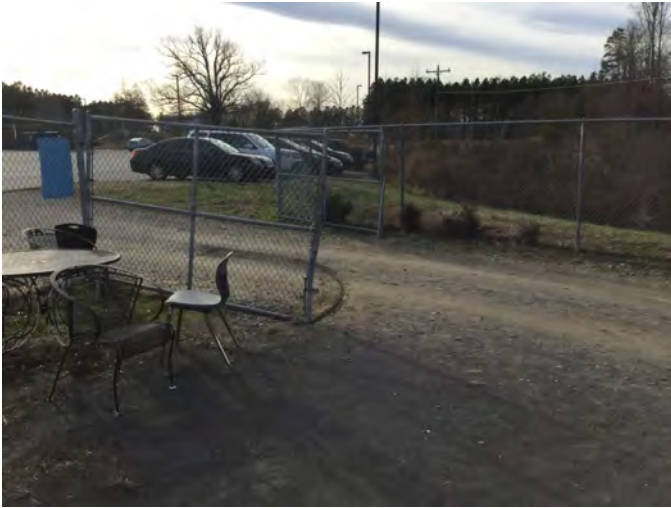
System: G2010 - Roadways

Location: Bus lot to athletic fields
Distress: Missing
Category: Deferred Maintenance / Safety
Priority: 4 - Recommended (Years 6-10)
Correction: Resurface the roadway
Qty: 1,000.00
Unit of Measure: L.F.
Estimate: \$171,600.00
Assessor Name: Terence Davis
Date Created: 02/11/2017

Notes: The road to the athletic fields is gravel. The circulation road east of the building is gravel. Paving with asphalt is recommended for safety and appearance..
