NC School District/400 Greene County/Elementary School

West Greene Elementary

Campus Assessment Report

March 13, 2017

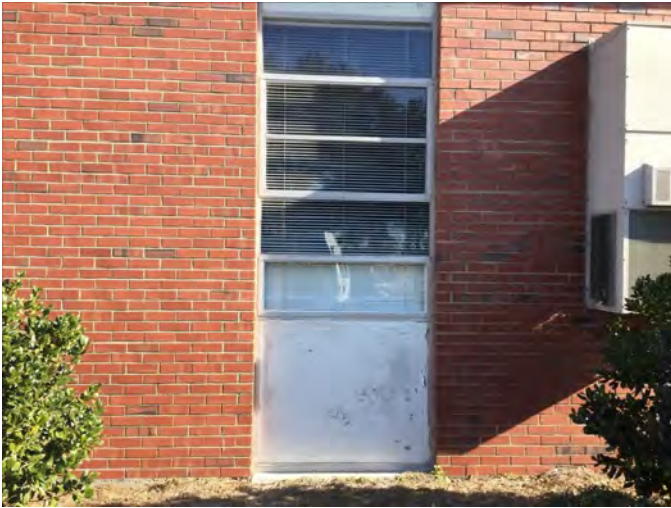
System: B2020 - Exterior Windows

Location: Exterior
Distress: Failing
Category: Deferred Maintenance
Priority: 3 - Necessary/Not Yet Critical (Years 2-5)
Correction: Renew System
Qty: 69,949.00
Unit of Measure: S.F.
Estimate: \$707,884.00
Assessor Name: Eduardo Lopez
Date Created: 02/10/2017

Notes: The aluminum frame, operable, single pane windows are aged, not energy efficient, and should be replaced.

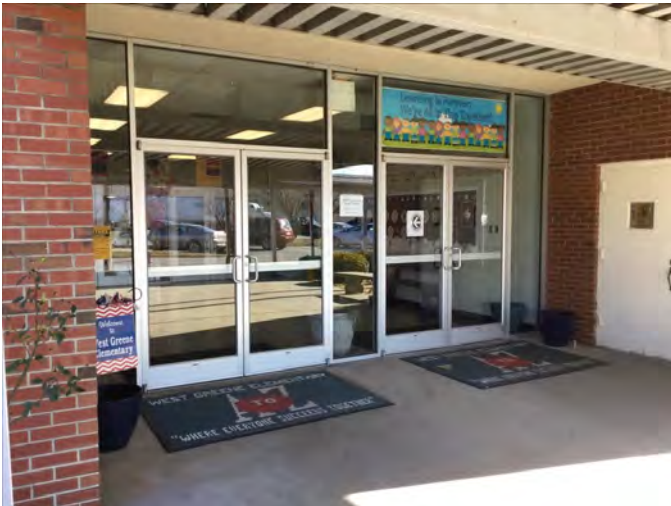
System: B2030 - Exterior Doors

Location: Exterior
Distress: Beyond Service Life
Category: Deferred Maintenance / Accessibility Code Compliance
Priority: 3 - Necessary/Not Yet Critical (Years 2-5)
Correction: Renew System
Qty: 69,949.00
Unit of Measure: S.F.
Estimate: \$78,483.00
Assessor Name: Eduardo Lopez
Date Created: 02/10/2017

Notes: The original exterior doors are aged and should be replaced.

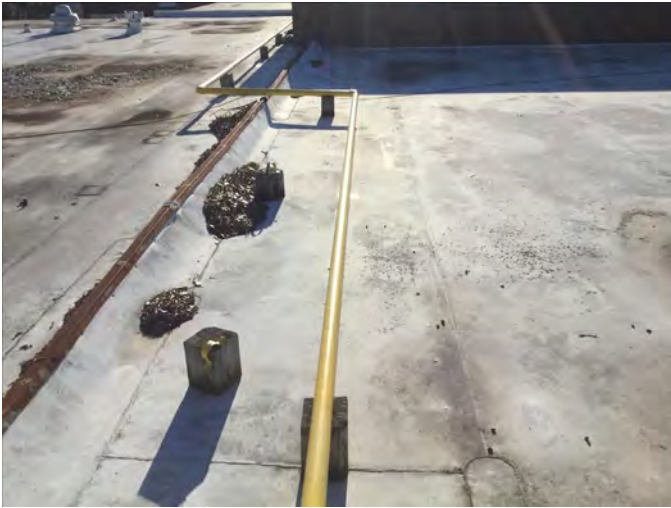
System: B3010120 - Single Ply Membrane

Location: Roof
Distress: Failing
Category: Deferred Maintenance
Priority: 3 - Necessary/Not Yet Critical (Years 2-5)
Correction: Renew System
Qty: 69,949.00
Unit of Measure: S.F.
Estimate: \$732,366.00
Assessor Name: Eduardo Lopez
Date Created: 02/10/2017

Notes: The asphalt shingle roofing is aged, repairs are increasing and it passed its service life and should be replaced.

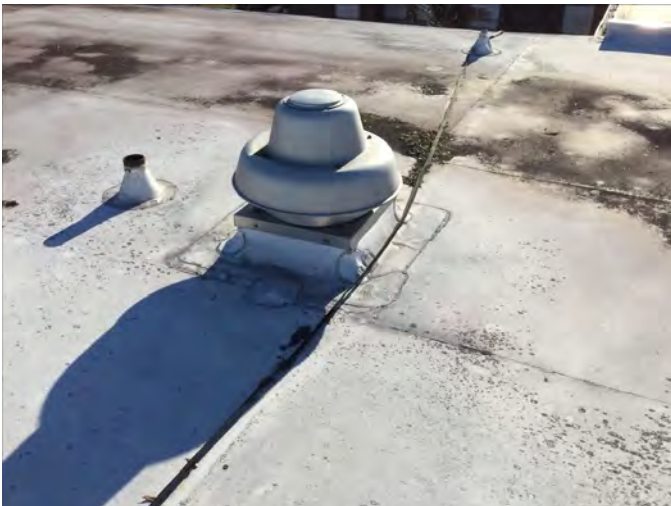
System: B3020 - Roof Openings

Location: Roof
Distress: Beyond Service Life
Category: Deferred Maintenance
Priority: 3 - Necessary/Not Yet Critical (Years 2-5)
Correction: Renew System
Qty: 69,949.00
Unit of Measure: S.F.
Estimate: \$22,314.00
Assessor Name: Eduardo Lopez
Date Created: 02/10/2017

Notes: Roof penetrations and openings should be inspected and repaired when the roof is replaced.

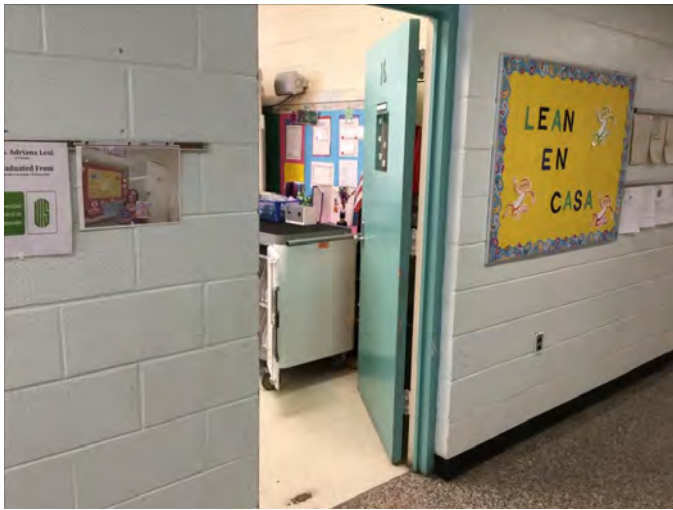
System: C1020 - Interior Doors

Location: Classrooms
Distress: Failing
Category: Deferred Maintenance
Priority: 3 - Necessary/Not Yet Critical (Years 2-5)
Correction: Renew System
Qty: 69,949.00
Unit of Measure: S.F.
Estimate: \$190,821.00
Assessor Name: Eduardo Lopez
Date Created: 02/10/2017

Notes: The original wood interior doors are aged, worn and should be replaced.

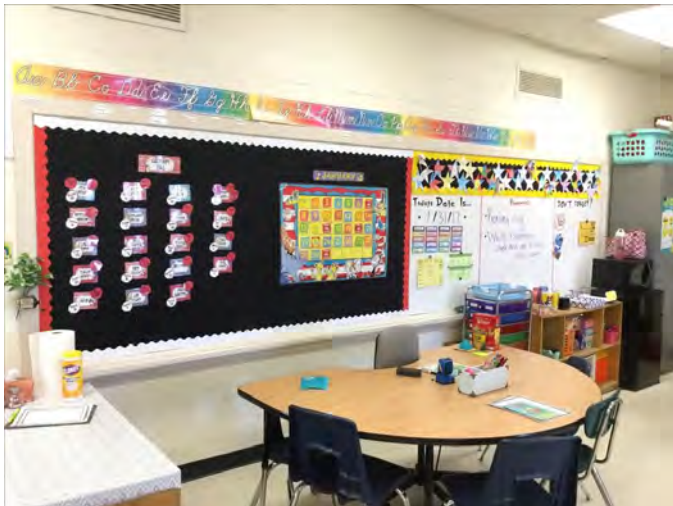
System: C1030 - Fittings

Location: Throughout the building
Distress: Beyond Service Life
Category: Deferred Maintenance
Priority: 3 - Necessary/Not Yet Critical (Years 2-5)
Correction: Renew System
Qty: 69,949.00
Unit of Measure: S.F.
Estimate: \$734,045.00
Assessor Name: Eduardo Lopez
Date Created: 02/22/2017

Notes: The fittings, such as signs, marker boards, tack boards and chalkboards have reached the end of their useful life and should be replaced.

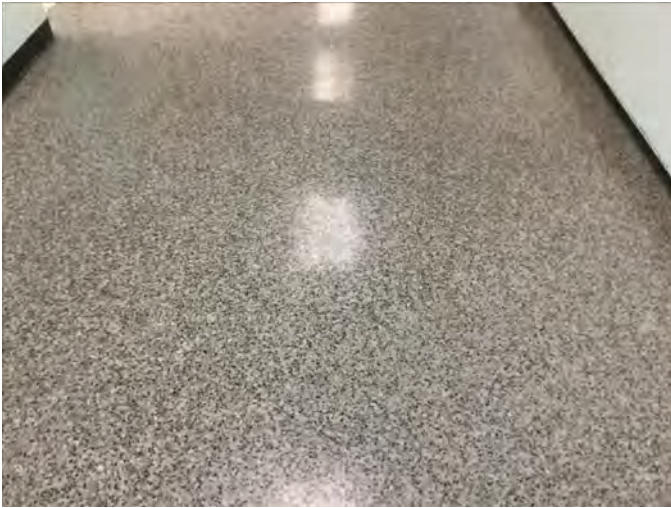
System: C3020 - Floor Finishes

Location: Throughout the building
Distress: Beyond Service Life
Category: Deferred Maintenance
Priority: 3 - Necessary/Not Yet Critical (Years 2-5)
Correction: Renew System
Qty: 69,949.00
Unit of Measure: S.F.
Estimate: \$857,924.00
Assessor Name: Eduardo Lopez
Date Created: 02/22/2017

Notes: The floor coverings are beyond their service life, damaged in different areas throughout the building and should be replaced.

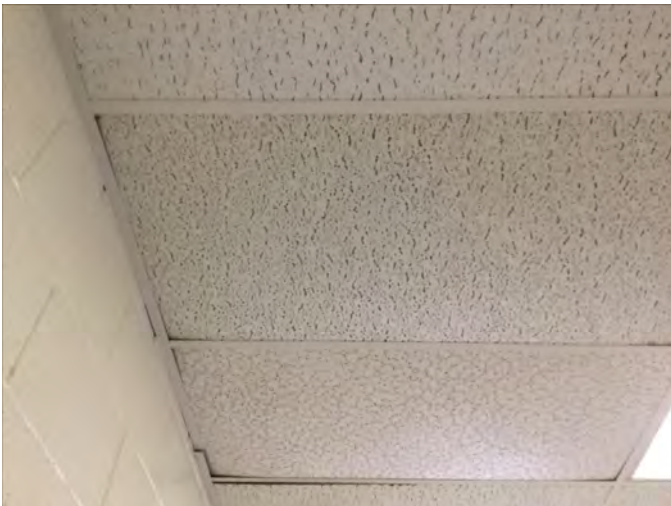
System: C3030 - Ceiling Finishes

Location: Throughout the building
Distress: Damaged
Category: Deferred Maintenance
Priority: 3 - Necessary/Not Yet Critical (Years 2-5)
Correction: Renew System
Qty: 69,949.00
Unit of Measure: S.F.
Estimate: \$826,377.00
Assessor Name: Eduardo Lopez
Date Created: 02/15/2017

Notes: The acoustical ceiling tiles and grid system is aged, and should be replaced.

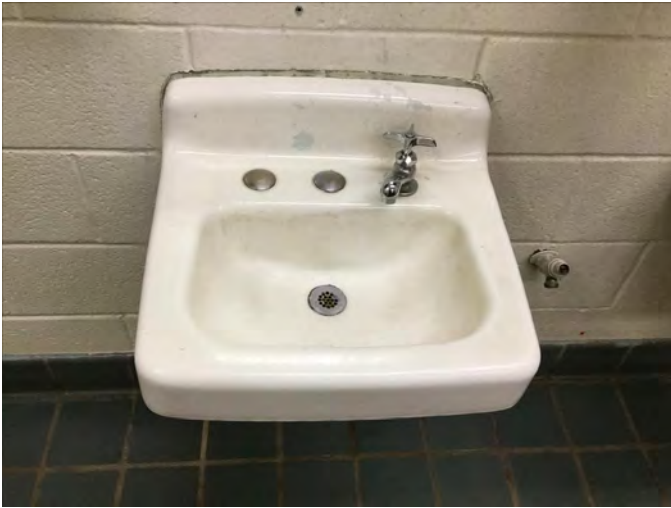
System: D2010 - Plumbing Fixtures

Location: Restroom
Distress: Inadequate
Category: Deferred Maintenance
Priority: 3 - Necessary/Not Yet Critical (Years 2-5)
Correction: Renew System
Qty: 69,949.00
Unit of Measure: S.F.
Estimate: \$866,388.00
Assessor Name: Eduardo Lopez
Date Created: 02/10/2017

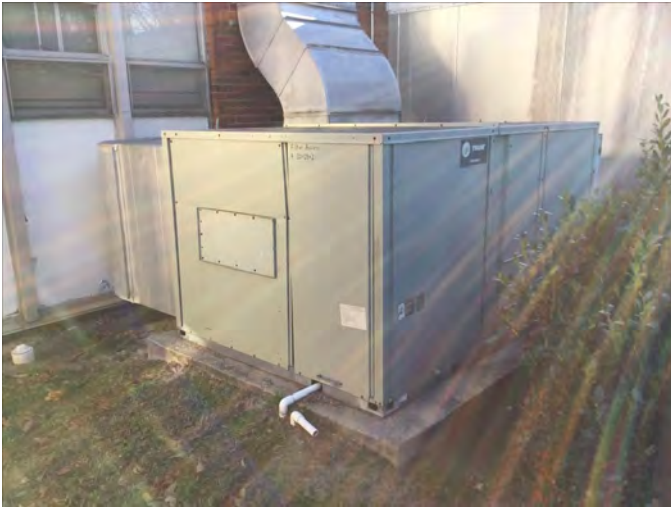
System: D3050 - Terminal & Package Units

Location: Exterior
Distress: Beyond Service Life
Category: Deferred Maintenance
Priority: 3 - Necessary/Not Yet Critical (Years 2-5)
Correction: Renew System
Qty: 69,949.00
Unit of Measure: S.F.
Estimate: \$1,007,196.00
Assessor Name: Eduardo Lopez
Date Created: 02/10/2017

Notes: The pad mounted heat pumps are aged and should be replaced.

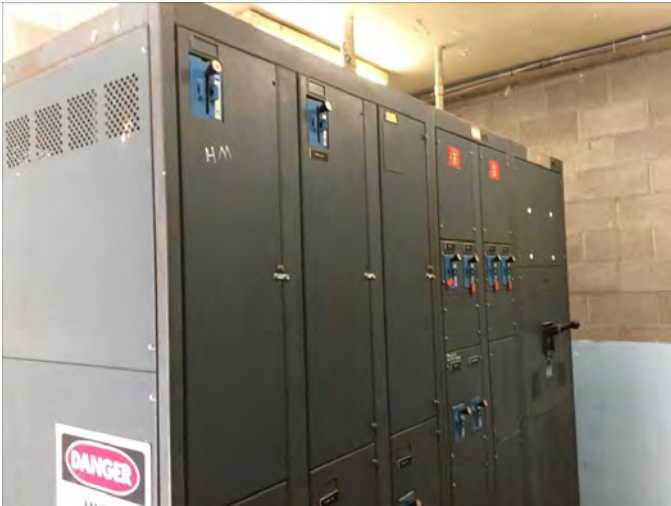
System: D5010 - Electrical Service/Distribution

Location: Throughout the building
Distress: Beyond Service Life
Category: Deferred Maintenance
Priority: 3 - Necessary/Not Yet Critical (Years 2-5)
Correction: Renew System
Qty: 69,949.00
Unit of Measure: S.F.
Estimate: \$126,957.00
Assessor Name: Eduardo Lopez
Date Created: 02/10/2017

Notes: The electrical distribution system is aged, becoming logistically unsupportable and should be replaced.

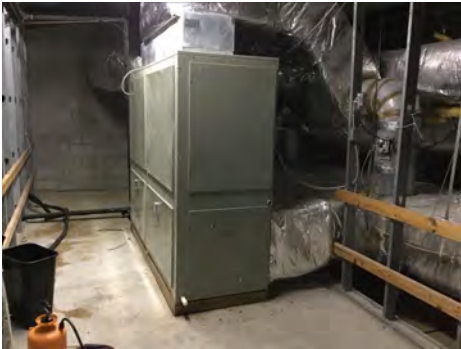
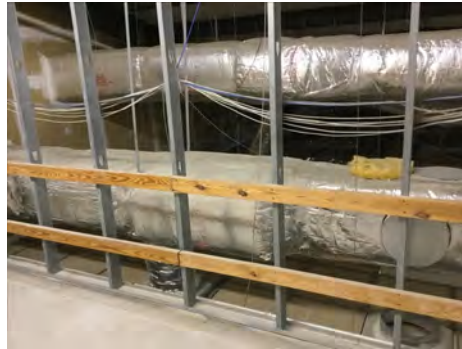
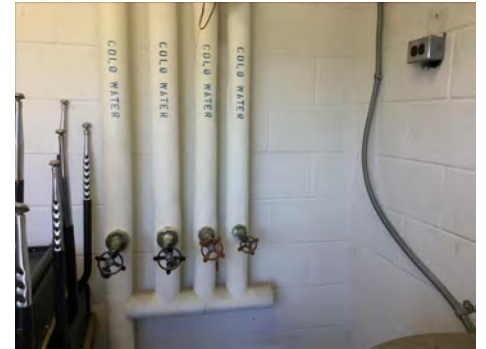
System: D3040 - Distribution Systems

Note: Air Handler major issues. improper drainage.

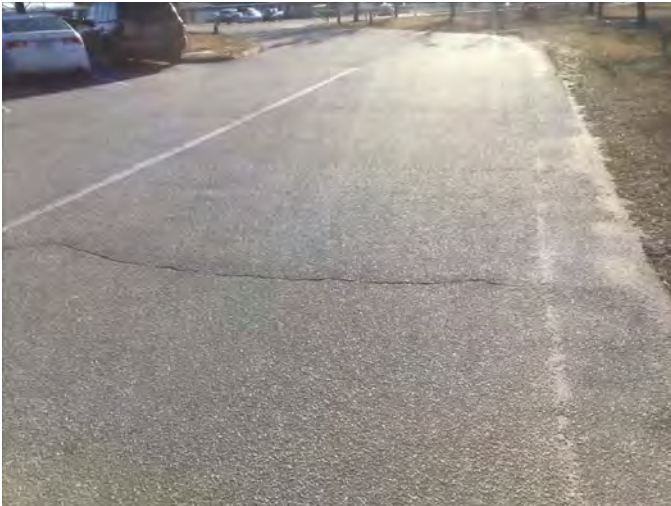
System: G2010 - Roadways

Location: Site
Distress: Damaged
Category: Deferred Maintenance
Priority: 3 - Necessary/Not Yet Critical (Years 2-5)
Correction: Renew System
Qty: 103,697.00
Unit of Measure: S.F.
Estimate: \$481,361.00
Assessor Name: Somnath Das
Date Created: 01/30/2017

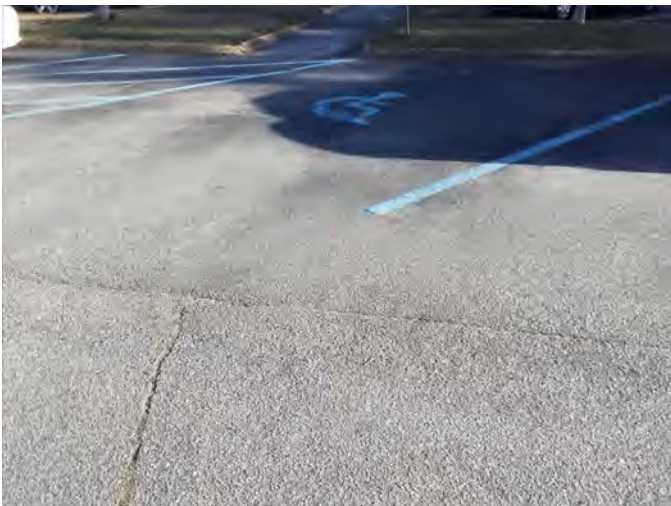
System: G2020 - Parking Lots

Location: Site
Distress: Damaged
Category: Deferred Maintenance
Priority: 3 - Necessary/Not Yet Critical (Years 2-5)
Correction: Renew System
Qty: 103,697.00
Unit of Measure: S.F.
Estimate: \$158,553.00
Assessor Name: Somnath Das
Date Created: 01/30/2017
