NC School District/400 Greene County/High School

# Greene Central High

## Campus Assessment Report

March 13, 2017

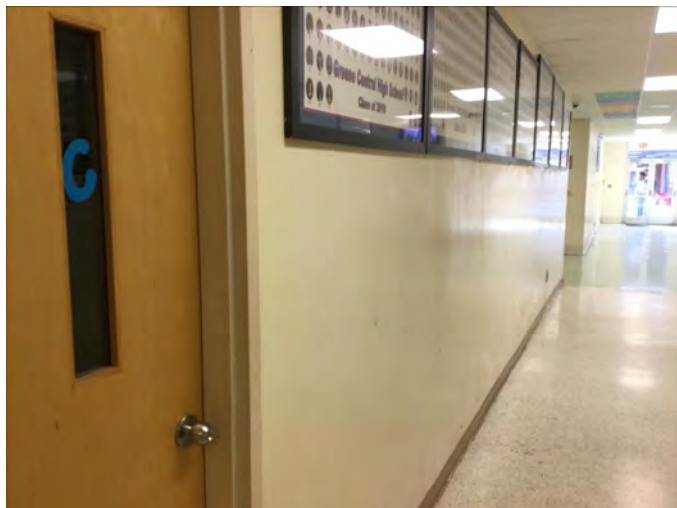
#### **System: C1030 - Fittings**

**Location:** Throughout the building  
**Distress:** Inadequate  
**Category:** Accessibility Code Compliance  
**Priority:** 2 - Potentially Critical (Year 1)  
**Correction:** Replace signage and toilet partitions  
**Qty:** 400.00  
**Unit of Measure:** Ea.  
**Estimate:** \$44,643.72  
**Assessor Name:** Eduardo Lopez  
**Date Created:** 02/21/2017

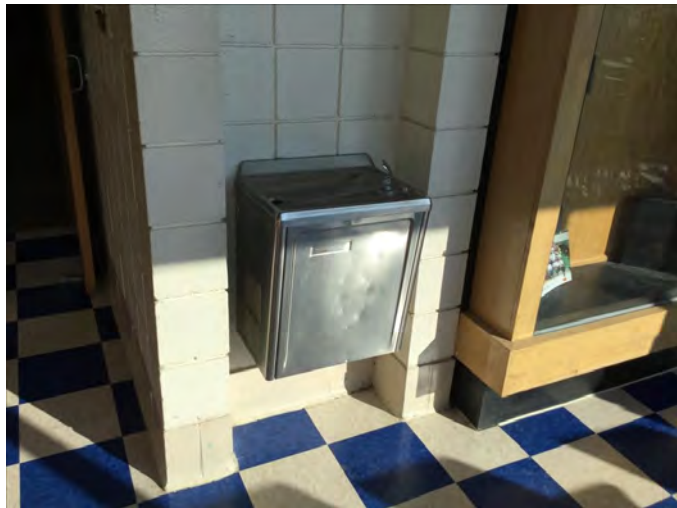
**System: D2010 - Plumbing Fixtures**

**Location:** Throughout the building  
**Distress:** Inadequate  
**Category:** Deferred Maintenance  
**Priority:** 3 - Necessary/Not Yet Critical (Years 2-5)  
**Correction:** Renew System  
**Qty:** 18,118.00  
**Unit of Measure:** S.F.  
**Estimate:** \$188,536.00  
**Assessor Name:** Eduardo Lopez  
**Date Created:** 02/16/2017

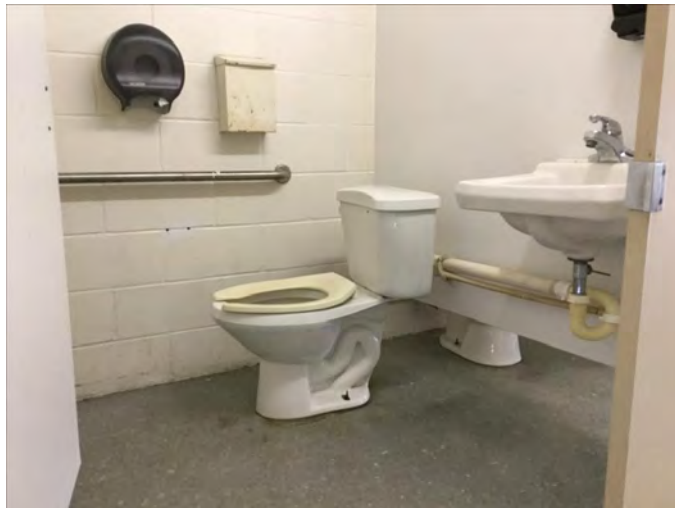
**System: D2010 - Plumbing Fixtures**

**Location:** Restroom  
**Distress:** Beyond Service Life  
**Category:** Deferred Maintenance  
**Priority:** 3 - Necessary/Not Yet Critical (Years 2-5)  
**Correction:** Renew System  
**Qty:** 1,100.00  
**Unit of Measure:** S.F.  
**Estimate:** \$12,076.00  
**Assessor Name:** Eduardo Lopez  
**Date Created:** 02/14/2017

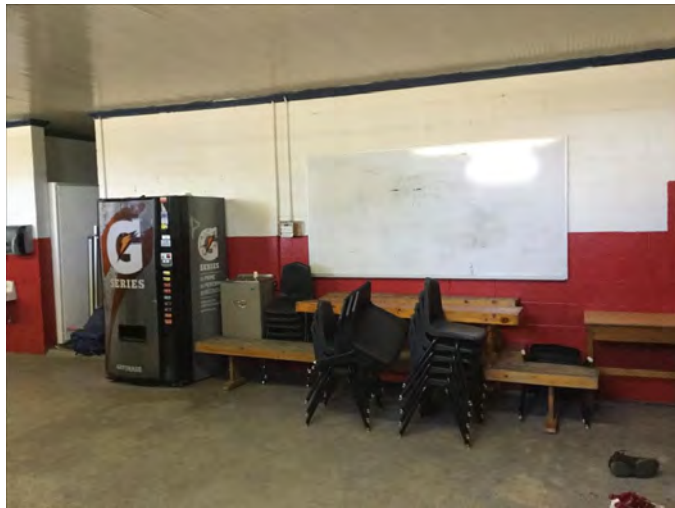
**System: E2010 - Fixed Furnishings**

**Location:** Throughout the building  
**Distress:** Damaged  
**Category:** Deferred Maintenance  
**Priority:** 3 - Necessary/Not Yet Critical (Years 2-5)  
**Correction:** Renew System  
**Qty:** 2,400.00  
**Unit of Measure:** S.F.  
**Estimate:** \$13,411.00  
**Assessor Name:** Eduardo Lopez  
**Date Created:** 02/16/2017
