NC School District/430 Harnett County/Elementary School

Benhaven Elementary

Campus Assessment Report

March 11, 2017

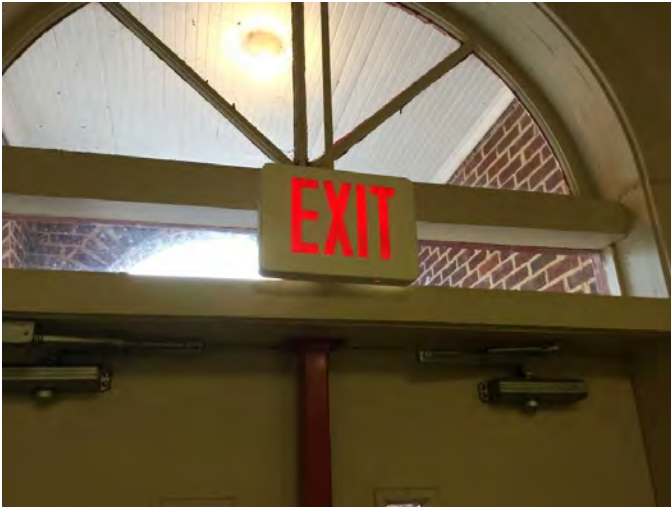
System: C1030 - Fittings

Location: Throughout
Distress: Beyond Service Life
Category: Deferred Maintenance / Accessibility Code Compliance
Priority: 3 - Necessary/Not Yet Critical (Years 2-5)
Correction: Renew System
Qty: 12,688.00
Unit of Measure: S.F.
Estimate: \$138,731.00
Assessor Name: Terence Davis
Date Created: 12/06/2016

Notes: The fittings throughout the building are aged, in marginal condition, handrails and room signage are ADA non-compliance and system should be replaced.

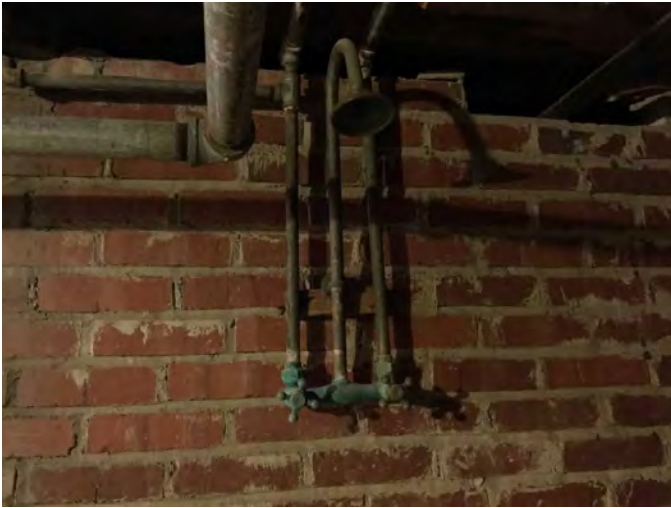
System: D2010 - Plumbing Fixtures

Location: Throughout
Distress: Beyond Service Life
Category: Deferred Maintenance / Accessibility Code Compliance
Priority: 3 - Necessary/Not Yet Critical (Years 2-5)
Correction: Renew System
Qty: 12,688.00
Unit of Measure: S.F.
Estimate: \$163,434.00
Assessor Name: Terence Davis
Date Created: 12/06/2016

Notes: Plumbing fixtures are in operational conditions. However, they are aged, not ADA compliant and should be replaced with a low-flow water fixtures.

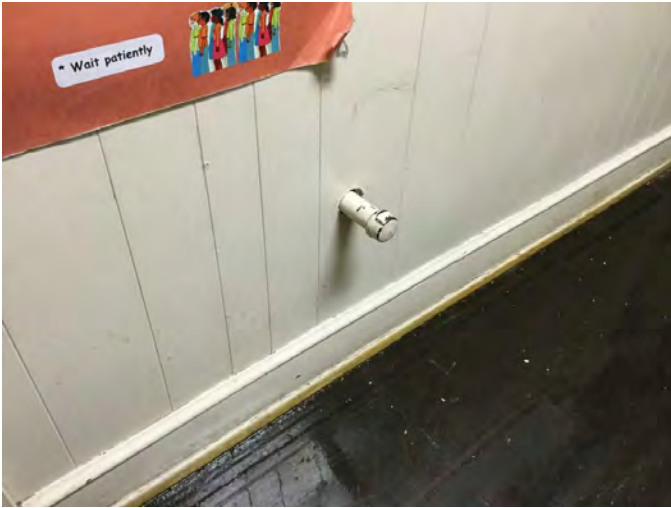
System: D2030 - Sanitary Waste

Location: Throughout
Distress: Beyond Service Life
Category: Deferred Maintenance
Priority: 3 - Necessary/Not Yet Critical (Years 2-5)
Correction: Renew System
Qty: 12,688.00
Unit of Measure: S.F.
Estimate: \$21,912.00
Assessor Name: Terence Davis
Date Created: 12/06/2016

Notes: The sanitary waste system is aged, has reported periodic failures, and should be replaced.

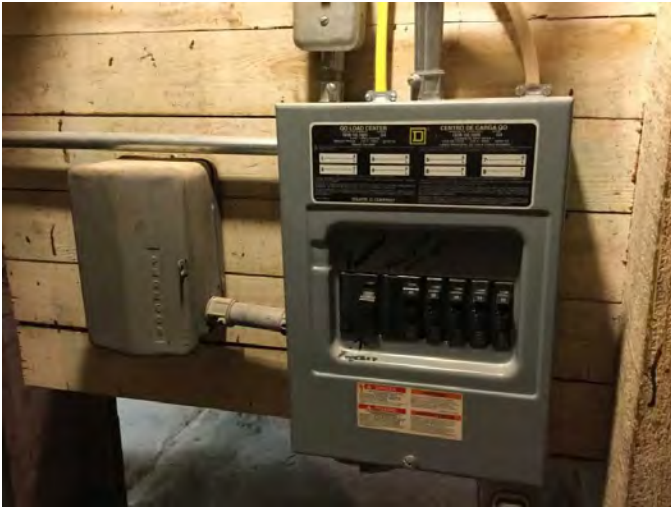
System: D5020 - Branch Wiring

Location: Throughout
Distress: Beyond Service Life
Category: Deferred Maintenance
Priority: 3 - Necessary/Not Yet Critical (Years 2-5)
Correction: Renew System
Qty: 12,688.00
Unit of Measure: S.F.
Estimate: \$72,575.00
Assessor Name: Terence Davis
Date Created: 12/06/2016

Notes: The original branch wiring system is operating, but is aged, in poor condition, and should be replaced

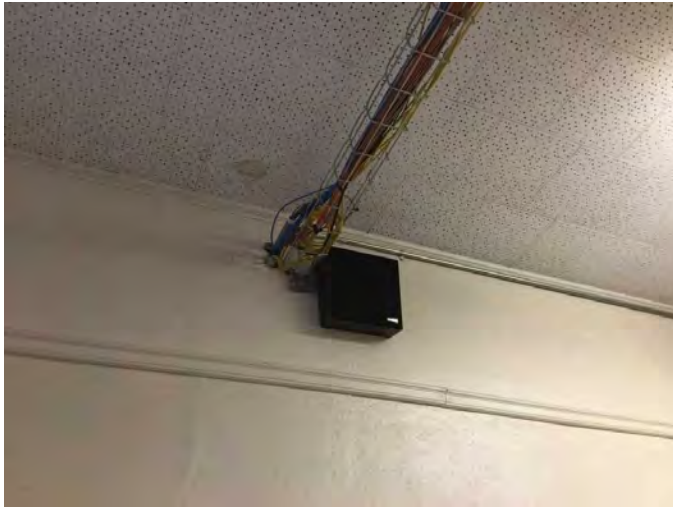
System: D5030920 - Data Communication

Location: Throughout
Distress: Beyond Service Life
Category: Deferred Maintenance
Priority: 3 - Necessary/Not Yet Critical (Years 2-5)
Correction: Renew System
Qty: 12,688.00
Unit of Measure: S.F.
Estimate: \$62,387.00
Assessor Name: Terence Davis
Date Created: 12/06/2016

Notes: The majority of the system is beyond its expected service life and should be scheduled for replacement.

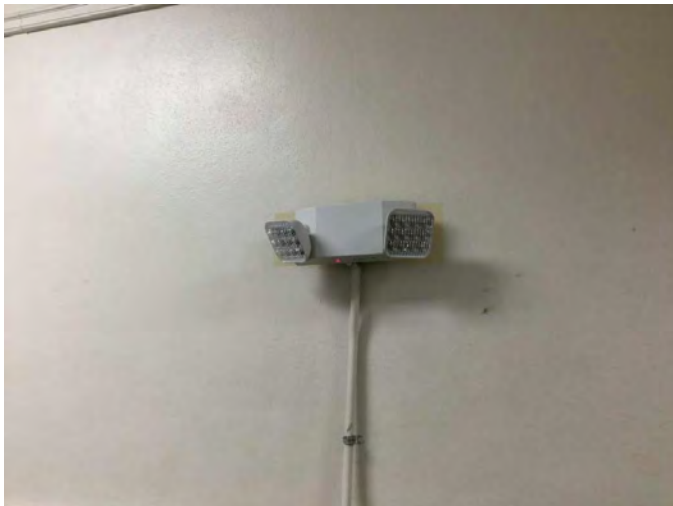
System: D5090 - Other Electrical Systems

Location: Throughout
Distress: Beyond Service Life
Category: Deferred Maintenance
Priority: 3 - Necessary/Not Yet Critical (Years 2-5)
Correction: Renew System
Qty: 12,688.00
Unit of Measure: S.F.
Estimate: \$1,675.00
Assessor Name: Terence Davis
Date Created: 12/06/2016

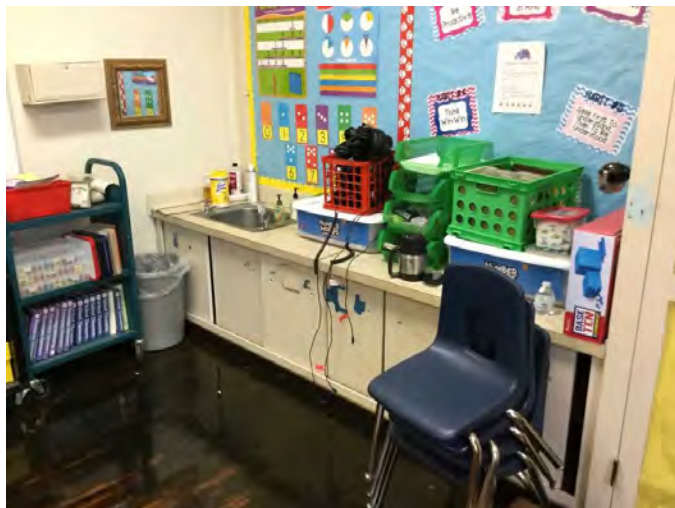
System: E2010 - Fixed Furnishings

Location: Throughout
Distress: Beyond Service Life
Category: Deferred Maintenance
Priority: 3 - Necessary/Not Yet Critical (Years 2-5)
Correction: Renew System
Qty: 12,688.00
Unit of Measure: S.F.
Estimate: \$83,043.00
Assessor Name: Terence Davis
Date Created: 12/06/2016

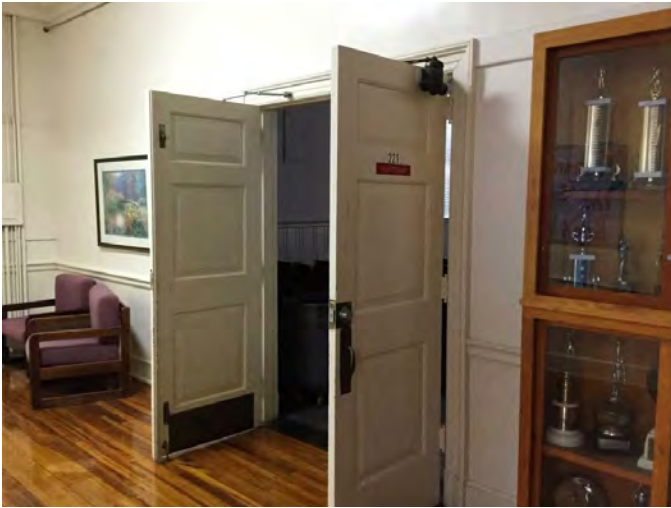
System: C1020 - Interior Doors

Location: Throughout
Distress: Beyond Service Life
Category: Deferred Maintenance
Priority: 3 - Necessary/Not Yet Critical (Years 2-5)
Correction: Renew System
Qty: 24,319.00
Unit of Measure: S.F.
Estimate: \$69,285.00
Assessor Name: Terence Davis
Date Created: 12/07/2016

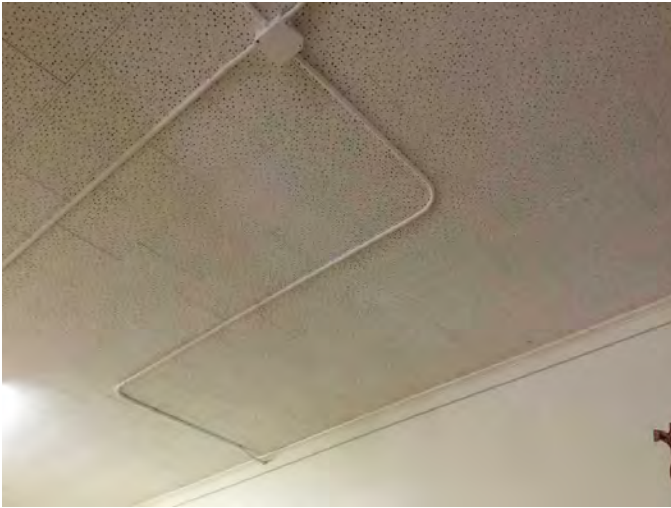
System: C3030 - Ceiling Finishes

Location: Throughout
Distress: Beyond Service Life
Category: Deferred Maintenance / Appearance
Priority: 3 - Necessary/Not Yet Critical (Years 2-5)
Correction: Renew System
Qty: 24,319.00
Unit of Measure: S.F.
Estimate: \$299,343.00
Assessor Name: Terence Davis
Date Created: 12/07/2016

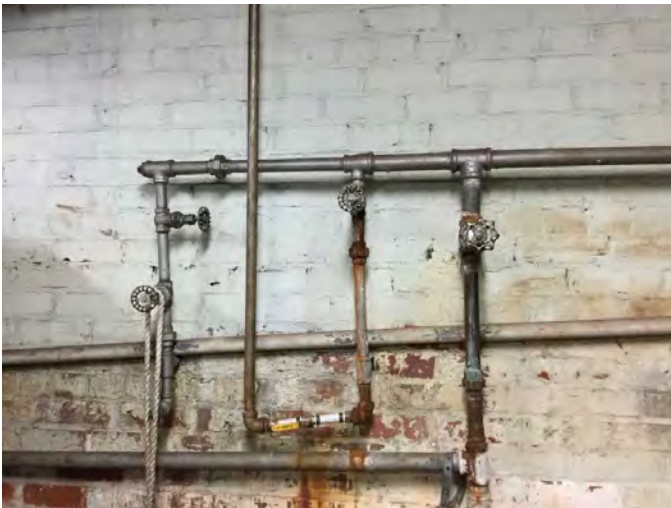
System: D2020 - Domestic Water Distribution

Location: Throughout
Distress: Beyond Service Life
Category: Deferred Maintenance
Priority: 3 - Necessary/Not Yet Critical (Years 2-5)
Correction: Renew System
Qty: 24,319.00
Unit of Measure: S.F.
Estimate: \$26,483.00
Assessor Name: Terence Davis
Date Created: 12/07/2016

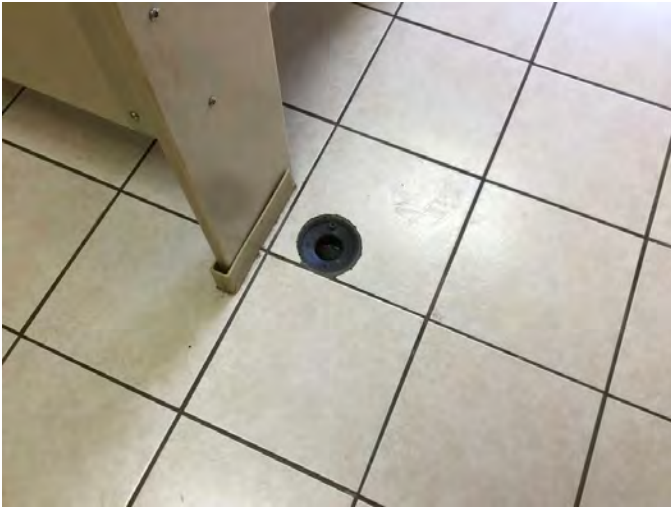
System: D2030 - Sanitary Waste

Location: Throughout
Distress: Beyond Service Life
Category: Deferred Maintenance
Priority: 3 - Necessary/Not Yet Critical (Years 2-5)
Correction: Renew System
Qty: 24,319.00
Unit of Measure: S.F.
Estimate: \$41,999.00
Assessor Name: Terence Davis
Date Created: 12/07/2016

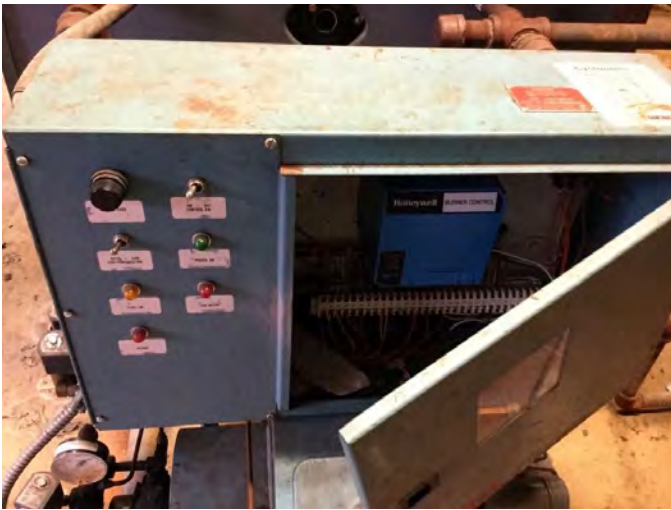
System: D3060 - Controls & Instrumentation

Location: Throughout
Distress: Beyond Service Life
Category: Deferred Maintenance / Environmental
Priority: 3 - Necessary/Not Yet Critical (Years 2-5)
Correction: Renew System
Qty: 24,319.00
Unit of Measure: S.F.
Estimate: \$52,967.00
Assessor Name: Terence Davis
Date Created: 12/07/2016

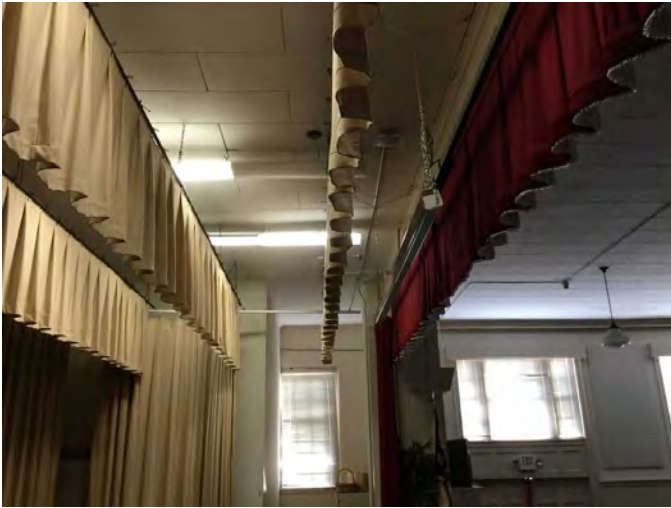
System: E1020 - Institutional Equipment

Location: Throughout
Distress: Beyond Service Life
Category: Deferred Maintenance
Priority: 3 - Necessary/Not Yet Critical (Years 2-5)
Correction: Renew System
Qty: 24,319.00
Unit of Measure: S.F.
Estimate: \$8,025.00
Assessor Name: Terence Davis
Date Created: 12/07/2016

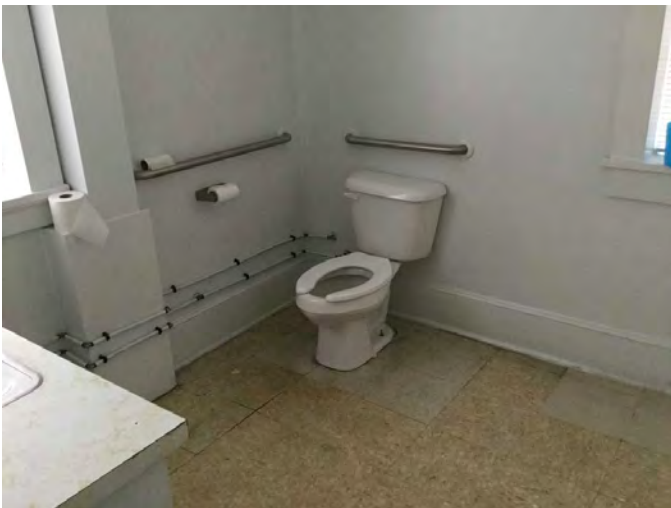
System: C1030 - Fittings

Location: Throughout
Distress: Beyond Service Life
Category: Deferred Maintenance / Accessibility Code Compliance
Priority: 3 - Necessary/Not Yet Critical (Years 2-5)
Correction: Renew System
Qty: 4,725.00
Unit of Measure: S.F.
Estimate: \$51,663.00
Assessor Name: Terence Davis
Date Created: 12/07/2016

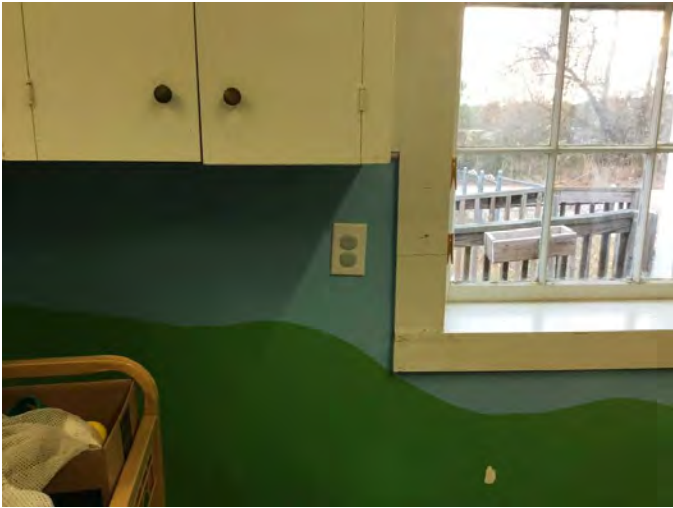
System: C3010 - Wall Finishes

Location: Throughout
Distress: Beyond Service Life
Category: Deferred Maintenance / Appearance
Priority: 3 - Necessary/Not Yet Critical (Years 2-5)
Correction: Renew System
Qty: 4,725.00
Unit of Measure: S.F.
Estimate: \$14,761.00
Assessor Name: Terence Davis
Date Created: 12/07/2016

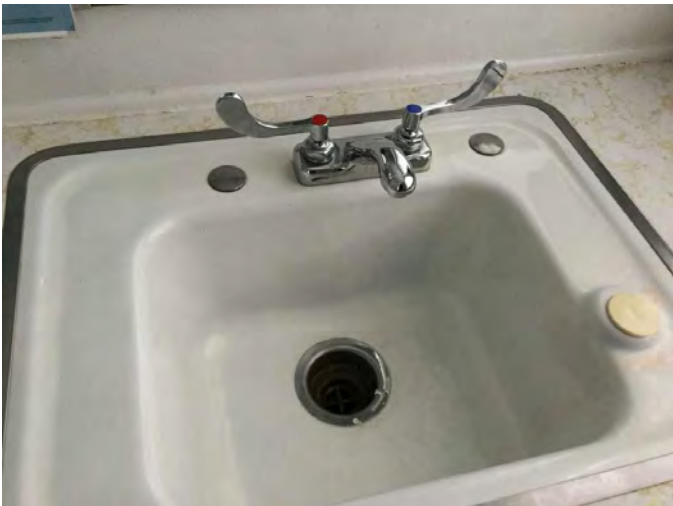
System: D2010 - Plumbing Fixtures

Location: Throughout
Distress: Beyond Service Life
Category: Deferred Maintenance
Priority: 3 - Necessary/Not Yet Critical (Years 2-5)
Correction: Renew System
Qty: 4,725.00
Unit of Measure: S.F.
Estimate: \$60,863.00
Assessor Name: Terence Davis
Date Created: 12/07/2016

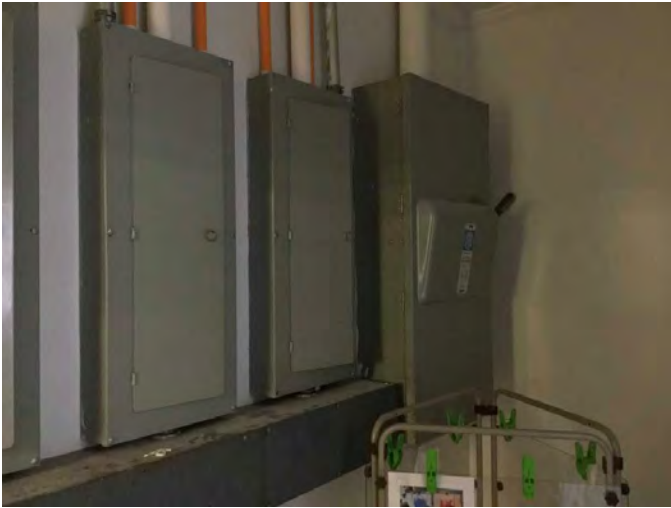
System: D5010 - Electrical Service/Distribution

Location: Throughout
Distress: Beyond Service Life
Category: Deferred Maintenance
Priority: 3 - Necessary/Not Yet Critical (Years 2-5)
Correction: Renew System
Qty: 4,725.00
Unit of Measure: S.F.
Estimate: \$8,992.00
Assessor Name: Terence Davis
Date Created: 12/07/2016

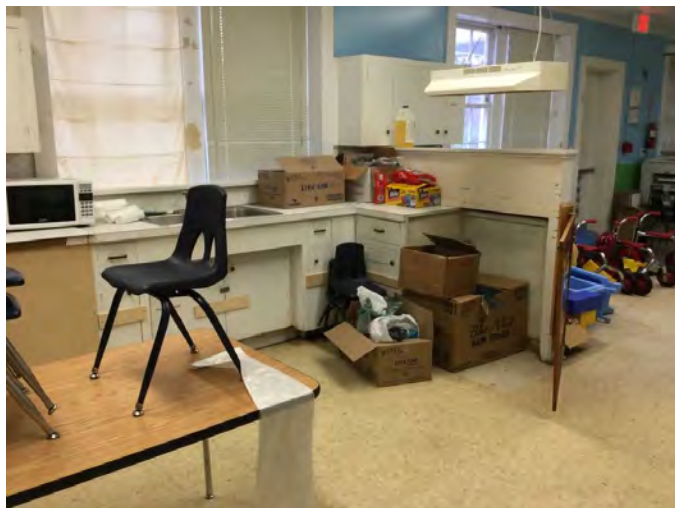
System: E2010 - Fixed Furnishings

Location: Throughout
Distress: Beyond Service Life
Category: Deferred Maintenance
Priority: 3 - Necessary/Not Yet Critical (Years 2-5)
Correction: Renew System
Qty: 4,725.00
Unit of Measure: S.F.
Estimate: \$30,925.00
Assessor Name: Terence Davis
Date Created: 12/07/2016

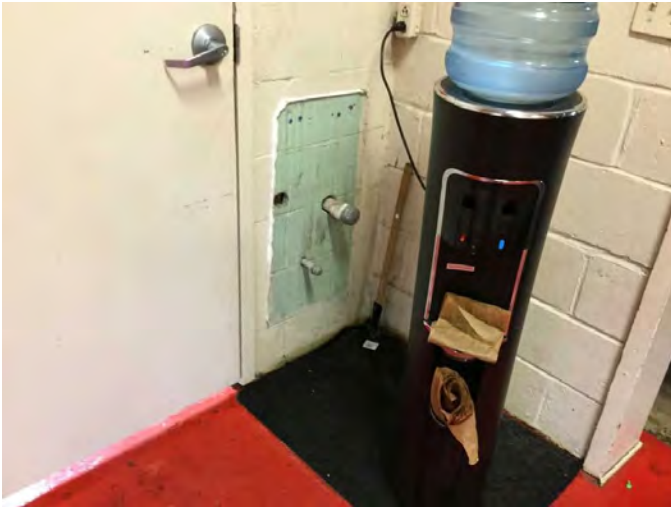
System: D2020 - Domestic Water Distribution

Location: Throughout
Distress: Beyond Service Life
Category: Deferred Maintenance
Priority: 3 - Necessary/Not Yet Critical (Years 2-5)
Correction: Renew System
Qty: 20,200.00
Unit of Measure: S.F.
Estimate: \$21,998.00
Assessor Name: Terence Davis
Date Created: 12/07/2016

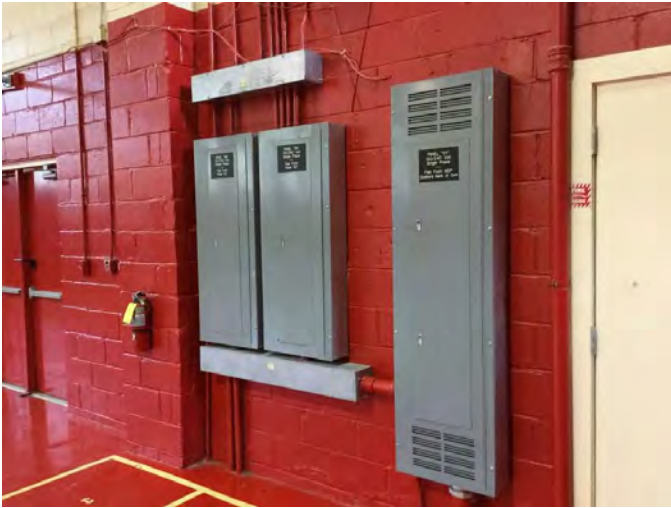
System: D5010 - Electrical Service/Distribution

Location: Throughout
Distress: Beyond Service Life
Category: Deferred Maintenance
Priority: 3 - Necessary/Not Yet Critical (Years 2-5)
Correction: Renew System
Qty: 20,200.00
Unit of Measure: S.F.
Estimate: \$38,441.00
Assessor Name: Terence Davis
Date Created: 12/07/2016

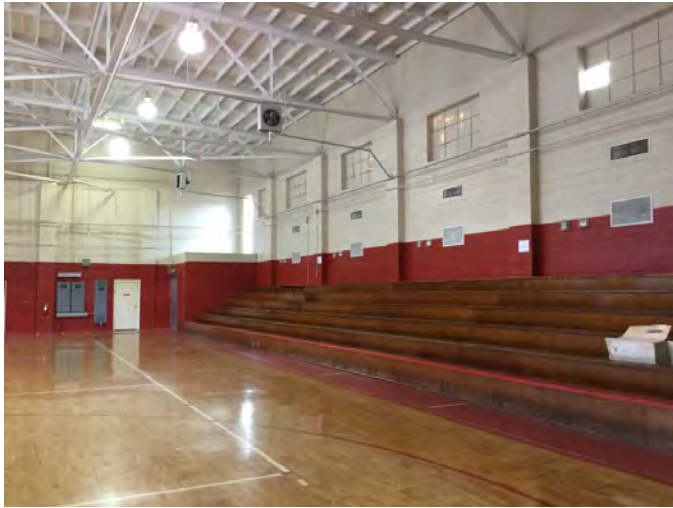
System: E2010 - Fixed Furnishings

Location: Throughout
Distress: Beyond Service Life
Category: Deferred Maintenance
Priority: 3 - Necessary/Not Yet Critical (Years 2-5)
Correction: Renew System
Qty: 20,200.00
Unit of Measure: S.F.
Estimate: \$132,209.00
Assessor Name: Terence Davis
Date Created: 12/07/2016

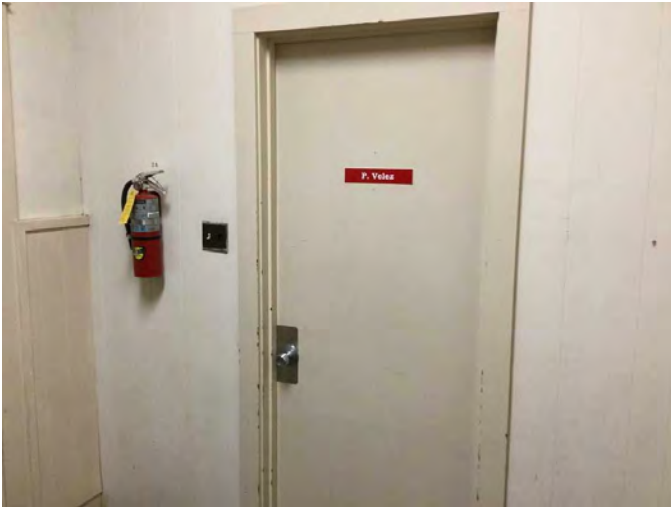
System: C1030 - Fittings

Location: Throughout
Distress: Beyond Service Life
Category: Deferred Maintenance
Priority: 3 - Necessary/Not Yet Critical (Years 2-5)
Correction: Renew System
Qty: 12,688.00
Unit of Measure: S.F.
Estimate: \$138,731.00
Assessor Name: Terence Davis
Date Created: 12/07/2016

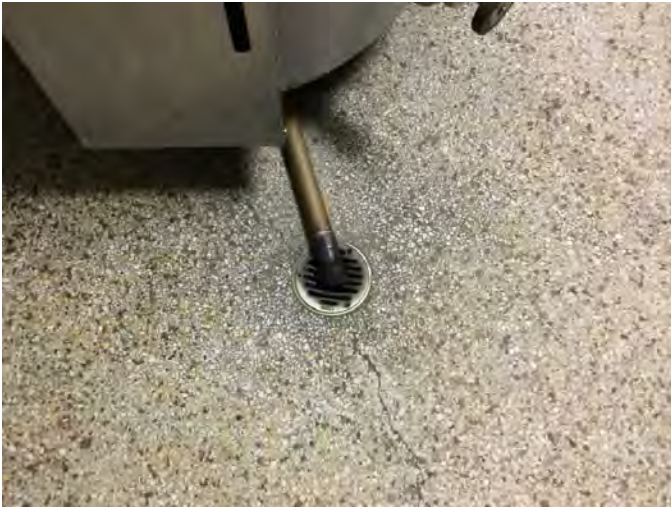
System: D2030 - Sanitary Waste

Location: Throughout
Distress: Beyond Service Life
Category: Deferred Maintenance
Priority: 3 - Necessary/Not Yet Critical (Years 2-5)
Correction: Renew System
Qty: 12,688.00
Unit of Measure: S.F.
Estimate: \$21,912.00
Assessor Name: Terence Davis
Date Created: 12/07/2016

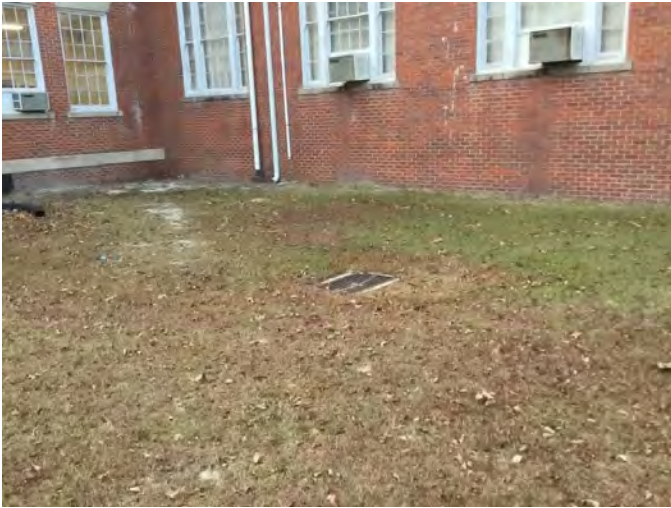
Location: Site
Distress: Beyond Service Life
Category: Deferred Maintenance
Priority: 3 - Necessary/Not Yet Critical (Years 2-5)
Correction: Renew System
Qty: 81,395.00
Unit of Measure: S.F.
Estimate: \$406,487.00
Assessor Name: Eduardo Lopez
Date Created: 12/07/2016

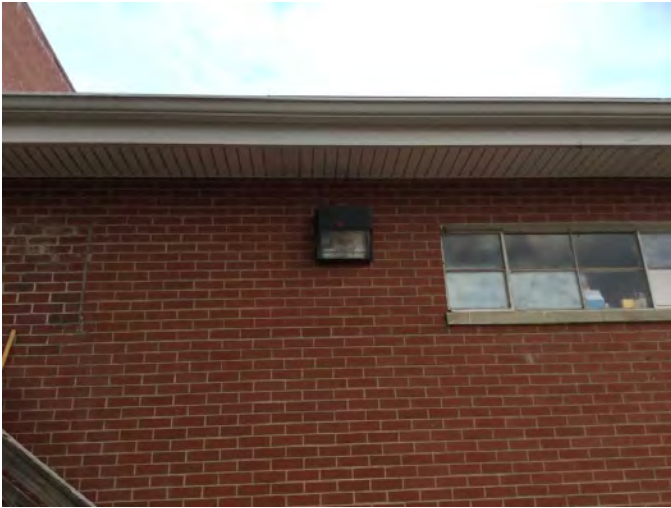
Location: Site
Distress: Inadequate
Category: Deferred Maintenance
Priority: 3 - Necessary/Not Yet Critical (Years 2-5)
Correction: Renew System
Qty: 81,395.00
Unit of Measure: S.F.
Estimate: \$131,616.00
Assessor Name: Eduardo Lopez
Date Created: 12/07/2016
