NC School District/430 Harnett County/Elementary School

Buies Creek Elementary

Campus Assessment Report

March 11, 2017

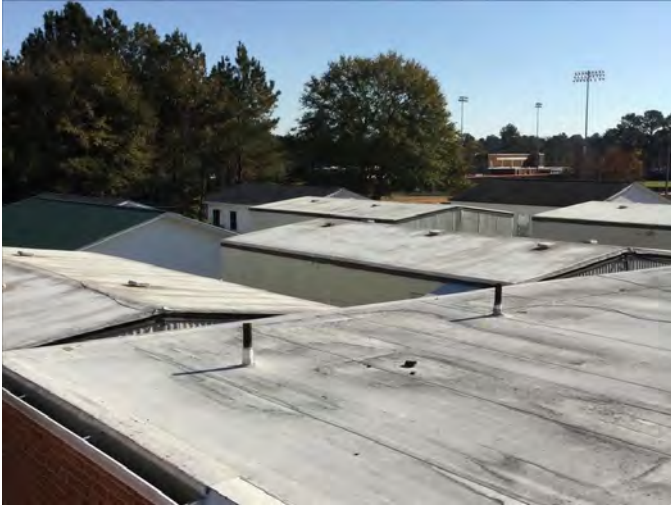
System: B3010120 - Single Ply Membrane

Location: Roof
Distress: Failing
Category: Deferred Maintenance
Priority: 2 - Potentially Critical (Year 1)
Correction: Renew System
Qty: 36,750.00
Unit of Measure: S.F.
Estimate: \$384,773.00
Assessor Name: Eduardo Lopez
Date Created: 12/06/2016

Notes: The EPDM adhered roof coverings are aging, showing signs of failure and should be replaced.

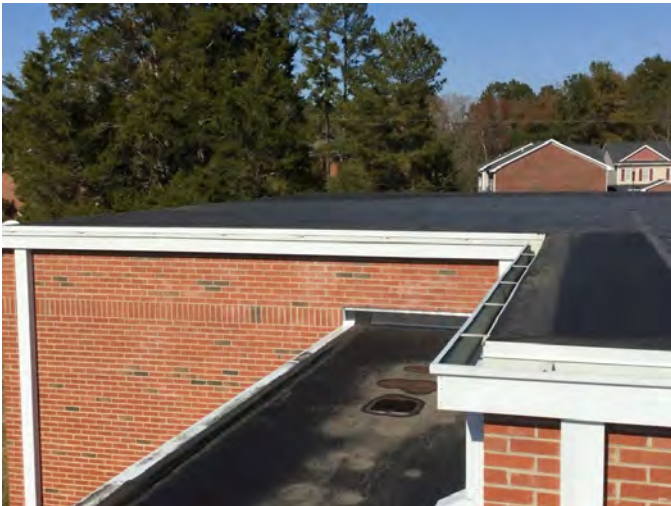
System: B3020 - Roof Openings

Location: Roof
Distress: Failing
Category: Deferred Maintenance
Priority: 2 - Potentially Critical (Year 1)
Correction: Renew System
Qty: 36,750.00
Unit of Measure: S.F.
Estimate: \$11,723.00
Assessor Name: Eduardo Lopez
Date Created: 12/06/2016

Notes: Roof penetrations should be inspected and repaired when the roof is replaced.

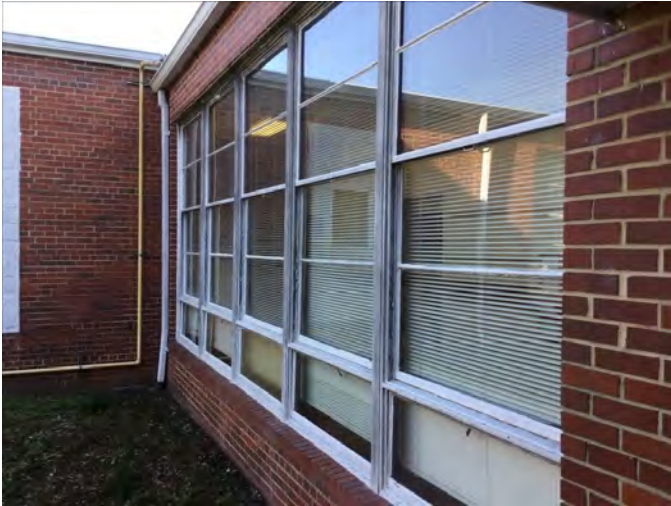
System: B2020 - Exterior Windows

Location: Exterior
Distress: Beyond Service Life
Category: Deferred Maintenance
Priority: 3 - Necessary/Not Yet Critical (Years 2-5)
Correction: Renew System
Qty: 36,750.00
Unit of Measure: S.F.
Estimate: \$379,591.00
Assessor Name: Eduardo Lopez
Date Created: 12/06/2016

Notes: The aluminum frame, operable, single pane windows are aged, rusted, not energy efficient, and should be replaced.

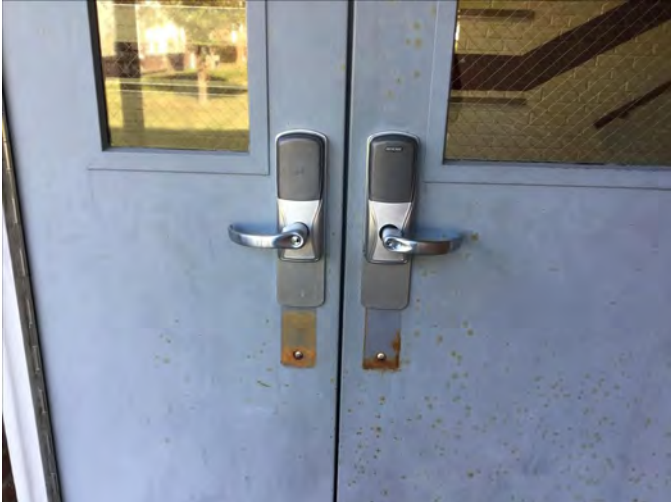
System: B2030 - Exterior Doors

Location: Exterior
Distress: Beyond Service Life
Category: Deferred Maintenance
Priority: 3 - Necessary/Not Yet Critical (Years 2-5)
Correction: Renew System
Qty: 36,750.00
Unit of Measure: S.F.
Estimate: \$42,042.00
Assessor Name: Eduardo Lopez
Date Created: 12/06/2016

Notes: The original exterior doors are aged, rusted, and should be replaced.

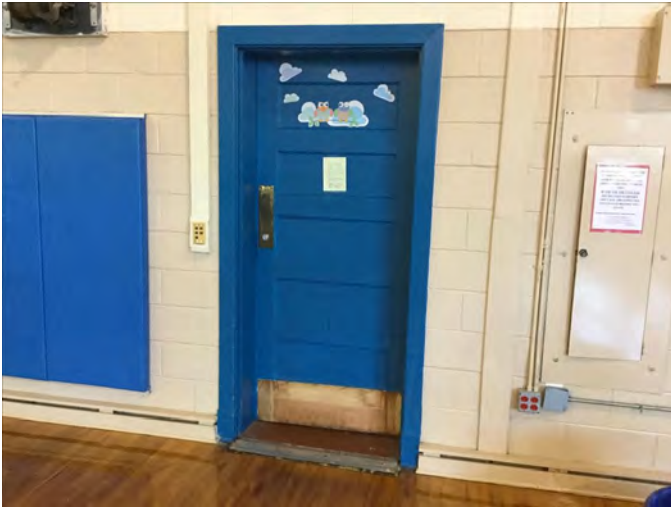
System: C1020 - Interior Doors

Location: Throughout the building
Distress: Failing
Category: Deferred Maintenance
Priority: 3 - Necessary/Not Yet Critical (Years 2-5)
Correction: Renew System
Qty: 36,750.00
Unit of Measure: S.F.
Estimate: \$102,275.00
Assessor Name: Eduardo Lopez
Date Created: 12/06/2016

Notes: The interior doors are aged, failing, hardware is not ADA compliant and should be replaced.

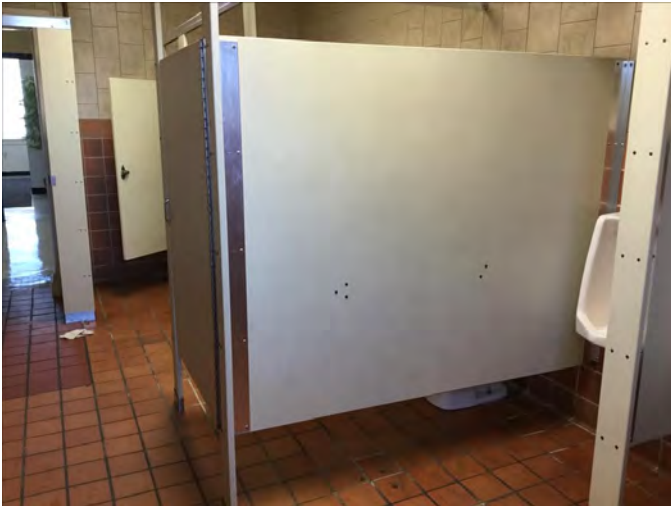
System: C1030 - Fittings

Location: Restroom-Classrooms
Distress: Damaged
Category: Deferred Maintenance / Accessibility Code Compliance
Priority: 3 - Necessary/Not Yet Critical (Years 2-5)
Correction: Renew System
Qty: 36,750.00
Unit of Measure: S.F.
Estimate: \$393,740.00
Assessor Name: Eduardo Lopez
Date Created: 12/06/2016

Notes: The fittings throughout the building are aged, in marginal condition, handrails and room signage are ADA non-compliance and system should be replaced.

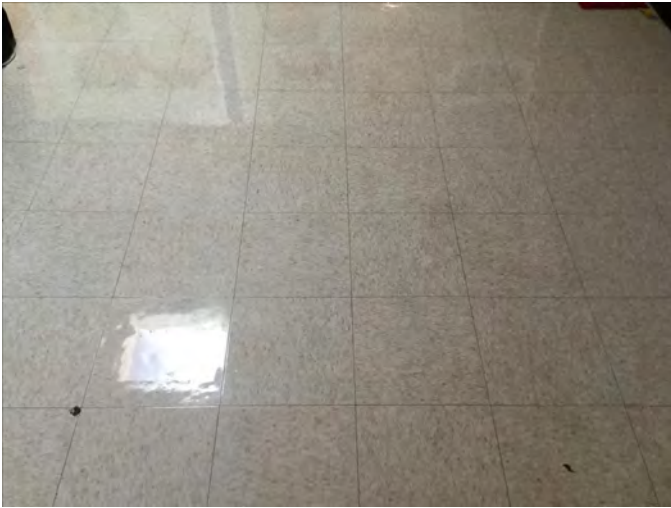
System: C3020 - Floor Finishes

Location: Throughout the building
Distress: Beyond Service Life
Category: Deferred Maintenance
Priority: 3 - Necessary/Not Yet Critical (Years 2-5)
Correction: Renew System
Qty: 36,750.00
Unit of Measure: S.F.
Estimate: \$460,037.00
Assessor Name: Eduardo Lopez
Date Created: 12/05/2016

Notes: The floor finishes are damaged, stained and aged. The VCT and tile should be replaced. The wood floor should be sanded, stained and sealed.

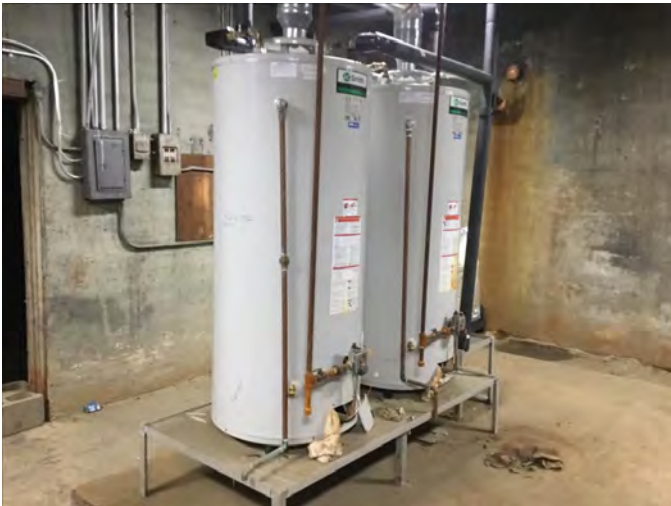
System: D2020 - Domestic Water Distribution

Location: Throughout the building
Distress: Beyond Service Life
Category: Deferred Maintenance
Priority: 3 - Necessary/Not Yet Critical (Years 2-5)
Correction: Renew System
Qty: 36,750.00
Unit of Measure: S.F.
Estimate: \$39,617.00
Assessor Name: Eduardo Lopez
Date Created: 12/05/2016

Notes: There are no reported issues or observed deficiencies with the domestic water piping. Due to the age of the pipe there can be internal pitting corrosion that may be a costly problem that leads to the formation of pinhole leaks and possible water contamination.

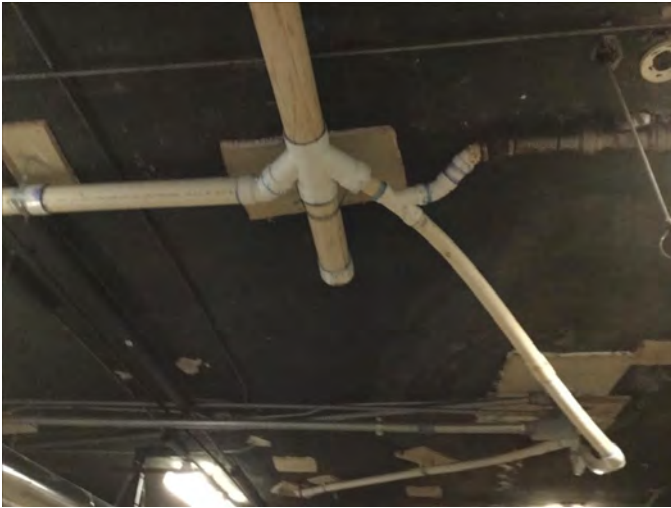
System: D2030 - Sanitary Waste

Location: Throughout the building
Distress: Beyond Service Life
Category: Deferred Maintenance
Priority: 3 - Necessary/Not Yet Critical (Years 2-5)
Correction: Renew System
Qty: 36,750.00
Unit of Measure: S.F.
Estimate: \$62,255.00
Assessor Name: Eduardo Lopez
Date Created: 12/05/2016

Notes: There are no reported issues or observed deficiencies with the sanitary waste piping. The aging sanitary sewer piping is subject to leaks, infiltration, and it can even collapse in the interior walls. The system should be inspected with cameras to ensure that none of these deficiencies exist.

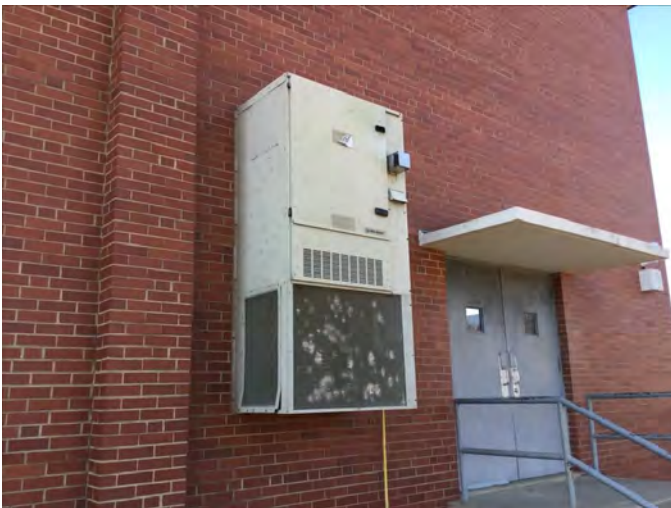
System: D3050 - Terminal & Package Units

Location: Exterior
Distress: Beyond Service Life
Category: Deferred Maintenance
Priority: 3 - Necessary/Not Yet Critical (Years 2-5)
Correction: Renew System
Qty: 36,750.00
Unit of Measure: S.F.
Estimate: \$540,482.00
Assessor Name: Eduardo Lopez
Date Created: 12/05/2016

Notes: The roof mounted, gas fired package unit is aged, worn, rusted, inefficient, becoming logistically unsupportable and should be replaced with an energy efficient model.

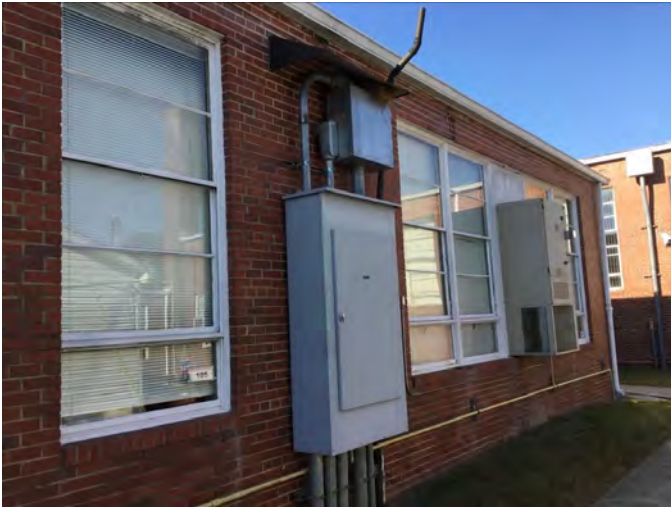
System: D5010 - Electrical Service/Distribution

Location: Throughout the building
Distress: Beyond Service Life
Category: Deferred Maintenance
Priority: 3 - Necessary/Not Yet Critical (Years 2-5)
Correction: Renew System
Qty: 36,750.00
Unit of Measure: S.F.
Estimate: \$68,318.00
Assessor Name: Eduardo Lopez
Date Created: 12/05/2016

Notes: The original electrical distribution system is operating properly due to an aggressive maintenance program but is aged, in marginal condition, and should be replaced.

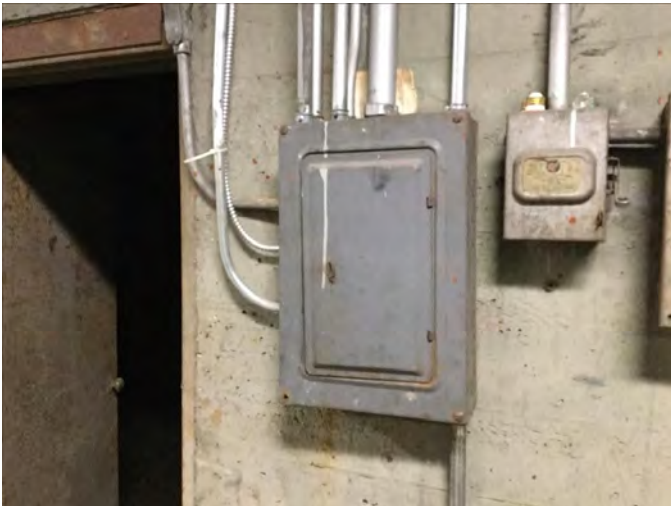
System: D5020 - Branch Wiring

Location: Throughout the building
Distress: Beyond Service Life
Category: Deferred Maintenance
Priority: 3 - Necessary/Not Yet Critical (Years 2-5)
Correction: Renew System
Qty: 36,750.00
Unit of Measure: S.F.
Estimate: \$204,551.00
Assessor Name: Eduardo Lopez
Date Created: 12/05/2016

Notes: The original branch wiring system is operating properly due to an aggressive maintenance program but is aged, in marginal condition, and should be replaced.

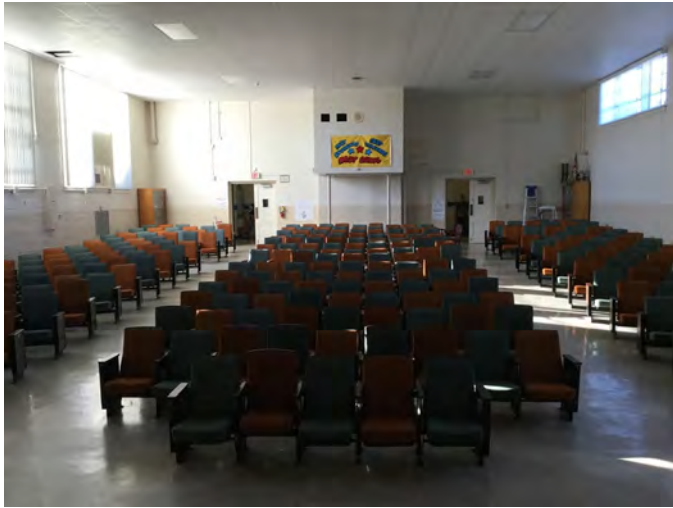
System: E2010 - Fixed Furnishings

Location: Throughout the building
Distress: Damaged
Category: Deferred Maintenance
Priority: 3 - Necessary/Not Yet Critical (Years 2-5)
Correction: Renew System
Qty: 36,750.00
Unit of Measure: S.F.
Estimate: \$235,678.00
Assessor Name: Eduardo Lopez
Date Created: 12/06/2016

Notes: The fixed furnishings are aged, in marginal condition, and should be replaced. The auditorium seating upholstery is stained, wood components are discolored. The wood components require sanding, stain and seal. The upholstery need to be stripped down and re-applied. All new hardware need to be installed. The blinds are damaged and need to be replaced.

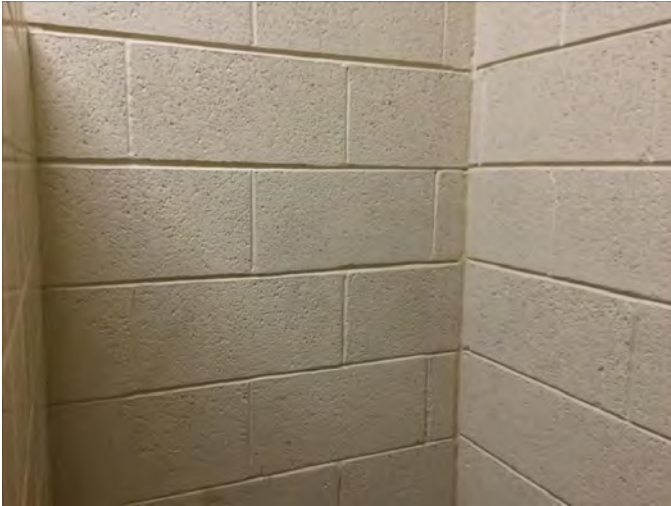
System: C3010 - Wall Finishes

Location: Throughout the building
Distress: Beyond Service Life
Category: Deferred Maintenance
Priority: 4 - Recommended (Years 6-10)
Correction: Renew System
Qty: 36,750.00
Unit of Measure: S.F.
Estimate: \$112,786.00
Assessor Name: Eduardo Lopez
Date Created: 12/05/2016

Notes: The wall finishes are aged, scuffed, fading, stained, and should be re-painted.

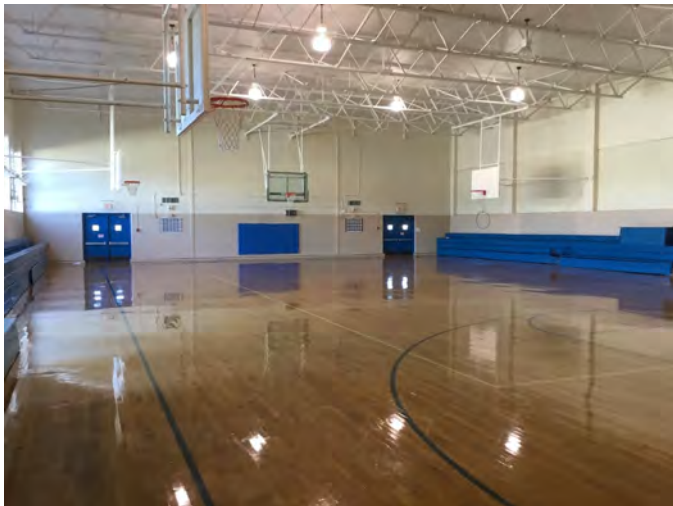
System: E1090 - Other Equipment

Location: Gym/Kitchen
Distress: Beyond Service Life
Category: Deferred Maintenance
Priority: 4 - Recommended (Years 6-10)
Correction: Renew System
Qty: 36,750.00
Unit of Measure: S.F.
Estimate: \$300,358.00
Assessor Name: Eduardo Lopez
Date Created: 12/05/2016

Notes: The Food Service Equipment is operating but is aged should be inspected and replaced or repaired as needed. The athletic, and recreational equipment is aged should be inspected and replaced or repaired as needed.

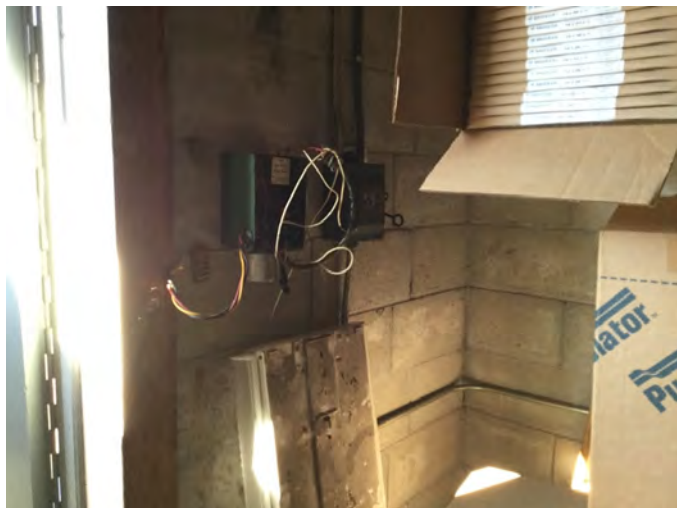
System: D5020 - Branch Wiring

Location: Interior
Distress: Damaged
Category: Deferred Maintenance
Priority: 1 - Currently Critical (Immediate)
Correction: Renew System
Qty: 400.00
Unit of Measure: S.F.
Estimate: \$1,575.00
Assessor Name: Eduardo Lopez
Date Created: 12/06/2016

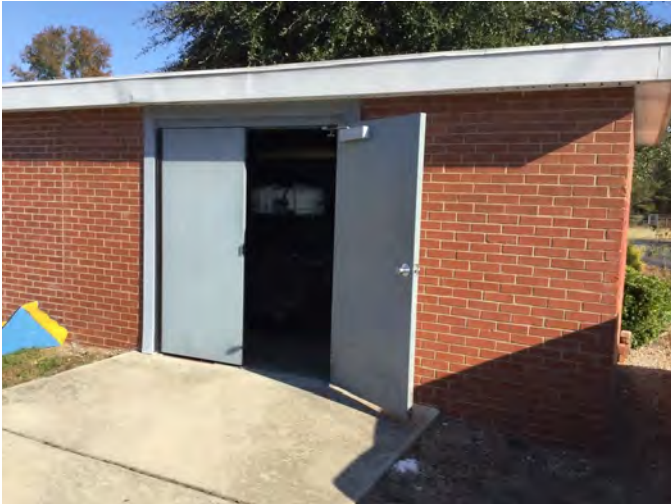
System: B2030 - Exterior Doors

Location: Exterior
Distress: Damaged
Category: Deferred Maintenance
Priority: 3 - Necessary/Not Yet Critical (Years 2-5)
Correction: Renew System
Qty: 400.00
Unit of Measure: S.F.
Estimate: \$3,810.00
Assessor Name: Eduardo Lopez
Date Created: 12/06/2016
