NC School District/430 Harnett County/Elementary School

Coats Elementary

Campus Assessment Report

March 11, 2017

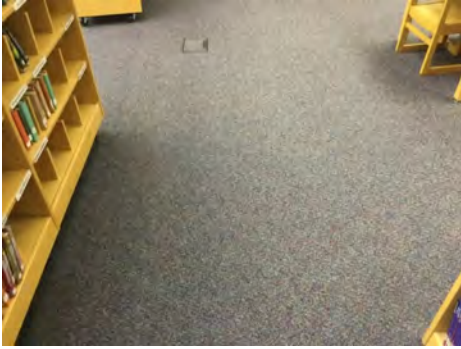
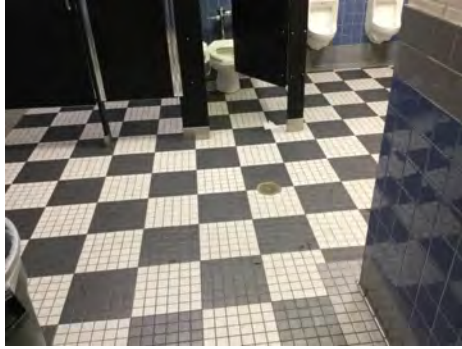
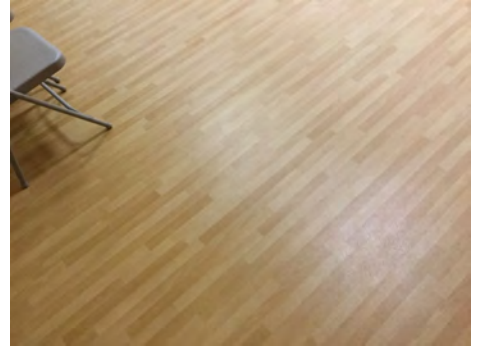
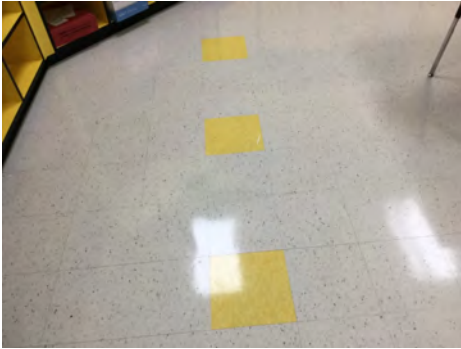
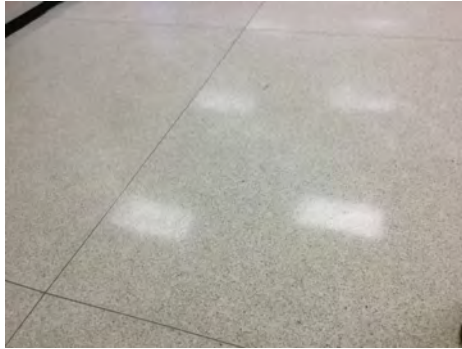
System: C3020 - Floor Finishes

Note: Multit-purpose room flooring replaced 2015. Media center carpet and admin carpet will be replaced w/ VCT when it is worn out.

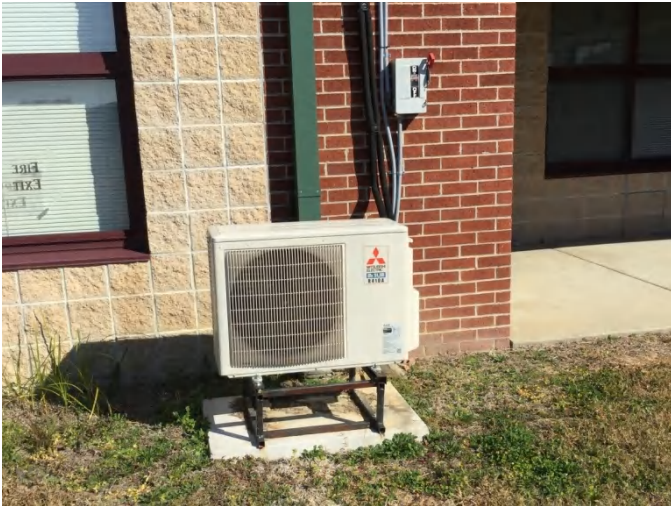
System: D3050 - Terminal & Package Units

Location: Data room
Distress: Beyond Service Life
Category: Deferred Maintenance
Priority: 3 - Necessary/Not Yet Critical (Years 2-5)
Correction: Renew System
Qty: 85,994.00
Unit of Measure: S.F.
Estimate: \$59,594.00
Assessor Name: Ann Buerger Linden
Date Created: 11/15/2016

Notes: The mini-split system serving the data room is beyond its expected service life. System replacement is recommended.

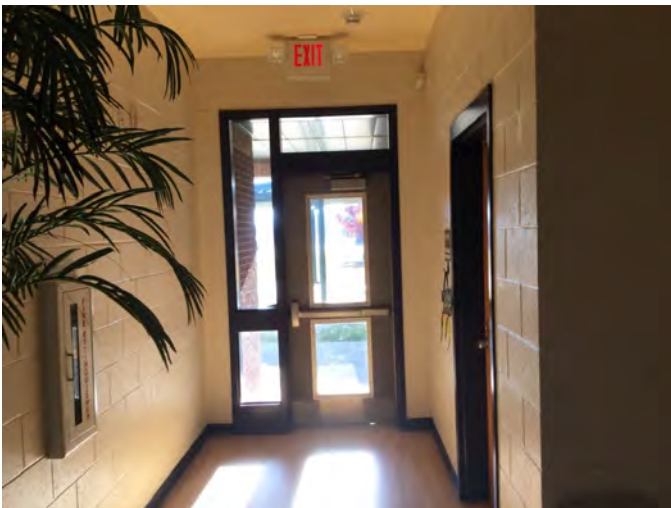
System: D5030810 - Security & Detection Systems

Location: Throughout the building
Distress: Beyond Service Life
Category: Deferred Maintenance
Priority: 3 - Necessary/Not Yet Critical (Years 2-5)
Correction: Renew System
Qty: 85,994.00
Unit of Measure: S.F.
Estimate: \$173,106.00
Assessor Name: Ann Buerger Linden
Date Created: 12/12/2016

Notes: Install access control system - Part 2 to ensure that all exterior doors are automatically locked during the school day and permit card entry.

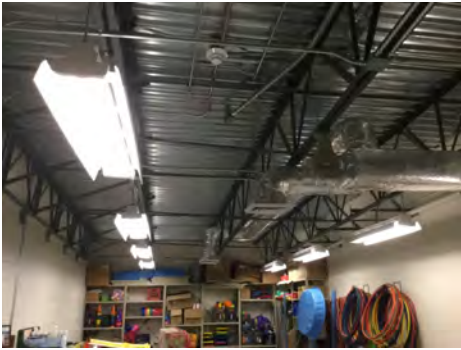
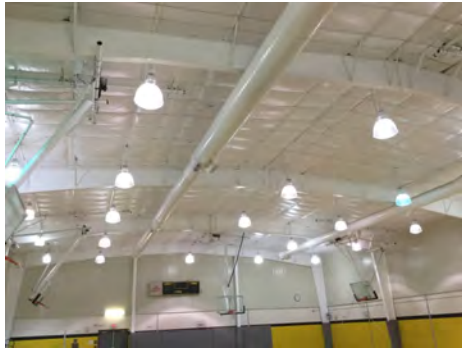
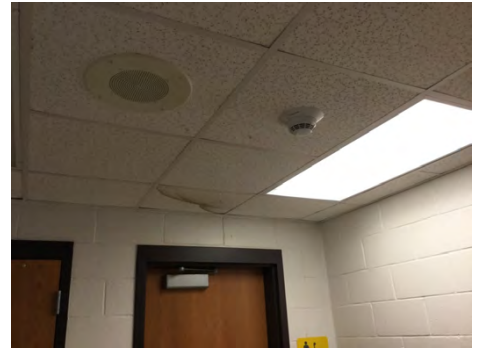
System: D5020 - Lighting

Note: Exterior wall packs replaced 2016. LED installation slated for 2017

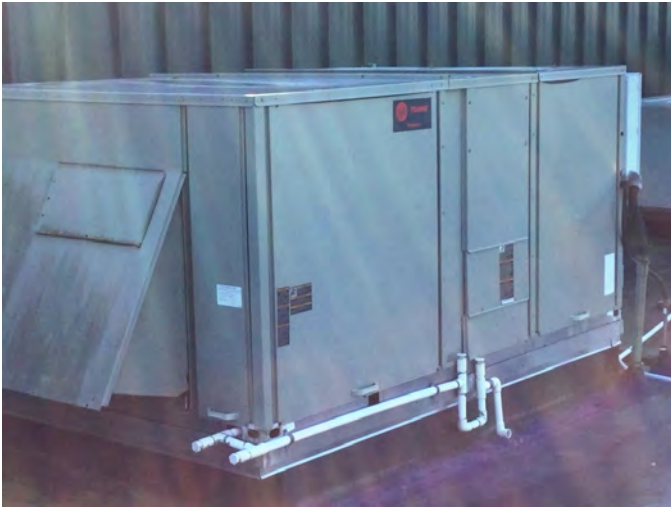
System: D3050 - Terminal & Package Units

Location: Rooftop package units
Distress: Beyond Service Life
Category: Deferred Maintenance
Priority: 3 - Necessary/Not Yet Critical (Years 2-5)
Correction: Renew System
Qty: 9,903.00
Unit of Measure: S.F.
Estimate: \$142,593.00
Assessor Name: Eduardo Lopez
Date Created: 11/15/2016

Notes: The system is beyond its expected service life and should be scheduled for replacement.

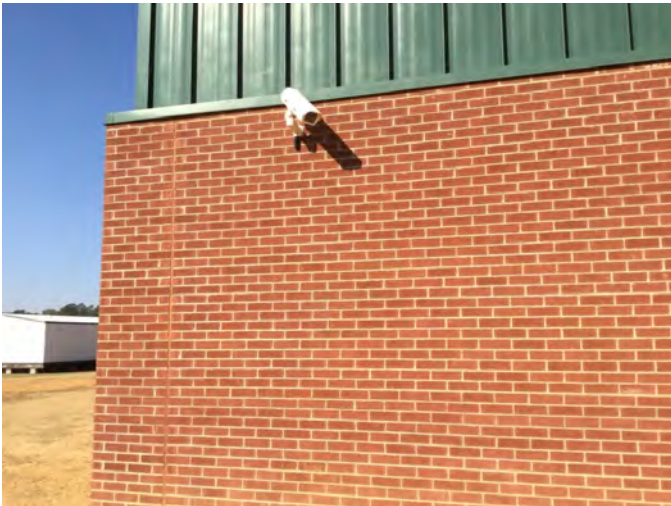
System: D5030810 - Security & Detection Systems

Location: Throughout building
Distress: Beyond Service Life
Category: Deferred Maintenance
Priority: 3 - Necessary/Not Yet Critical (Years 2-5)
Correction: Renew System
Qty: 9,903.00
Unit of Measure: S.F.
Estimate: \$19,935.00
Assessor Name: Eduardo Lopez
Date Created: 11/15/2016

Notes: The system is beyond its expected service life and should be scheduled for replacement. Install security access control at one set exterior doors.

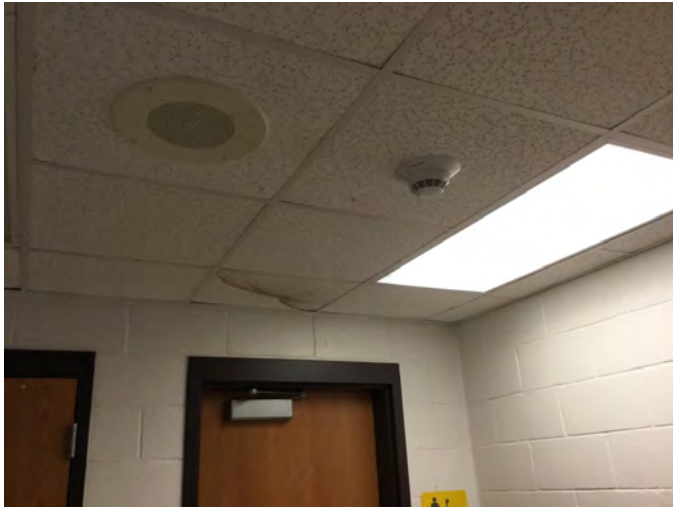
System: D5030920 - Data Communication

Location: Throughout the building
Distress: Beyond Service Life
Category: Deferred Maintenance
Priority: 3 - Necessary/Not Yet Critical (Years 2-5)
Correction: Renew System
Qty: 9,903.00
Unit of Measure: S.F.
Estimate: \$46,841.00
Assessor Name: Eduardo Lopez
Date Created: 11/15/2016

Notes: The system is beyond its expected service life and should be scheduled for replacement.

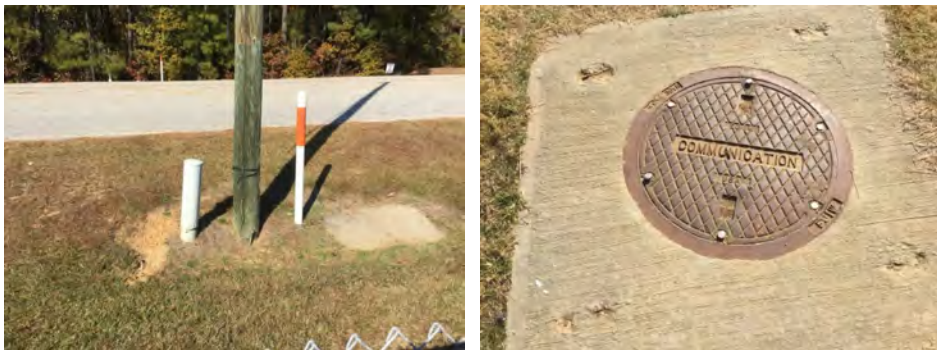
System: G4030 - Site Communications & Security

Note: The site communications and security is assumed to have been reviewed and updated as needed with the 2007 gym addition.
