NC School District/430 Harnett County/Elementary School

Erwin Elementary

Final
Campus Assessment Report

March 11, 2017

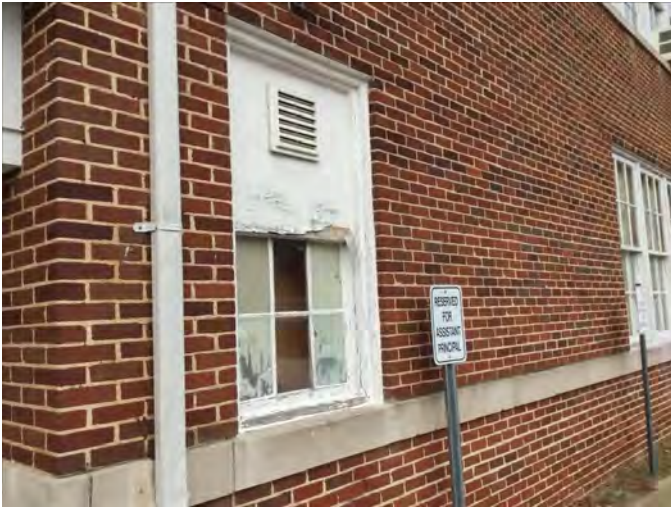
System: B2020 - Exterior Windows

Location: Exterior
Distress: Inadequate
Category: Deferred Maintenance
Priority: 3 - Necessary/Not Yet Critical (Years 2-5)
Correction: Renew System
Qty: 39,563.00
Unit of Measure: S.F.
Estimate: \$408,646.00
Assessor Name: Eduardo Lopez
Date Created: 12/01/2016

Notes: The aluminum frame, operable, single pane windows are aged, rusted, not energy efficient, and should be replaced.

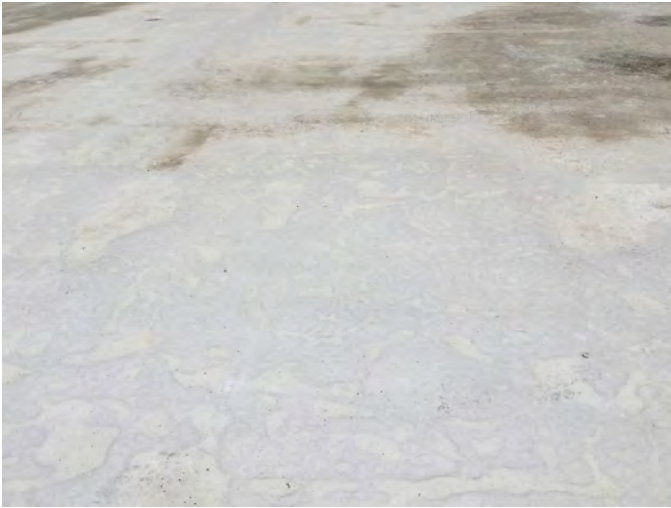
System: B3010120 - Single Ply Membrane

Location: Roof
Distress: Failing
Category: Deferred Maintenance
Priority: 3 - Necessary/Not Yet Critical (Years 2-5)
Correction: Renew System
Qty: 39,563.00
Unit of Measure: S.F.
Estimate: \$414,225.00
Assessor Name: Eduardo Lopez
Date Created: 12/06/2016

Notes: The EPDM adhered and ballasted roof coverings has blisters, is worn, or lost surfacing, ponding, showing signs of failure and should be replaced.

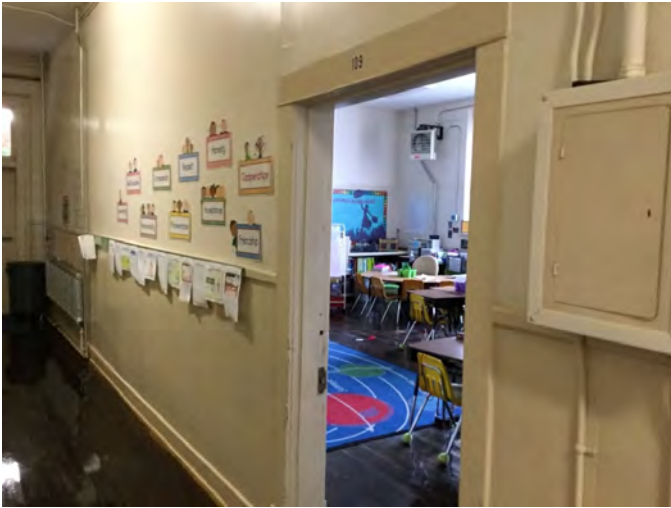
System: C1030 - Fittings

Location: Throughout the building
Distress: Beyond Service Life
Category: Deferred Maintenance
Priority: 3 - Necessary/Not Yet Critical (Years 2-5)
Correction: Renew System
Qty: 39,563.00
Unit of Measure: S.F.
Estimate: \$423,878.00
Assessor Name: Eduardo Lopez
Date Created: 12/05/2016

Notes: The fittings throughout the building are aged, in marginal condition, handrails and room signage are ADA non-compliance and system should be replaced.

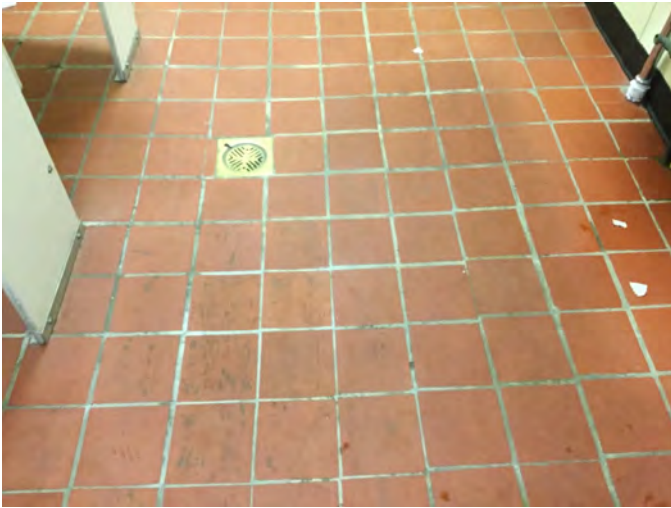
System: C3020 - Floor Finishes

Location: Throughout the building
Distress: Beyond Service Life
Category: Deferred Maintenance
Priority: 3 - Necessary/Not Yet Critical (Years 2-5)
Correction: Renew System
Qty: 39,563.00
Unit of Measure: S.F.
Estimate: \$495,250.00
Assessor Name: Eduardo Lopez
Date Created: 12/06/2016

Notes: The wood floors are damaged and the VCT and ceramic tile is cracking. The flooring need to be replaced.

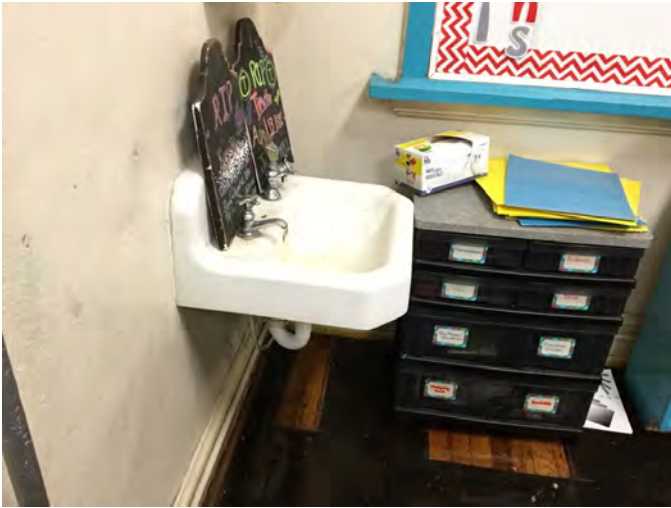
System: D2010 - Plumbing Fixtures

Location: Restrooms
Distress: Beyond Service Life
Category: Deferred Maintenance
Priority: 3 - Necessary/Not Yet Critical (Years 2-5)
Correction: Renew System
Qty: 39,563.00
Unit of Measure: S.F.
Estimate: \$499,602.00
Assessor Name: Eduardo Lopez
Date Created: 12/07/2016

Notes: Plumbing fixtures are in operational conditions. However, they are aged, not ADA compliant and should be replaced with a low-flow water fixtures.

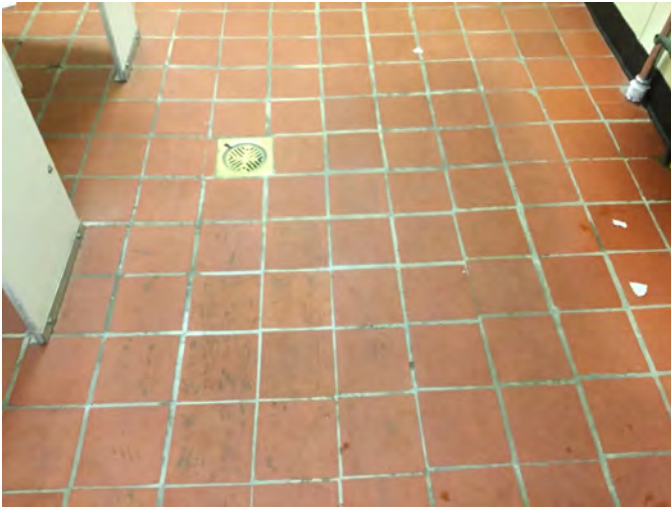
System: D2030 - Sanitary Waste

Location: Throughout the building
Distress: Failing
Category: Deferred Maintenance
Priority: 3 - Necessary/Not Yet Critical (Years 2-5)
Correction: Renew System
Qty: 39,563.00
Unit of Measure: S.F.
Estimate: \$67,020.00
Assessor Name: Eduardo Lopez
Date Created: 12/06/2016

Notes: The sanitary waste system is aged, has reported periodic failures, and should be replaced.

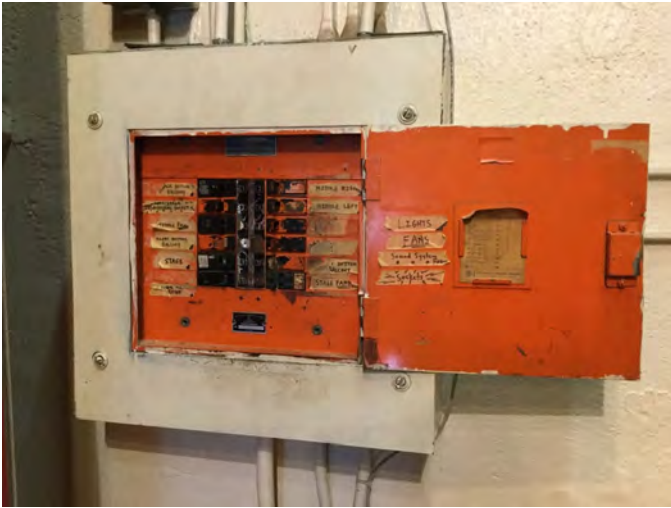
System: D5020 - Branch Wiring

Location: Throughout the building
Distress: Beyond Service Life
Category: Deferred Maintenance
Priority: 3 - Necessary/Not Yet Critical (Years 2-5)
Correction: Renew System
Qty: 39,563.00
Unit of Measure: S.F.
Estimate: \$220,208.00
Assessor Name: Eduardo Lopez
Date Created: 12/06/2016

Notes: The original electrical service is operating, maxed to capacity and should be replaced.

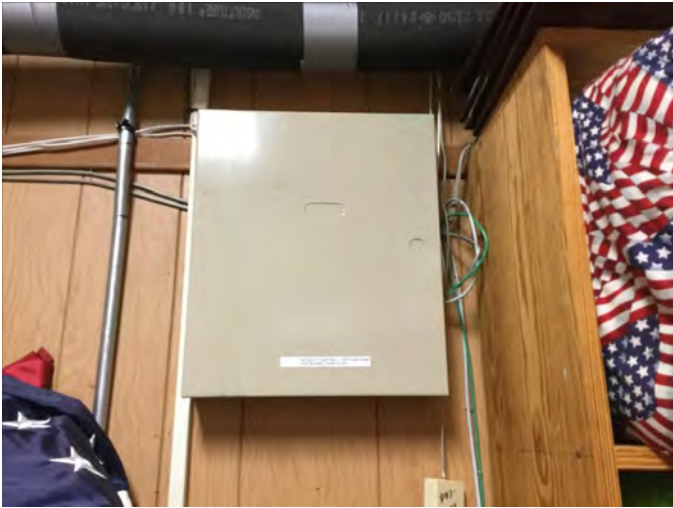
System: D5030810 - Security & Detection Systems

Location: Throughout the building
Distress: Beyond Service Life
Category: Deferred Maintenance
Priority: 3 - Necessary/Not Yet Critical (Years 2-5)
Correction: Renew System
Qty: 39,563.00
Unit of Measure: S.F.
Estimate: \$81,381.00
Assessor Name: Eduardo Lopez
Date Created: 12/06/2016

Notes: The security system is aged, has poor coverage and camera resolution, and should be replaced.

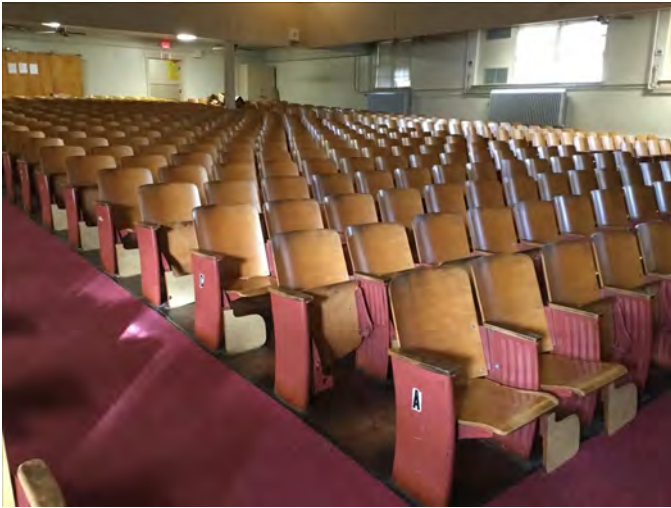
System: E2010 - Fixed Furnishings

Location: Auditorium-classrooms
Distress: Damaged
Category: Deferred Maintenance
Priority: 3 - Necessary/Not Yet Critical (Years 2-5)
Correction: Renew System
Qty: 39,563.00
Unit of Measure: S.F.
Estimate: \$253,718.00
Assessor Name: Eduardo Lopez
Date Created: 12/01/2016

Notes: The fixed furnishings are aged, in marginal condition, and should be replaced. The auditorium seating upholstery is stained, wood components are discolored. The wood components require sanding, stain and seal. The upholstery need to be stripped down and re-applied. All new hardware need to be installed. The blinds are damaged and need to be replaced.

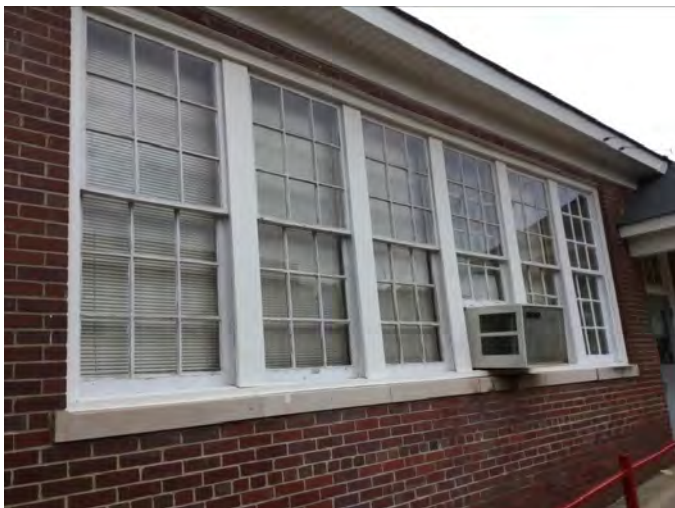
System: B2020 - Exterior Windows

Location: Exterior
Distress: Inadequate
Category: Deferred Maintenance
Priority: 3 - Necessary/Not Yet Critical (Years 2-5)
Correction: Renew System
Qty: 9,379.00
Unit of Measure: S.F.
Estimate: \$96,876.00
Assessor Name: Eduardo Lopez
Date Created: 12/06/2016

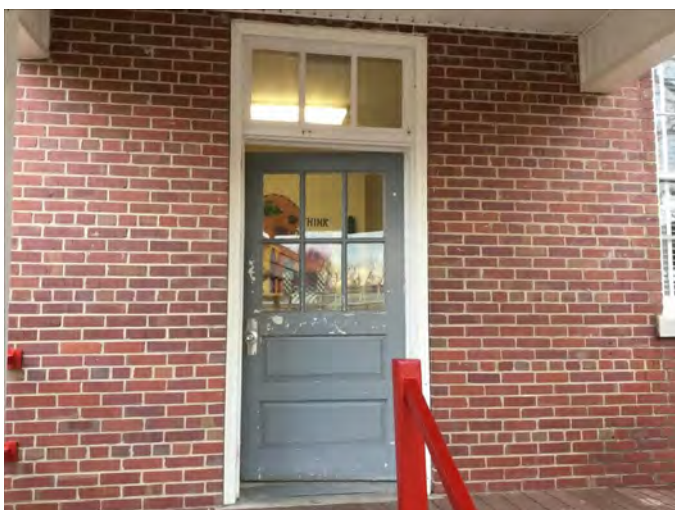
System: B2030 - Exterior Doors

Location: Exterior Exits
Distress: Inadequate
Category: Deferred Maintenance
Priority: 3 - Necessary/Not Yet Critical (Years 2-5)
Correction: Renew System
Qty: 9,379.00
Unit of Measure: S.F.
Estimate: \$10,730.00
Assessor Name: Eduardo Lopez
Date Created: 12/06/2016

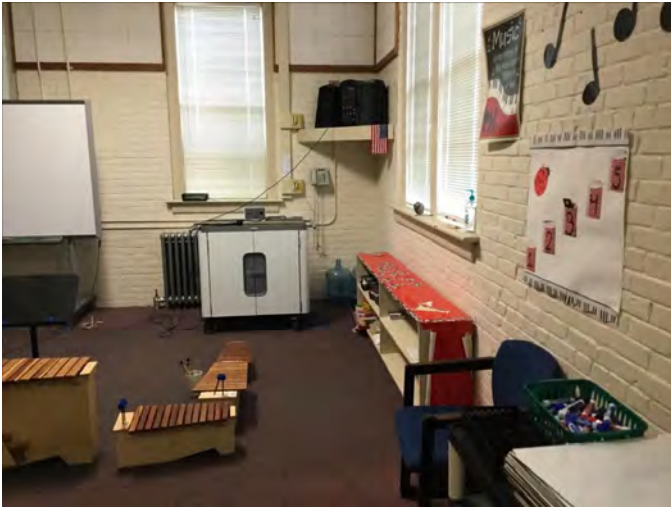
System: C3010 - Wall Finishes

Location: Throughout the building
Distress: Damaged
Category: Deferred Maintenance
Priority: 3 - Necessary/Not Yet Critical (Years 2-5)
Correction: Renew System
Qty: 9,379.00
Unit of Measure: S.F.
Estimate: \$28,784.00
Assessor Name: Eduardo Lopez
Date Created: 12/06/2016

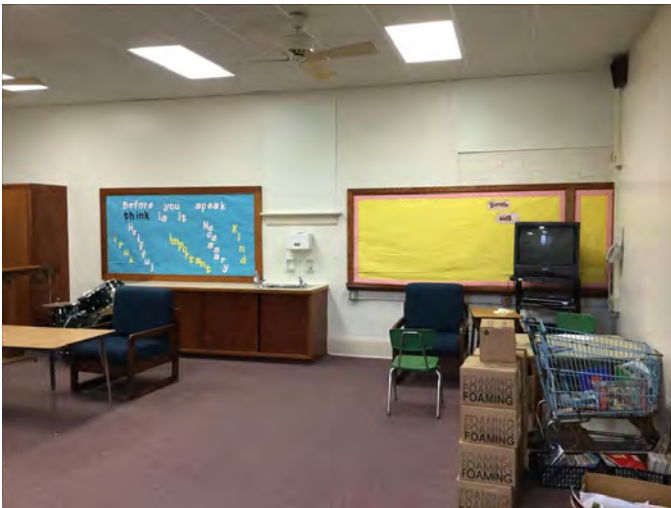
System: C3020 - Floor Finishes

Location: Throughout the building
Distress: Damaged
Category: Deferred Maintenance
Priority: 3 - Necessary/Not Yet Critical (Years 2-5)
Correction: Renew System
Qty: 9,379.00
Unit of Measure: S.F.
Estimate: \$117,406.00
Assessor Name: Eduardo Lopez
Date Created: 12/06/2016

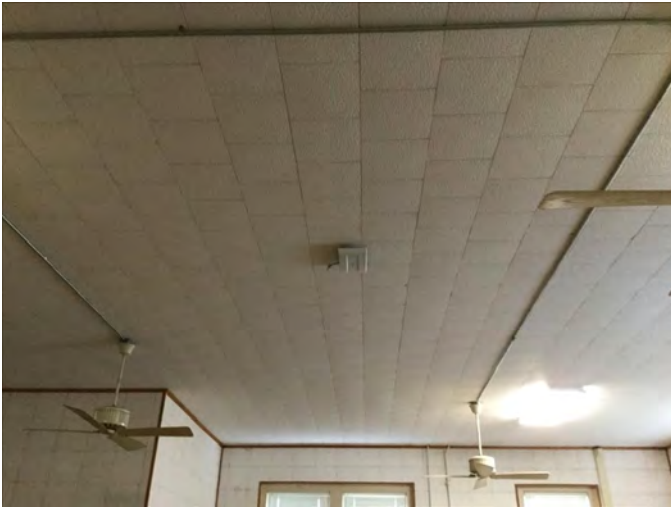
System: C3030 - Ceiling Finishes

Location: Throughout the building
Distress: Beyond Service Life
Category: Deferred Maintenance
Priority: 3 - Necessary/Not Yet Critical (Years 2-5)
Correction: Renew System
Qty: 9,379.00
Unit of Measure: S.F.
Estimate: \$113,176.00
Assessor Name: Eduardo Lopez
Date Created: 12/06/2016

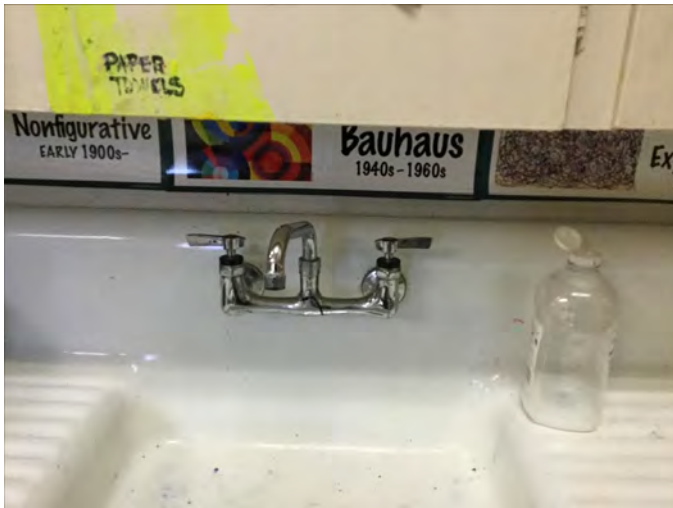
System: D2020 - Domestic Water Distribution

Location: Throughout the building
Distress: Beyond Service Life
Category: Deferred Maintenance
Priority: 3 - Necessary/Not Yet Critical (Years 2-5)
Correction: Renew System
Qty: 9,379.00
Unit of Measure: S.F.
Estimate: \$10,111.00
Assessor Name: Eduardo Lopez
Date Created: 12/06/2016

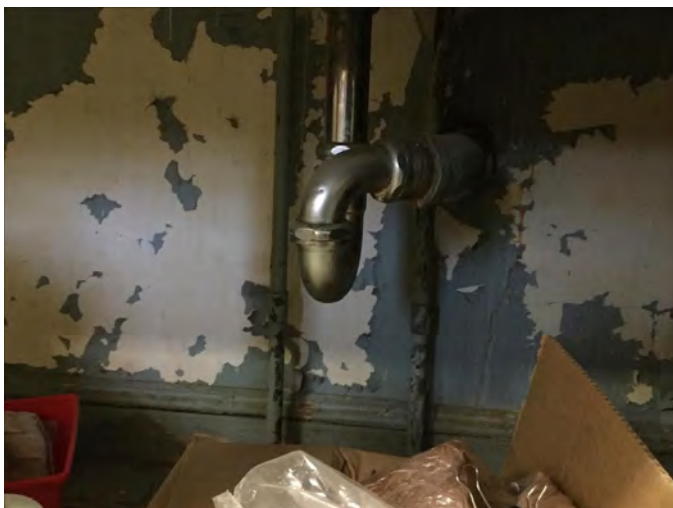
System: D2030 - Sanitary Waste

Location: Throughout the building
Distress: Beyond Service Life
Category: Deferred Maintenance
Priority: 3 - Necessary/Not Yet Critical (Years 2-5)
Correction: Renew System
Qty: 9,379.00
Unit of Measure: S.F.
Estimate: \$15,888.00
Assessor Name: Eduardo Lopez
Date Created: 12/06/2016

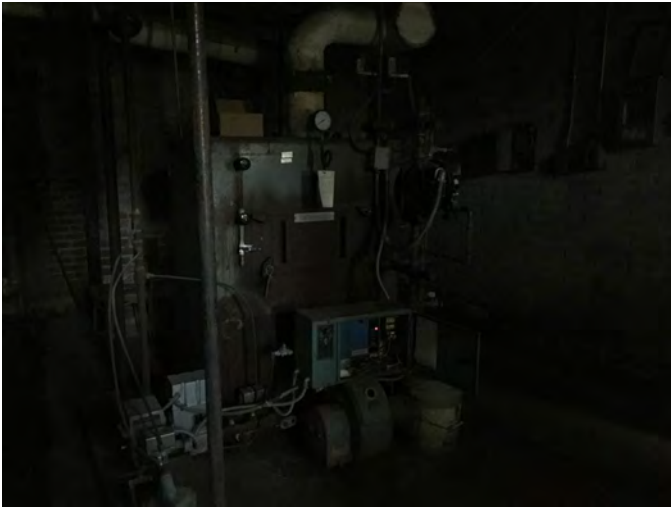
System: D3020 - Heat Generating Systems

Location: Basement
Distress: Beyond Service Life
Category: Deferred Maintenance
Priority: 3 - Necessary/Not Yet Critical (Years 2-5)
Correction: Renew System
Qty: 9,379.00
Unit of Measure: S.F.
Estimate: \$52,410.00
Assessor Name: Eduardo Lopez
Date Created: 12/06/2016

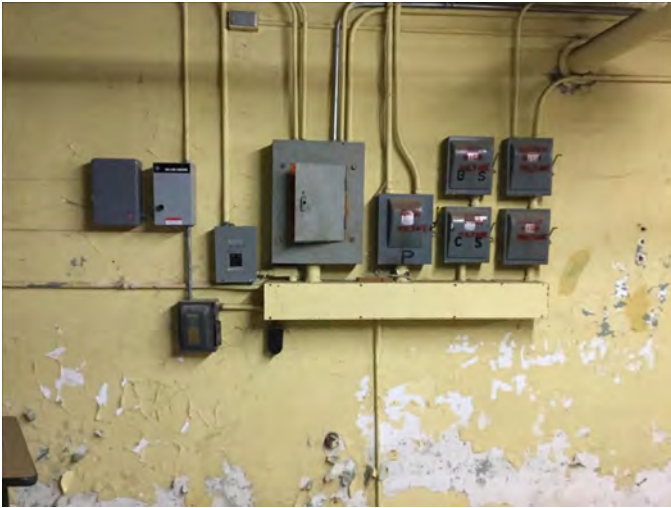
System: D5020 - Branch Wiring

Location: Throughout the building
Distress: Beyond Service Life
Category: Deferred Maintenance
Priority: 3 - Necessary/Not Yet Critical (Years 2-5)
Correction: Renew System
Qty: 9,379.00
Unit of Measure: S.F.
Estimate: \$52,204.00
Assessor Name: Eduardo Lopez
Date Created: 12/06/2016

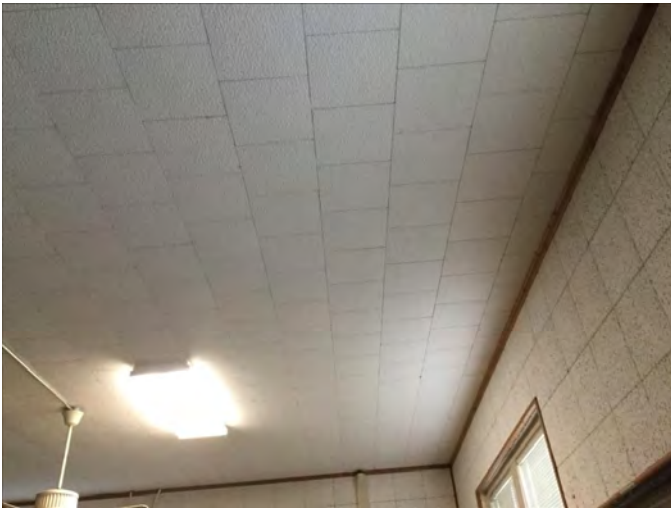
System: D5020 - Lighting

Location: Throughout the building
Distress: Beyond Service Life
Category: Deferred Maintenance
Priority: 3 - Necessary/Not Yet Critical (Years 2-5)
Correction: Renew System
Qty: 9,379.00
Unit of Measure: S.F.
Estimate: \$122,977.00
Assessor Name: Eduardo Lopez
Date Created: 12/06/2016

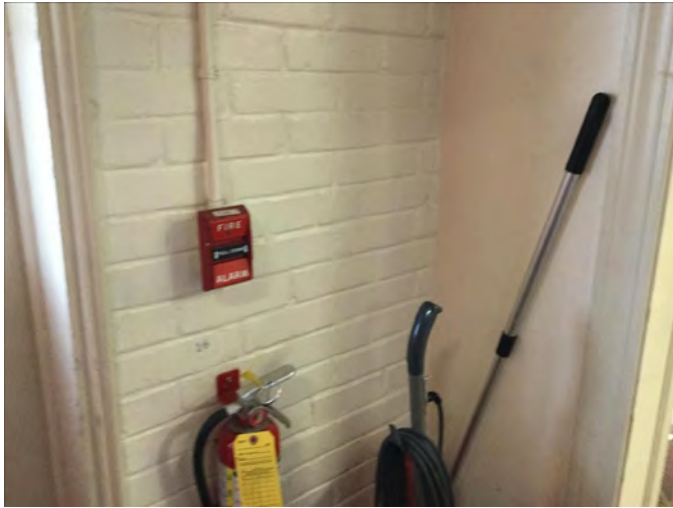
System: D5030910 - Fire Alarm Systems

Location: Throughout the building
Distress: Beyond Service Life
Category: Deferred Maintenance
Priority: 3 - Necessary/Not Yet Critical (Years 2-5)
Correction: Renew System
Qty: 9,379.00
Unit of Measure: S.F.
Estimate: \$34,974.00
Assessor Name: Eduardo Lopez
Date Created: 12/06/2016

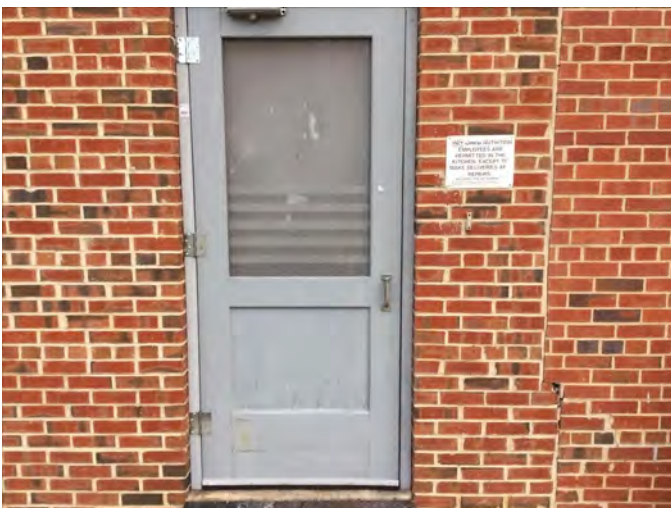
System: B2030 - Exterior Doors

Location: Exterior
Distress: Beyond Service Life
Category: Deferred Maintenance
Priority: 3 - Necessary/Not Yet Critical (Years 2-5)
Correction: Renew System
Qty: 7,300.00
Unit of Measure: S.F.
Estimate: \$8,351.00
Assessor Name: Eduardo Lopez
Date Created: 12/06/2016

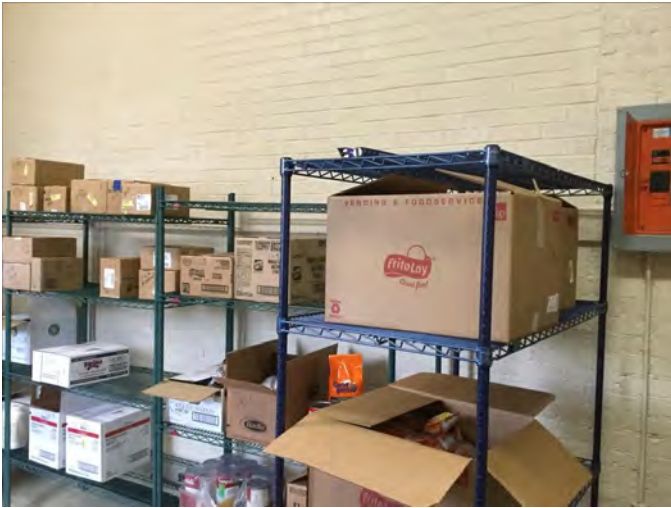
System: C3010 - Wall Finishes

Location: Throughout the building
Distress: Damaged
Category: Deferred Maintenance
Priority: 3 - Necessary/Not Yet Critical (Years 2-5)
Correction: Renew System
Qty: 7,300.00
Unit of Measure: S.F.
Estimate: \$22,404.00
Assessor Name: Eduardo Lopez
Date Created: 12/06/2016

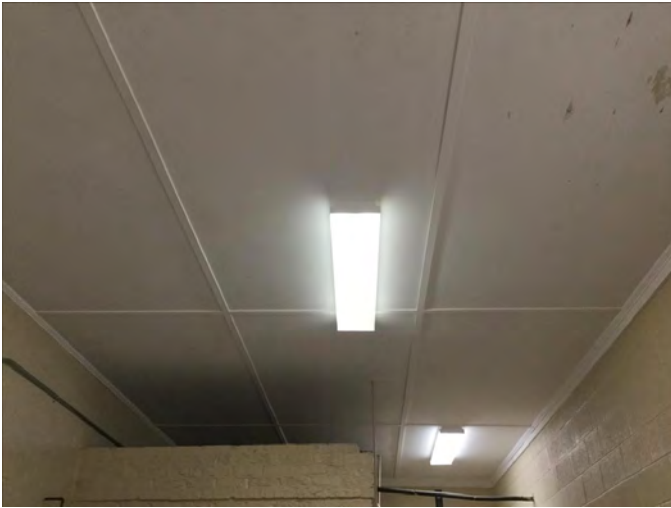
Location: Throughout the building
Distress: Damaged
Category: Deferred Maintenance
Priority: 3 - Necessary/Not Yet Critical (Years 2-5)
Correction: Renew System
Qty: 7,300.00
Unit of Measure: S.F.
Estimate: \$88,089.00
Assessor Name: Eduardo Lopez
Date Created: 12/06/2016

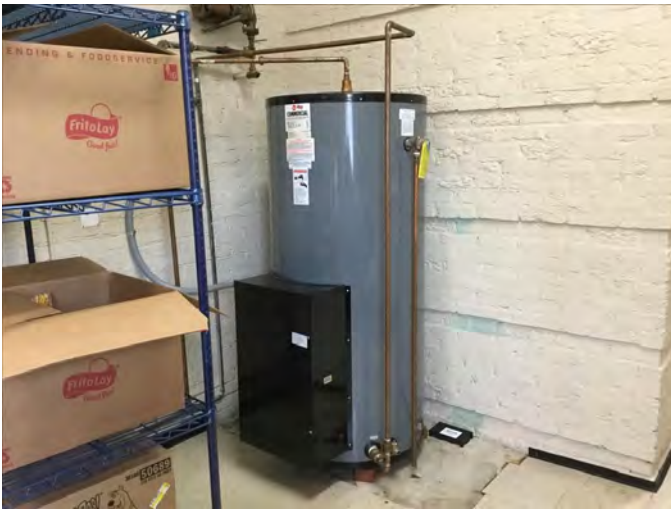
Location: Throughout the building
Distress: Beyond Service Life
Category: Deferred Maintenance
Priority: 3 - Necessary/Not Yet Critical (Years 2-5)
Correction: Renew System
Qty: 7,300.00
Unit of Measure: S.F.
Estimate: \$7,869.00
Assessor Name: Eduardo Lopez
Date Created: 12/06/2016

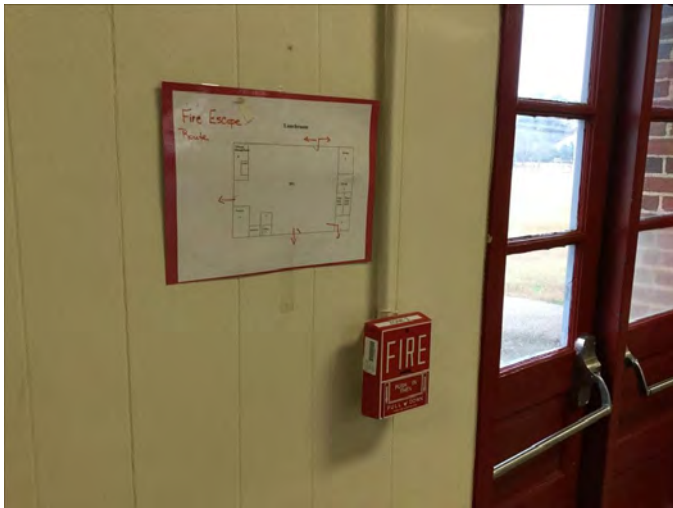
Location: Throughout the building
Distress: Beyond Service Life
Category: Deferred Maintenance
Priority: 3 - Necessary/Not Yet Critical (Years 2-5)
Correction: Renew System
Qty: 7,300.00
Unit of Measure: S.F.
Estimate: \$27,222.00
Assessor Name: Eduardo Lopez
Date Created: 12/06/2016

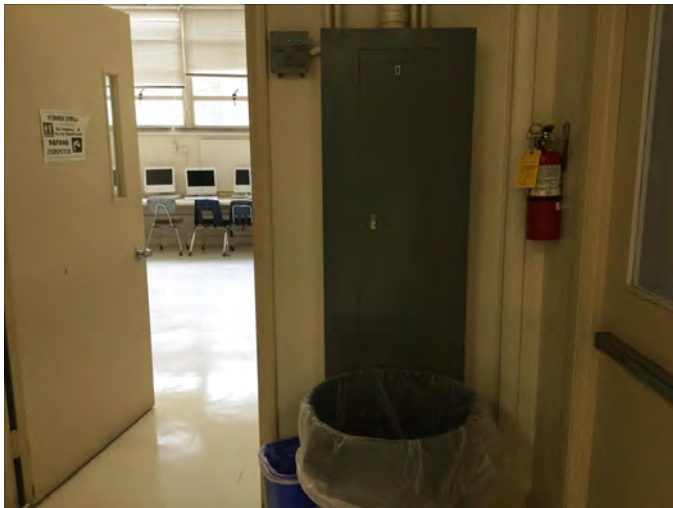
Location: Throughout the building
Distress: Beyond Service Life
Category: Deferred Maintenance
Priority: 3 - Necessary/Not Yet Critical (Years 2-5)
Correction: Renew System
Qty: 4,818.00
Unit of Measure: S.F.
Estimate: \$26,817.00
Assessor Name: Eduardo Lopez
Date Created: 12/07/2016

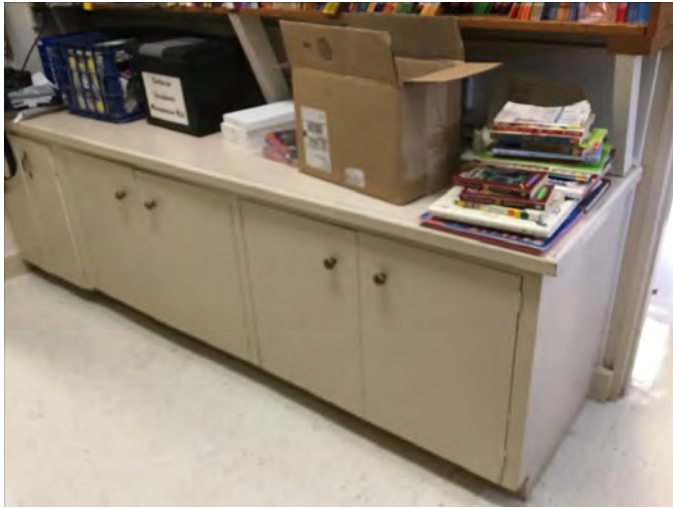
Location: Throughout the building
Distress: Beyond Service Life
Category: Deferred Maintenance
Priority: 3 - Necessary/Not Yet Critical (Years 2-5)
Correction: Renew System
Qty: 4,818.00
Unit of Measure: S.F.
Estimate: \$30,898.00
Assessor Name: Eduardo Lopez
Date Created: 12/06/2016

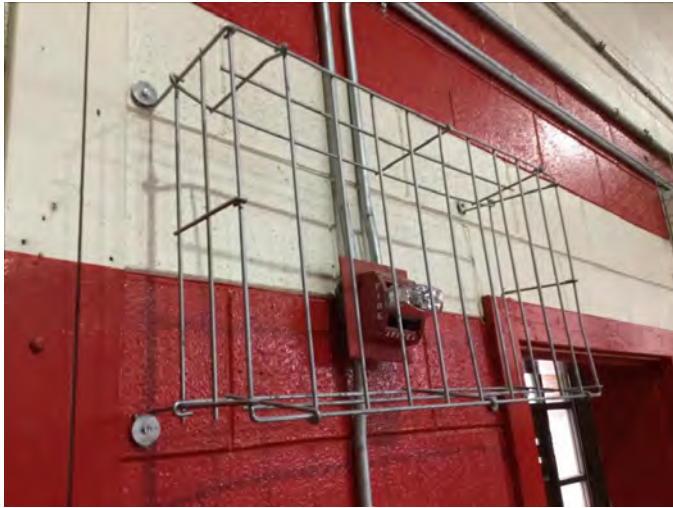
Location: Throughout the building
Distress: Beyond Service Life
Category: Deferred Maintenance
Priority: 3 - Necessary/Not Yet Critical (Years 2-5)
Correction: Renew System
Qty: 13,087.00
Unit of Measure: S.F.
Estimate: \$48,801.00
Assessor Name: Eduardo Lopez
Date Created: 12/06/2016

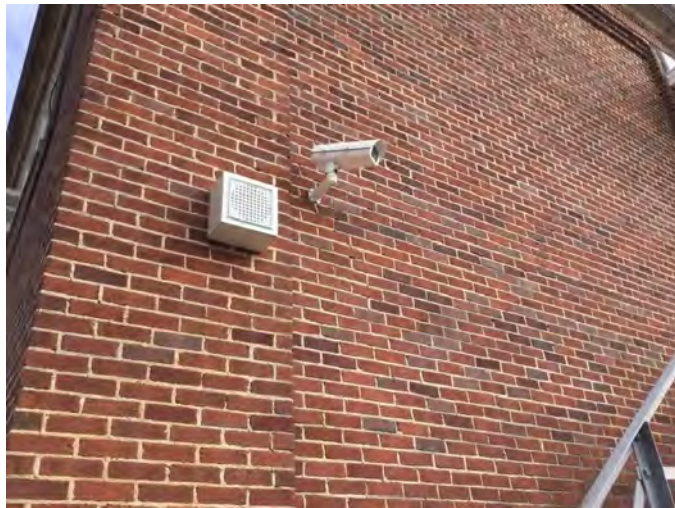
Location: Site
Distress: Beyond Service Life
Category: Deferred Maintenance
Priority: 3 - Necessary/Not Yet Critical (Years 2-5)
Correction: Renew System
Qty: 74,147.00
Unit of Measure: S.F.
Estimate: \$68,512.00
Assessor Name: Eduardo Lopez
Date Created: 12/07/2016
