NC School District/430 Harnett County/Elementary School

# Gentry Primary

## Campus Assessment Report

March 11, 2017

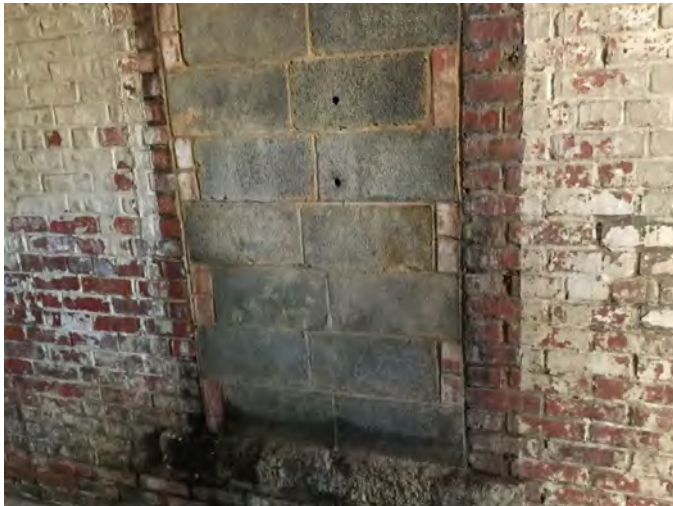
**System: A2020 - Basement Walls**

**Location:** Basement boiler room  
**Distress:** Failing  
**Category:** Safety  
**Priority:** 3 - Necessary/Not Yet Critical (Years 2-5)  
**Correction:** Fill abandoned basement  
**Qty:** 400.00  
**Unit of Measure:** S.F.  
**Estimate:** \$20,929.92  
**Assessor Name:** Eduardo Lopez  
**Date Created:** 12/09/2016

**Notes:** The basement boiler room is not in used and is a safety hazard. Steps to the basement are in poor condition. The door does not secure properly. The space is abandoned and of no use. Building elements above grade (roof, shade structure) are in poor condition and unsightly. It is recommended that walls be removed to below grade and the basement be filled, and that landscaping be restored at the surface.

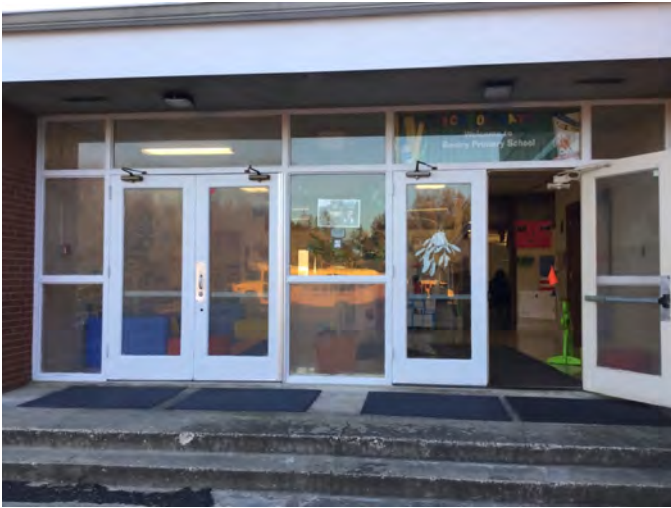
**System: B2030 - Exterior Doors**

**Location:** Exterior doors  
**Distress:** Beyond Service Life  
**Category:** Deferred Maintenance  
**Priority:** 3 - Necessary/Not Yet Critical (Years 2-5)  
**Correction:** Renew System  
**Qty:** 27,130.00  
**Unit of Measure:** S.F.  
**Estimate:** \$31,037.00  
**Assessor Name:** Eduardo Lopez  
**Date Created:** 12/08/2016

**Notes:** The original exterior doors are aged, and should be replaced. Install access control system - Part 2 to ensure that all exterior doors are automatically locked during the school day and permit card entry.

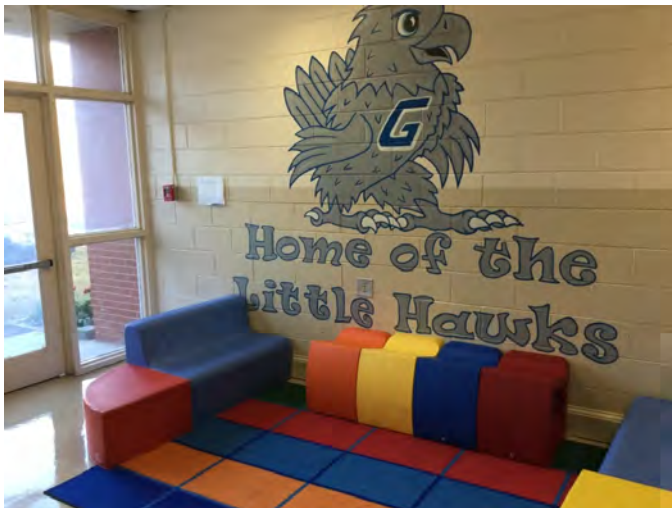
**System: C3010 - Wall Finishes**

**Location:** Throughout the building  
**Distress:** Beyond Service Life  
**Category:** Deferred Maintenance  
**Priority:** 3 - Necessary/Not Yet Critical (Years 2-5)  
**Correction:** Renew System  
**Qty:** 27,130.00  
**Unit of Measure:** S.F.  
**Estimate:** \$83,262.00  
**Assessor Name:** Eduardo Lopez  
**Date Created:** 12/08/2016

**Notes:** Wall finishes, while generally well maintained, will be adversely affected by other recommended renovations such as flooring, ceiling, door and window replacements. Budgeting for wall finish system renewal is recommended.

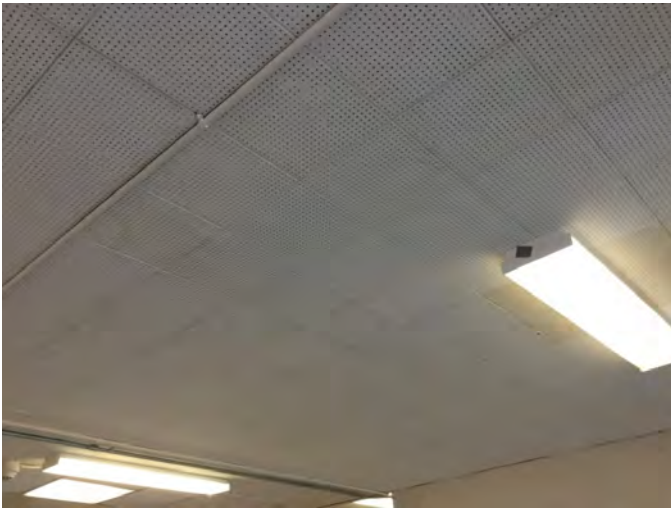
**System: C3030 - Ceiling Finishes**

**Location:** Throughout the building  
**Distress:** Beyond Service Life  
**Category:** Deferred Maintenance  
**Priority:** 3 - Necessary/Not Yet Critical (Years 2-5)  
**Correction:** Renew System  
**Qty:** 27,130.00  
**Unit of Measure:** S.F.  
**Estimate:** \$327,378.00  
**Assessor Name:** Eduardo Lopez  
**Date Created:** 12/08/2016

**Notes:** The original ceiling finishes are aged, stained and should be replaced. Lack of dropped ceilings in classrooms and corridors exposes many utilities and is unsightly.

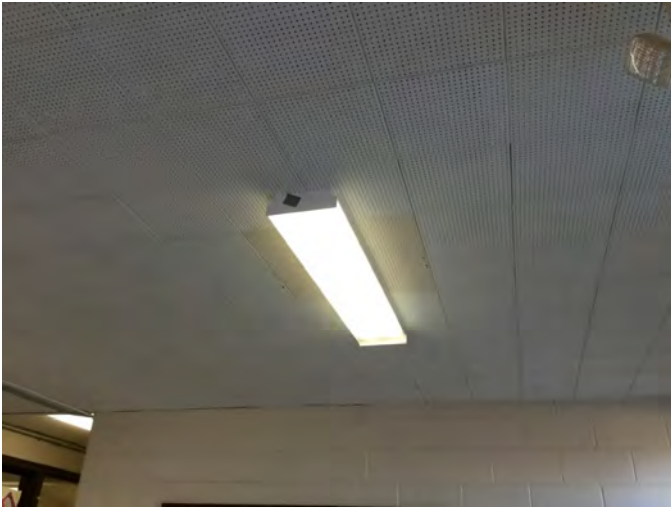
**System: D5020 - Lighting**

**Location:** Throughout the building.  
**Distress:** Beyond Service Life  
**Category:** Deferred Maintenance  
**Priority:** 3 - Necessary/Not Yet Critical (Years 2-5)  
**Correction:** Renew System  
**Qty:** 27,130.00  
**Unit of Measure:** S.F.  
**Estimate:** \$355,729.00  
**Assessor Name:** Eduardo Lopez  
**Date Created:** 12/09/2016

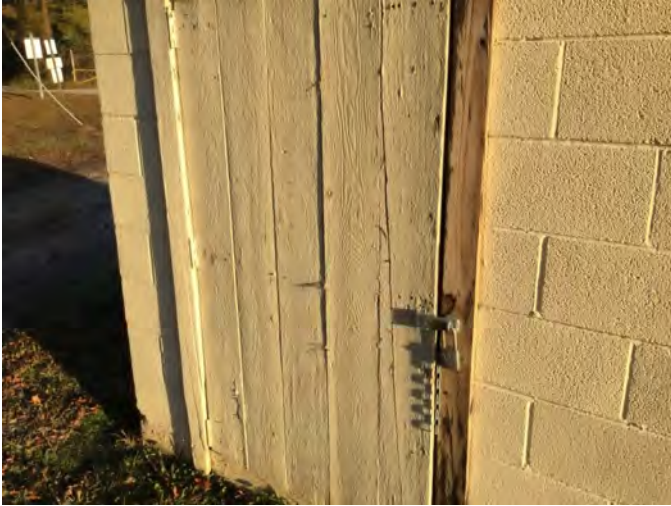
#### System: B2030 - Exterior Doors

**Location:** South wall  
**Distress:** Beyond Service Life  
**Category:** Deferred Maintenance  
**Priority:** 3 - Necessary/Not Yet Critical (Years 2-5)  
**Correction:** Renew System  
**Qty:** 48.00  
**Unit of Measure:** S.F.  
**Estimate:** \$1,115.00  
**Assessor Name:** Eduardo Lopez  
**Date Created:** 12/08/2016

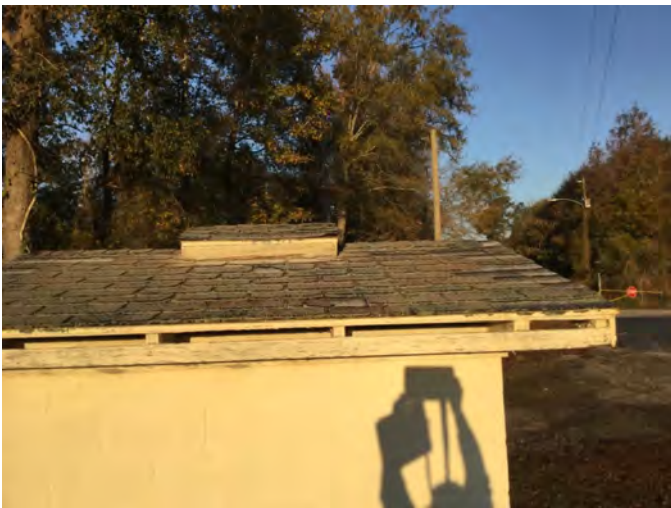
#### System: B3010140 - Asphalt Shingles

**Location:** Roof  
**Distress:** Beyond Service Life  
**Category:** Deferred Maintenance  
**Priority:** 3 - Necessary/Not Yet Critical (Years 2-5)  
**Correction:** Renew System  
**Qty:** 48.00  
**Unit of Measure:** S.F.  
**Estimate:** \$303.00  
**Assessor Name:** Eduardo Lopez  
**Date Created:** 12/08/2016

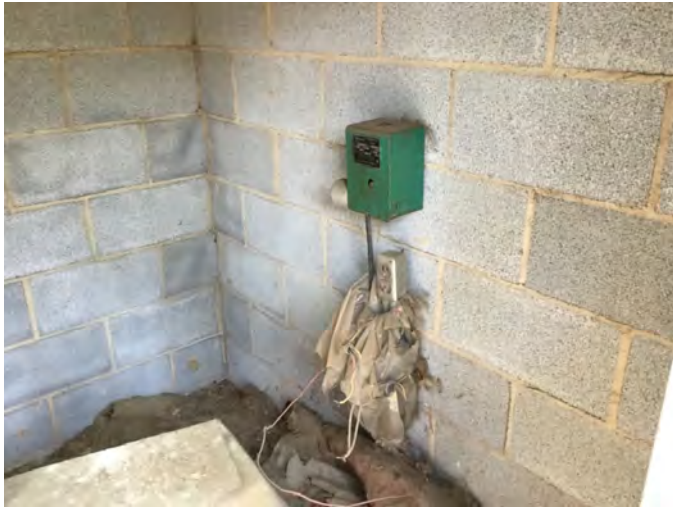
**System: D5020 - Branch Wiring**

**Location:** East wall  
**Distress:** Beyond Service Life  
**Category:** Deferred Maintenance  
**Priority:** 3 - Necessary/Not Yet Critical (Years 2-5)  
**Correction:** Renew System  
**Qty:** 48.00  
**Unit of Measure:** S.F.  
**Estimate:** \$150.00  
**Assessor Name:** Eduardo Lopez  
**Date Created:** 12/08/2016

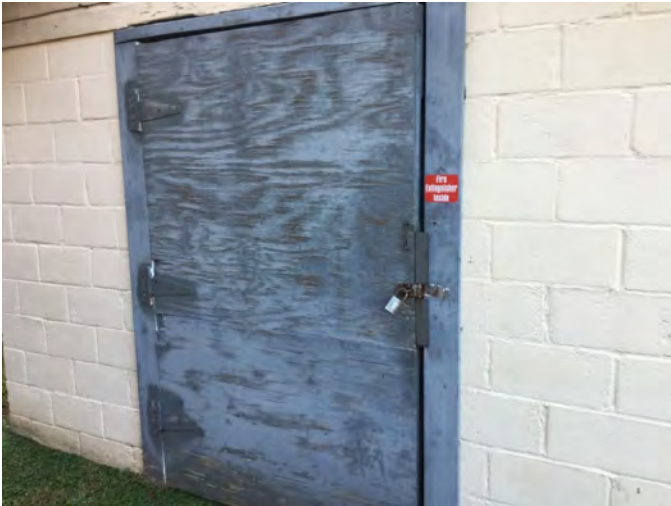
#### System: B2030 - Exterior Doors

**Location:** North and south walls  
**Distress:** Beyond Service Life  
**Category:** Deferred Maintenance  
**Priority:** 3 - Necessary/Not Yet Critical (Years 2-5)  
**Correction:** Renew System  
**Qty:** 325.00  
**Unit of Measure:** S.F.  
**Estimate:** \$2,467.00  
**Assessor Name:** Eduardo Lopez  
**Date Created:** 12/08/2016

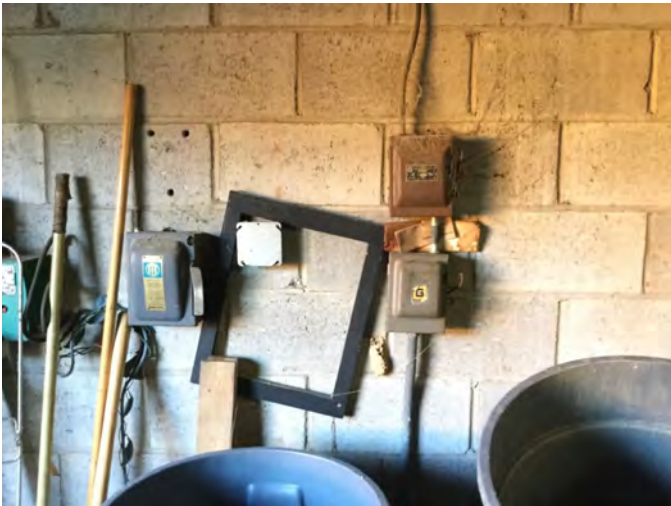
#### System: D5010 - Electrical Service/Distribution

**Location:** East wall interior  
**Distress:** Beyond Service Life  
**Category:** Deferred Maintenance  
**Priority:** 3 - Necessary/Not Yet Critical (Years 2-5)  
**Correction:** Renew System  
**Qty:** 325.00  
**Unit of Measure:** S.F.  
**Estimate:** \$604.00  
**Assessor Name:** Eduardo Lopez  
**Date Created:** 12/08/2016

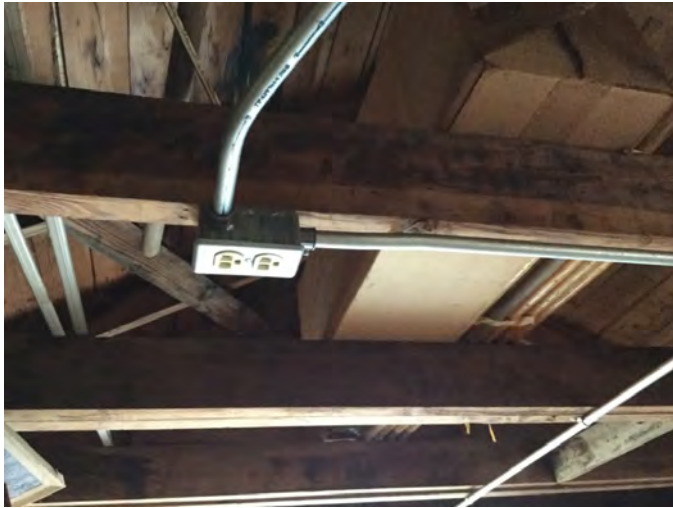
**System: D5020 - Branch Wiring**

**Location:** Interior  
**Distress:** Beyond Service Life  
**Category:** Deferred Maintenance  
**Priority:** 3 - Necessary/Not Yet Critical (Years 2-5)  
**Correction:** Renew System  
**Qty:** 325.00  
**Unit of Measure:** S.F.  
**Estimate:** \$1,015.00  
**Assessor Name:** Eduardo Lopez  
**Date Created:** 12/08/2016

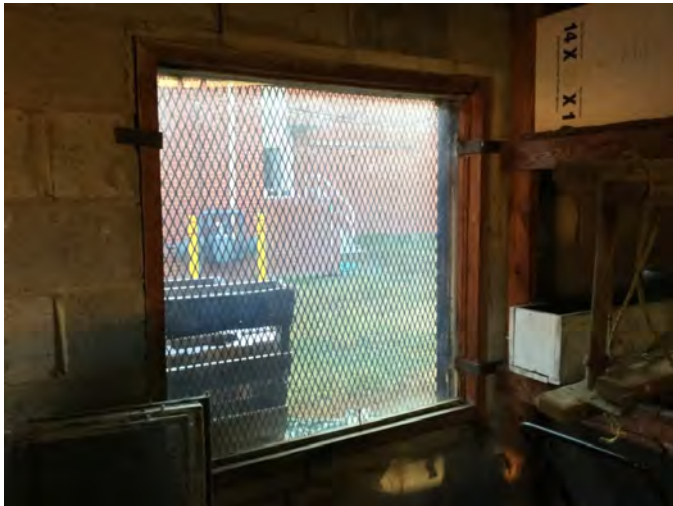
**System: B2020 - Exterior Windows**

**Location:** East wall  
**Distress:** Beyond Service Life  
**Category:** Deferred Maintenance  
**Priority:** 4 - Recommended (Years 6-10)  
**Correction:** Renew System  
**Qty:** 325.00  
**Unit of Measure:** S.F.  
**Estimate:** \$1,344.00  
**Assessor Name:** Eduardo Lopez  
**Date Created:** 12/08/2016

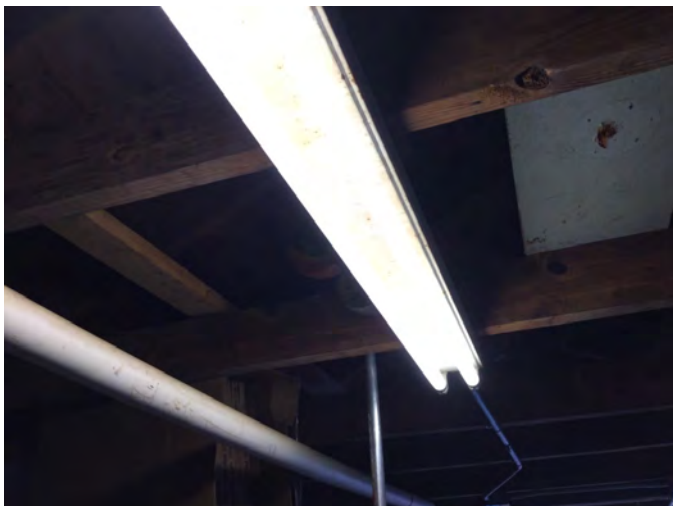
**System: D5020 - Lighting**

**Location:** Interior  
**Distress:** Beyond Service Life  
**Category:** Deferred Maintenance  
**Priority:** 4 - Recommended (Years 6-10)  
**Correction:** Renew System  
**Qty:** 325.00  
**Unit of Measure:** S.F.  
**Estimate:** \$2,717.00  
**Assessor Name:** Eduardo Lopez  
**Date Created:** 12/08/2016

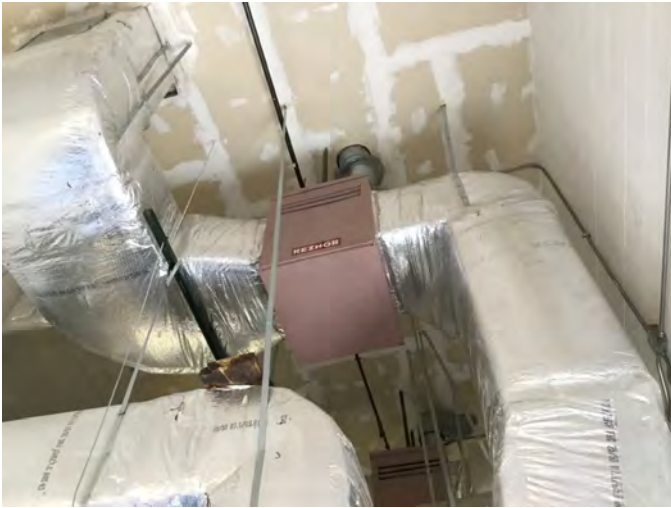
#### **System: C1010 - Partitions**

**Location:** Mechanical rooms  
**Distress:** Missing  
**Category:** Safety / Code Compliance  
**Priority:** 1 - Currently Critical (Immediate)  
**Correction:** Provide fixed access ladder  
**Qty:** 2.00  
**Unit of Measure:** Ea.  
**Estimate:** \$13,666.22  
**Assessor Name:** Eduardo Lopez  
**Date Created:** 12/08/2016

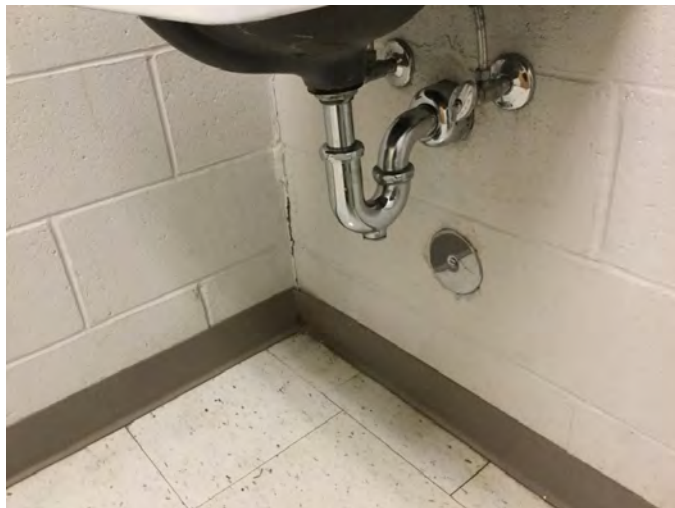
**System: D2010 - Plumbing Fixtures**

**Location:** Restrooms  
**Distress:** Inadequate  
**Category:** Accessibility Code Compliance  
**Priority:** 2 - Potentially Critical (Year 1)  
**Correction:** Add handicap compliant insulation for exposed piping under sinks or lavatories  
**Qty:** 4.00  
**Unit of Measure:** Ea.  
**Estimate:** \$293.08  
**Assessor Name:** Eduardo Lopez  
**Date Created:** 12/08/2016

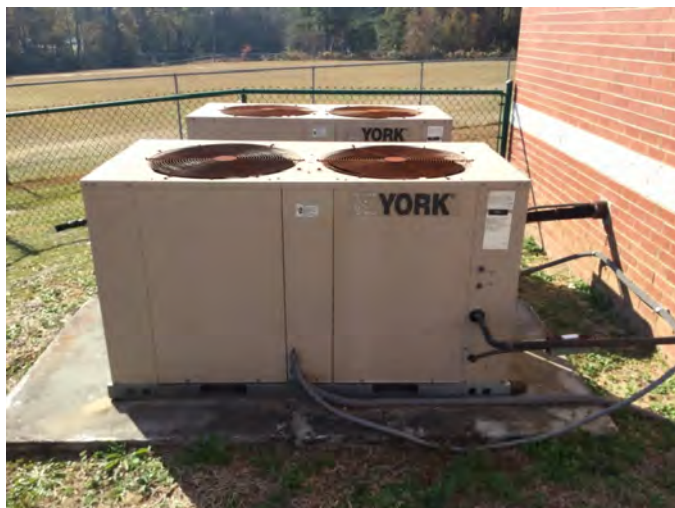
**System: D3050 - Terminal & Package Units**

**Location:** Gyn units  
**Distress:** Beyond Service Life  
**Category:** Deferred Maintenance  
**Priority:** 3 - Necessary/Not Yet Critical (Years 2-5)  
**Correction:** Renew System  
**Qty:** 9,758.00  
**Unit of Measure:** S.F.  
**Estimate:** \$112,061.00  
**Assessor Name:** Eduardo Lopez  
**Date Created:** 12/08/2016

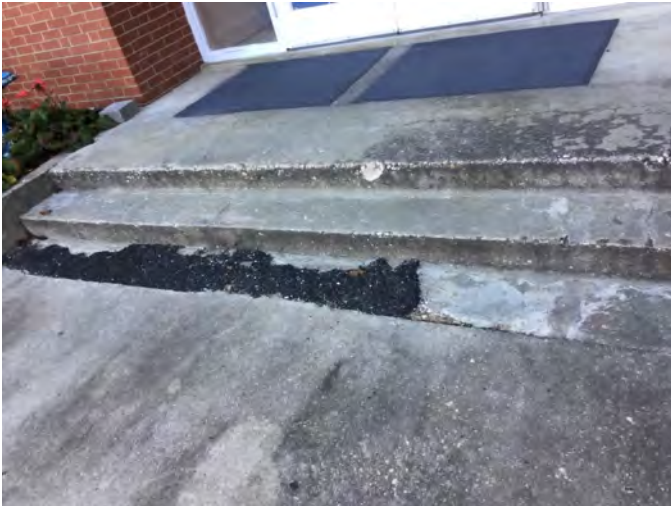
**Location:** Site at building entrances  
**Distress:** Inadequate  
**Category:** Deferred Maintenance / Safety  
**Priority:** 2 - Potentially Critical (Year 1)  
**Correction:** Renew System  
**Qty:** 40,231.00  
**Unit of Measure:** S.F.  
**Estimate:** \$84,525.00  
**Assessor Name:** Ann Buerger Linden  
**Date Created:** 12/09/2016

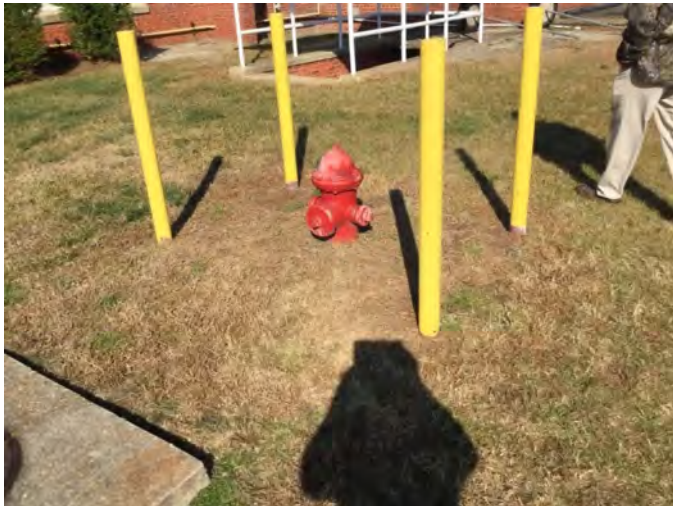
**Location:** Site  
**Distress:** Beyond Service Life  
**Category:** Deferred Maintenance  
**Priority:** 3 - Necessary/Not Yet Critical (Years 2-5)  
**Correction:** Renew System  
**Qty:** 40,231.00  
**Unit of Measure:** S.F.  
**Estimate:** \$103,555.00  
**Assessor Name:** Ann Buerger Linden  
**Date Created:** 11/15/2016

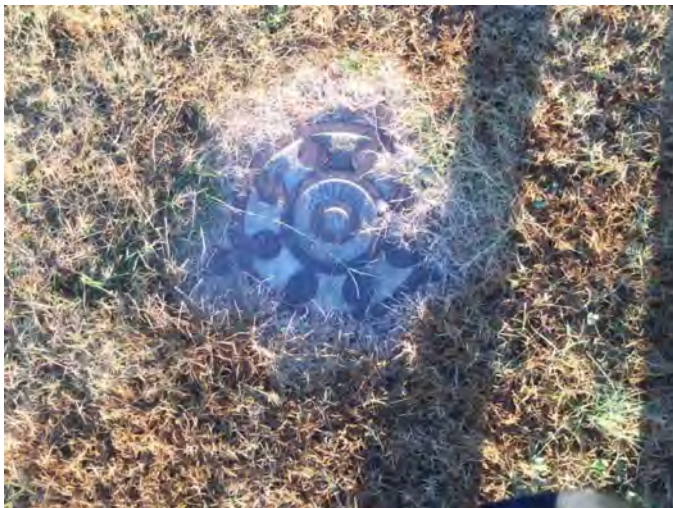
**Location:** Site  
**Distress:** Beyond Service Life  
**Category:** Deferred Maintenance  
**Priority:** 3 - Necessary/Not Yet Critical (Years 2-5)  
**Correction:** Renew System  
**Qty:** 40,231.00  
**Unit of Measure:** S.F.  
**Estimate:** \$64,168.00  
**Assessor Name:** Ann Buerger Linden  
**Date Created:** 11/15/2016

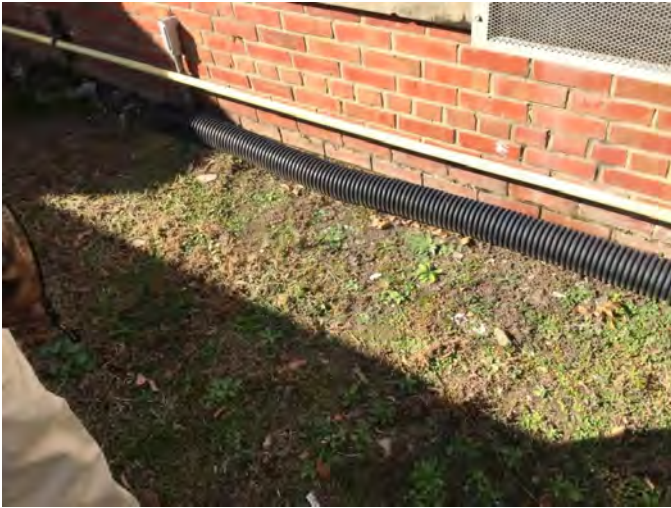
**Location:** Around buildings  
**Distress:** Missing  
**Category:** Safety  
**Priority:** 3 - Necessary/Not Yet Critical (Years 2-5)  
**Correction:** Renew System  
**Qty:** 40,231.00  
**Unit of Measure:** S.F.  
**Estimate:** \$200,914.00  
**Assessor Name:** Ann Buerger Linden  
**Date Created:** 11/15/2016

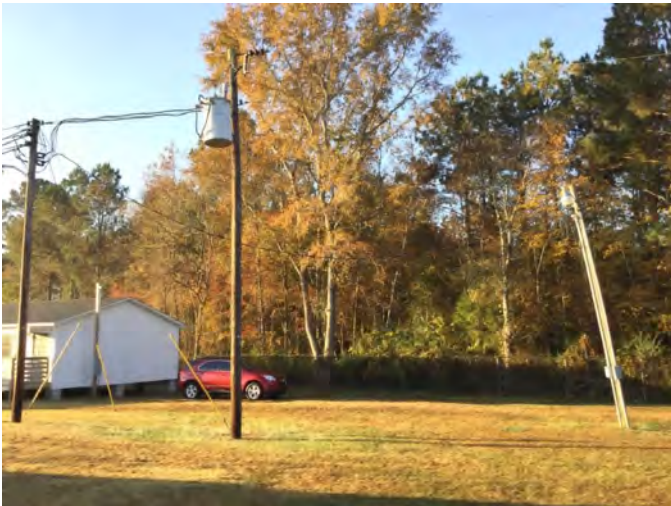
**Location:** Site  
**Distress:** Beyond Service Life  
**Category:** Deferred Maintenance  
**Priority:** 3 - Necessary/Not Yet Critical (Years 2-5)  
**Correction:** Renew System  
**Qty:** 40,231.00  
**Unit of Measure:** S.F.  
**Estimate:** \$103,997.00  
**Assessor Name:** Ann Buerger Linden  
**Date Created:** 11/15/2016
