NC School District/430 Harnett County/Elementary School

Highland Elementary

Campus Assessment Report

March 11, 2017

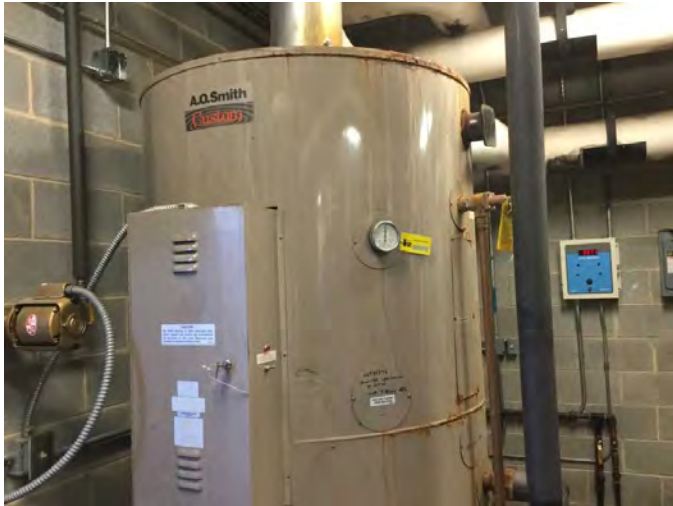
System: D2020 - Domestic Water Distribution

Location: Throughout
Distress: Beyond Service Life
Category: Deferred Maintenance
Priority: 2 - Potentially Critical (Year 1)
Correction: Replace water heater, gas / oil, 70 gallon
Qty: 1.00
Unit of Measure: Ea.
Estimate: \$15,232.80
Assessor Name: Terence Davis
Date Created: 12/06/2016

Notes: Hot water heaters are beyond service life with reported failures and should be replaced.

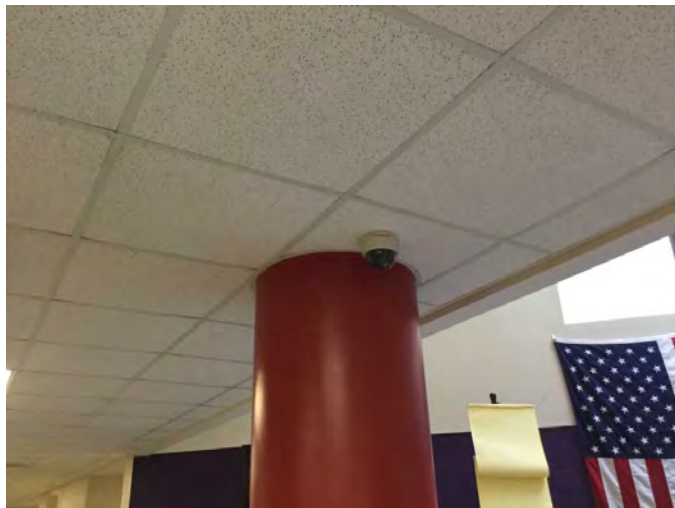
System: D5030810 - Security & Detection Systems

Location: Throughout
Distress: Beyond Service Life
Category: Deferred Maintenance
Priority: 3 - Necessary/Not Yet Critical (Years 2-5)
Correction: Renew System
Qty: 85,781.00
Unit of Measure: S.F.
Estimate: \$172,677.00
Assessor Name: Terence Davis
Date Created: 12/05/2016

Notes: Security system is nearing end of life. Cameras are analog and should be upgraded to digital.

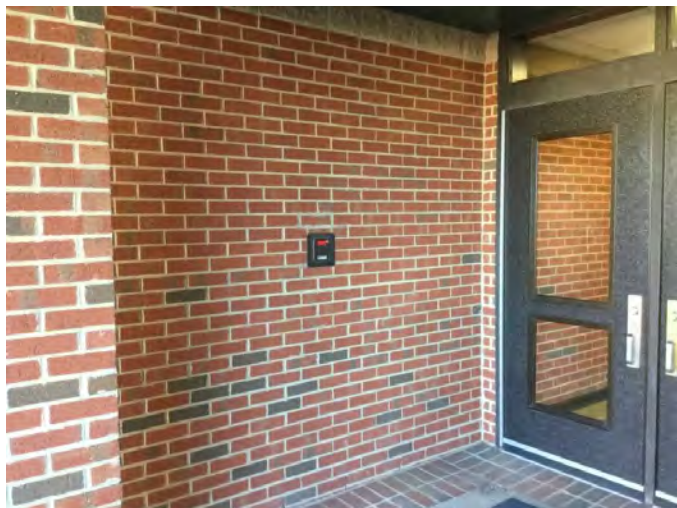
System: G4030 - Site Communications & Security

Location: Exterior
Distress: Beyond Service Life
Category: Deferred Maintenance
Priority: 3 - Necessary/Not Yet Critical (Years 2-5)
Correction: Renew System
Qty: 96,212.00
Unit of Measure: S.F.
Estimate: \$88,900.00
Assessor Name: Eduardo Lopez
Date Created: 12/05/2016

Notes: Security system is aged, analog cameras should be replaced with digital and key-card access added to exterior doors.
