NC School District/430 Harnett County/Elementary School

North Harnett Primary

Campus Assessment Report

March 11, 2017

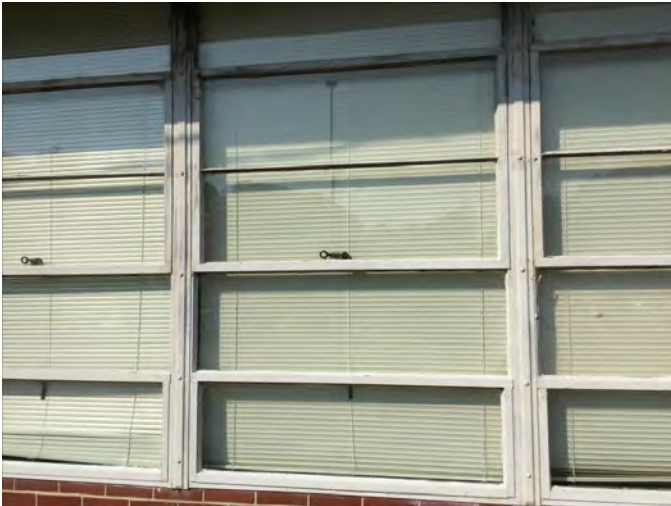
System: B2020 - Exterior Windows

Location: Throughout
Distress: Beyond Service Life
Category: Deferred Maintenance
Priority: 3 - Necessary/Not Yet Critical (Years 2-5)
Correction: Renew System
Qty: 7,950.00
Unit of Measure: S.F.
Estimate: \$80,454.00
Assessor Name: Eduardo Lopez
Date Created: 12/05/2016

Notes: The aluminum frame, operable, single pane plexi windows are aged, rusted, not energy efficient, and should be replaced.

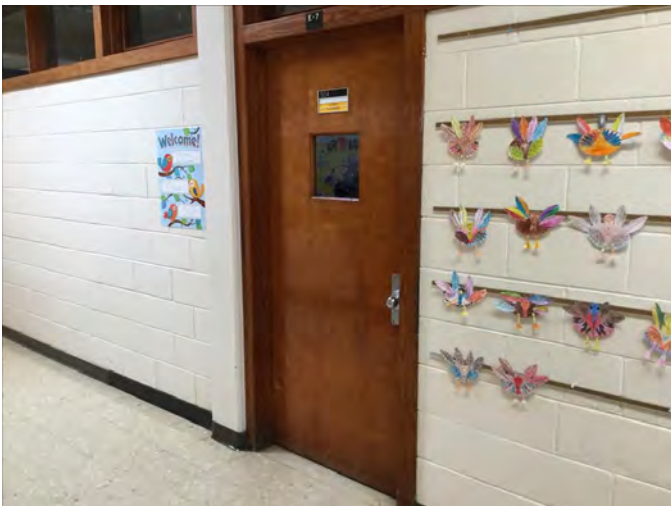
System: C1020 - Interior Doors

Location: Throughout
Distress: Beyond Service Life
Category: Deferred Maintenance
Priority: 3 - Necessary/Not Yet Critical (Years 2-5)
Correction: Renew System
Qty: 7,950.00
Unit of Measure: S.F.
Estimate: \$21,688.00
Assessor Name: Eduardo Lopez
Date Created: 12/05/2016

Notes: The interior doors are aged, failing, hardware is not ADA compliant and should be replaced.

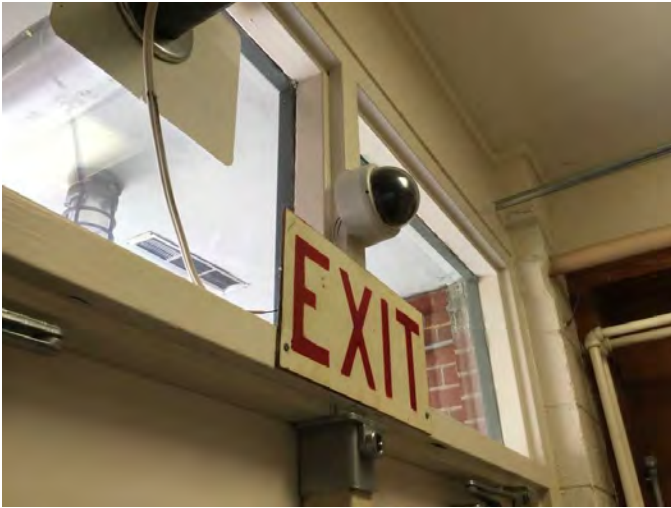
System: C1030 - Fittings

Location: Throughout
Distress: Beyond Service Life
Category: Deferred Maintenance
Priority: 3 - Necessary/Not Yet Critical (Years 2-5)
Correction: Renew System
Qty: 7,950.00
Unit of Measure: S.F.
Estimate: \$83,427.00
Assessor Name: Eduardo Lopez
Date Created: 12/05/2016

Notes: The fittings throughout the building are aged, in marginal condition, handrails and room signage are ADA non-compliance and system should be replaced.

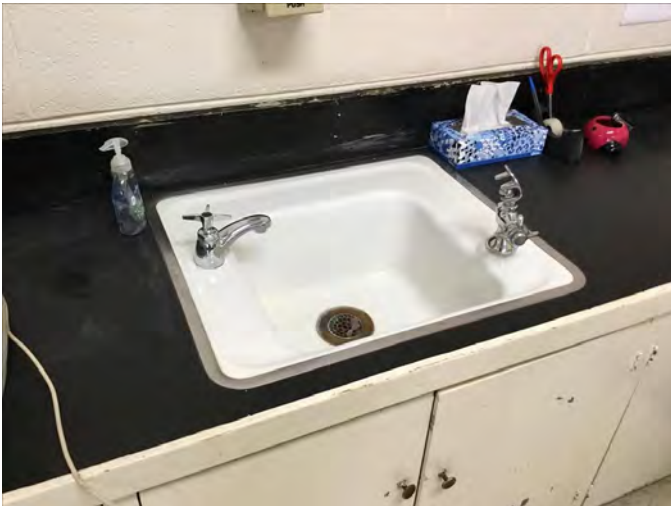
System: D2010 - Plumbing Fixtures

Location: Throughout
Distress: Beyond Service Life
Category: Deferred Maintenance
Priority: 3 - Necessary/Not Yet Critical (Years 2-5)
Correction: Renew System
Qty: 7,950.00
Unit of Measure: S.F.
Estimate: \$98,469.00
Assessor Name: Eduardo Lopez
Date Created: 12/05/2016

Notes: Plumbing fixtures are in operational conditions. However, they are aged, not ADA compliant and should be replaced with a low-flow water fixtures.

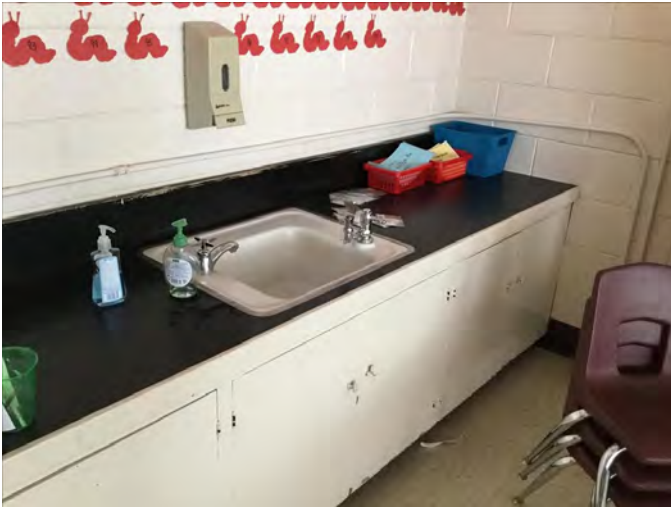
System: D2020 - Domestic Water Distribution

Location: Throughout
Distress: Beyond Service Life
Category: Deferred Maintenance
Priority: 3 - Necessary/Not Yet Critical (Years 2-5)
Correction: Renew System
Qty: 7,950.00
Unit of Measure: S.F.
Estimate: \$8,395.00
Assessor Name: Eduardo Lopez
Date Created: 12/05/2016

Notes: The domestic water distribution system is aged and should be replaced.

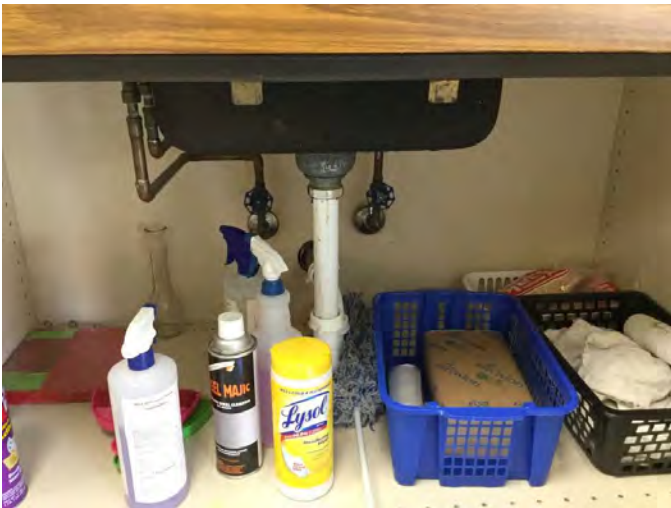
System: D2030 - Sanitary Waste

Location: Classrooms
Distress: Beyond Service Life
Category: Deferred Maintenance
Priority: 3 - Necessary/Not Yet Critical (Years 2-5)
Correction: Renew System
Qty: 7,950.00
Unit of Measure: S.F.
Estimate: \$13,292.00
Assessor Name: Eduardo Lopez
Date Created: 12/05/2016

Notes: The sanitary waste system is aged, has reported periodic failures, and should be replaced.

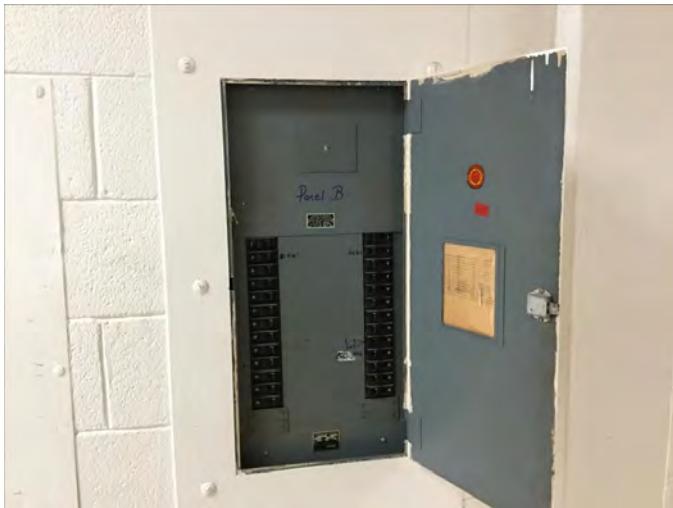
System: D5020 - Branch Wiring

Location: Throughout
Distress: Beyond Service Life
Category: Deferred Maintenance
Priority: 3 - Necessary/Not Yet Critical (Years 2-5)
Correction: Renew System
Qty: 7,950.00
Unit of Measure: S.F.
Estimate: \$43,638.00
Assessor Name: Eduardo Lopez
Date Created: 12/05/2016

Notes: The original branch wiring system is operating, but is aged, in poor condition, and should be replaced.

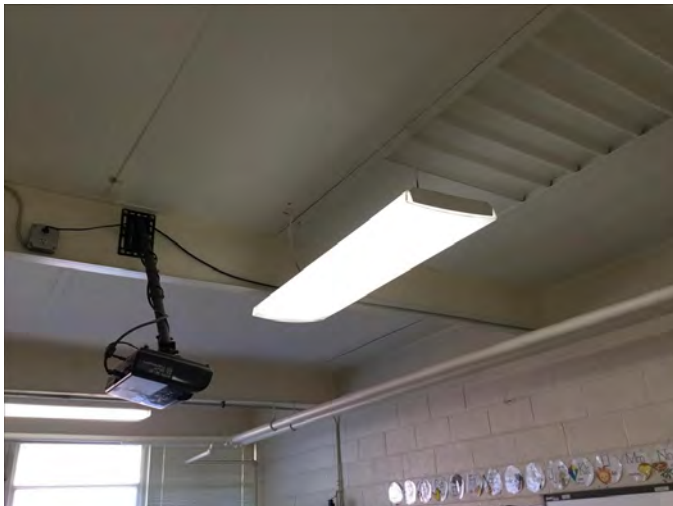
System: D5020 - Lighting

Location: Throughout
Distress: Beyond Service Life
Category: Deferred Maintenance
Priority: 3 - Necessary/Not Yet Critical (Years 2-5)
Correction: Renew System
Qty: 7,950.00
Unit of Measure: S.F.
Estimate: \$101,792.00
Assessor Name: Eduardo Lopez
Date Created: 12/05/2016

Notes: The lighting system is operating, but is aged, in poor condition, and should be replaced.

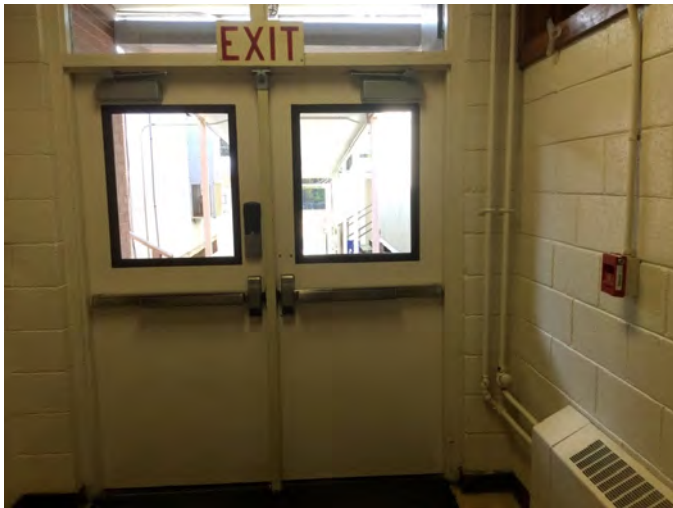
System: D5090 - Other Electrical Systems

Location: Throughout
Distress: Beyond Service Life
Category: Deferred Maintenance
Priority: 3 - Necessary/Not Yet Critical (Years 2-5)
Correction: Renew System
Qty: 7,950.00
Unit of Measure: S.F.
Estimate: \$1,049.00
Assessor Name: Eduardo Lopez
Date Created: 02/27/2017

Notes: The system is beyond service life and should be replaced.

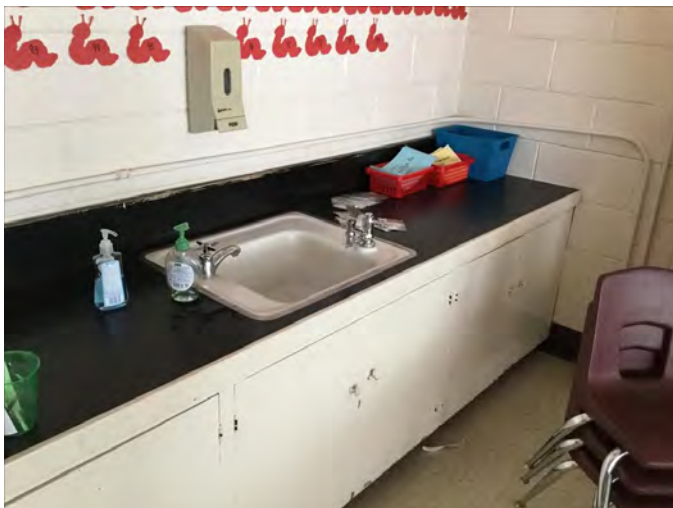
System: E2010 - Fixed Furnishings

Location: Classrooms
Distress: Beyond Service Life
Category: Deferred Maintenance
Priority: 3 - Necessary/Not Yet Critical (Years 2-5)
Correction: Renew System
Qty: 7,950.00
Unit of Measure: S.F.
Estimate: \$50,021.00
Assessor Name: Eduardo Lopez
Date Created: 12/05/2016

Notes: The fixed furnishings are aged, in marginal condition, and should be replaced.

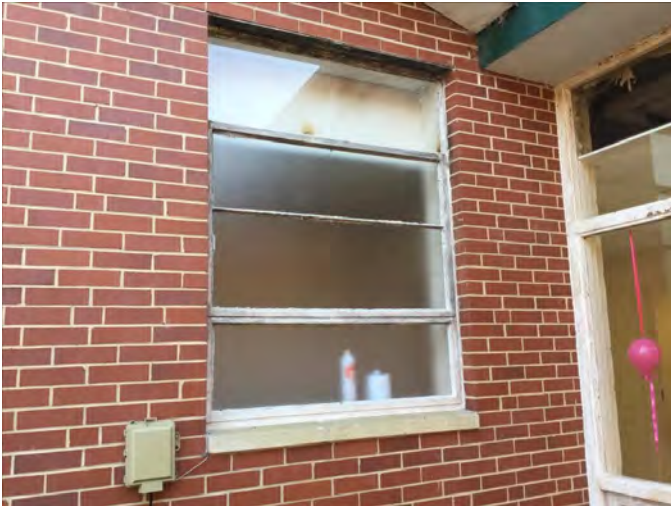
System: B2020 - Exterior Windows

Location: Throughout
Distress: Beyond Service Life
Category: Deferred Maintenance
Priority: 3 - Necessary/Not Yet Critical (Years 2-5)
Correction: Renew System
Qty: 15,964.00
Unit of Measure: S.F.
Estimate: \$161,556.00
Assessor Name: Matt Mahaffey
Date Created: 12/05/2016

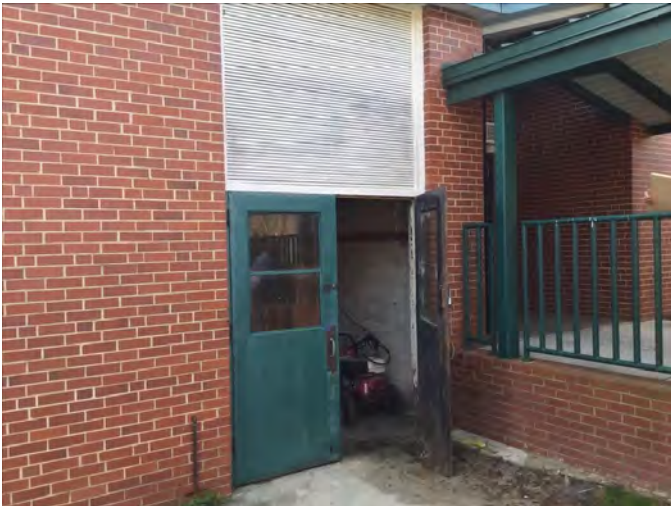
System: B2030 - Exterior Doors

Location: Throughout
Distress: Beyond Service Life
Category: Deferred Maintenance
Priority: 3 - Necessary/Not Yet Critical (Years 2-5)
Correction: Renew System
Qty: 15,964.00
Unit of Measure: S.F.
Estimate: \$17,912.00
Assessor Name: Matt Mahaffey
Date Created: 12/05/2016

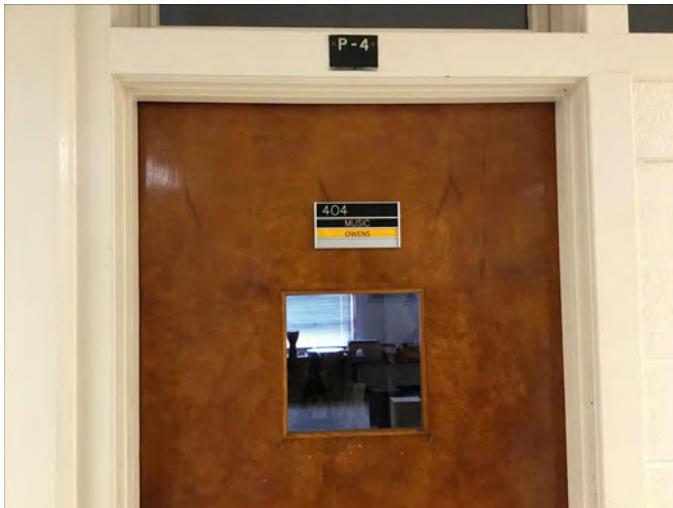
System: C1030 - Fittings

Location: Throughout
Distress: Beyond Service Life
Category: Deferred Maintenance
Priority: 3 - Necessary/Not Yet Critical (Years 2-5)
Correction: Renew System
Qty: 15,964.00
Unit of Measure: S.F.
Estimate: \$167,526.00
Assessor Name: Matt Mahaffey
Date Created: 12/05/2016

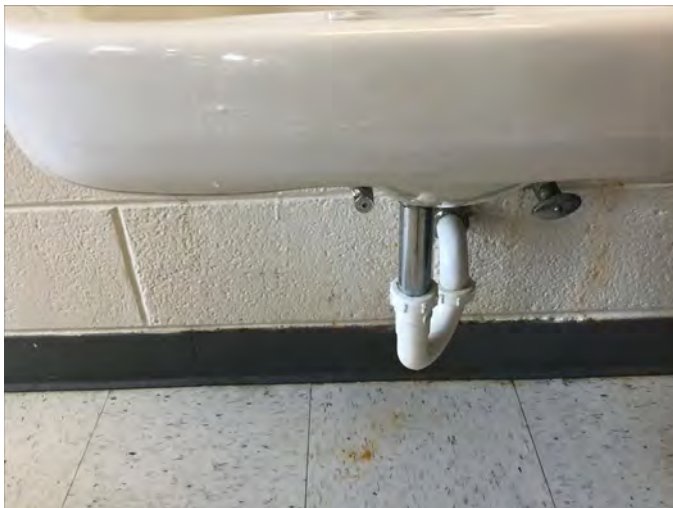
System: D2030 - Sanitary Waste

Location: Throughout
Distress: Beyond Service Life
Category: Deferred Maintenance
Priority: 3 - Necessary/Not Yet Critical (Years 2-5)
Correction: Renew System
Qty: 15,964.00
Unit of Measure: S.F.
Estimate: \$26,692.00
Assessor Name: Matt Mahaffey
Date Created: 12/05/2016

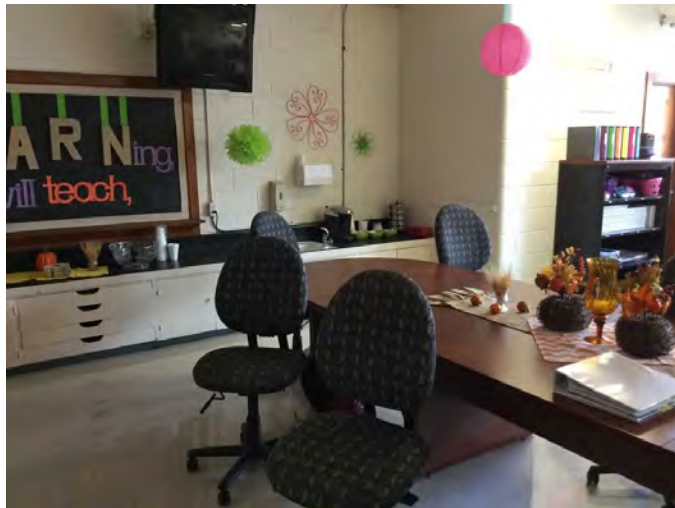
System: E2010 - Fixed Furnishings

Location: Throughout
Distress: Beyond Service Life
Category: Deferred Maintenance
Priority: 3 - Necessary/Not Yet Critical (Years 2-5)
Correction: Renew System
Qty: 15,964.00
Unit of Measure: S.F.
Estimate: \$100,445.00
Assessor Name: Matt Mahaffey
Date Created: 12/05/2016

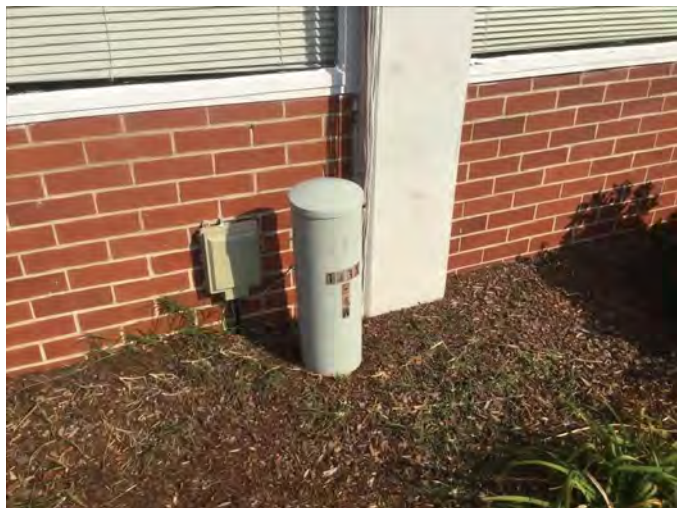
System: G4030 - Site Communications & Security

Location: Site
Distress: Beyond Service Life
Category: Deferred Maintenance
Priority: 3 - Necessary/Not Yet Critical (Years 2-5)
Correction: Renew System
Qty: 66,916.00
Unit of Measure: S.F.
Estimate: \$61,830.00
Assessor Name: Matt Mahaffey
Date Created: 11/14/2016
