NC School District/430 Harnett County/Elementary School

Overhills Elementary

Campus Assessment Report

March 11, 2017

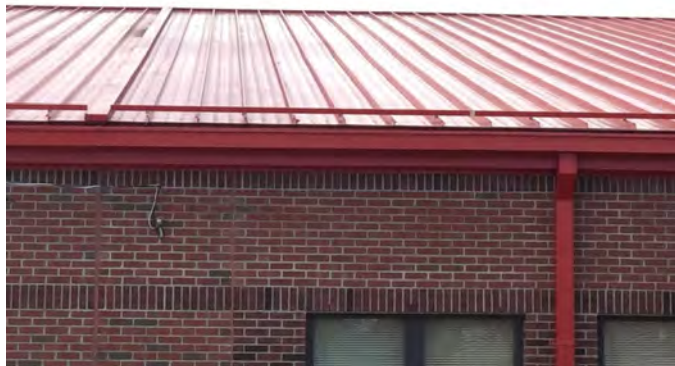
System: B3010130 - Preformed Metal Roofing

Location: Roof
Distress: Failing
Category: Deferred Maintenance
Priority: 2 - Potentially Critical (Year 1)
Correction: Minor metal roof panel replacement, 2.5% of roof area
Qty: 2,500.00
Unit of Measure: S.F.
Estimate: \$46,167.00
Assessor Name: Eduardo Lopez
Date Created: 12/01/2016

Notes: It has been reported water leaks in different areas with heavy rains and should be repaired.

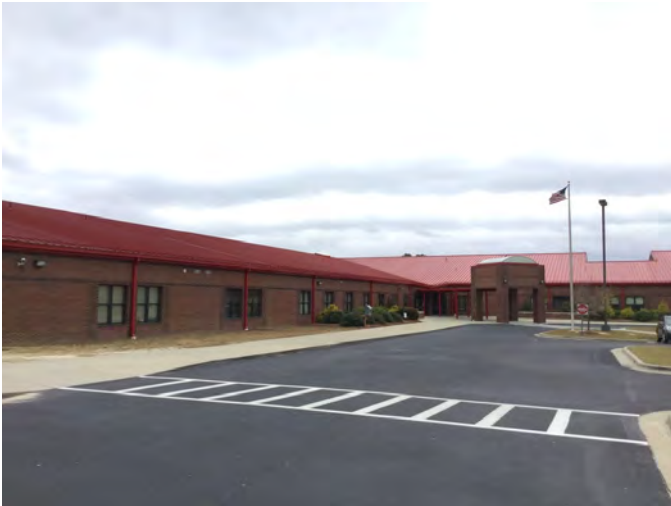
System: G2010 - Roadways

Location: Front of Building
Distress: Missing
Category: Building Code Compliance
Priority: 2 - Potentially Critical (Year 1)
Correction: Fire lane marking; incl. curb painting and with the words "No Parking, Fire Lane" painted in black
Qty: 500.00
Unit of Measure: L.F.
Estimate: \$1,479.59
Assessor Name: Terence Davis
Date Created: 12/01/2016

Notes: Fire lane markings are missing and should be provided to maintain it free of obstruction at all times for emergency vehicles. Provide Fire lane markings per Local Code requirements.

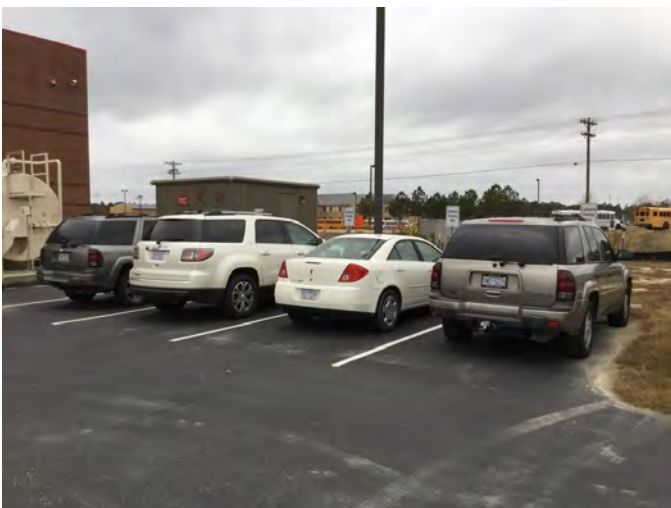
System: G2020 - Parking Lots

Location: Rear Parking Lot
Distress: Missing
Category: Accessibility Code Compliance
Priority: 2 - Potentially Critical (Year 1)
Correction: Add handicap parking space, incl. pavement markings, sign and post
Qty: 1.00
Unit of Measure: Ea.
Estimate: \$490.18
Assessor Name: Terence Davis
Date Created: 12/07/2016

Notes: The parking area designated for employees is missing a designated handicap parking space and should be provided per ADA standards.

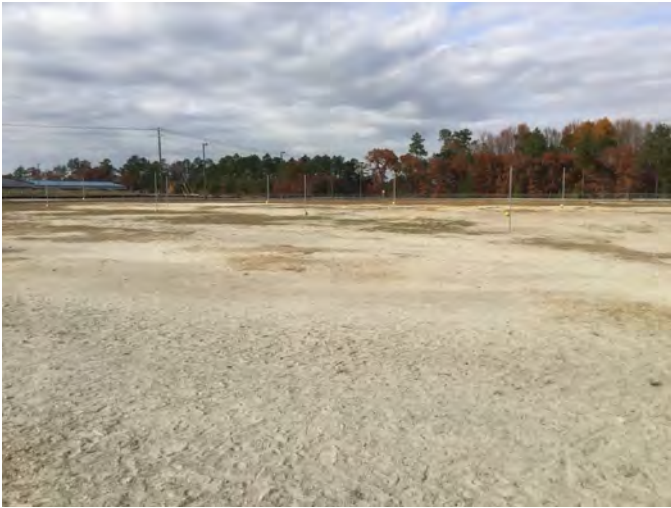
System: G2040950 - Playing Field

Location: Playing Field
Distress: Inadequate
Category: Deferred Maintenance
Priority: 2 - Potentially Critical (Year 1)
Correction: Renew System
Qty: 103,553.00
Unit of Measure: S.F.
Estimate: \$517,144.00
Assessor Name: Terence Davis
Date Created: 12/01/2016

Notes: The playing field is in poor conditions, and should be re-sodded to prevent further erosion.

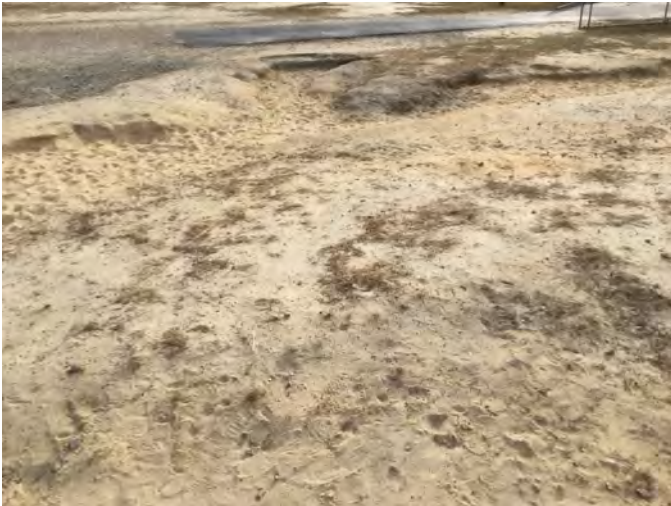
System: G2050 - Landscaping

Location: Site
Distress: Inadequate
Category: Deferred Maintenance
Priority: 2 - Potentially Critical (Year 1)
Correction: Renew System
Qty: 103,553.00
Unit of Measure: S.F.
Estimate: \$213,009.00
Assessor Name: Terence Davis
Date Created: 12/01/2016

Notes: Landscape is minimum with many areas completely eroded away, causing sediments to accumulate at lower levels including; playgrounds, playing field, parking lots and into storm sewer system. Landscape should be provided.

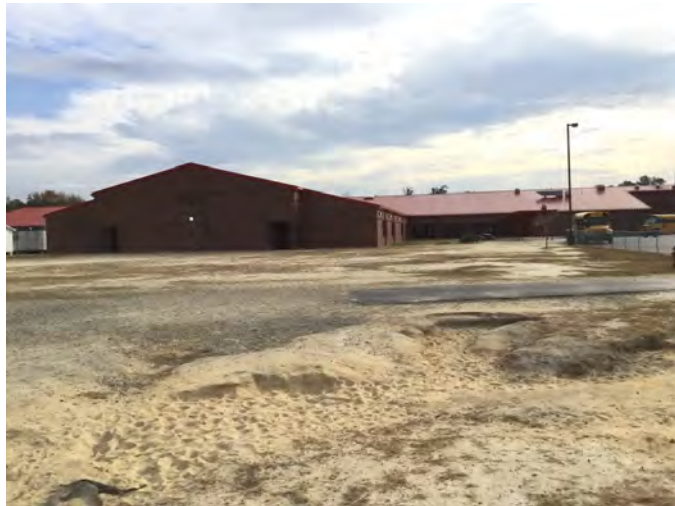
System: G2030 - Pedestrian Paving

Location: Playground and Playing Field
Distress: Missing
Category: Accessibility Code Compliance
Priority: 3 - Necessary/Not Yet Critical (Years 2-5)
Correction: Remove and replace concrete sidewalk, 4' wide
Qty: 500.00
Unit of Measure: L.F.
Estimate: \$25,392.14
Assessor Name: Terence Davis
Date Created: 12/01/2016

Notes: An accessible route from the building to the playing area is missing. Provide accessible route to comply with ADA standards.
