NC School District/430 Harnett County/High School

Harnett Central High

Campus Assessment Report

March 11, 2017

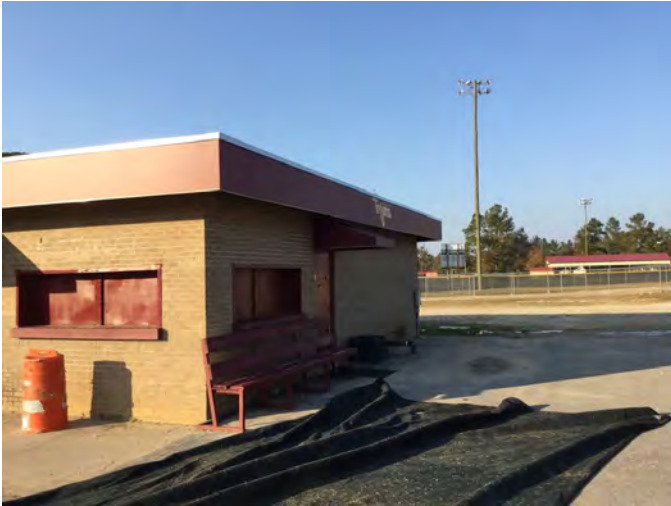
System: B2020 - Exterior Windows

Location: Exterior
Distress: Beyond Service Life
Category: Deferred Maintenance
Priority: 3 - Necessary/Not Yet Critical (Years 2-5)
Correction: Renew System
Qty: 3,200.00
Unit of Measure: S.F.
Estimate: \$4,189.00
Assessor Name: Terence Davis
Date Created: 11/22/2016

Notes: The single pane windows are aged, not energy efficient, and should be replaced.

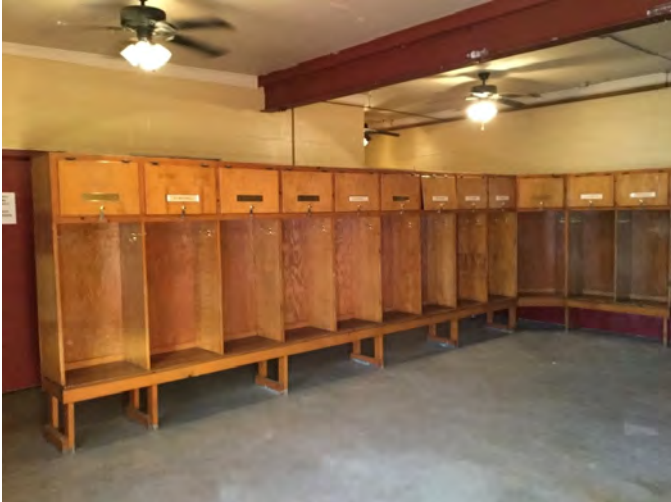
System: C1030 - Fittings

Location: Throughout the building
Distress: Beyond Service Life
Category: Deferred Maintenance
Priority: 3 - Necessary/Not Yet Critical (Years 2-5)
Correction: Renew System
Qty: 3,200.00
Unit of Measure: S.F.
Estimate: \$11,229.00
Assessor Name: Terence Davis
Date Created: 11/22/2016

Notes: The fittings throughout the building are aged, in marginal condition, and should be replaced.

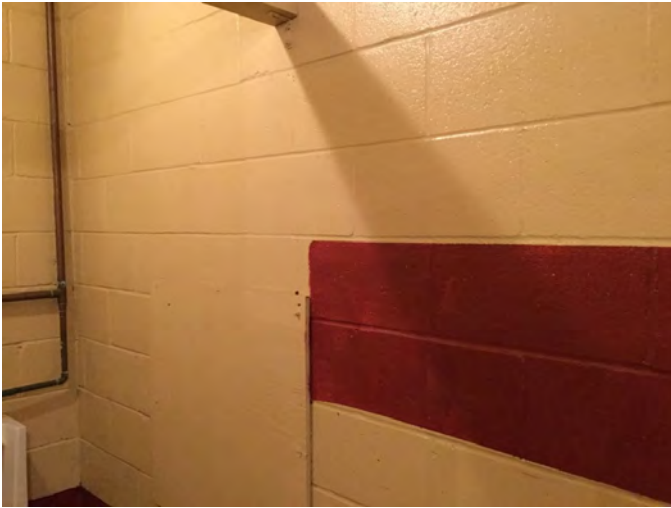
System: C3010 - Wall Finishes

Location: Throughout the building
Distress: Damaged
Category: Deferred Maintenance
Priority: 3 - Necessary/Not Yet Critical (Years 2-5)
Correction: Renew System
Qty: 3,200.00
Unit of Measure: S.F.
Estimate: \$11,053.00
Assessor Name: Terence Davis
Date Created: 11/22/2016

Notes: The wall finishes are aged, scuffed, fading, stained, and should be repainted.

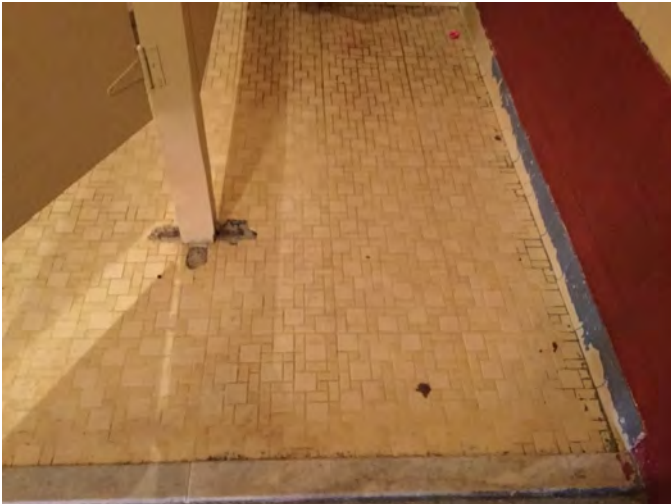
System: C3020 - Floor Finishes

Location: Restroom
Distress: Beyond Service Life
Category: Deferred Maintenance
Priority: 3 - Necessary/Not Yet Critical (Years 2-5)
Correction: Renew System
Qty: 3,200.00
Unit of Measure: S.F.
Estimate: \$19,642.00
Assessor Name: Terence Davis
Date Created: 11/22/2016

Notes: The ceramic tile in the is aged, chipped, cracked, patched, worn and should be replaced.

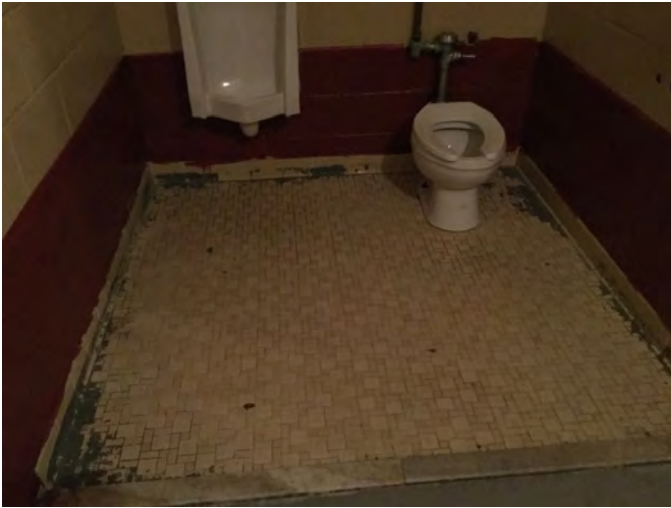
System: D2010 - Plumbing Fixtures

Location: Restroom
Distress: Beyond Service Life
Category: Deferred Maintenance
Priority: 3 - Necessary/Not Yet Critical (Years 2-5)
Correction: Renew System
Qty: 3,200.00
Unit of Measure: S.F.
Estimate: \$21,190.00
Assessor Name: Terence Davis
Date Created: 11/22/2016

Notes: Plumbing fixtures are in operational conditions. However, they are aged, not ADA compliant and should be replaced with a low-flow water fixtures.

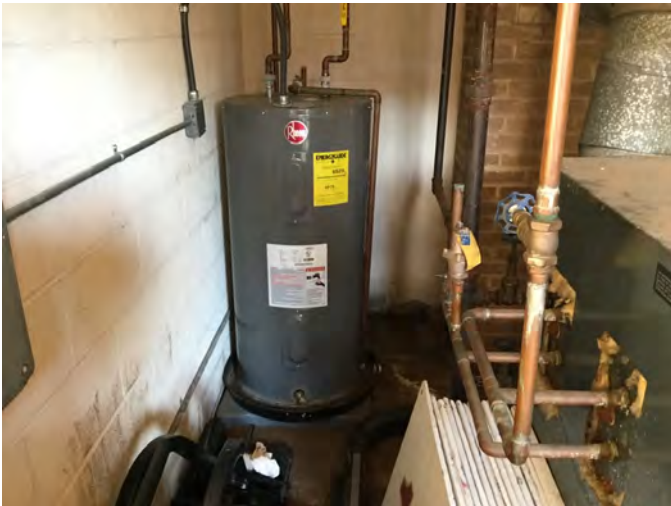
System: D2020 - Domestic Water Distribution

Location: Throughout the building
Distress: Beyond Service Life
Category: Deferred Maintenance
Priority: 3 - Necessary/Not Yet Critical (Years 2-5)
Correction: Renew System
Qty: 3,200.00
Unit of Measure: S.F.
Estimate: \$7,251.00
Assessor Name: Terence Davis
Date Created: 11/22/2016

Notes: There are no reported issues or observed deficiencies with the domestic water piping. Due to the age of the pipe there can be internal pitting corrosion that may be a costly problem that leads to the formation of pinhole leaks and possible water contamination.

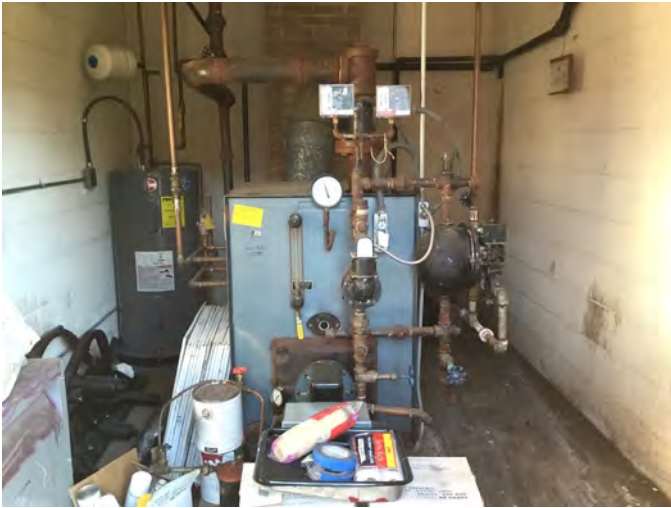
System: D3020 - Heat Generating Systems

Location: Mechanical Room
Distress: Beyond Service Life
Category: Deferred Maintenance
Priority: 3 - Necessary/Not Yet Critical (Years 2-5)
Correction: Renew System
Qty: 3,200.00
Unit of Measure: S.F.
Estimate: \$21,190.00
Assessor Name: Terence Davis
Date Created: 11/22/2016

Notes: The gas-fired boilers are operating properly and are in fair condition but; are aging, inefficient, becoming logistically unsupportable, and should be replaced with energy efficient models.

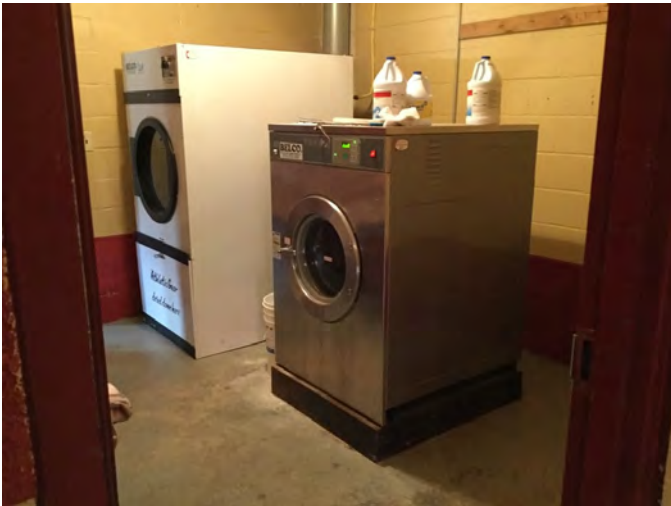
System: F1020 - Institutional Equipment

Location: 1977 Field House
Distress: Beyond Service Life
Category: Deferred Maintenance
Priority: 3 - Necessary/Not Yet Critical (Years 2-5)
Correction: Renew System
Qty: 3,200.00
Unit of Measure: S.F.
Estimate: \$20,205.00
Assessor Name: Terence Davis
Date Created: 03/01/2017

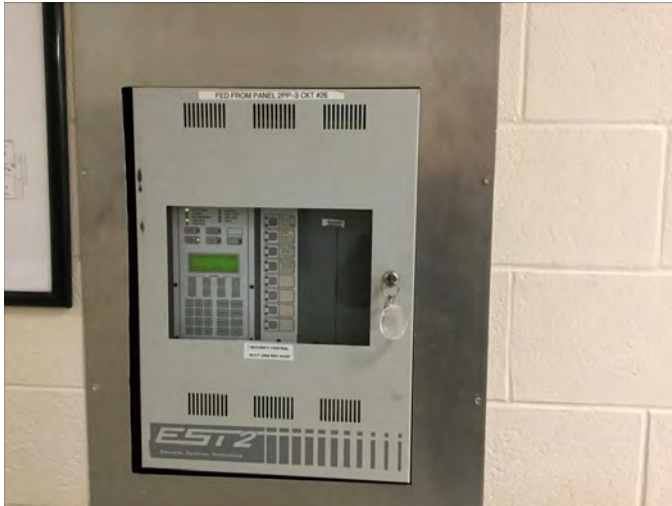
System: D5030910 - Fire & Alarm Systems

Location: Throughout the building
Distress: Beyond Service Life
Category: Deferred Maintenance / Building Code Compliance
Priority: 2 - Potentially Critical (Year 1)
Correction: Renew System
Qty: 152,718.00
Unit of Measure: S.F.
Estimate: \$611,483.00
Assessor Name: Eduardo Lopez
Date Created: 12/05/2016

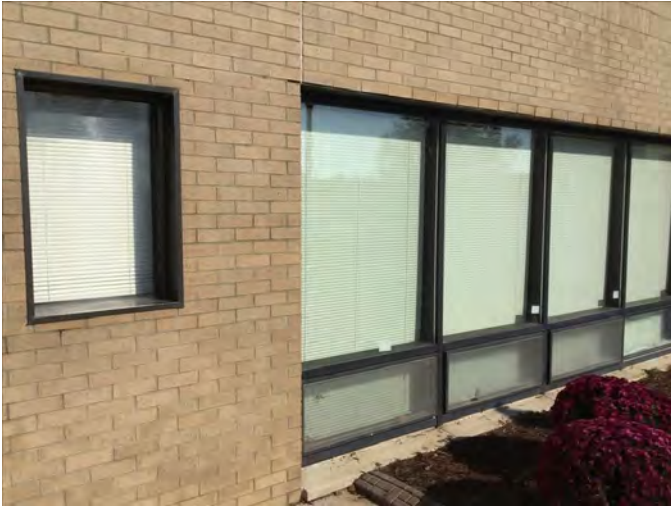
System: B2020 - Exterior Windows

Location: Exterior
Distress: Beyond Service Life
Category: Deferred Maintenance
Priority: 3 - Necessary/Not Yet Critical (Years 2-5)
Correction: Renew System
Qty: 152,718.00
Unit of Measure: S.F.
Estimate: \$2,190,587.00
Assessor Name: Eduardo Lopez
Date Created: 12/05/2016

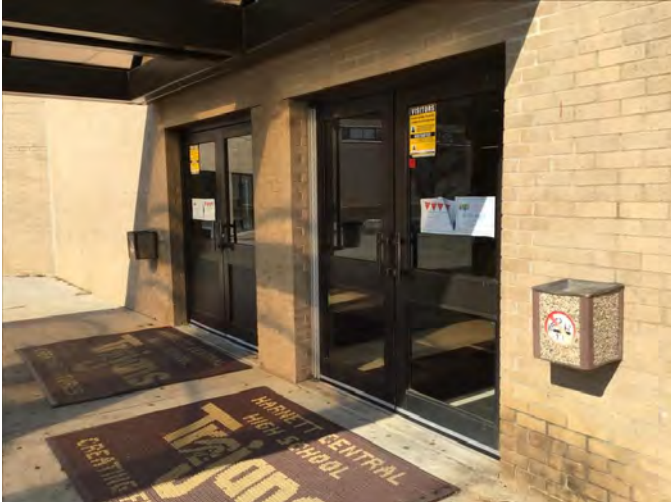
System: B2030 - Exterior Doors

Location: Exterior Exits
Distress: Beyond Service Life
Category: Deferred Maintenance
Priority: 3 - Necessary/Not Yet Critical (Years 2-5)
Correction: Renew System
Qty: 152,718.00
Unit of Measure: S.F.
Estimate: \$137,752.00
Assessor Name: Eduardo Lopez
Date Created: 12/05/2016

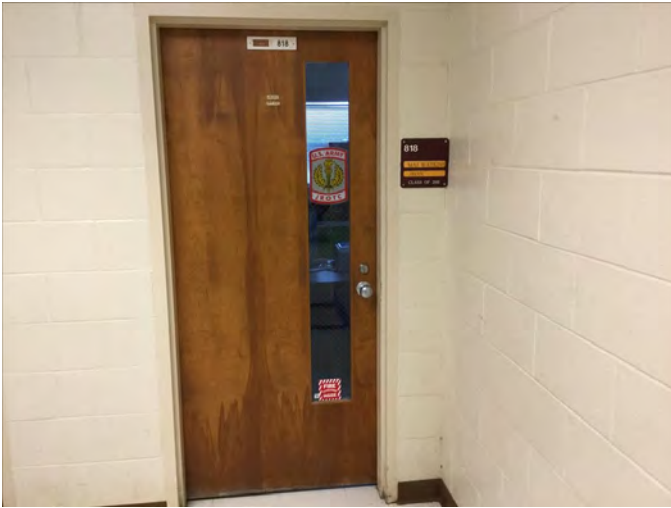
System: C1020 - Interior Doors

Location: Throughout the building
Distress: Beyond Service Life
Category: Deferred Maintenance
Priority: 3 - Necessary/Not Yet Critical (Years 2-5)
Correction: Renew System
Qty: 152,718.00
Unit of Measure: S.F.
Estimate: \$418,295.00
Assessor Name: Eduardo Lopez
Date Created: 12/05/2016

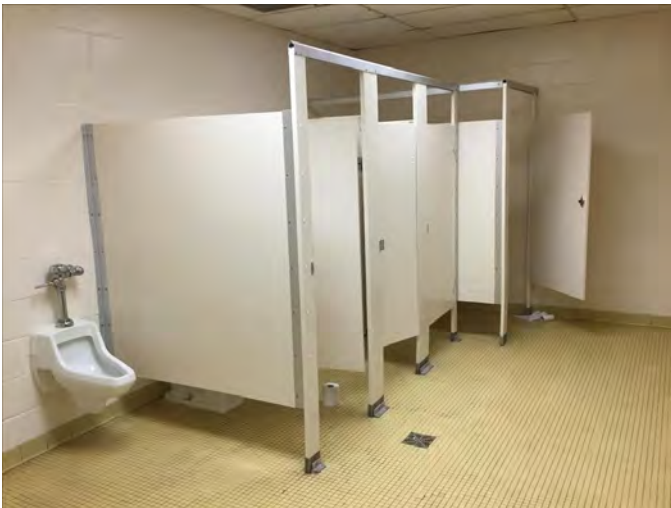
System: C1030 - Fittings

Location: Throughout the building
Distress: Beyond Service Life
Category: Deferred Maintenance
Priority: 3 - Necessary/Not Yet Critical (Years 2-5)
Correction: Renew System
Qty: 152,718.00
Unit of Measure: S.F.
Estimate: \$251,985.00
Assessor Name: Eduardo Lopez
Date Created: 12/05/2016

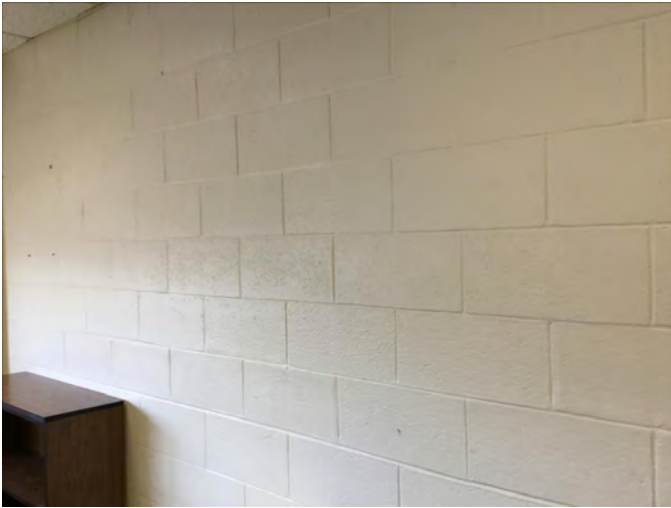
System: C3010 - Wall Finishes

Location: Throughout the building
Distress: Damaged
Category: Deferred Maintenance
Priority: 3 - Necessary/Not Yet Critical (Years 2-5)
Correction: Renew System
Qty: 152,718.00
Unit of Measure: S.F.
Estimate: \$438,453.00
Assessor Name: Eduardo Lopez
Date Created: 12/05/2016

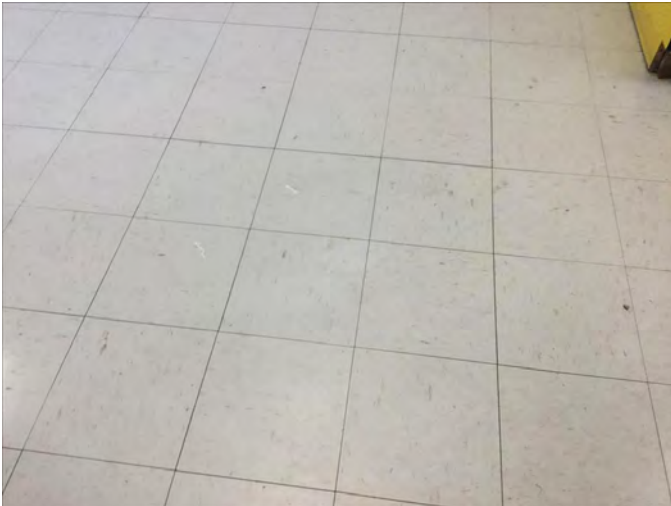
System: C3020 - Floor Finishes

Location: Throughout the building
Distress: Damaged
Category: Deferred Maintenance
Priority: 3 - Necessary/Not Yet Critical (Years 2-5)
Correction: Renew System
Qty: 152,718.00
Unit of Measure: S.F.
Estimate: \$1,876,446.00
Assessor Name: Eduardo Lopez
Date Created: 12/05/2016

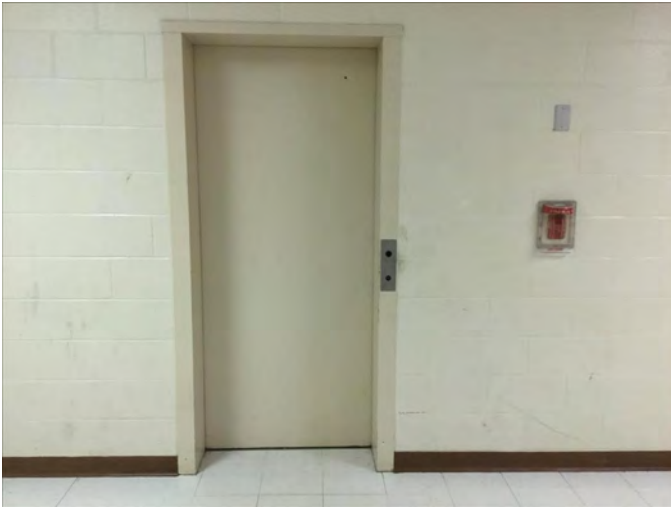
System: D1010 - Elevators and Lifts

Location: Corridor
Distress: Beyond Service Life
Category: Deferred Maintenance
Priority: 3 - Necessary/Not Yet Critical (Years 2-5)
Correction: Renew System
Qty: 152,718.00
Unit of Measure: S.F.
Estimate: \$166,310.00
Assessor Name: Eduardo Lopez
Date Created: 12/05/2016

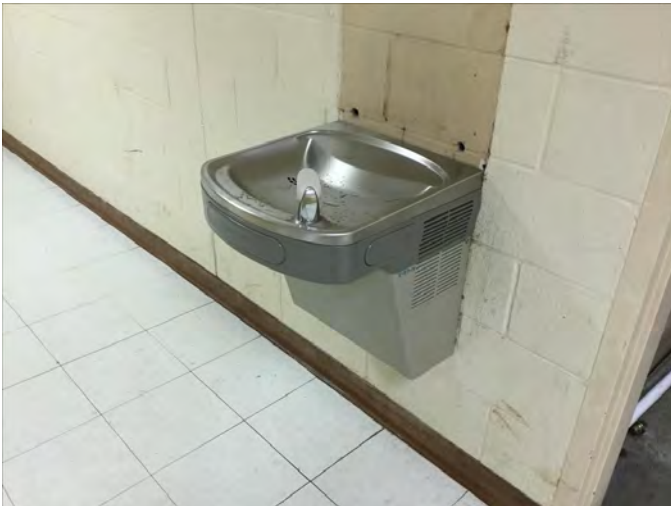
System: D2010 - Plumbing Fixtures

Location: Restroom
Distress: Beyond Service Life
Category: Deferred Maintenance
Priority: 3 - Necessary/Not Yet Critical (Years 2-5)
Correction: Renew System
Qty: 152,718.00
Unit of Measure: S.F.
Estimate: \$1,515,268.00
Assessor Name: Eduardo Lopez
Date Created: 12/05/2016

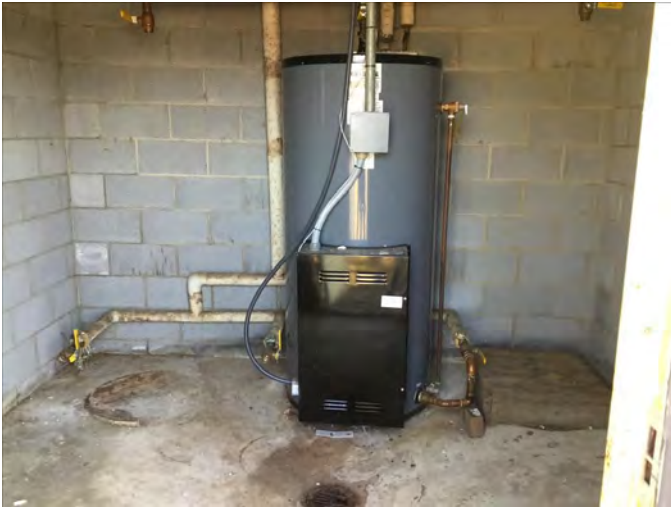
System: D2020 - Domestic Water Distribution

Location: Throughout the building
Distress: Beyond Service Life
Category: Deferred Maintenance
Priority: 3 - Necessary/Not Yet Critical (Years 2-5)
Correction: Renew System
Qty: 152,718.00
Unit of Measure: S.F.
Estimate: \$282,223.00
Assessor Name: Eduardo Lopez
Date Created: 12/05/2016

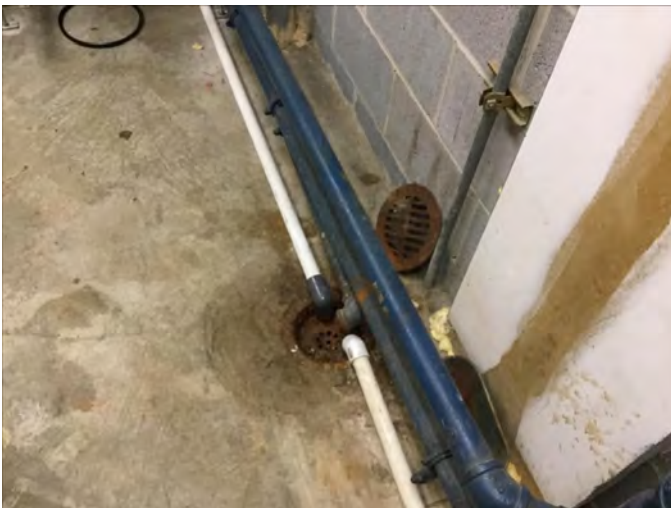
System: D2030 - Sanitary Waste

Location: Throughout the building
Distress: Beyond Service Life
Category: Deferred Maintenance
Priority: 3 - Necessary/Not Yet Critical (Years 2-5)
Correction: Renew System
Qty: 152,718.00
Unit of Measure: S.F.
Estimate: \$443,493.00
Assessor Name: Eduardo Lopez
Date Created: 12/05/2016

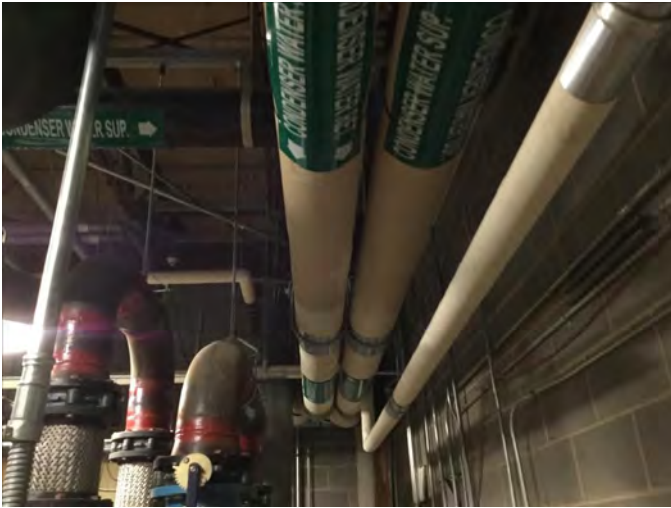
System: D3040 - Distribution Systems

Location: Throughout the building
Distress: Beyond Service Life
Category: Deferred Maintenance
Priority: 3 - Necessary/Not Yet Critical (Years 2-5)
Correction: Renew System
Qty: 152,718.00
Unit of Measure: S.F.
Estimate: \$1,434,633.00
Assessor Name: Eduardo Lopez
Date Created: 12/05/2016

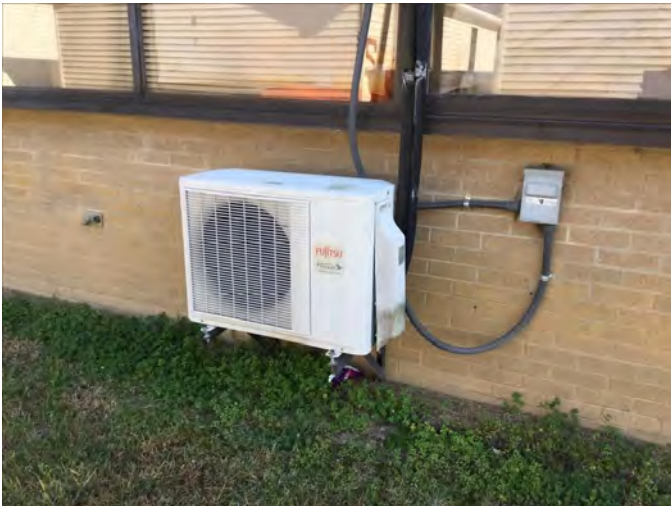
System: D3050 - Terminal & Package Units

Location: Exterior
Distress: Beyond Service Life
Category: Deferred Maintenance
Priority: 3 - Necessary/Not Yet Critical (Years 2-5)
Correction: Renew System
Qty: 152,718.00
Unit of Measure: S.F.
Estimate: \$285,583.00
Assessor Name: Eduardo Lopez
Date Created: 12/05/2016

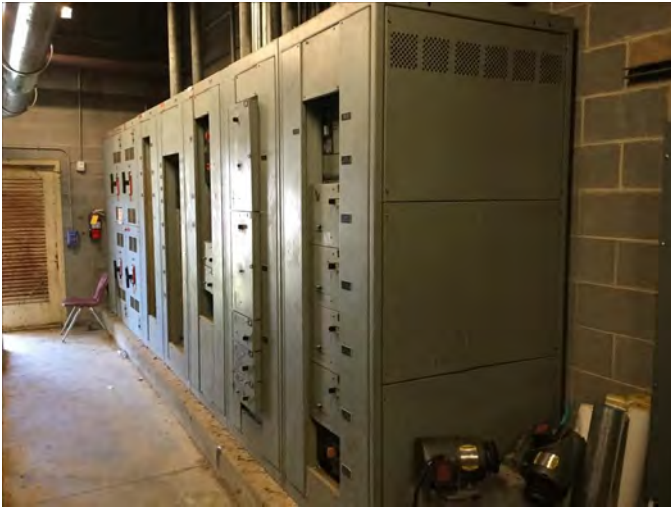
System: D5010 - Electrical Service/Distribution

Location: Throughout the building
Distress: Beyond Service Life
Category: Deferred Maintenance
Priority: 3 - Necessary/Not Yet Critical (Years 2-5)
Correction: Renew System
Qty: 152,718.00
Unit of Measure: S.F.
Estimate: \$272,143.00
Assessor Name: Eduardo Lopez
Date Created: 12/05/2016

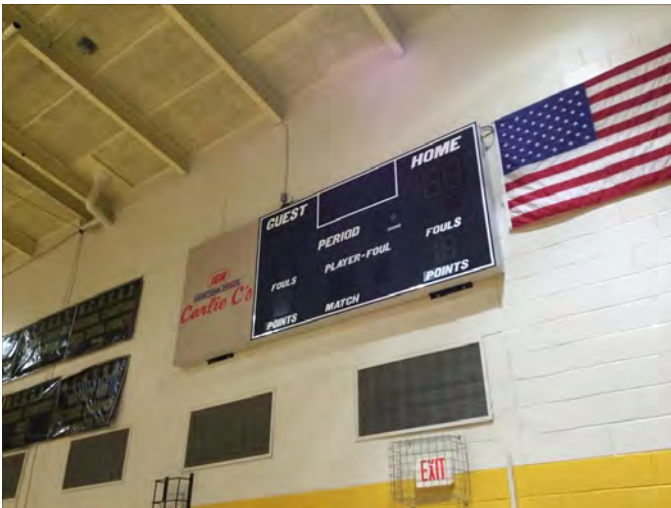
System: E1090 - Other Equipment

Location: Gym-Kitchen
Distress: Beyond Service Life
Category: Deferred Maintenance
Priority: 3 - Necessary/Not Yet Critical (Years 2-5)
Correction: Renew System
Qty: 152,718.00
Unit of Measure: S.F.
Estimate: \$1,259,924.00
Assessor Name: Eduardo Lopez
Date Created: 12/05/2016

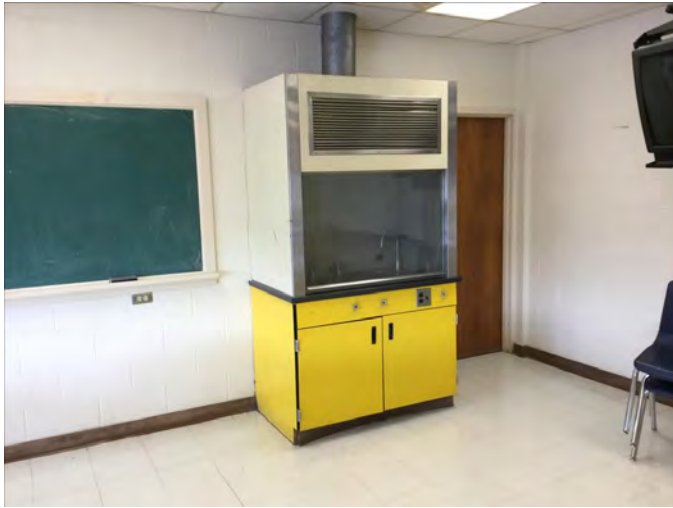
System: E2010 - Fixed Furnishings

Location: Throughout the building
Distress: Damaged
Category: Deferred Maintenance
Priority: 3 - Necessary/Not Yet Critical (Years 2-5)
Correction: Renew System
Qty: 152,718.00
Unit of Measure: S.F.
Estimate: \$853,388.00
Assessor Name: Eduardo Lopez
Date Created: 12/05/2016

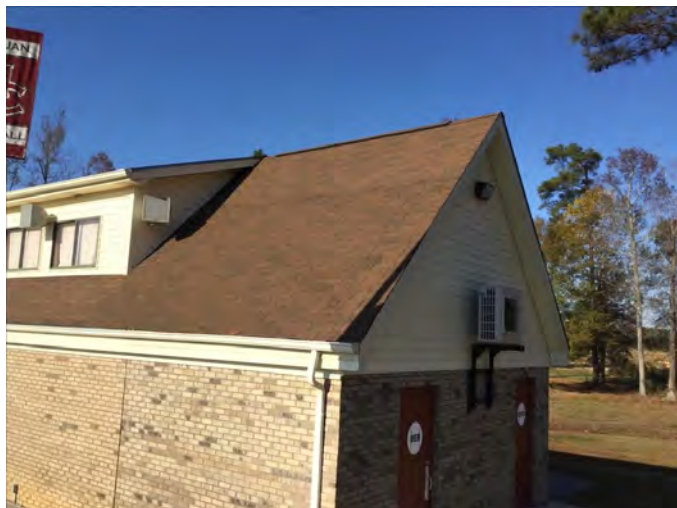
System: B3010140 - Asphalt Shingles

Location: Roof
Distress: Damaged
Category: Deferred Maintenance
Priority: 3 - Necessary/Not Yet Critical (Years 2-5)
Correction: Renew System
Qty: 1,200.00
Unit of Measure: S.F.
Estimate: \$7,569.00
Assessor Name: Terence Davis
Date Created: 11/18/2016

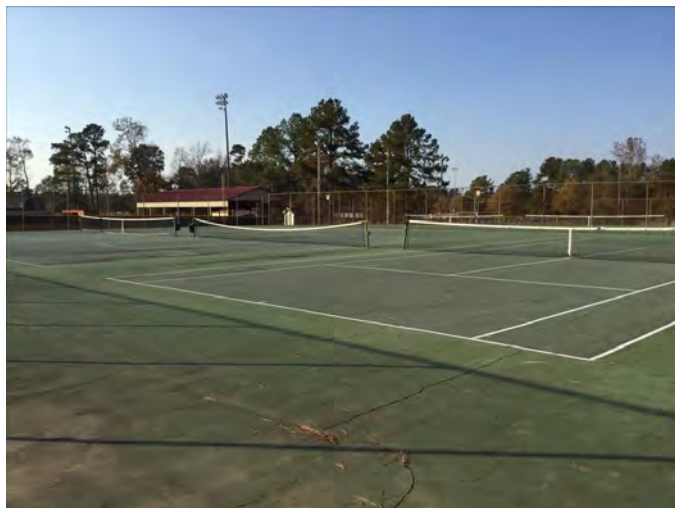
Location: East of the school
Distress: Damaged
Category: Safety
Priority: 1 - Currently Critical (Immediate)
Correction: Renew System
Qty: 208,181.00
Unit of Measure: S.F.
Estimate: \$412,198.00
Assessor Name: Eduardo Lopez
Date Created: 11/22/2016
