NC School District/430 Harnett County/High School

Western Harnett High

Campus Assessment Report

March 11, 2017

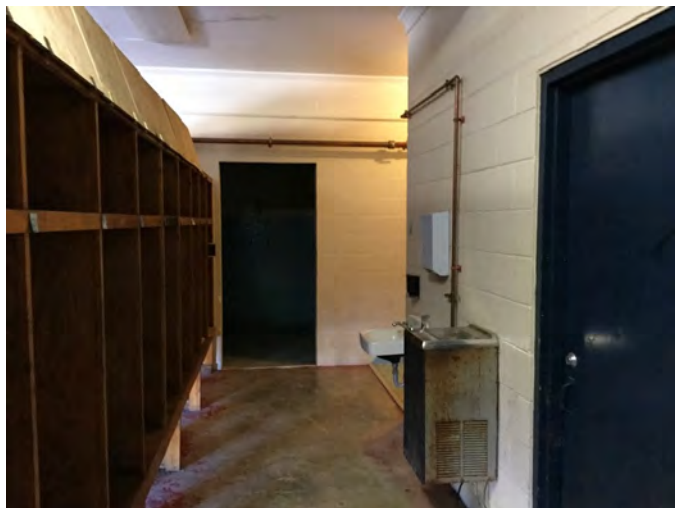
System: D5090 - Other Electrical Systems

Location: Throughout the building
Distress: Missing
Category: Building Code Compliance
Priority: 2 - Potentially Critical (Year 1)
Correction: Renew System
Qty: 3,200.00
Unit of Measure: S.F.
Estimate: \$2,358.00
Assessor Name: Eduardo Lopez
Date Created: 02/27/2017

Notes: Other electric systems is missing and should be provided to include; emergency lighting and illuminated exit signs.

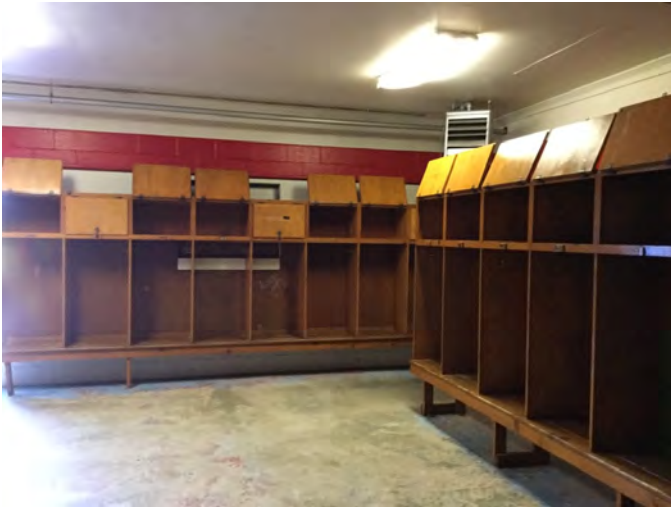
System: C1030 - Fittings

Location: Throughout the Building
Distress: Beyond Service Life
Category: Deferred Maintenance / Accessibility Code Compliance
Priority: 3 - Necessary/Not Yet Critical (Years 2-5)
Correction: Renew System
Qty: 3,200.00
Unit of Measure: S.F.
Estimate: \$29,814.00
Assessor Name: Eduardo Lopez
Date Created: 11/23/2016

Notes: The fittings throughout the building are aged, in marginal condition, and are not ADA compliant and should be replaced.

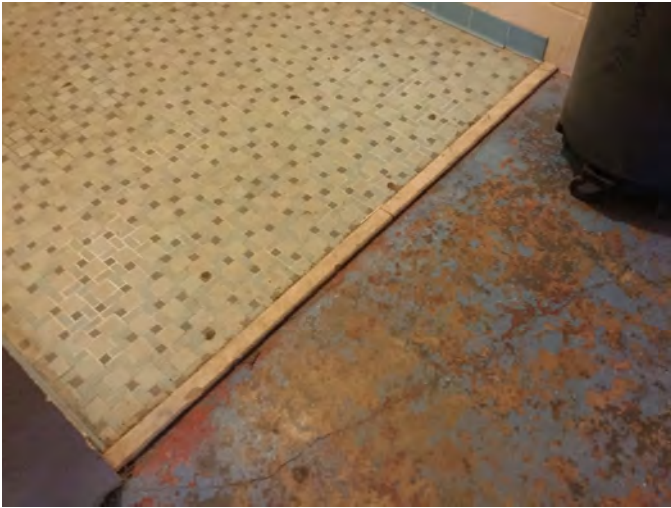
System: C3020 - Floor Finishes

Location: Throughout the Building
Distress: Beyond Service Life
Category: Deferred Maintenance
Priority: 3 - Necessary/Not Yet Critical (Years 2-5)
Correction: Renew System
Qty: 3,200.00
Unit of Measure: S.F.
Estimate: \$44,845.00
Assessor Name: Eduardo Lopez
Date Created: 11/23/2016

Notes: The original flooring is in poor conditions and should be replaced.

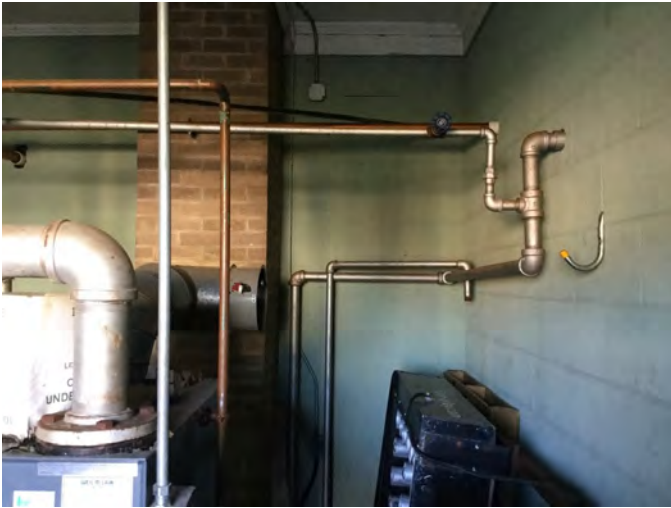
System: D3040 - Distribution Systems

Location: Throughout the Building
Distress: Beyond Service Life
Category: Deferred Maintenance
Priority: 3 - Necessary/Not Yet Critical (Years 2-5)
Correction: Renew System
Qty: 3,200.00
Unit of Measure: S.F.
Estimate: \$18,832.00
Assessor Name: Eduardo Lopez
Date Created: 11/23/2016

Notes: Distribution systems are aged, becoming logistically unsupportable, and should be replaced.

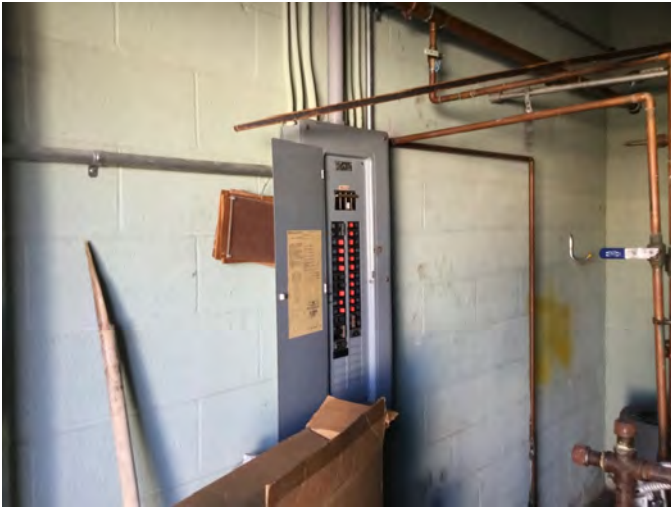
System: D5010 - Electrical Service/Distribution

Location: Throughout the Building
Distress: Beyond Service Life
Category: Deferred Maintenance
Priority: 3 - Necessary/Not Yet Critical (Years 2-5)
Correction: Renew System
Qty: 3,200.00
Unit of Measure: S.F.
Estimate: \$5,174.00
Assessor Name: Eduardo Lopez
Date Created: 11/23/2016

Notes: The original electrical service is operating but is in poor condition and should be replaced.

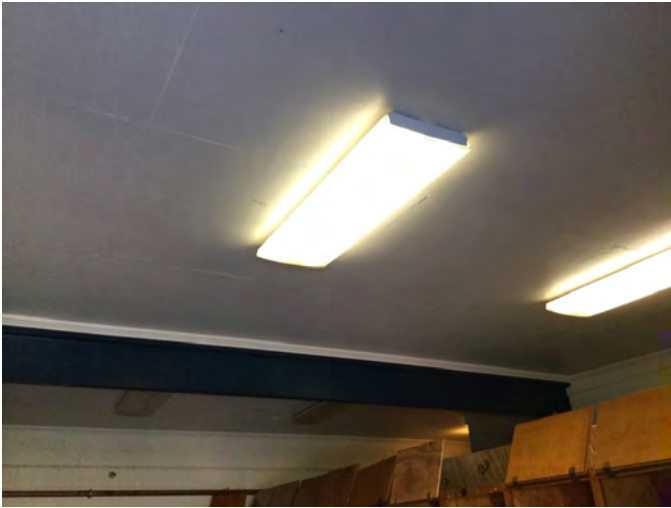
System: D5020 - Lighting

Location: Throughout the Building
Distress: Beyond Service Life
Category: Deferred Maintenance / Energy
Priority: 3 - Necessary/Not Yet Critical (Years 2-5)
Correction: Renew System
Qty: 3,200.00
Unit of Measure: S.F.
Estimate: \$12,602.00
Assessor Name: Eduardo Lopez
Date Created: 11/23/2016

Notes: The original lighting system is operating, but is aged, in poor condition, and should be replaced.

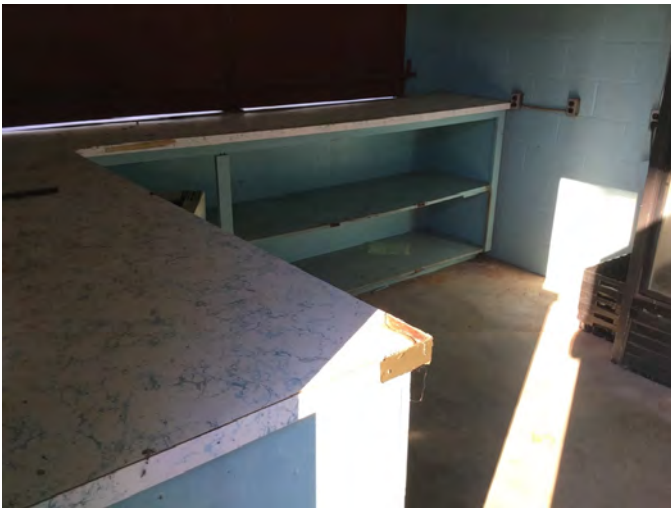
System: E2010 - Fixed Furnishings

Location: Throughout the Building
Distress: Beyond Service Life
Category: Deferred Maintenance
Priority: 3 - Necessary/Not Yet Critical (Years 2-5)
Correction: Renew System
Qty: 3,200.00
Unit of Measure: S.F.
Estimate: \$17,882.00
Assessor Name: Eduardo Lopez
Date Created: 11/23/2016

Notes: The fixed furnishings are aged, in marginal condition, damaged, and should be replaced.

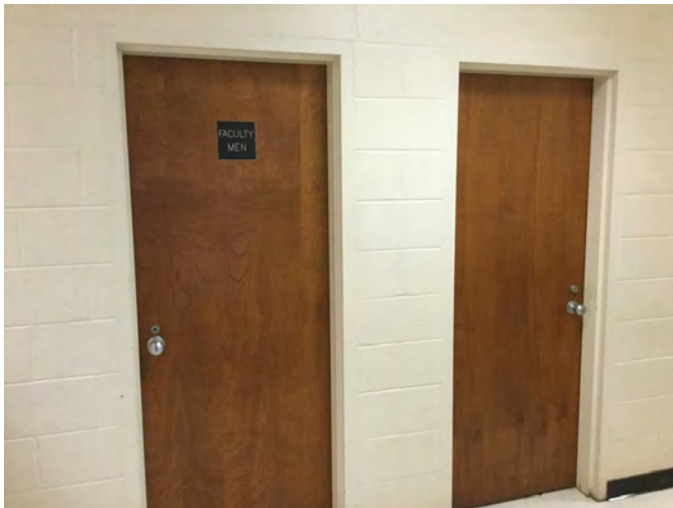
System: C1020 - Interior Doors

Location: Throughout the Building
Distress: Beyond Service Life
Category: Deferred Maintenance / Accessibility Code Compliance
Priority: 3 - Necessary/Not Yet Critical (Years 2-5)
Correction: Renew System
Qty: 130,900.00
Unit of Measure: S.F.
Estimate: \$351,336.00
Assessor Name: Eduardo Lopez
Date Created: 11/16/2016

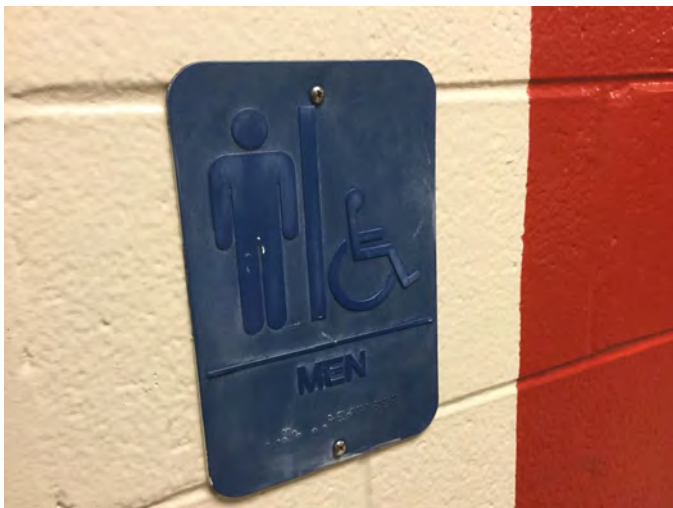
System: C1030 - Fittings

Location: Throughout the Building
Distress: Beyond Service Life
Category: Deferred Maintenance / Accessibility Code Compliance
Priority: 3 - Necessary/Not Yet Critical (Years 2-5)
Correction: Renew System
Qty: 130,900.00
Unit of Measure: S.F.
Estimate: \$213,105.00
Assessor Name: Eduardo Lopez
Date Created: 11/16/2016

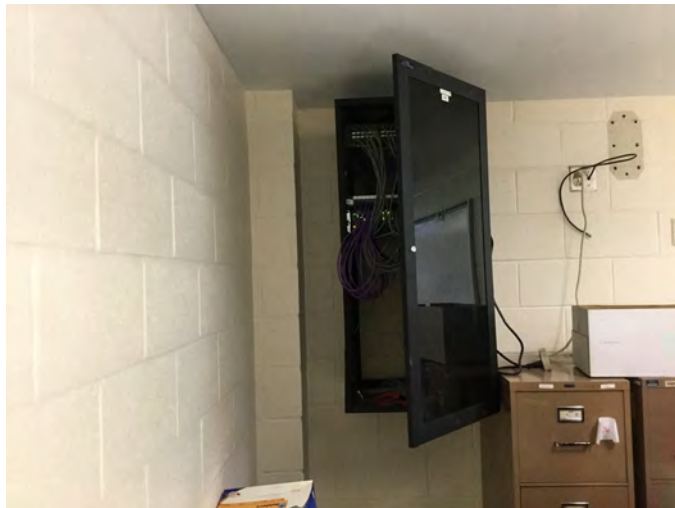
System: D5030920 - Data Communication

Location: Throughout the Building
Distress: Beyond Service Life
Category: Deferred Maintenance
Priority: 3 - Necessary/Not Yet Critical (Years 2-5)
Correction: Renew System
Qty: 63,917.00
Unit of Measure: S.F.
Estimate: \$324,123.00
Assessor Name: Eduardo Lopez
Date Created: 11/17/2016

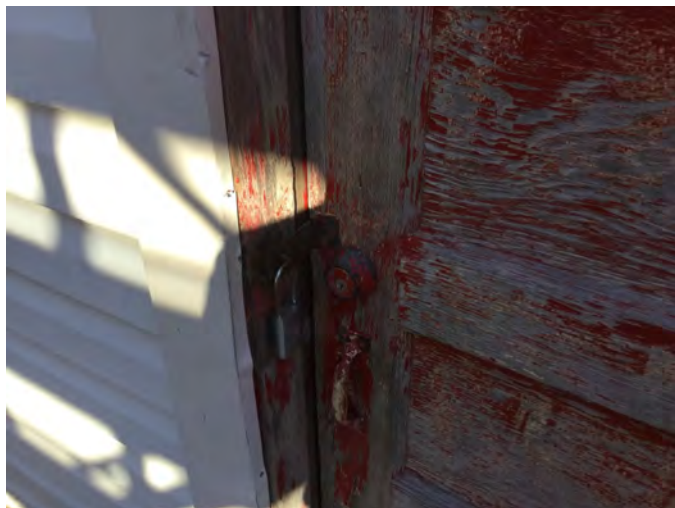
System: B2030 - Exterior Doors

Location: Exterior Walls
Distress: Beyond Service Life
Category: Deferred Maintenance
Priority: 2 - Potentially Critical (Year 1)
Correction: Renew System
Qty: 720.00
Unit of Measure: S.F.
Estimate: \$6,859.00
Assessor Name: Eduardo Lopez
Date Created: 11/23/2016

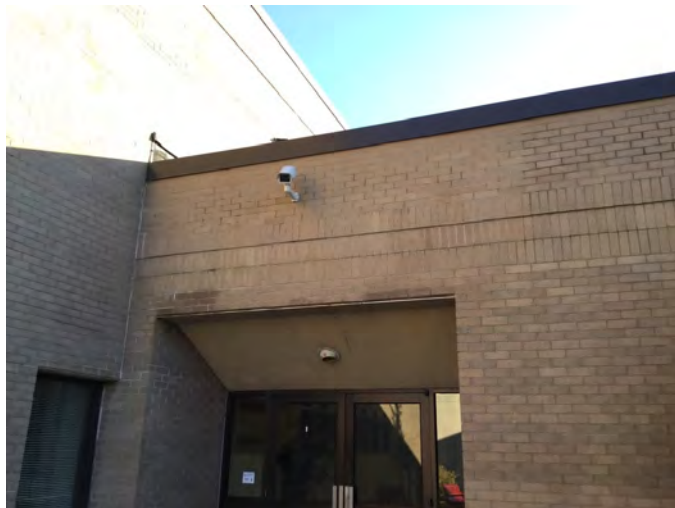
Location: Site
Distress: Beyond Service Life
Category: Deferred Maintenance
Priority: 3 - Necessary/Not Yet Critical (Years 2-5)
Correction: Renew System
Qty: 204,686.00
Unit of Measure: S.F.
Estimate: \$198,136.00
Assessor Name: Eduardo Lopez
Date Created: 12/06/2016
