NC School District/430 Harnett County/Middle School

Dunn Middle

Campus Assessment Report

March 11, 2017

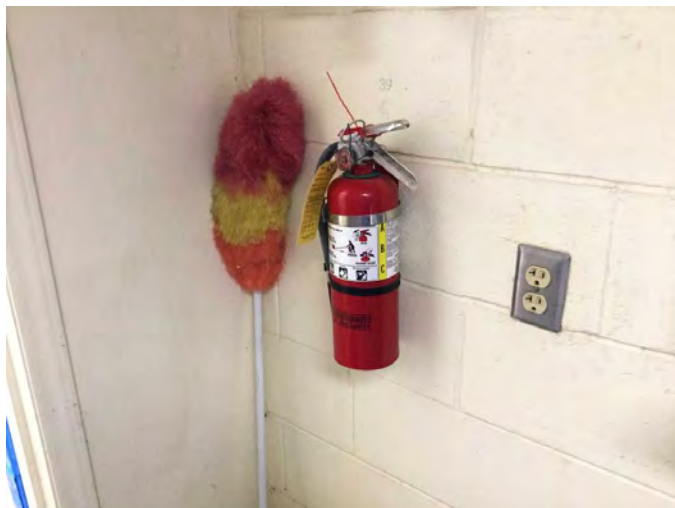
System: D5030910 - Fire Alarm Systems

Location: Throughout
Distress: Missing
Category: Life Safety Code Compliance
Priority: 1 - Currently Critical (Immediate)
Correction: Renew System
Qty: 832.00
Unit of Measure: S.F.
Estimate: \$1,107.00
Assessor Name: Matt Mahaffey
Date Created: 11/17/2016

Notes: Add fire alarm system.

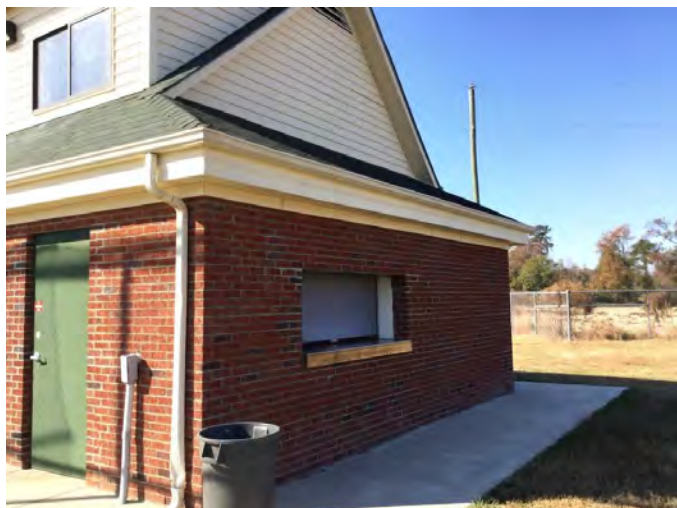
System: D5030810 - Security & Detection Systems

Location: Throughout
Distress: Missing
Category: Safety
Priority: 2 - Potentially Critical (Year 1)
Correction: Renew System
Qty: 832.00
Unit of Measure: Ea.
Estimate: \$915.00
Assessor Name: Matt Mahaffey
Date Created: 11/17/2016

Notes: Add security system and integrate into main system.

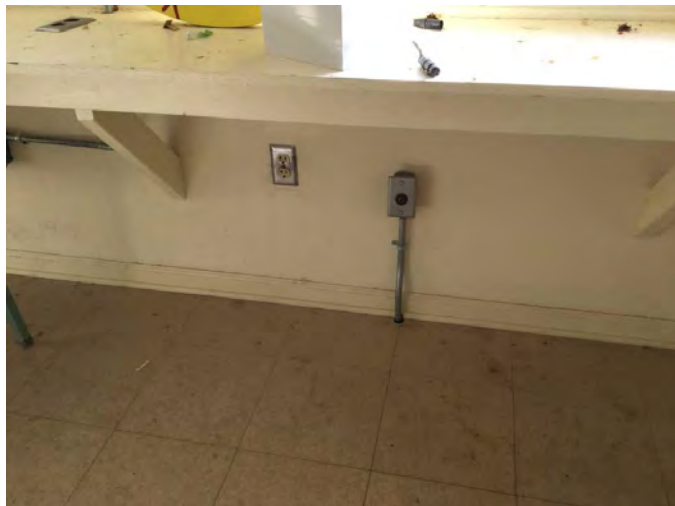
System: D5030920 - Data Communication

Location: Consession
Distress: Inadequate
Category: Deferred Maintenance
Priority: 3 - Necessary/Not Yet Critical (Years 2-5)
Correction: Renew System
Qty: 832.00
Unit of Measure: S.F.
Estimate: \$2,279.00
Assessor Name: Matt Mahaffey
Date Created: 11/17/2016

Notes: Communication to building is limited, replace system.

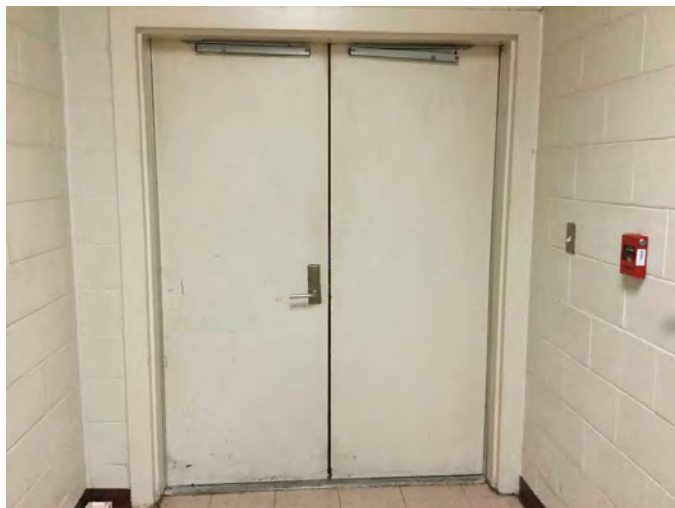
System: D5030810 - Security & Detection Systems

Location: Throughout
Distress: Beyond Service Life
Category: Deferred Maintenance
Priority: 2 - Potentially Critical (Year 1)
Correction: Renew System
Qty: 118,861.00
Unit of Measure: S.F.
Estimate: \$296,796.00
Assessor Name: Matt Mahaffey
Date Created: 11/17/2016

Notes: Security cameras are analog and beginning to fail.
No door alarms or card access for exterior doors. Upgrade system.

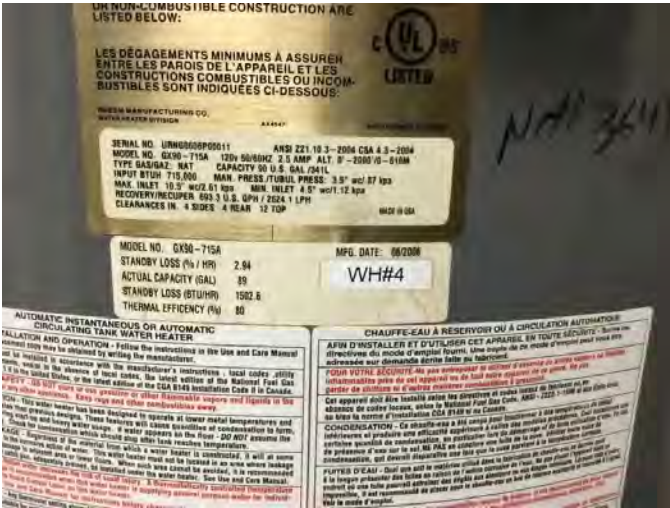
System: D2020 - Domestic Water Distribution

Location: Throughout
Distress: Beyond Service Life
Category: Deferred Maintenance
Priority: 3 - Necessary/Not Yet Critical (Years 2-5)
Correction: Replace water heater, electric, 120 gallon
Qty: 6.00
Unit of Measure: Ea.
Estimate: \$129,096.00
Assessor Name: Matt Mahaffey
Date Created: 11/23/2016

Notes: Water heaters are beyond service life and beginning to fail. Replace.

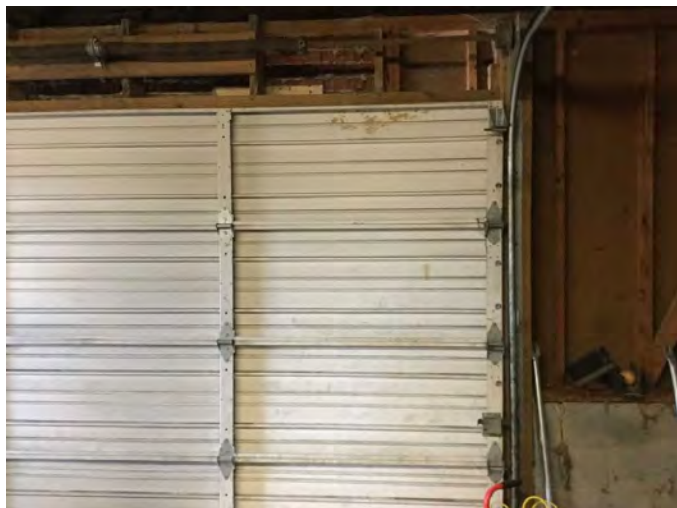
System: B2030 - Exterior Doors

Location: Ext. doors
Distress: Damaged
Category: Deferred Maintenance / Appearance
Priority: 3 - Necessary/Not Yet Critical (Years 2-5)
Correction: Repair aluminum frame and door
Qty: 1.00
Unit of Measure: Ea.
Estimate: \$6,025.35
Assessor Name: Terence Davis
Date Created: 11/23/2016

Notes: Exterior door and roll up door have been damaged by vandalism. Replace

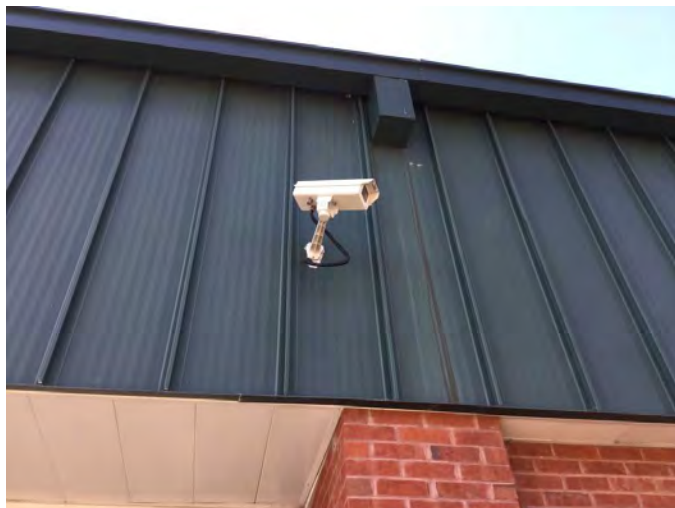
System: G4030 - Site Communications & Security

Location: Throughout
Distress: Beyond Service Life
Category: Deferred Maintenance
Priority: 3 - Necessary/Not Yet Critical (Years 2-5)
Correction: Renew System
Qty: 120,851.00
Unit of Measure: S.F.
Estimate: \$116,984.00
Assessor Name: Matt Mahaffey
Date Created: 11/17/2016

Notes: Security system cameras are analog and beginning to fail. Replace
