NC School District/430 Harnett County/Middle School

Harnett Central Middle

Campus Assessment Report

March 11, 2017

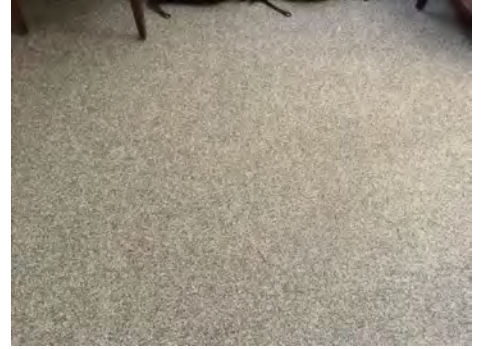
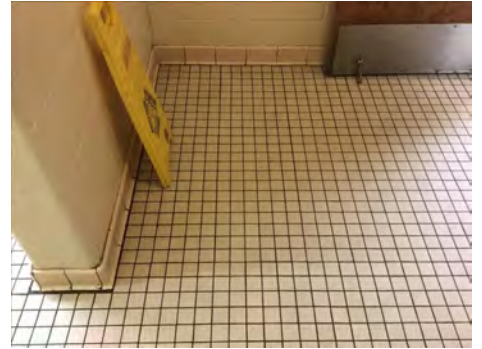
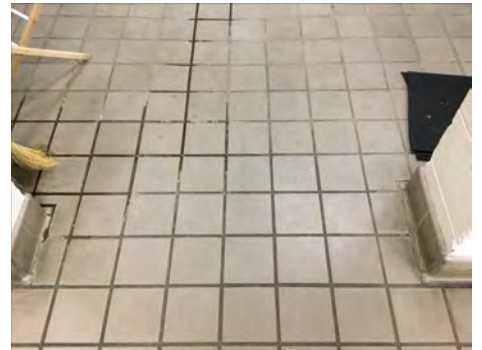
System: C3020 - Floor Finishes

Note: VCT and carpet is original and needs to be replaced.

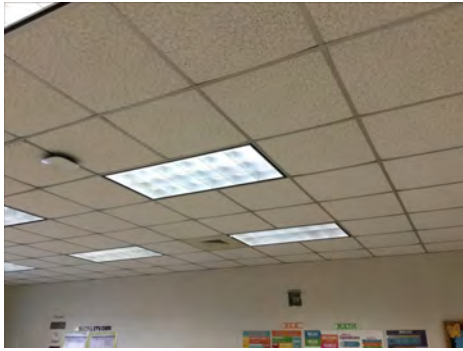
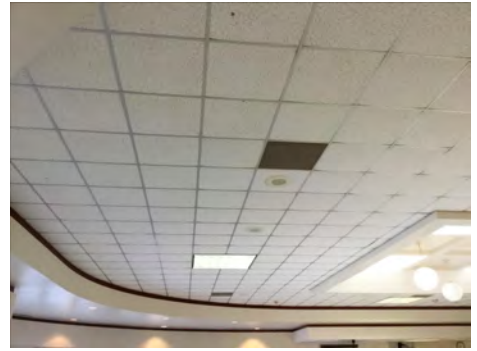
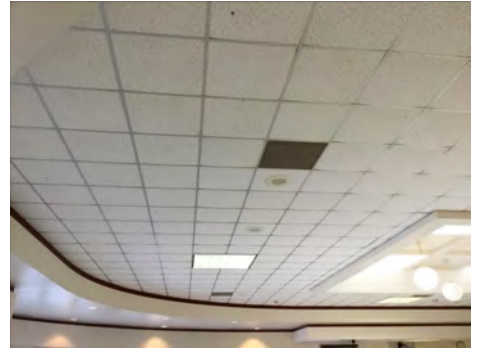
System: C3030 - Ceiling Finishes

Note: ACT Tiles needs to be replaced

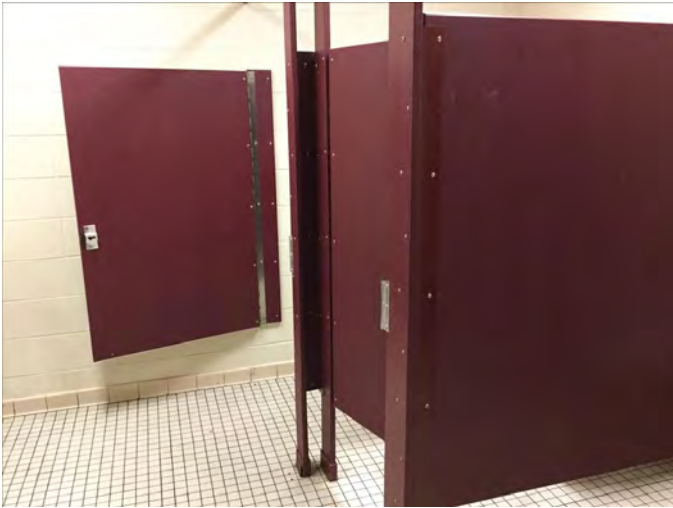
System: C1030 - Fittings

Location: Throughout Building
Distress: Beyond Service Life
Category: Deferred Maintenance / Appearance
Priority: 3 - Necessary/Not Yet Critical (Years 2-5)
Correction: Renew System
Qty: 142,358.00
Unit of Measure: S.F.
Estimate: \$2,052,945.00
Assessor Name: Eduardo Lopez
Date Created: 11/15/2016

Notes: The fittings are beyond its service life and should be replaced.

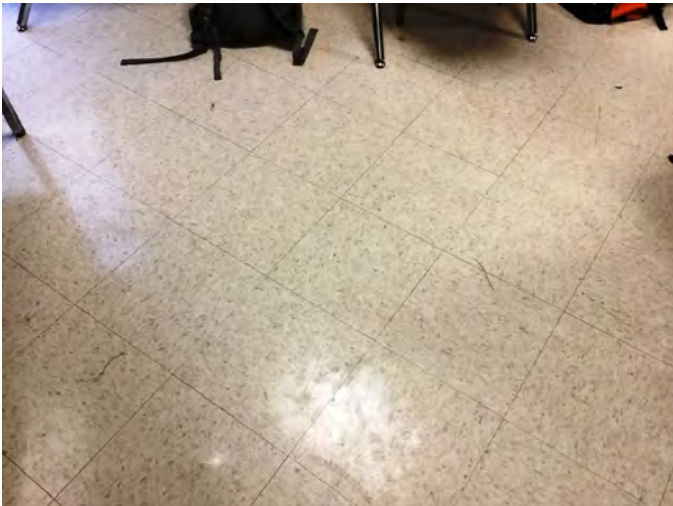
System: C3020 - Floor Finishes

Location: Throughout Building
Distress: Beyond Service Life
Category: Deferred Maintenance
Priority: 3 - Necessary/Not Yet Critical (Years 2-5)
Correction: Replace vinyl tile flooring
Qty: 4,072.00
Unit of Measure: S.Y.
Estimate: \$437,797.01
Assessor Name: Eduardo Lopez
Date Created: 11/15/2016

Notes: The vinyl flooring is beyond its service life and should be replaced.

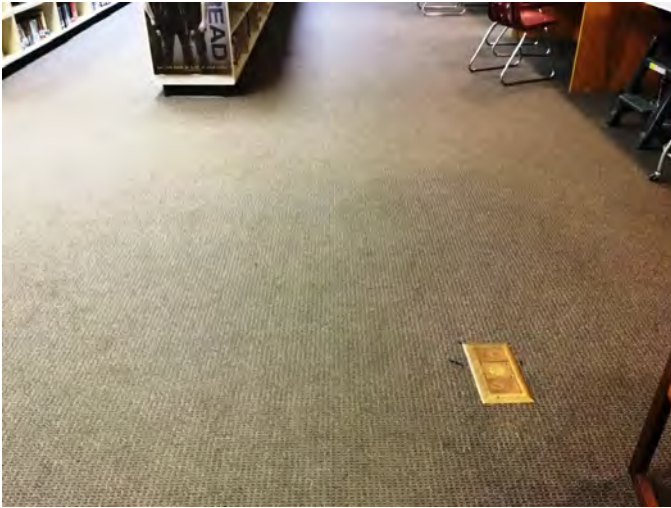
System: C3020 - Floor Finishes

Location: Throughout Building
Distress: Beyond Service Life
Category: Deferred Maintenance
Priority: 3 - Necessary/Not Yet Critical (Years 2-5)
Correction: Replace carpet
Qty: 948.88
Unit of Measure: S.Y.
Estimate: \$81,113.30
Assessor Name: Eduardo Lopez
Date Created: 11/15/2016

Notes: The carpet is beyond its service life and should be replaced.

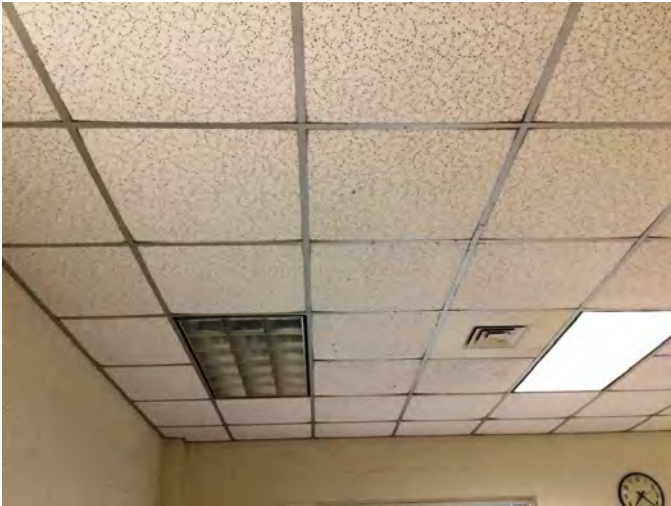
System: C3030 - Ceiling Finishes

Location: Throughout Building
Distress: Beyond Service Life
Category: Deferred Maintenance
Priority: 3 - Necessary/Not Yet Critical (Years 2-5)
Correction: Replace acoustic tile ceiling, fire-rated
Qty: 1,138.86
Unit of Measure: C.S.F.
Estimate: \$323,509.12
Assessor Name: Eduardo Lopez
Date Created: 11/15/2016

Notes: The acoustical ceiling tiles are beyond service life due to moisture and age, and the tiles should be replaced.

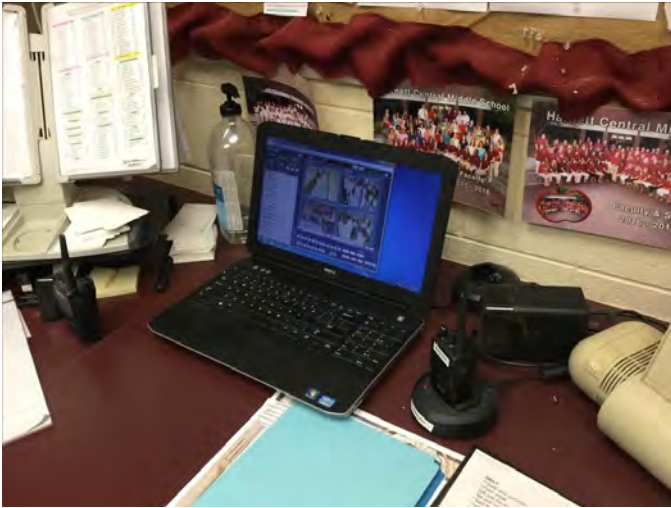
System: D5030810 - Security & Detection Systems

Location: Throughout Building
Distress: Beyond Service Life
Category: Deferred Maintenance
Priority: 3 - Necessary/Not Yet Critical (Years 2-5)
Correction: Renew System
Qty: 142,358.00
Unit of Measure: S.F.
Estimate: \$355,468.00
Assessor Name: Eduardo Lopez
Date Created: 11/15/2016

Notes: The security system is beyond its service life and inadequate and should be replaced.

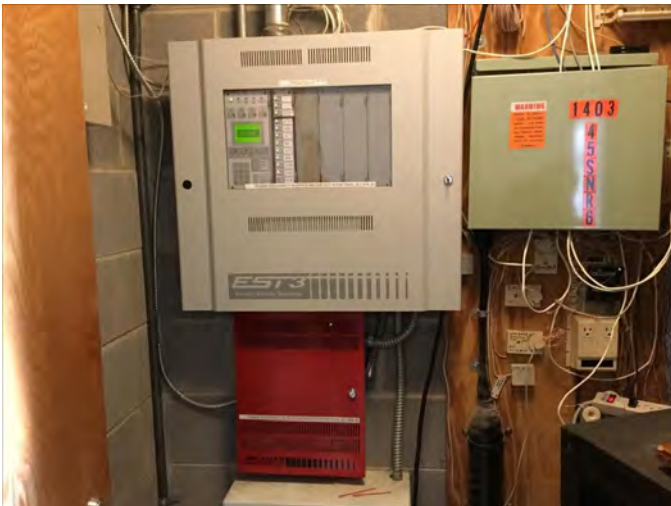
System: D5030910 - Fire Alarm Systems

Location: Throughout Building
Distress: Beyond Service Life
Category: Deferred Maintenance / Building Code Compliance
Priority: 3 - Necessary/Not Yet Critical (Years 2-5)
Correction: Renew System
Qty: 142,358.00
Unit of Measure: S.F.
Estimate: \$643,601.00
Assessor Name: Eduardo Lopez
Date Created: 11/15/2016

Notes: The fire alarm system is beyond its service life and should be replaced.

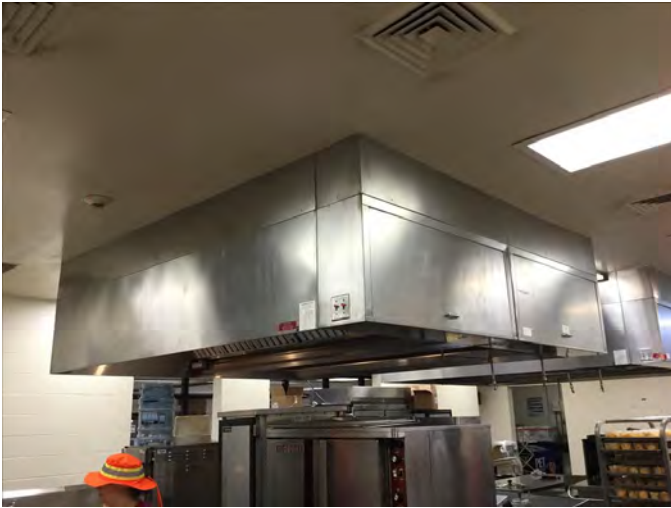
System: E1090 - Other Equipment

Location: Cafeteria
Distress: Beyond Service Life
Category: Deferred Maintenance
Priority: 3 - Necessary/Not Yet Critical (Years 2-5)
Correction: Renew System
Qty: 142,358.00
Unit of Measure: S.F.
Estimate: \$1,067,970.00
Assessor Name: Eduardo Lopez
Date Created: 11/15/2016

Notes: The kitchen equipment is beyond its service life and should be replaced.

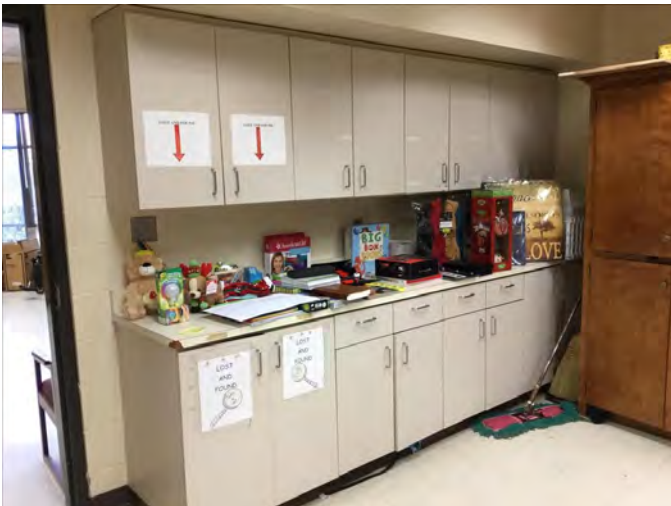
System: E2010 - Fixed Furnishings

Location: Throughout Building
Distress: Beyond Service Life
Category: Deferred Maintenance / Appearance
Priority: 3 - Necessary/Not Yet Critical (Years 2-5)
Correction: Renew System
Qty: 142,358.00
Unit of Measure: S.F.
Estimate: \$853,436.00
Assessor Name: Eduardo Lopez
Date Created: 11/15/2016

Notes: The fixed furnishing is beyond service life and should be replaced.

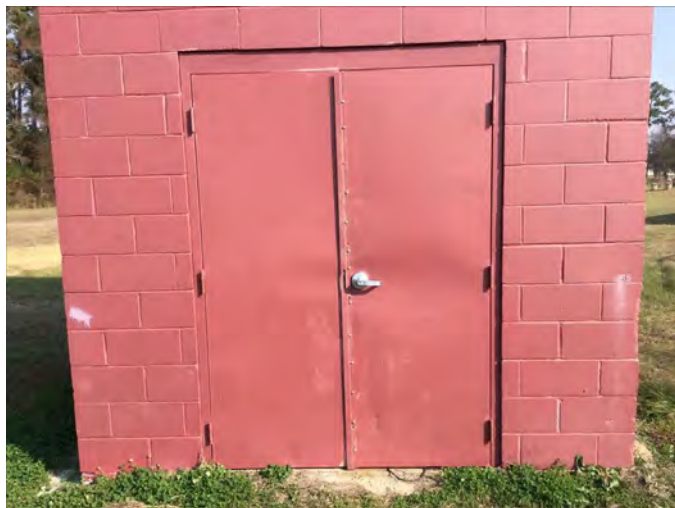
System: B2030 - Exterior Doors

Location: Exterior of the building
Distress: Damaged
Category: Deferred Maintenance / Building Code Compliance
Priority: 3 - Necessary/Not Yet Critical (Years 2-5)
Correction: Renew System
Qty: 200.00
Unit of Measure: S.F.
Estimate: \$1,905.00
Assessor Name: Eduardo Lopez
Date Created: 11/16/2016

Notes: The exterior door is rusted and damaged and should be replaced.

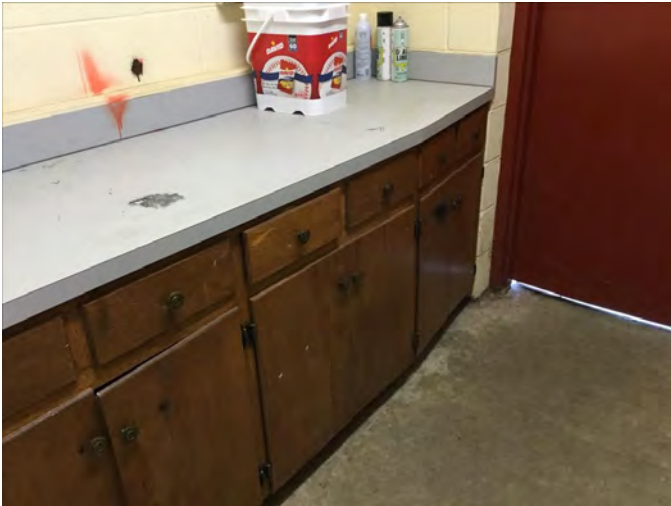
System: E2010 - Fixed Furnishings

Location: Throughout Building
Distress: Beyond Service Life
Category: Deferred Maintenance
Priority: 3 - Necessary/Not Yet Critical (Years 2-5)
Correction: Renew System
Qty: 832.00
Unit of Measure: S.F.
Estimate: \$9,765.00
Assessor Name: Somnath Das
Date Created: 11/16/2016

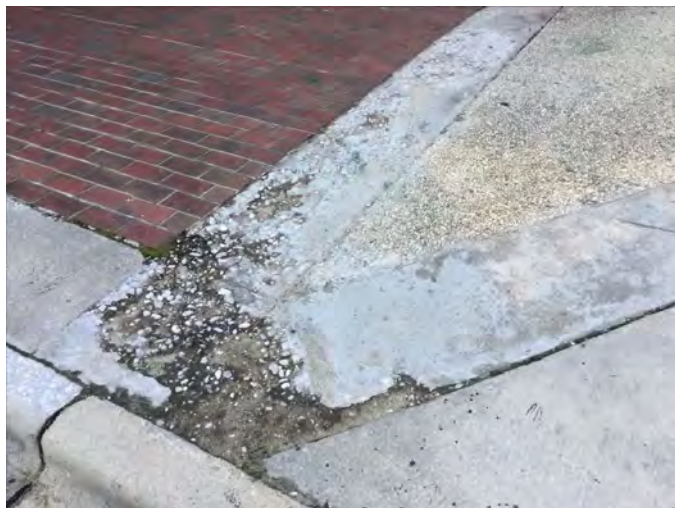
System: G2030 - Pedestrian Paving

Location: Site
Distress: Failing
Category: Safety
Priority: 3 - Necessary/Not Yet Critical (Years 2-5)
Correction: Renew System
Qty: 143,390.00
Unit of Measure: S.F.
Estimate: \$312,303.00
Assessor Name: Eduardo Lopez
Date Created: 11/16/2016
