NC School District/430 Harnett County/Middle School

# Western Harnett Middle

## Campus Assessment Report

March 11, 2017

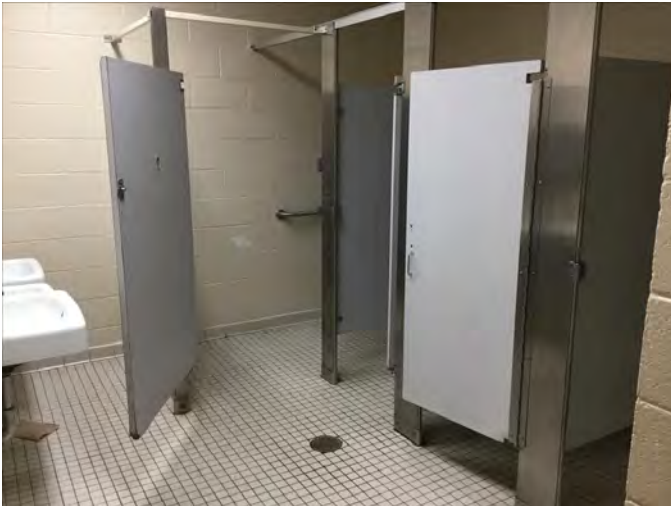
#### **System: C1030 - Fittings**

**Location:** Restroom  
**Distress:** Beyond Service Life  
**Category:** Deferred Maintenance  
**Priority:** 3 - Necessary/Not Yet Critical (Years 2-5)  
**Correction:** Renew System  
**Qty:** 142,358.00  
**Unit of Measure:** S.F.  
**Estimate:** \$234,891.00  
**Assessor Name:** Somnath Das  
**Date Created:** 12/07/2016

**Notes:** The fittings throughout the building are aged, in marginal condition, and should be replaced.

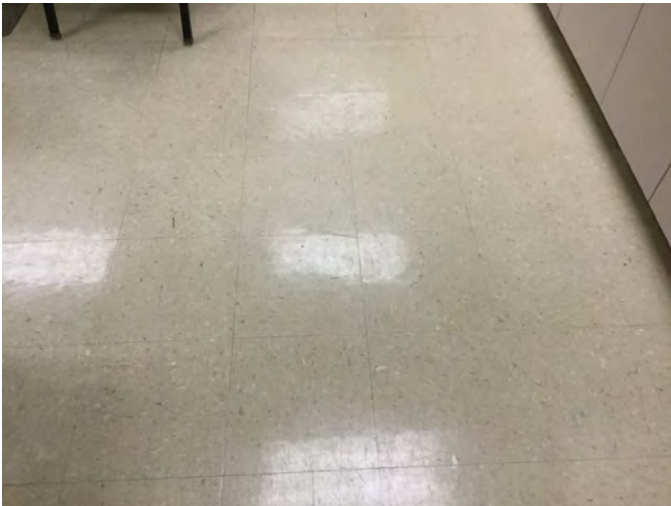
#### **System: C3020 - Floor Finishes**

**Location:** Cafeteria-Classrooms  
**Distress:** Damaged  
**Category:** Deferred Maintenance  
**Priority:** 3 - Necessary/Not Yet Critical (Years 2-5)  
**Correction:** Replace vinyl tile flooring  
**Qty:** 3,163.00  
**Unit of Measure:** S.Y.  
**Estimate:** \$340,066.78  
**Assessor Name:** Somnath Das  
**Date Created:** 12/07/2016

**Notes:** The VCT flooring is aged, cracked, worn, and should be replaced.

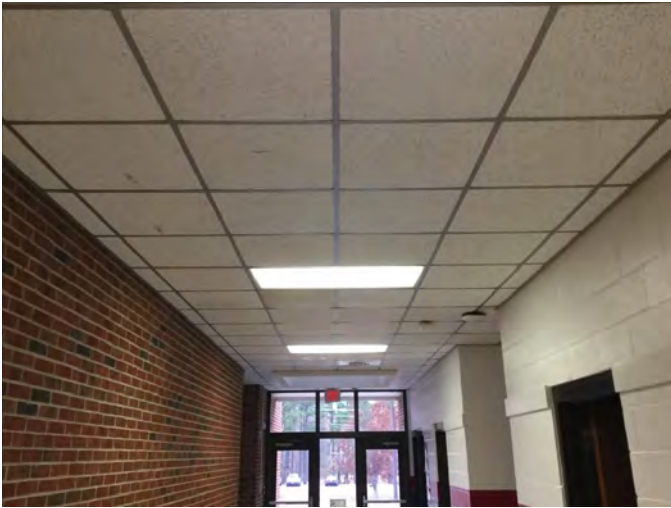
**System: C3030 - Ceiling Finishes**

**Location:** Throughout the building  
**Distress:** Damaged  
**Category:** Deferred Maintenance  
**Priority:** 3 - Necessary/Not Yet Critical (Years 2-5)  
**Correction:** Renew System  
**Qty:** 142,358.00  
**Unit of Measure:** S.F.  
**Estimate:** \$1,686,515.00  
**Assessor Name:** Somnath Das  
**Date Created:** 12/07/2016

**Notes:** The ceiling tiles have been replaced as needed. However the grid shows signs of aging and the tiles are sagging or damaged and should be replaced.

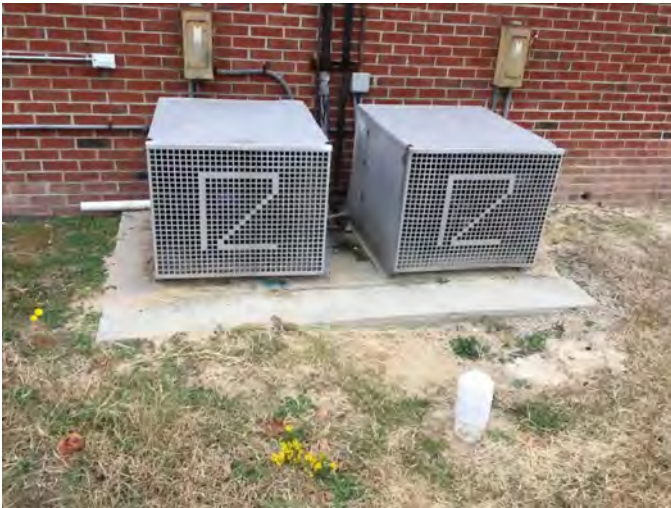
**System: D3050 - Terminal & Package Units**

**Location:** Exterior  
**Distress:** Beyond Service Life  
**Category:** Deferred Maintenance  
**Priority:** 3 - Necessary/Not Yet Critical (Years 2-5)  
**Correction:** Renew System  
**Qty:** 142,358.00  
**Unit of Measure:** S.F.  
**Estimate:** \$782,969.00  
**Assessor Name:** Somnath Das  
**Date Created:** 12/07/2016

**Notes:** The pad mounted DX condensing units are aged and should be scheduled for replacement.

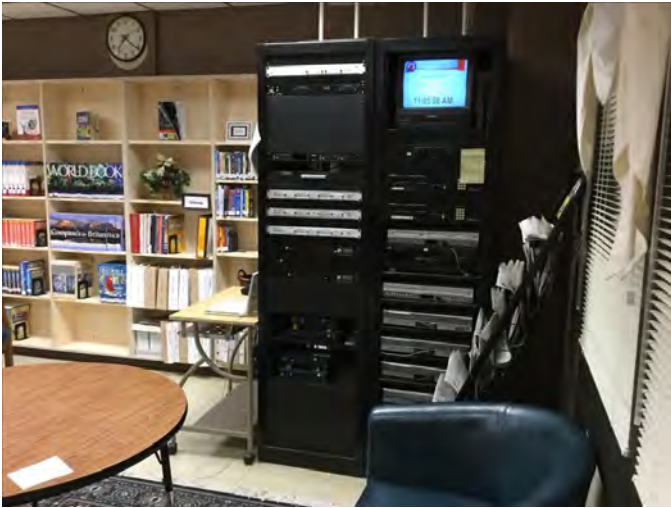
**System: D5030810 - Security & Detection Systems**

**Location:** Throughout the building  
**Distress:** Beyond Service Life  
**Category:** Deferred Maintenance  
**Priority:** 3 - Necessary/Not Yet Critical (Years 2-5)  
**Correction:** Renew System  
**Qty:** 142,358.00  
**Unit of Measure:** S.F.  
**Estimate:** \$314,754.00  
**Assessor Name:** Somnath Das  
**Date Created:** 12/07/2016

**Notes:** The security system is aged, has poor coverage and camera resolution, and should be replaced.

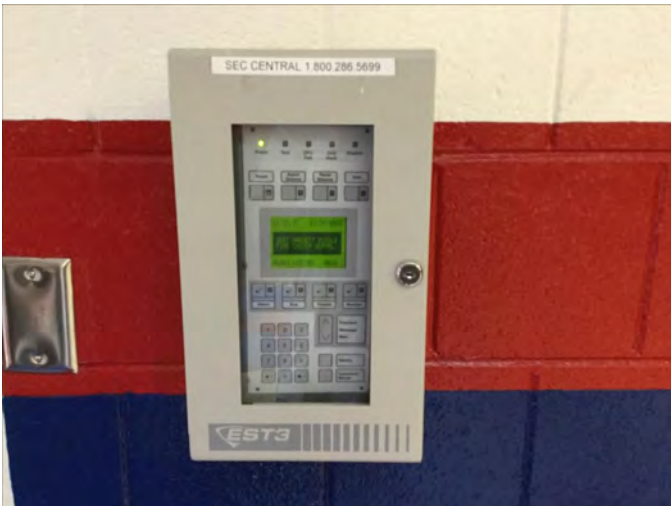
**System: D5030910 - Fire & Alarm Systems**

**Location:** Throughout the building  
**Distress:** Beyond Service Life  
**Category:** Deferred Maintenance  
**Priority:** 3 - Necessary/Not Yet Critical (Years 2-5)  
**Correction:** Renew System  
**Qty:** 142,358.00  
**Unit of Measure:** S.F.  
**Estimate:** \$570,001.00  
**Assessor Name:** Somnath Das  
**Date Created:** 12/07/2016

**Notes:** The original fire alarm system operating as designed, but is beyond its service life and should be replaced.

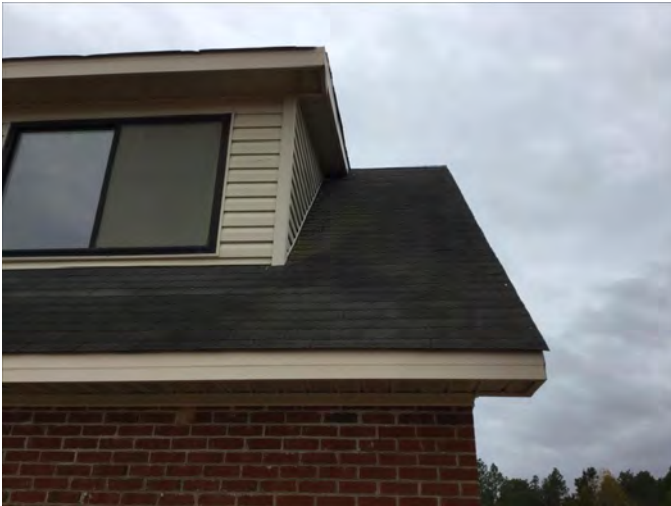
#### System: B3010140 - Asphalt Shingles

**Location:** Roof  
**Distress:** Beyond Service Life  
**Category:** Deferred Maintenance  
**Priority:** 3 - Necessary/Not Yet Critical (Years 2-5)  
**Correction:** Renew System  
**Qty:** 832.00  
**Unit of Measure:** S.F.  
**Estimate:** \$5,248.00  
**Assessor Name:** Terence Davis  
**Date Created:** 12/07/2016

**Notes:** There are shingles missing. The roof should be replaced.

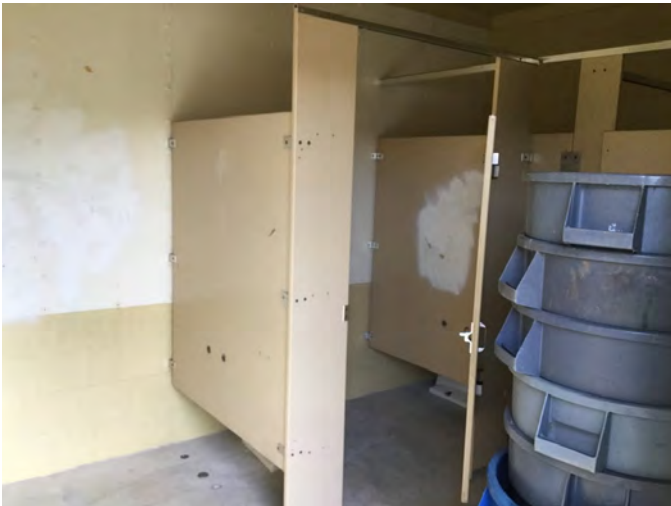
#### System: C1030 - Fittings

**Location:** Restroom  
**Distress:** Damaged  
**Category:** Deferred Maintenance  
**Priority:** 3 - Necessary/Not Yet Critical (Years 2-5)  
**Correction:** Renew System  
**Qty:** 832.00  
**Unit of Measure:** S.F.  
**Estimate:** \$943.00  
**Assessor Name:** Terence Davis  
**Date Created:** 12/07/2016

**Notes:** The fittings throughout the building are aged, in marginal condition, and should be replaced.

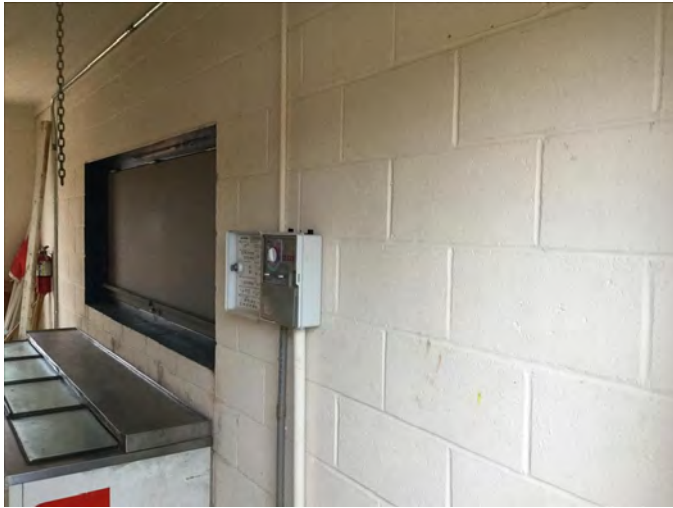
**System: C3010 - Wall Finishes**

**Location:** Throughout the building  
**Distress:** Damaged  
**Category:** Deferred Maintenance  
**Priority:** 3 - Necessary/Not Yet Critical (Years 2-5)  
**Correction:** Renew System  
**Qty:** 832.00  
**Unit of Measure:** S.F.  
**Estimate:** \$4,677.00  
**Assessor Name:** Terence Davis  
**Date Created:** 12/07/2016

**Notes:** The wall finishes are aged, scuffed, fading, stained, and should be re-painted.

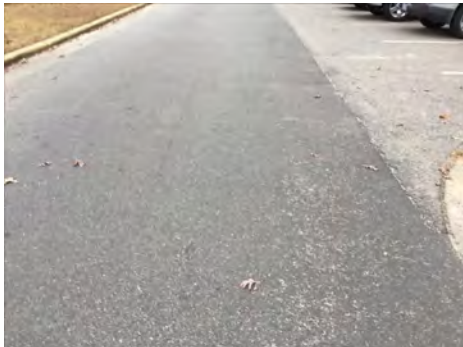
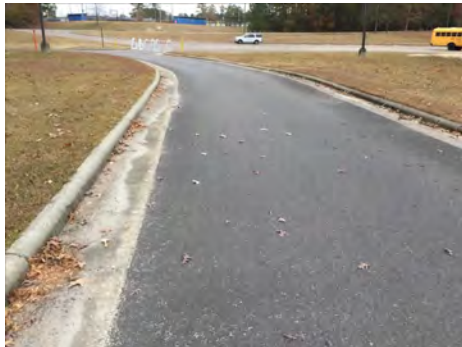
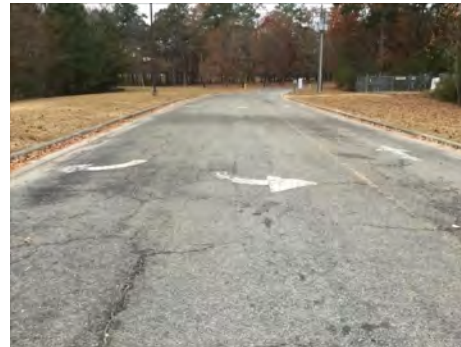
**System:** G2010 - Roadways

**Note:** Only part was repaired.
