NC School District/520 Jones County/Middle School

# Jones Middle

## Campus Assessment Report

March 11, 2017

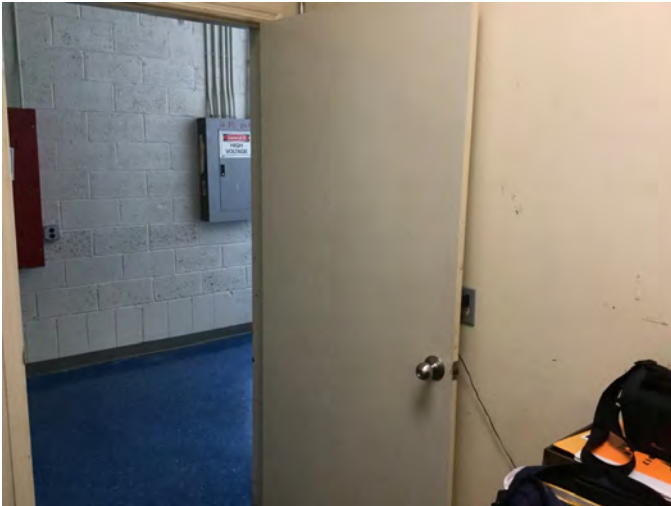
#### System: C1020 - Interior Doors

**Location:** Throughout the building  
**Distress:** Beyond Service Life  
**Category:** Deferred Maintenance / Accessibility Code Compliance  
**Priority:** 3 - Necessary/Not Yet Critical (Years 2-5)  
**Correction:** Renew System  
**Qty:** 30,983.00  
**Unit of Measure:** S.F.  
**Estimate:** \$9,884.00  
**Assessor Name:** Ann Buerger Linden  
**Date Created:** 02/17/2017

**Notes:** Interior doors are typically original and beyond their expected useful life. Hardware is not ADA compliant. System renewal is recommended.

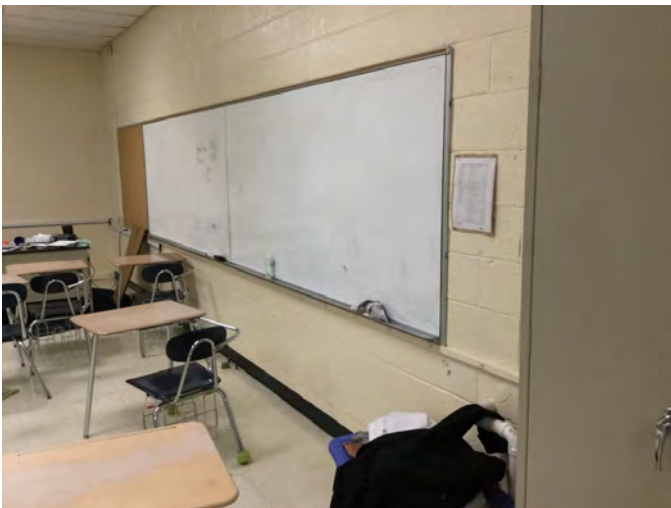
#### System: C1030 - Fittings

**Location:** Throughout the building  
**Distress:** Beyond Service Life  
**Category:** Deferred Maintenance / Accessibility Code Compliance  
**Priority:** 3 - Necessary/Not Yet Critical (Years 2-5)  
**Correction:** Renew System  
**Qty:** 30,983.00  
**Unit of Measure:** S.F.  
**Estimate:** \$460,098.00  
**Assessor Name:** Ann Buerger Linden  
**Date Created:** 02/17/2017

**Notes:** Although main gang restrooms have been renovated with new toilet partitions, in general building fittings are expired. Signage is not up to ADA code. Whiteboards are stained. Locker rooms do not have proper fittings. System renewal is recommended.

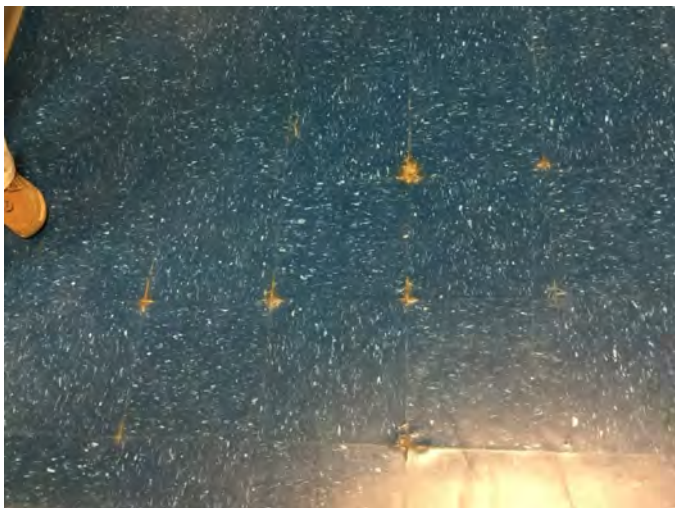
**System: C3020 - Floor Finishes**

**Location:** Throughout the building  
**Distress:** Beyond Service Life  
**Category:** Deferred Maintenance  
**Priority:** 3 - Necessary/Not Yet Critical (Years 2-5)  
**Correction:** Renew System  
**Qty:** 30,983.00  
**Unit of Measure:** S.F.  
**Estimate:** \$365,692.00  
**Assessor Name:** Ann Buerger Linden  
**Date Created:** 02/17/2017

**Notes:** Floor finishes are generally beyond their expected life. Asbestos containing materials have been encapsulated beneath VCT. System renewal including complete asbestos abatement is recommended.

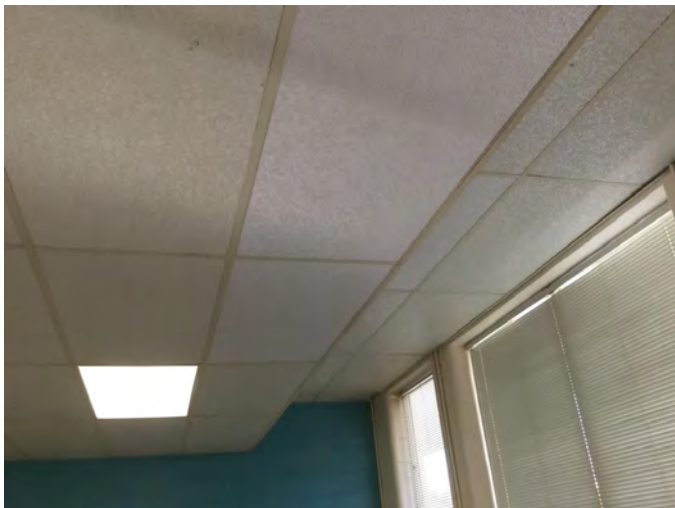
**System: C3030 - Ceiling Finishes**

**Location:** Throughout the building  
**Distress:** Beyond Service Life  
**Category:** Deferred Maintenance  
**Priority:** 3 - Necessary/Not Yet Critical (Years 2-5)  
**Correction:** Renew System  
**Qty:** 30,983.00  
**Unit of Measure:** S.F.  
**Estimate:** \$399,092.00  
**Assessor Name:** Ann Buerger Linden  
**Date Created:** 02/28/2017

**Notes:** Ceiling finishes have exceeded their expected life. Grids are discolored. Tile are mismatched where replacements have been made piecemeal. System renewal is recommended.

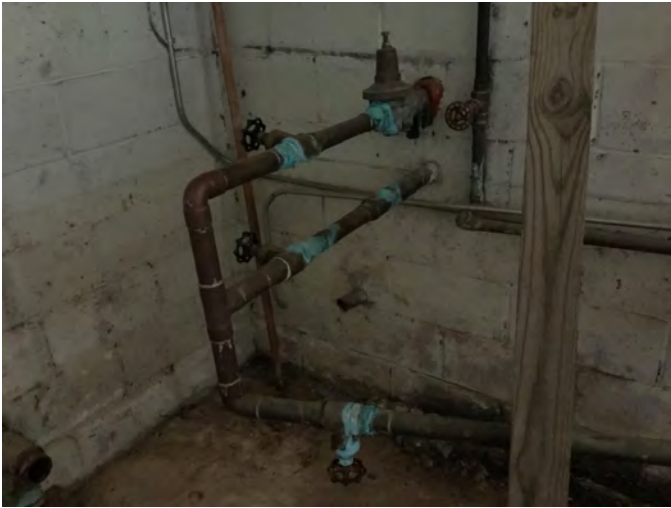
**System: D2020 - Domestic Water Distribution**

**Location:** Throughout the building  
**Distress:** Beyond Service Life  
**Category:** Deferred Maintenance  
**Priority:** 3 - Necessary/Not Yet Critical (Years 2-5)  
**Correction:** Renew System  
**Qty:** 30,983.00  
**Unit of Measure:** S.F.  
**Estimate:** \$36,126.00  
**Assessor Name:** Ann Buerger Linden  
**Date Created:** 02/17/2017

**Notes:** The domestic water supply system is typically original. System renewal is recommended.

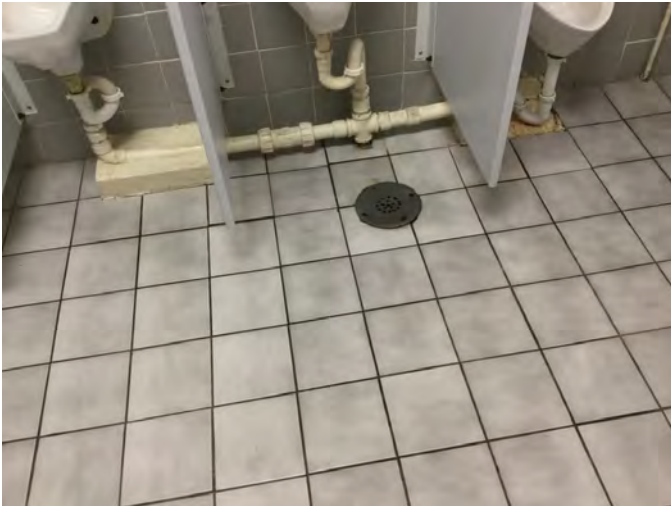
**System: D2030 - Sanitary Waste**

**Location:** Throughout the building  
**Distress:** Beyond Service Life  
**Category:** Deferred Maintenance  
**Priority:** 3 - Necessary/Not Yet Critical (Years 2-5)  
**Correction:** Renew System  
**Qty:** 30,983.00  
**Unit of Measure:** S.F.  
**Estimate:** \$57,257.00  
**Assessor Name:** Ann Buerger Linden  
**Date Created:** 02/17/2017

**Notes:** The sanitary waste system is largely original. Piecemeal updates have been done over the years as needed, however the system as a whole is beyond its expected life. System renewal is recommended.

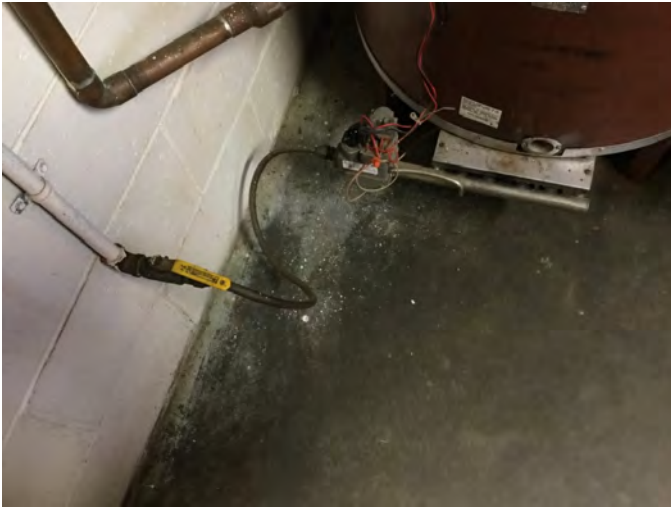
**System: D2090 - Other Plumbing Systems - Propane**

**Location:** Kitchen  
**Distress:** Beyond Service Life  
**Category:** Deferred Maintenance  
**Priority:** 3 - Necessary/Not Yet Critical (Years 2-5)  
**Correction:** Renew System  
**Qty:** 30,983.00  
**Unit of Measure:** S.F.  
**Estimate:** \$5,453.00  
**Assessor Name:** Ann Buerger Linden  
**Date Created:** 02/17/2017

**Notes:** The propane plumbing system is beyond its expected life. System renewal is recommended.

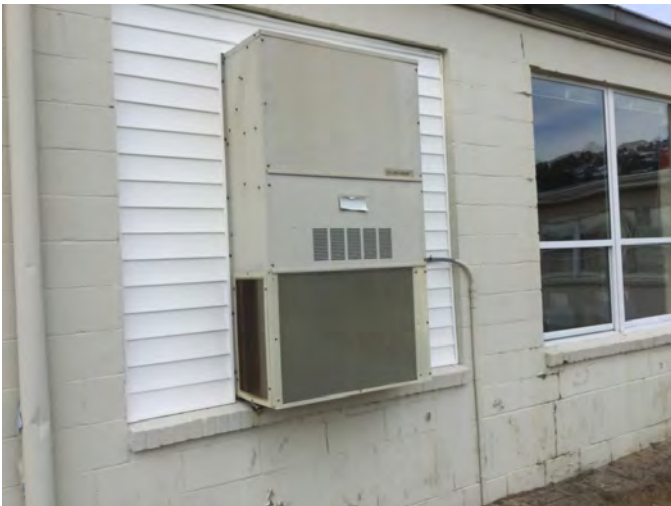
**System: D3050 - Terminal & Package Units**

**Location:** Throughout the building  
**Distress:** Beyond Service Life  
**Category:** Deferred Maintenance  
**Priority:** 3 - Necessary/Not Yet Critical (Years 2-5)  
**Correction:** Renew System  
**Qty:** 30,983.00  
**Unit of Measure:** S.F.  
**Estimate:** \$791,027.00  
**Assessor Name:** Ann Buerger Linden  
**Date Created:** 02/17/2017

**Notes:** The HVAC system is beyond its expected useful life. Provide independent cooling for data rooms. System renewal is recommended.

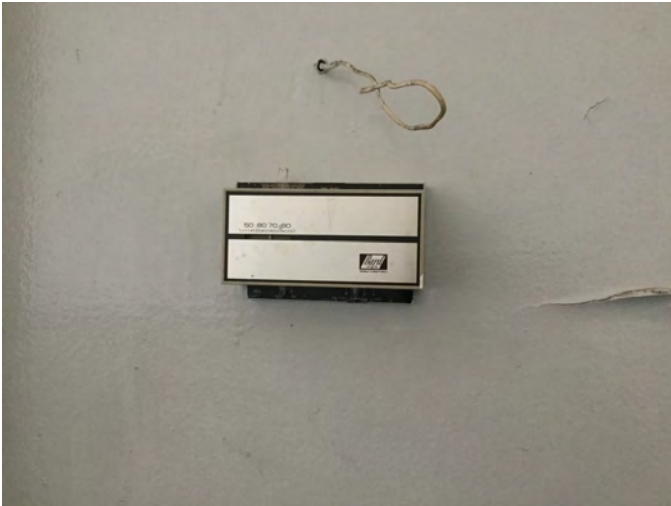
**System: D3060 - Controls & Instrumentation**

**Location:** Throughout the building  
**Distress:** Beyond Service Life  
**Category:** Deferred Maintenance  
**Priority:** 3 - Necessary/Not Yet Critical (Years 2-5)  
**Correction:** Renew System  
**Qty:** 30,983.00  
**Unit of Measure:** S.F.  
**Estimate:** \$116,217.00  
**Assessor Name:** Ann Buerger Linden  
**Date Created:** 02/17/2017

**Notes:** Building controls are locally controlled. Installation of a modern digital system with remote monitoring and control capability for energy conservation is recommended.

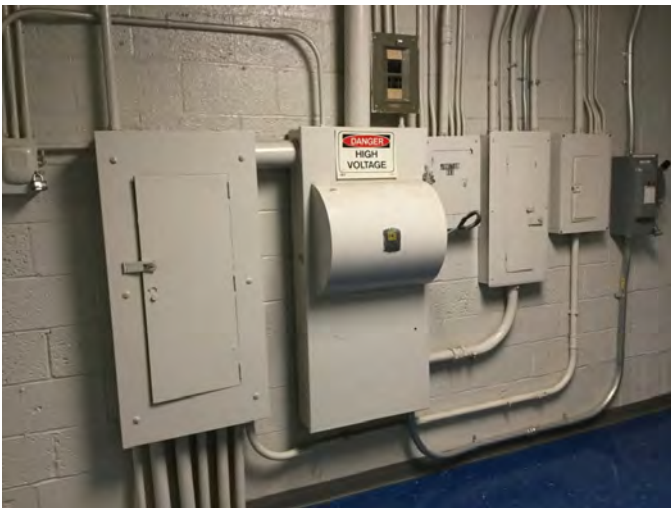
**System: D5010 - Electrical Service/Distribution**

**Location:** Electric service  
**Distress:** Beyond Service Life  
**Category:** Deferred Maintenance  
**Priority:** 3 - Necessary/Not Yet Critical (Years 2-5)  
**Correction:** Renew System  
**Qty:** 30,983.00  
**Unit of Measure:** S.F.  
**Estimate:** \$57,597.00  
**Assessor Name:** Ann Buerger Linden  
**Date Created:** 02/17/2017

**Notes:** The main system was added onto in 1992 to support the HVAC renovation, however the original electric distribution system has not been replaced. Main switchgear is located in a corridor rather than a dedicated electrical equipment room. System renewal is recommended.

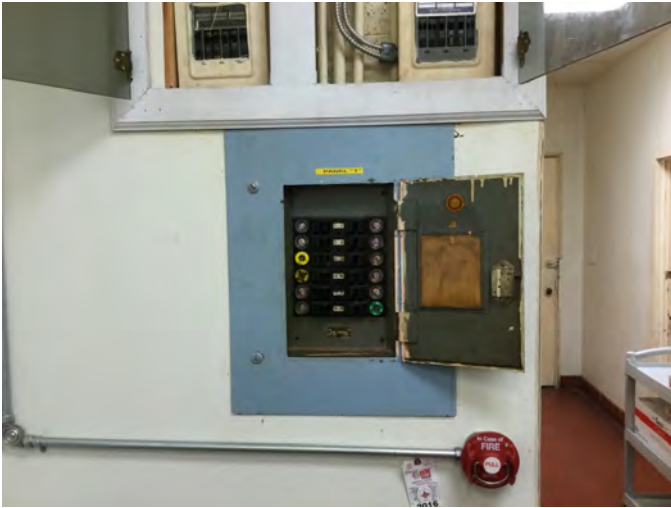
**System: D5020 - Branch Wiring**

**Location:** Throughout the building  
**Distress:** Beyond Service Life  
**Category:** Deferred Maintenance  
**Priority:** 3 - Necessary/Not Yet Critical (Years 2-5)  
**Correction:** Renew System  
**Qty:** 30,983.00  
**Unit of Measure:** S.F.  
**Estimate:** \$172,451.00  
**Assessor Name:** Ann Buerger Linden  
**Date Created:** 02/17/2017

**Notes:** While outlet distribution is sufficient, circuits are overloaded. The system was added onto in 1992, but original components were not replaced. System renewal is recommended.

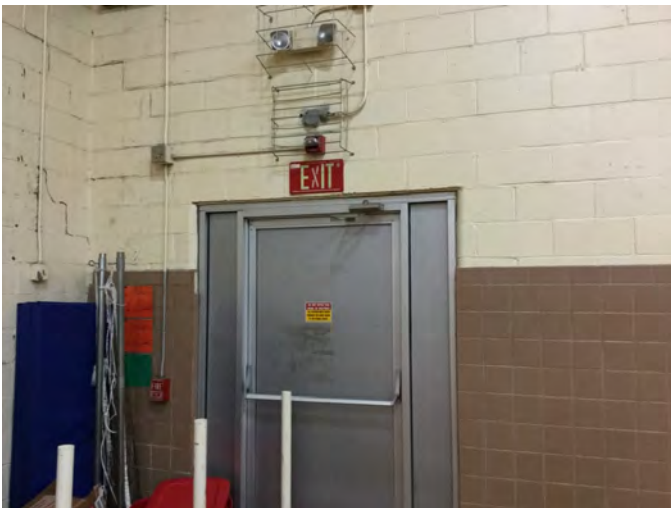
**System: D5090 - Other Electrical Systems**

**Location:** Throughout the building  
**Distress:** Beyond Service Life  
**Category:** Deferred Maintenance  
**Priority:** 3 - Necessary/Not Yet Critical (Years 2-5)  
**Correction:** Renew System  
**Qty:** 30,983.00  
**Unit of Measure:** S.F.  
**Estimate:** \$18,063.00  
**Assessor Name:** Ann Buerger Linden  
**Date Created:** 02/17/2017

**Notes:** Egress lighting is beyond its expected useful life. System renewal is recommended.

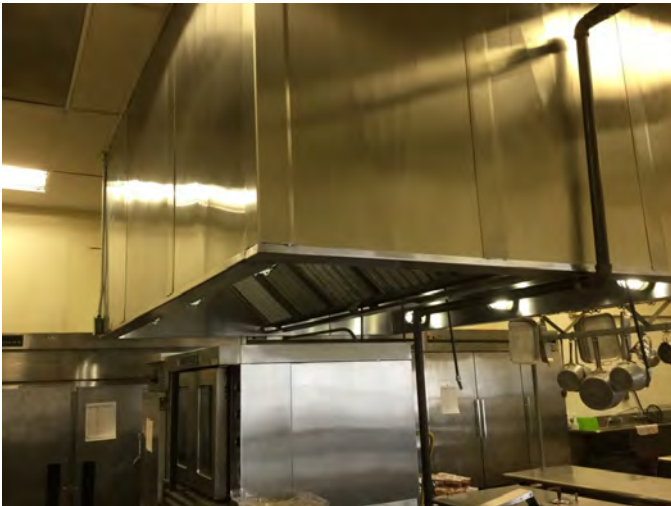
**System: E1090 - Other Equipment**

**Location:** Kitchen  
**Distress:** Beyond Service Life  
**Category:** Deferred Maintenance  
**Priority:** 3 - Necessary/Not Yet Critical (Years 2-5)  
**Correction:** Renew System  
**Qty:** 30,983.00  
**Unit of Measure:** S.F.  
**Estimate:** \$239,932.00  
**Assessor Name:** Ann Buerger Linden  
**Date Created:** 02/17/2017

**Notes:** Kitchen equipment is typically beyond its expected life. System renewal is recommended.

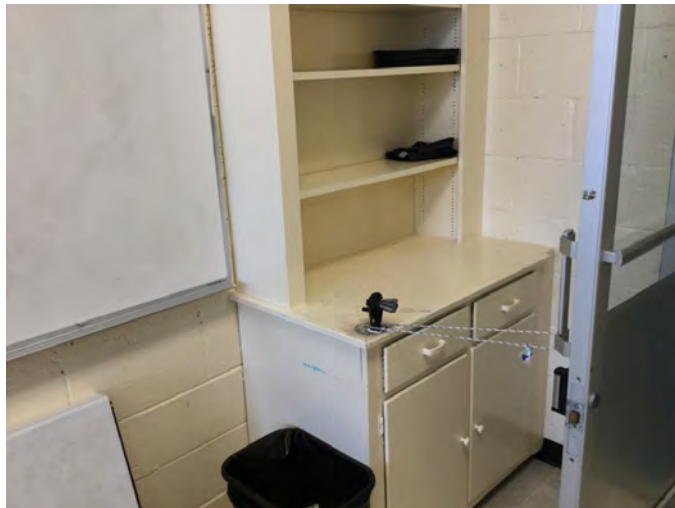
**System: E2010 - Fixed Furnishings**

**Location:** Throughout the building  
**Distress:** Beyond Service Life  
**Category:** Deferred Maintenance  
**Priority:** 3 - Necessary/Not Yet Critical (Years 2-5)  
**Correction:** Renew System  
**Qty:** 30,983.00  
**Unit of Measure:** S.F.  
**Estimate:** \$191,196.00  
**Assessor Name:** Ann Buerger Linden  
**Date Created:** 02/17/2017

**Notes:** Fixed furnishings throughout the building are original or very old and in poor condition. System renewal is recommended.

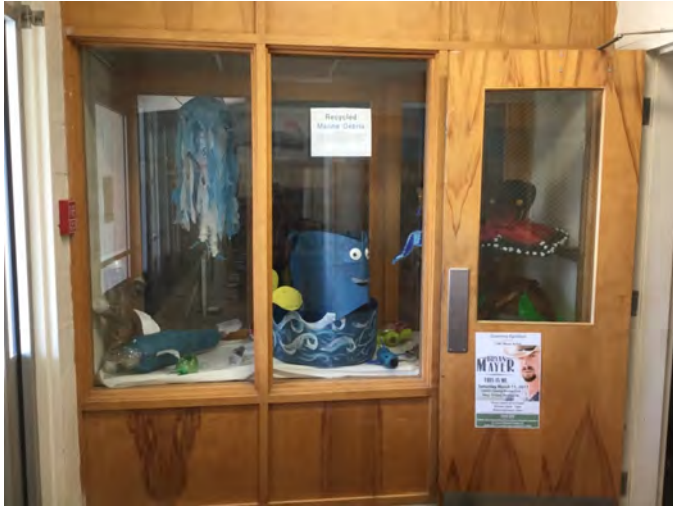
**System: C1020 - Interior Doors**

**Location:** Throughout the building  
**Distress:** Beyond Service Life  
**Category:** Deferred Maintenance  
**Priority:** 3 - Necessary/Not Yet Critical (Years 2-5)  
**Correction:** Renew System  
**Qty:** 10,800.00  
**Unit of Measure:** S.F.  
**Estimate:** \$3,445.00  
**Assessor Name:** Ann Buerger Linden  
**Date Created:** 02/16/2017

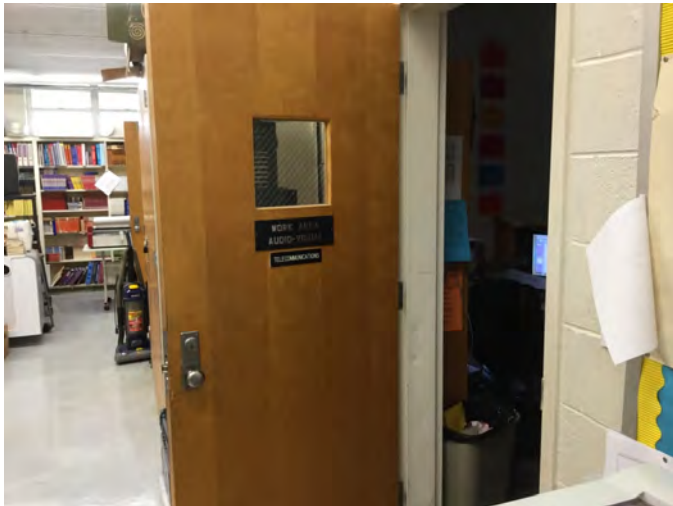
**System: C1030 - Fittings**

**Location:** Throughout the building  
**Distress:** Beyond Service Life  
**Category:** Deferred Maintenance  
**Priority:** 3 - Necessary/Not Yet Critical (Years 2-5)  
**Correction:** Renew System  
**Qty:** 10,800.00  
**Unit of Measure:** S.F.  
**Estimate:** \$160,380.00  
**Assessor Name:** Ann Buerger Linden  
**Date Created:** 02/16/2017

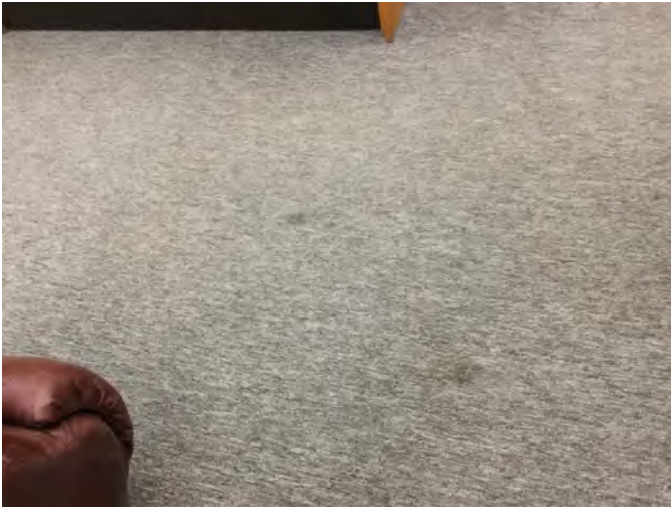
**Location:** Throughout the building  
**Distress:** Beyond Service Life  
**Category:** Deferred Maintenance  
**Priority:** 3 - Necessary/Not Yet Critical (Years 2-5)  
**Correction:** Renew System  
**Qty:** 10,800.00  
**Unit of Measure:** S.F.  
**Estimate:** \$127,472.00  
**Assessor Name:** Ann Buerger Linden  
**Date Created:** 02/16/2017

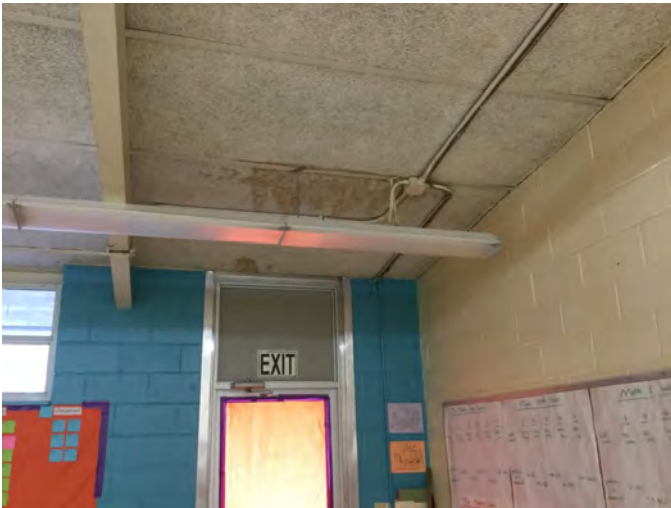
**Location:** Throughout the building  
**Distress:** Beyond Service Life  
**Category:** Deferred Maintenance  
**Priority:** 3 - Necessary/Not Yet Critical (Years 2-5)  
**Correction:** Renew System  
**Qty:** 10,800.00  
**Unit of Measure:** S.F.  
**Estimate:** \$139,115.00  
**Assessor Name:** Ann Buerger Linden  
**Date Created:** 02/16/2017

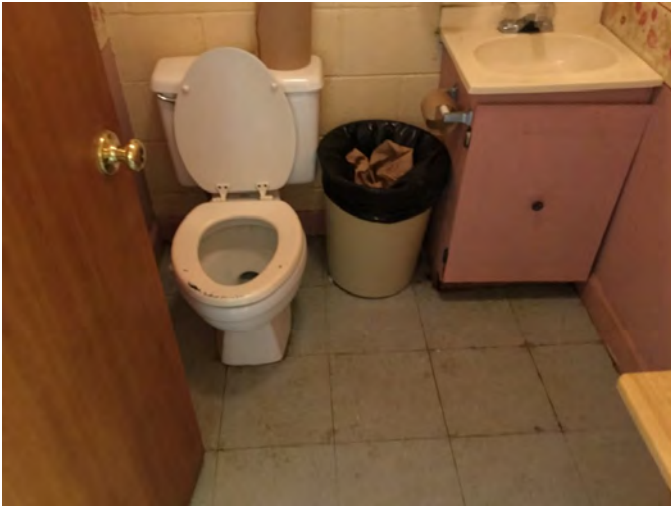
**Location:** Restrooms and workrooms  
**Distress:** Beyond Service Life  
**Category:** Deferred Maintenance  
**Priority:** 3 - Necessary/Not Yet Critical (Years 2-5)  
**Correction:** Renew System  
**Qty:** 10,800.00  
**Unit of Measure:** S.F.  
**Estimate:** \$117,968.00  
**Assessor Name:** Ann Buerger Linden  
**Date Created:** 02/16/2017

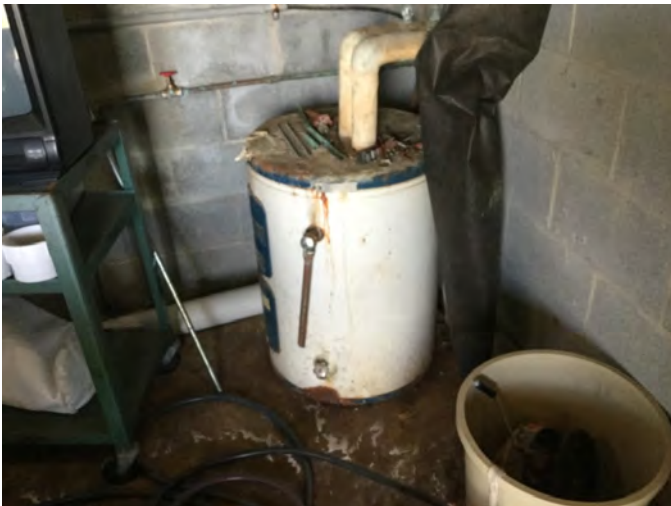
**Location:** Throughout the building  
**Distress:** Beyond Service Life  
**Category:** Deferred Maintenance  
**Priority:** 3 - Necessary/Not Yet Critical (Years 2-5)  
**Correction:** Renew System  
**Qty:** 10,800.00  
**Unit of Measure:** S.F.  
**Estimate:** \$12,593.00  
**Assessor Name:** Ann Buerger Linden  
**Date Created:** 02/16/2017

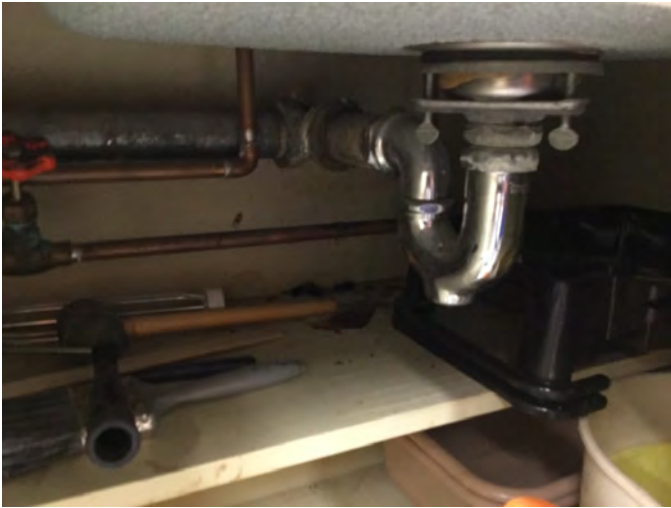
**Location:** Throughout the building  
**Distress:** Beyond Service Life  
**Category:** Deferred Maintenance  
**Priority:** 3 - Necessary/Not Yet Critical (Years 2-5)  
**Correction:** Renew System  
**Qty:** 10,800.00  
**Unit of Measure:** S.F.  
**Estimate:** \$19,958.00  
**Assessor Name:** Ann Buerger Linden  
**Date Created:** 02/16/2017

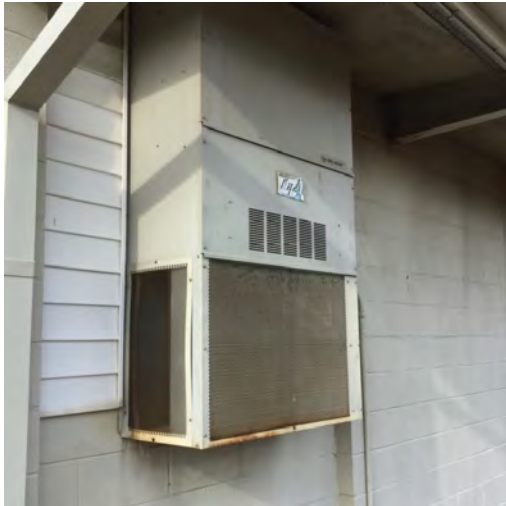
**Location:** Throughout the building  
**Distress:** Beyond Service Life  
**Category:** Deferred Maintenance  
**Priority:** 3 - Necessary/Not Yet Critical (Years 2-5)  
**Correction:** Renew System  
**Qty:** 10,800.00  
**Unit of Measure:** S.F.  
**Estimate:** \$275,735.00  
**Assessor Name:** Ann Buerger Linden  
**Date Created:** 02/16/2017

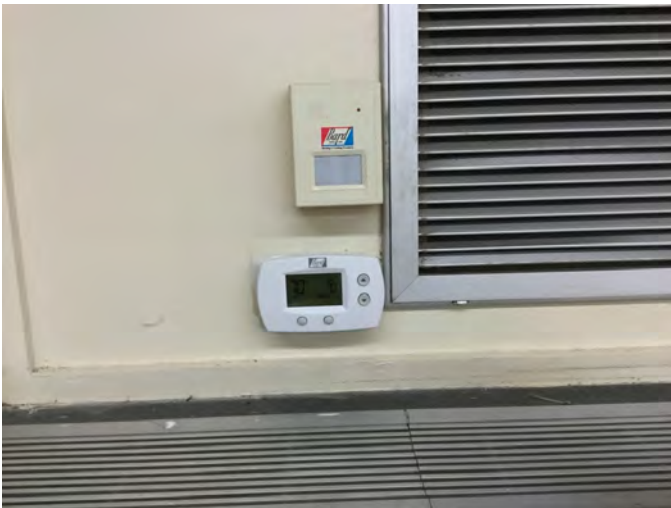
**Location:** Throughout the building  
**Distress:** Beyond Service Life  
**Category:** Deferred Maintenance  
**Priority:** 3 - Necessary/Not Yet Critical (Years 2-5)  
**Correction:** Renew System  
**Qty:** 10,800.00  
**Unit of Measure:** S.F.  
**Estimate:** \$40,511.00  
**Assessor Name:** Ann Buerger Linden  
**Date Created:** 02/16/2017

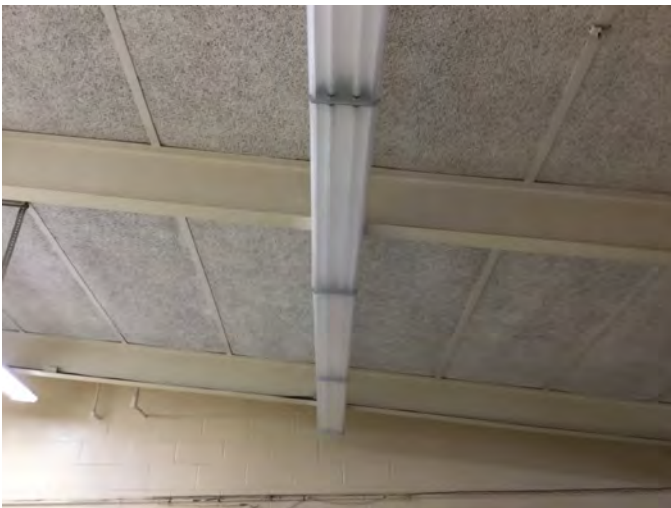
**Location:** Throughout the building  
**Distress:** Beyond Service Life  
**Category:** Deferred Maintenance  
**Priority:** 3 - Necessary/Not Yet Critical (Years 2-5)  
**Correction:** Renew System  
**Qty:** 10,800.00  
**Unit of Measure:** S.F.  
**Estimate:** \$140,065.00  
**Assessor Name:** Ann Buerger Linden  
**Date Created:** 02/16/2017

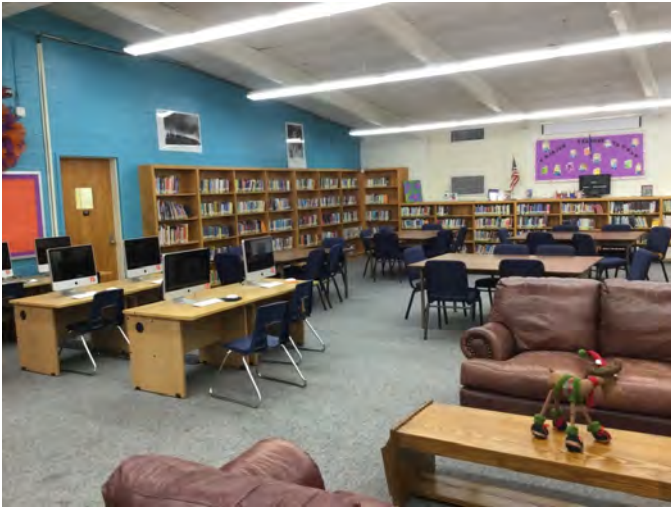
**Location:** Library  
**Distress:** Beyond Service Life  
**Category:** Deferred Maintenance  
**Priority:** 3 - Necessary/Not Yet Critical (Years 2-5)  
**Correction:** Renew System  
**Qty:** 10,800.00  
**Unit of Measure:** S.F.  
**Estimate:** \$33,383.00  
**Assessor Name:** Ann Buerger Linden  
**Date Created:** 02/16/2017

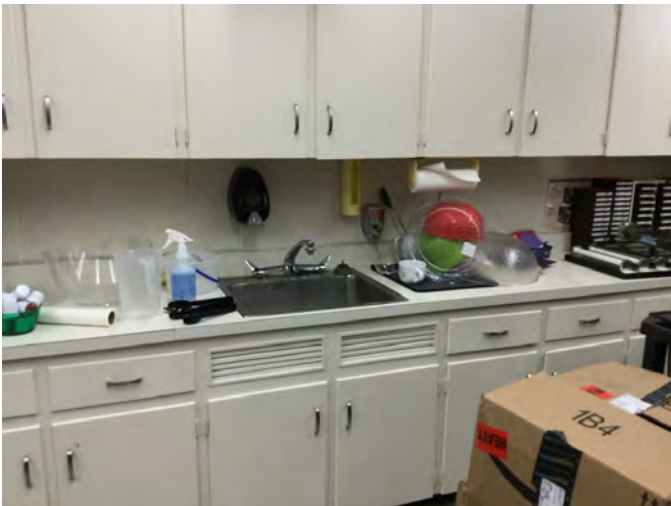
**Location:** Throughout the building  
**Distress:** Beyond Service Life  
**Category:** Deferred Maintenance  
**Priority:** 3 - Necessary/Not Yet Critical (Years 2-5)  
**Correction:** Renew System  
**Qty:** 10,800.00  
**Unit of Measure:** S.F.  
**Estimate:** \$66,647.00  
**Assessor Name:** Ann Buerger Linden  
**Date Created:** 02/16/2017

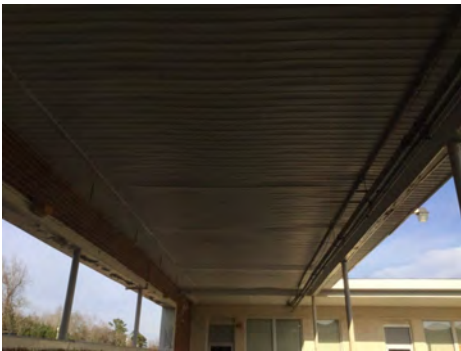
**Note:** Covered walkways do not have any observed deficiencies. Renewal date pushed 5 years.

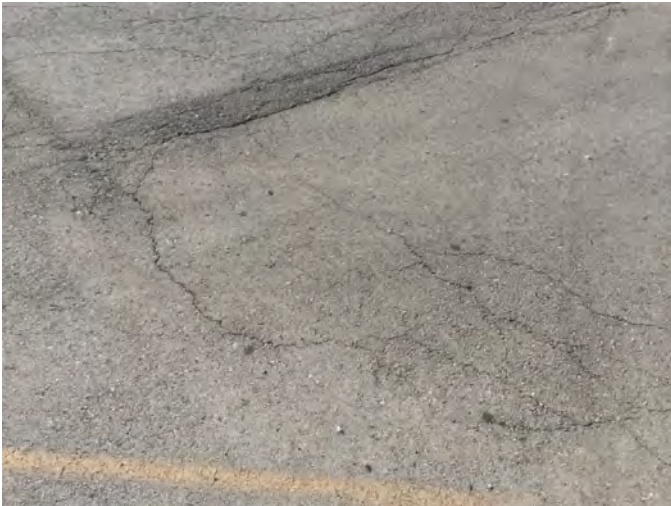
**Location:** Roadways  
**Distress:** Beyond Service Life  
**Category:** Deferred Maintenance  
**Priority:** 3 - Necessary/Not Yet Critical (Years 2-5)  
**Correction:** Renew System  
**Qty:** 41,783.00  
**Unit of Measure:** S.F.  
**Estimate:** \$193,957.00  
**Assessor Name:** Eduardo Lopez  
**Date Created:** 02/16/2017

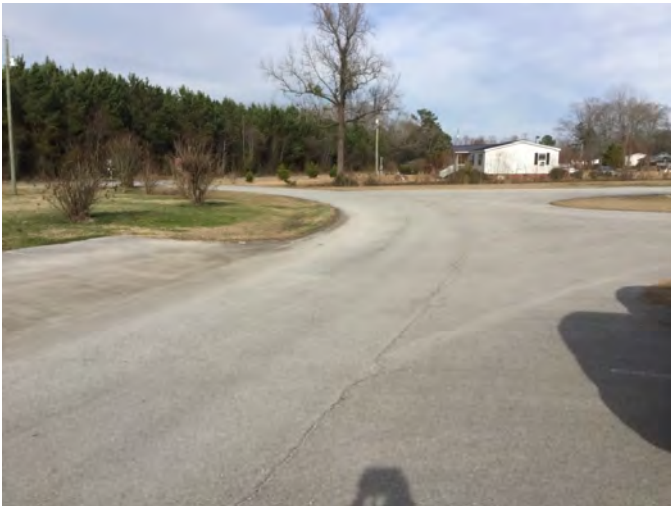
**Location:** Parking lots  
**Distress:** Beyond Service Life  
**Category:** Deferred Maintenance  
**Priority:** 3 - Necessary/Not Yet Critical (Years 2-5)  
**Correction:** Renew System  
**Qty:** 41,783.00  
**Unit of Measure:** S.F.  
**Estimate:** \$63,886.00  
**Assessor Name:** Eduardo Lopez  
**Date Created:** 02/16/2017

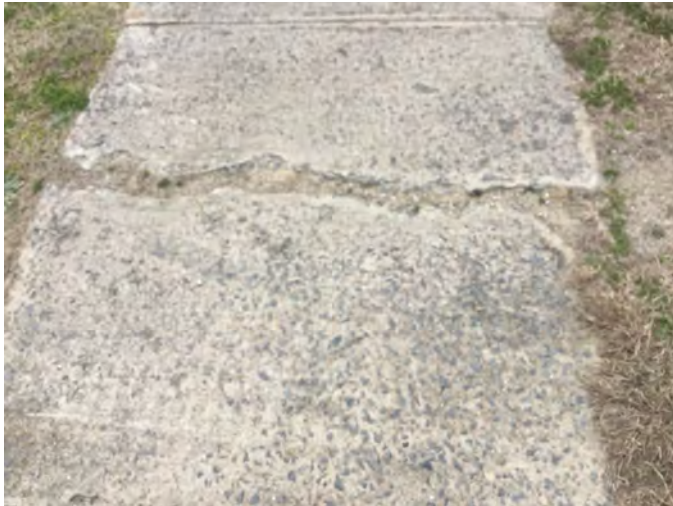
**Location:** Site pedestrian concrete  
**Distress:** Beyond Service Life  
**Category:** Deferred Maintenance  
**Priority:** 3 - Necessary/Not Yet Critical (Years 2-5)  
**Correction:** Renew System  
**Qty:** 41,783.00  
**Unit of Measure:** S.F.  
**Estimate:** \$91,003.00  
**Assessor Name:** Eduardo Lopez  
**Date Created:** 02/16/2017

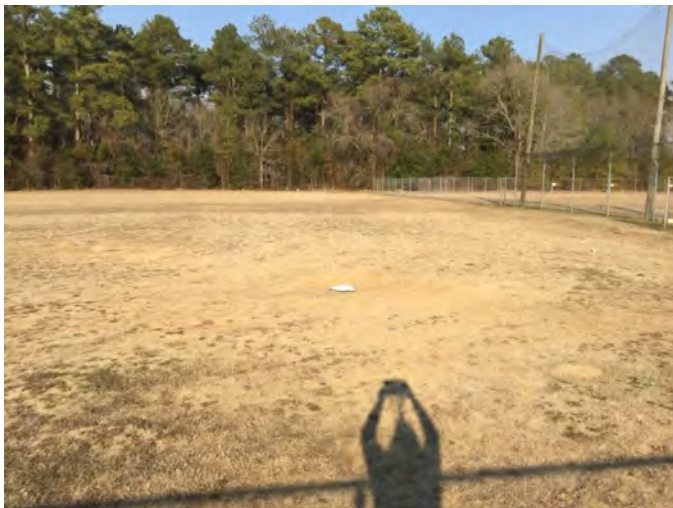
**Location:** West end of site  
**Distress:** Beyond Service Life  
**Category:** Deferred Maintenance  
**Priority:** 3 - Necessary/Not Yet Critical (Years 2-5)  
**Correction:** Renew System  
**Qty:** 41,783.00  
**Unit of Measure:** S.F.  
**Estimate:** \$325,406.00  
**Assessor Name:** Eduardo Lopez  
**Date Created:** 02/16/2017

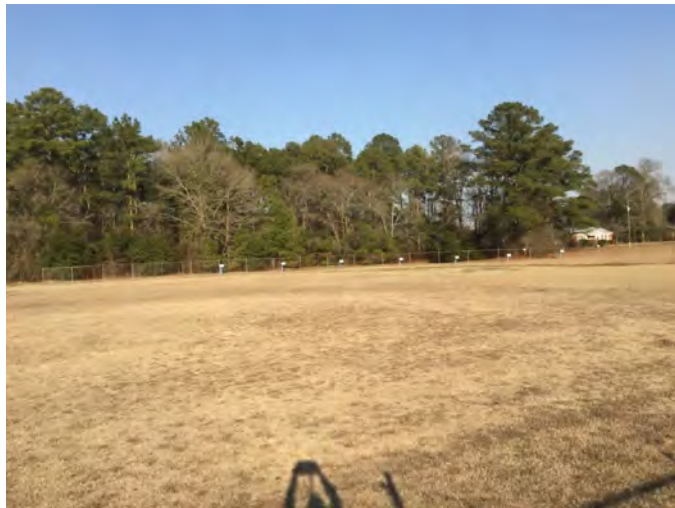
**Location:** West end of site  
**Distress:** Beyond Service Life  
**Category:** Deferred Maintenance  
**Priority:** 3 - Necessary/Not Yet Critical (Years 2-5)  
**Correction:** Renew System  
**Qty:** 41,783.00  
**Unit of Measure:** S.F.  
**Estimate:** \$234,862.00  
**Assessor Name:** Eduardo Lopez  
**Date Created:** 02/16/2017
