NC School District/830 Scotland County/Elementary School

Covington Street Elementary

Campus Assessment Report

March 11, 2017

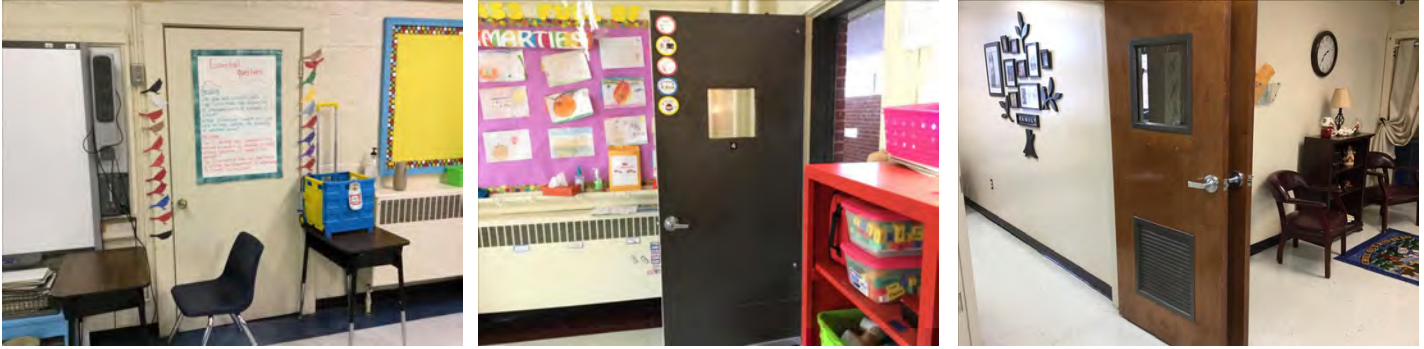
System: C1020 - Interior Doors

Note: The interior doors are beyond their service life and should be replaced, also while replacing the doors the hardware installed should be ADA compliant.

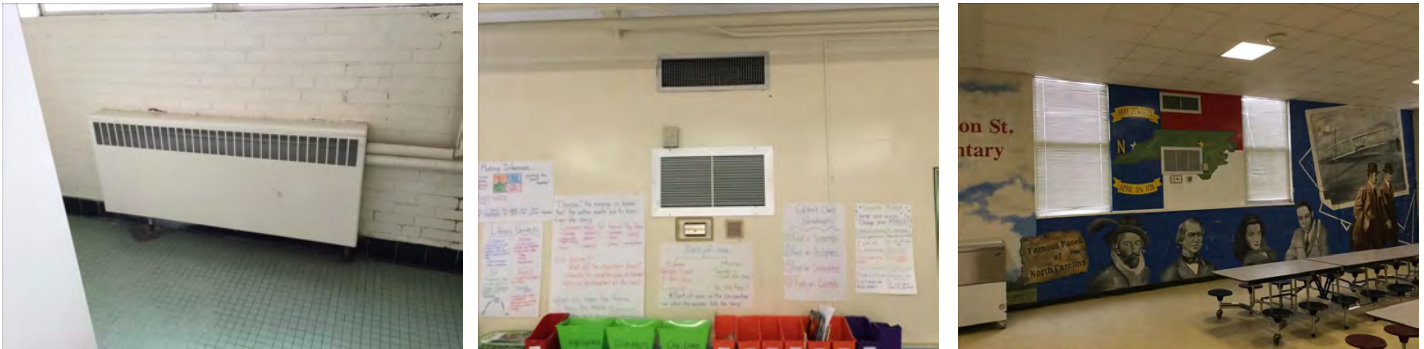
System: C3010 - Wall Finishes

Note: The wall finishes are beyond their service life and should be replaced.

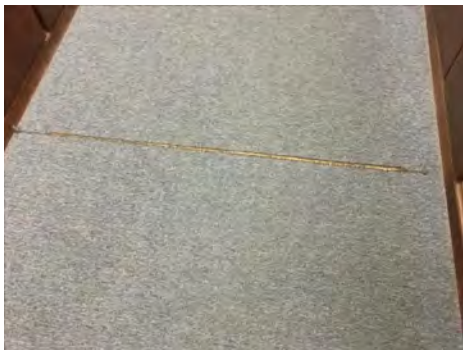
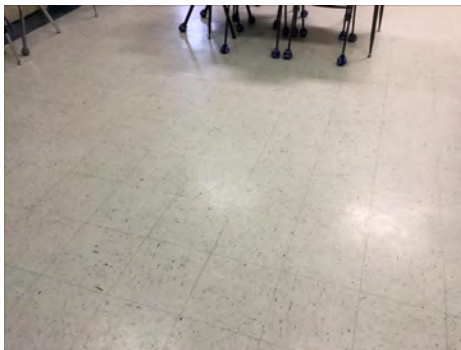
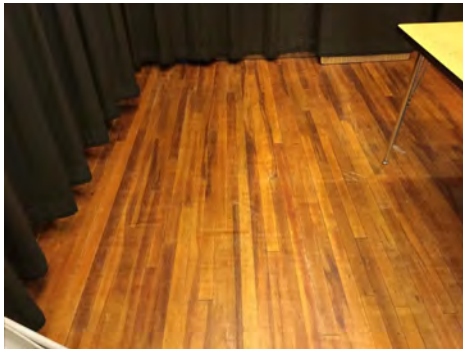
System: C3020 - Floor Finishes

Note: The carpet is in poor condition and should be replaced.

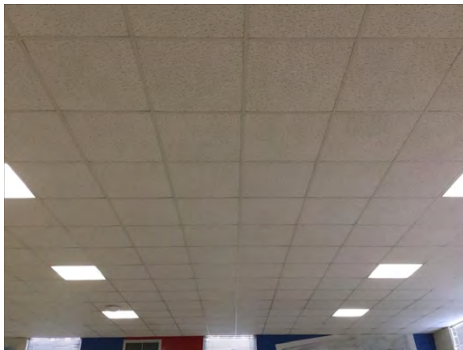
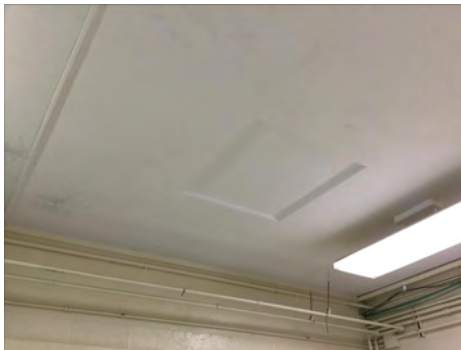
System: C3030 - Ceiling Finishes

Note: The acoustical ceiling tiles are beyond their service life and should be replaced.

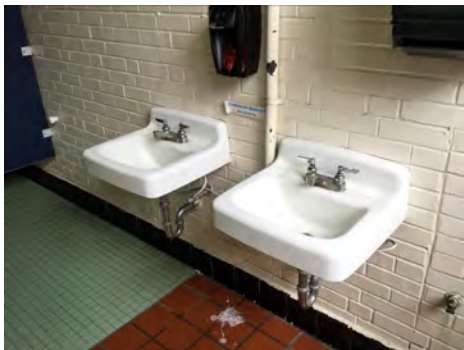
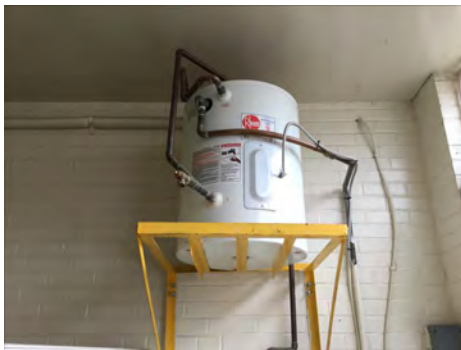
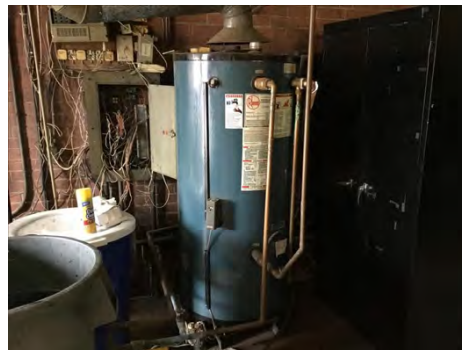
System: D2020 - Domestic Water Distribution

Note: The domestic water distribution system is beyond its service life and should be replaced.

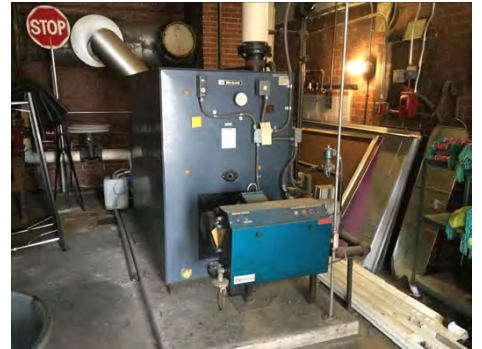
System: D3020 - Heat Generating Systems

Note: The heat generation system is beyond its service life and should be replaced.

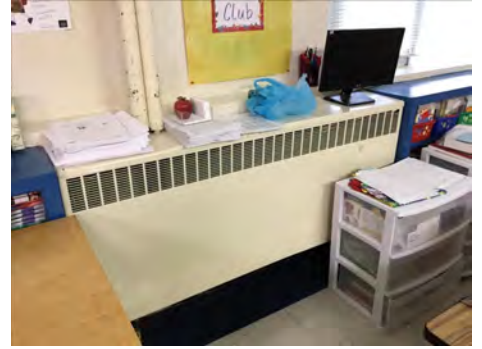
System: D3050 - Terminal & Package Units

Note: The radiating heating system is beyond its service life and should be replaced.

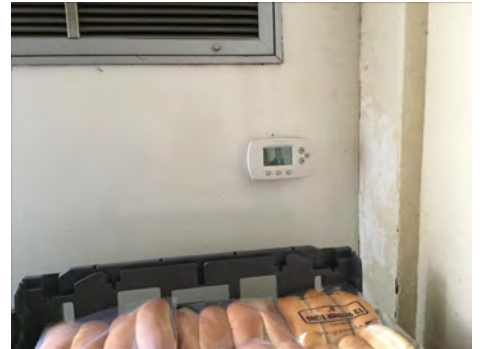
System: D3060 - Controls & Instrumentation

Note: The controls are beyond their service life and should be replaced.

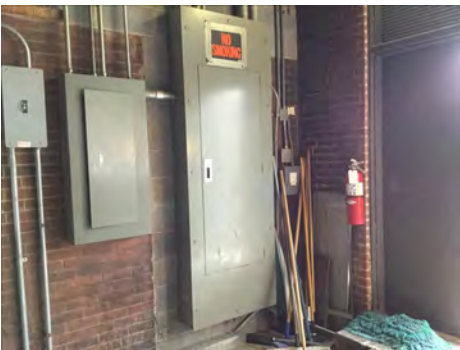
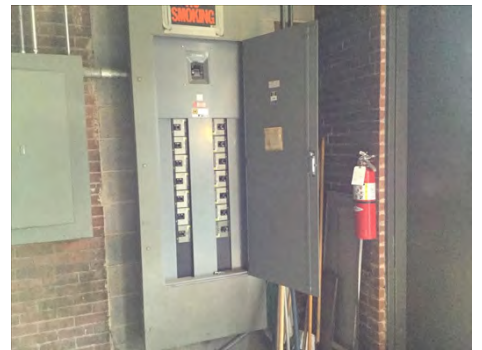
System: D5010 - Electrical Service/Distribution

Note: The electrical service distribution system is beyond its service life and should be replaced.

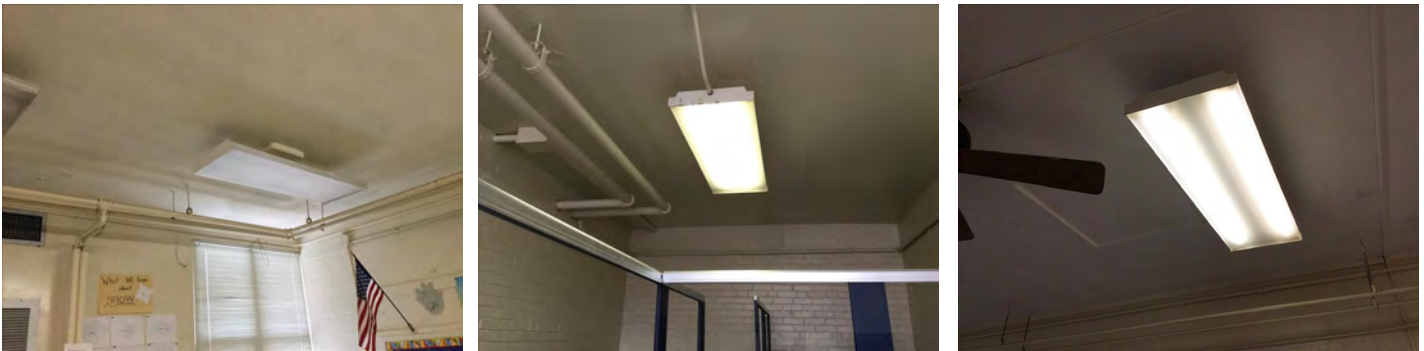
System: D5020 - Lighting

Note: The lighting system is beyond its service life and should be replaced.

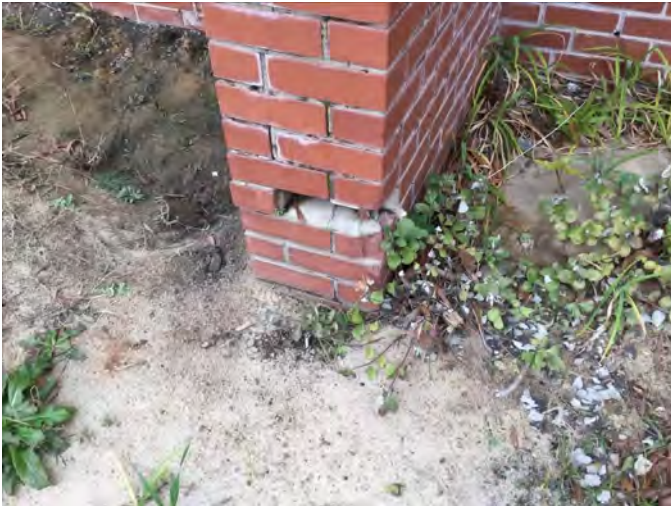
System: B2010 - Exterior Walls

Location: Exterior walls
Distress: Damaged
Category: Safety / Building Code Compliance
Priority: 1 - Currently Critical (Immediate)
Correction: Engineering Study-2016-11-15 17:41:59
Qty: 1.00
Unit of Measure: Ea.
Estimate: \$13,200.00
Assessor Name: Terence Davis
Date Created: 01/05/2017

Notes: There are multiple areas where the bricks are missing or there are visible cracks on the exterior walls, a professional engineer should study the problem.

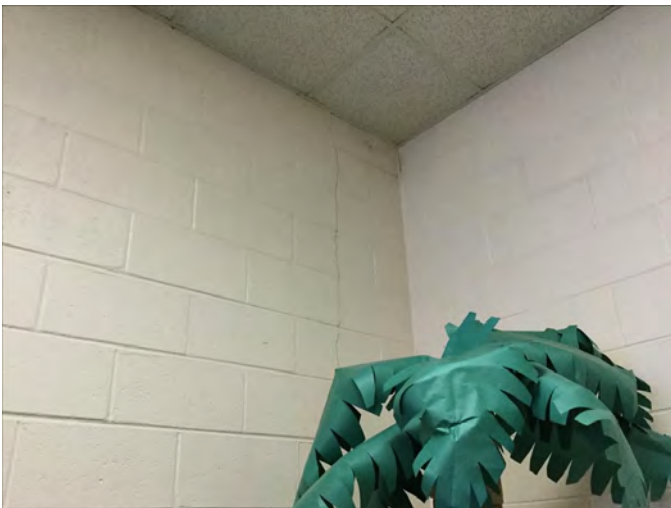
System: C1010 - Partitions

Location: Office and Media Center
Distress: Damaged
Category: Safety / Building Code Compliance
Priority: 1 - Currently Critical (Immediate)
Correction: Engineering Study
Qty: 1.00
Unit of Measure: Ea.
Estimate: \$13,200.00
Assessor Name: Terence Davis
Date Created: 01/05/2017

Notes: There are visible cracks on the partition wall which should be studied by a professional engineer.

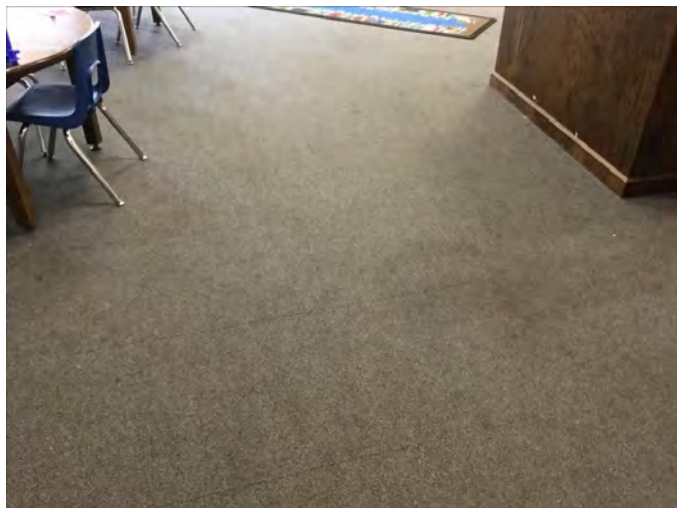
System: C3020 - Floor Finishes

Location: Throughout the building
Distress: Failing
Category: Life Safety Code Compliance
Priority: 1 - Currently Critical (Immediate)
Correction: Replace carpet
Qty: 755.00
Unit of Measure: S.Y.
Estimate: \$64,539.82
Assessor Name: Terence Davis
Date Created: 01/05/2017

Notes: The carpet is in poor condition and should be replaced as it has become a tripping hazard.

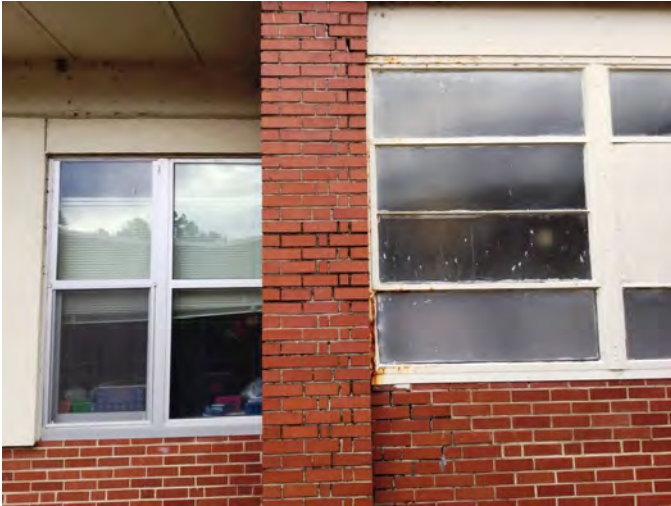
System: B2020 - Exterior Windows

Location: Exterior wall
Distress: Beyond Service Life
Category: Deferred Maintenance
Priority: 3 - Necessary/Not Yet Critical (Years 2-5)
Correction: Replace 3' x 4' aluminum window - 1st floor
Qty: 15.00
Unit of Measure: Ea.
Estimate: \$19,207.73
Assessor Name: Terence Davis
Date Created: 01/09/2017

Notes: The exterior windows on the cafeteria and few places on the original building are beyond their service life and should be replaced.

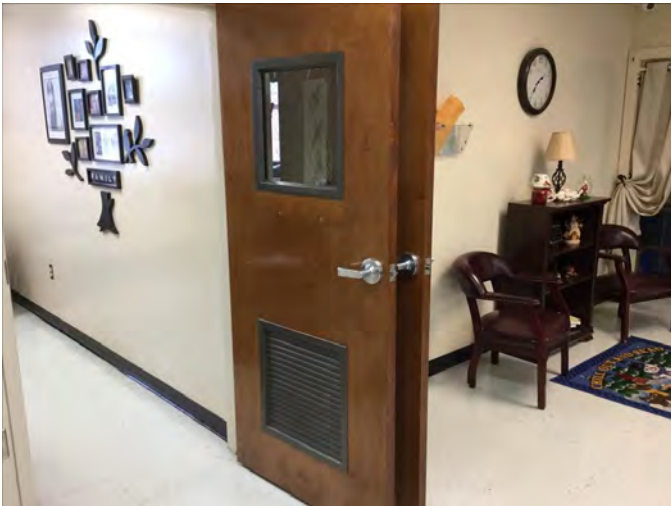
System: C1020 - Interior Doors

Location: Throughout Building
Distress: Beyond Service Life
Category: Deferred Maintenance
Priority: 3 - Necessary/Not Yet Critical (Years 2-5)
Correction: Renew System
Qty: 32,364.00
Unit of Measure: S.F.
Estimate: \$90,069.00
Assessor Name: Terence Davis
Date Created: 12/30/2016

Notes: The interior doors are beyond their service life and should be replaced, also while replacing the doors the hardware installed should be ADA compliant.

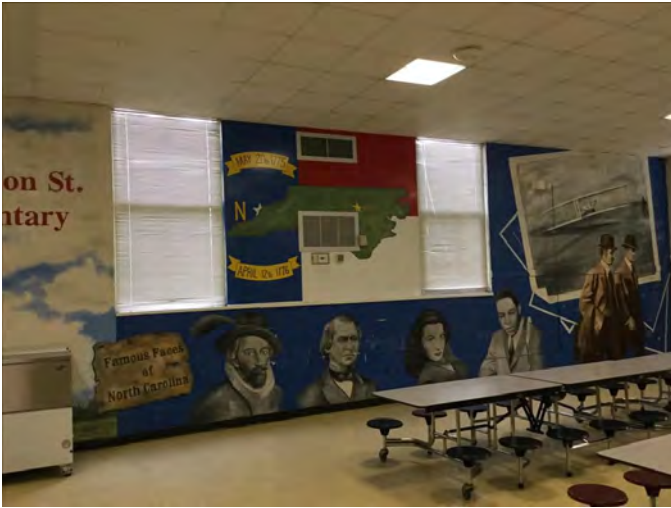
System: C3010 - Wall Finishes

Location: Throughout Building
Distress: Beyond Service Life
Category: Deferred Maintenance
Priority: 3 - Necessary/Not Yet Critical (Years 2-5)
Correction: Renew System
Qty: 32,364.00
Unit of Measure: S.F.
Estimate: \$99,325.00
Assessor Name: Terence Davis
Date Created: 12/30/2016

Notes: The wall finishes are beyond their service life and should be replaced.

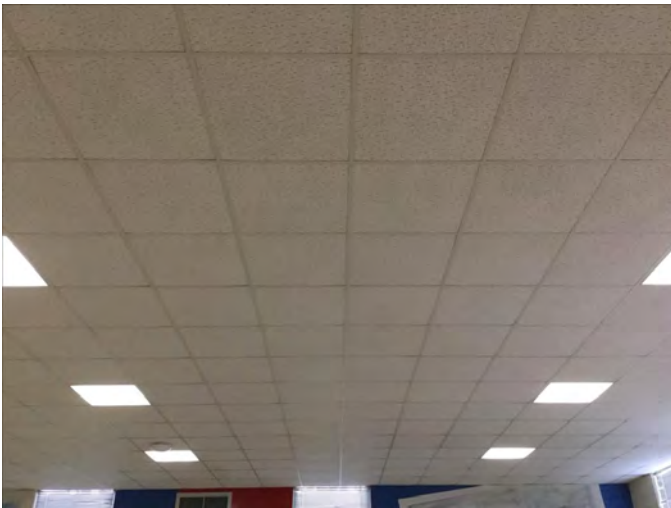
System: C3030 - Ceiling Finishes

Location: Throughout the building
Distress: Beyond Service Life
Category: Deferred Maintenance / Appearance
Priority: 3 - Necessary/Not Yet Critical (Years 2-5)
Correction: Replace acoustic tile ceiling, non fire-rated
Qty: 195.00
Unit of Measure: C.S.F.
Estimate: \$146,718.00
Assessor Name: Terence Davis
Date Created: 01/05/2017

Notes: The acoustical ceiling tiles are beyond their service life and should be replaced.

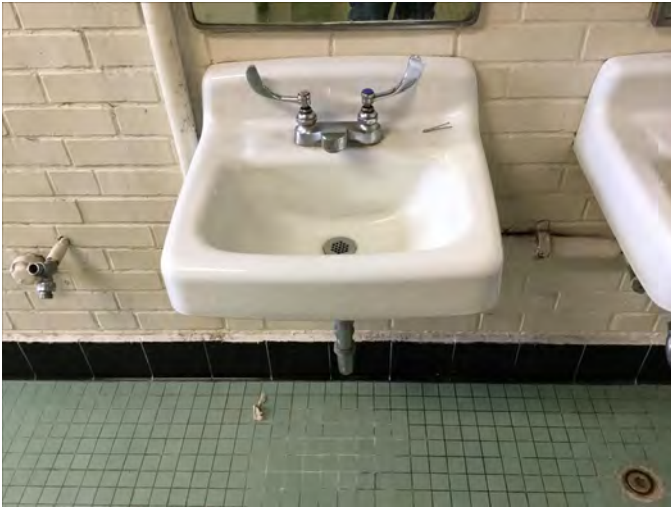
System: D2010 - Plumbing Fixtures

Location: Throughout Building
Distress: Beyond Service Life
Category: Deferred Maintenance
Priority: 3 - Necessary/Not Yet Critical (Years 2-5)
Correction: Renew System
Qty: 32,364.00
Unit of Measure: S.F.
Estimate: \$408,693.00
Assessor Name: Terence Davis
Date Created: 12/30/2016

Notes: The plumbing fixtures are beyond their service life and should be replaced.

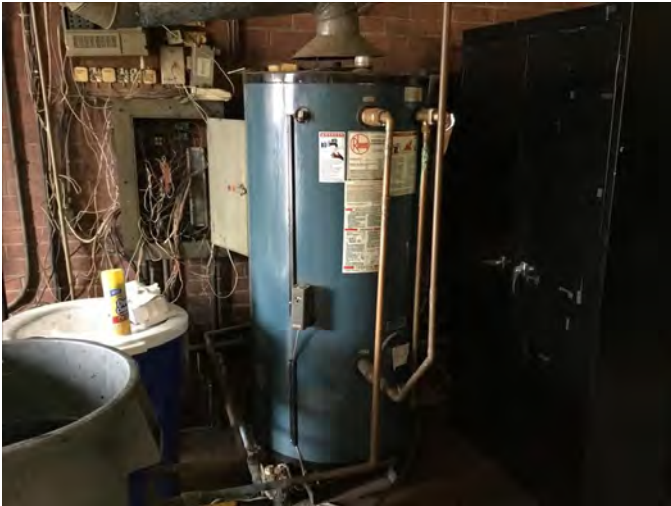
System: D2020 - Domestic Water Distribution

Location: Throughout Building
Distress: Beyond Service Life
Category: Deferred Maintenance
Priority: 3 - Necessary/Not Yet Critical (Years 2-5)
Correction: Renew System
Qty: 32,364.00
Unit of Measure: S.F.
Estimate: \$34,888.00
Assessor Name: Terence Davis
Date Created: 12/30/2016

Notes: The domestic water distribution system is beyond its service life and should be replaced.

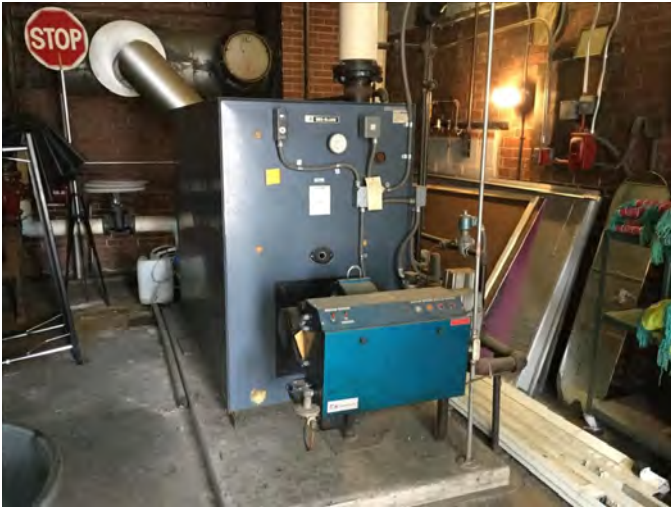
System: D3020 - Heat Generating Systems

Location: Throughout Building
Distress: Beyond Service Life
Category: Deferred Maintenance / Energy
Priority: 3 - Necessary/Not Yet Critical (Years 2-5)
Correction: Renew System
Qty: 32,364.00
Unit of Measure: S.F.
Estimate: \$180,850.00
Assessor Name: Terence Davis
Date Created: 12/30/2016

Notes: The heat generation system is beyond its service life and should be replaced.

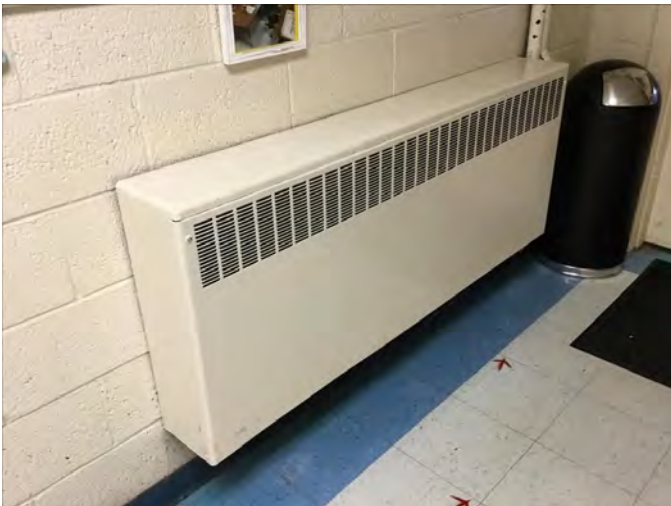
System: D3050 - Terminal & Package Units

Location: Throughout the building
Distress: Beyond Service Life
Category: Deferred Maintenance / Energy
Priority: 3 - Necessary/Not Yet Critical (Years 2-5)
Correction: Replace heat pump, thru-wall unit, 1.5 ton
Qty: 5.00
Unit of Measure: Ea.
Estimate: \$36,927.00
Assessor Name: Terence Davis
Date Created: 01/05/2017

Notes: The radiating heaters are beyond their service life and should be replaced.

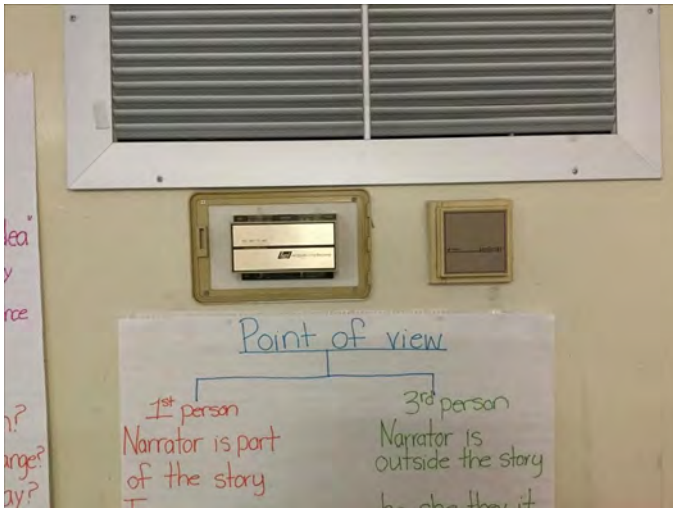
System: D3060 - Controls & Instrumentation

Location: Throughout Building
Distress: Beyond Service Life
Category: Deferred Maintenance / Energy
Priority: 3 - Necessary/Not Yet Critical (Years 2-5)
Correction: Renew System
Qty: 32,364.00
Unit of Measure: S.F.
Estimate: \$69,065.00
Assessor Name: Terence Davis
Date Created: 12/30/2016

Notes: The controls are beyond their service life and should be replaced.

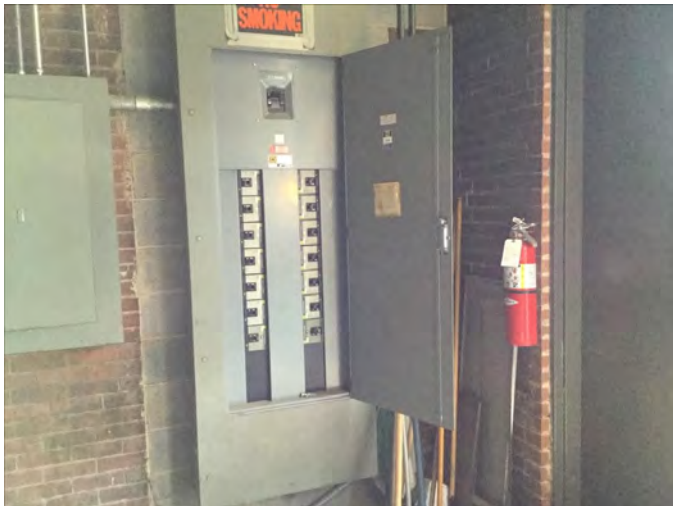
System: D5010 - Electrical Service/Distribution

Location: Throughout Building
Distress: Beyond Service Life
Category: Deferred Maintenance / Energy
Priority: 3 - Necessary/Not Yet Critical (Years 2-5)
Correction: Renew System
Qty: 32,364.00
Unit of Measure: S.F.
Estimate: \$60,165.00
Assessor Name: Terence Davis
Date Created: 12/30/2016

Notes: The electrical service distribution system is beyond its service life and should be replaced.

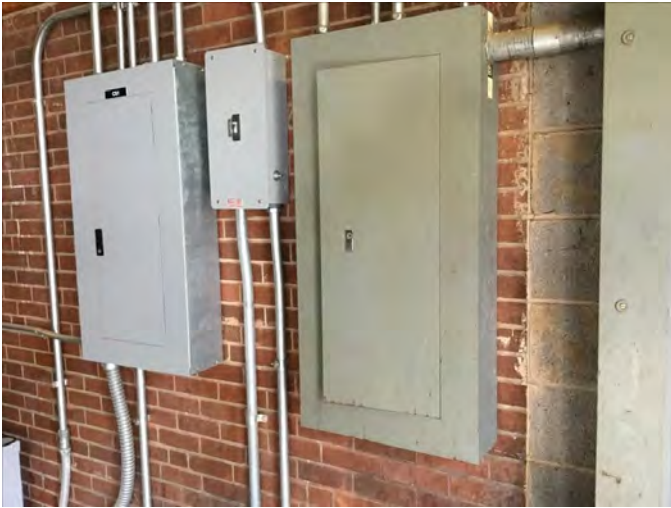
System: D5020 - Branch Wiring

Location: Throughout Building
Distress: Beyond Service Life
Category: Deferred Maintenance / Energy
Priority: 3 - Necessary/Not Yet Critical (Years 2-5)
Correction: Renew System
Qty: 32,364.00
Unit of Measure: S.F.
Estimate: \$180,138.00
Assessor Name: Terence Davis
Date Created: 12/30/2016

Notes: The branch wiring is beyond its service life and should be replaced.

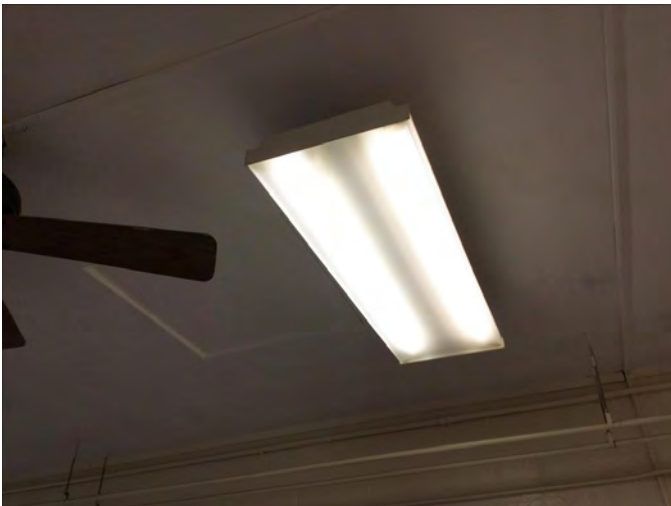
System: D5020 - Lighting

Location: Throughout Building
Distress: Beyond Service Life
Category: Deferred Maintenance / Energy
Priority: 3 - Necessary/Not Yet Critical (Years 2-5)
Correction: Renew System
Qty: 32,364.00
Unit of Measure: S.F.
Estimate: \$424,357.00
Assessor Name: Terence Davis
Date Created: 12/30/2016

Notes: The lighting system is beyond its service life and should be replaced.

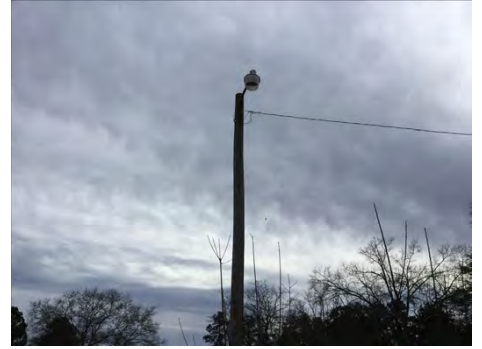
System: G4020 - Site Lighting

Note: The site lighting system is beyond its service life and should be replaced.

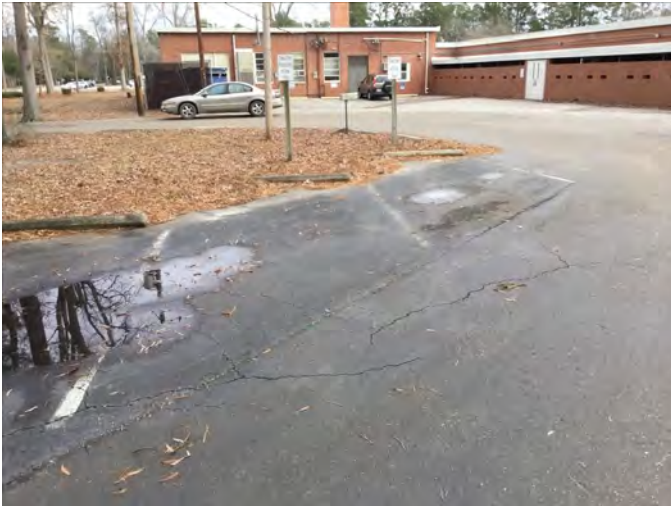
System: G2020 - Parking Lots

Location: Site
Distress: Beyond Service Life
Category: Deferred Maintenance
Priority: 3 - Necessary/Not Yet Critical (Years 2-5)
Correction: Parking lot repair and resurface
Qty: 4.00
Unit of Measure: M.S.F.
Estimate: \$5,431.06
Assessor Name: Eduardo Lopez
Date Created: 01/05/2017

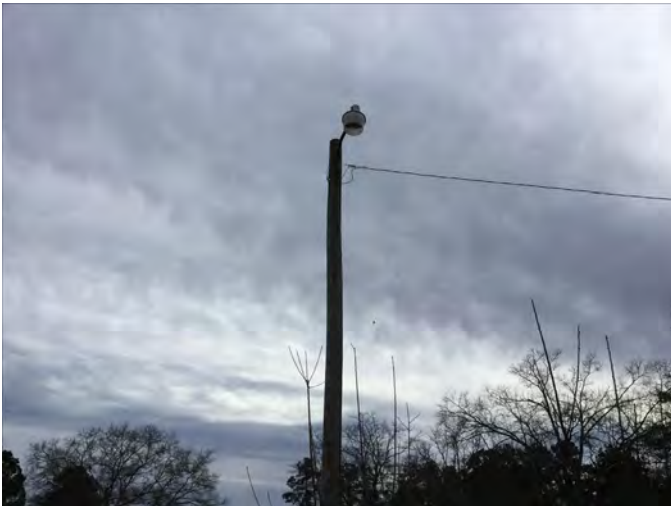
System: G4020 - Site Lighting

Location: Site
Distress: Beyond Service Life
Category: Deferred Maintenance
Priority: 3 - Necessary/Not Yet Critical (Years 2-5)
Correction: Renew System
Qty: 32,364.00
Unit of Measure: S.F.
Estimate: \$52,333.00
Assessor Name: Eduardo Lopez
Date Created: 12/30/2016
