NC School District/830 Scotland County/Elementary School

I E Johnson Elementary

Campus Assessment Report

March 11, 2017

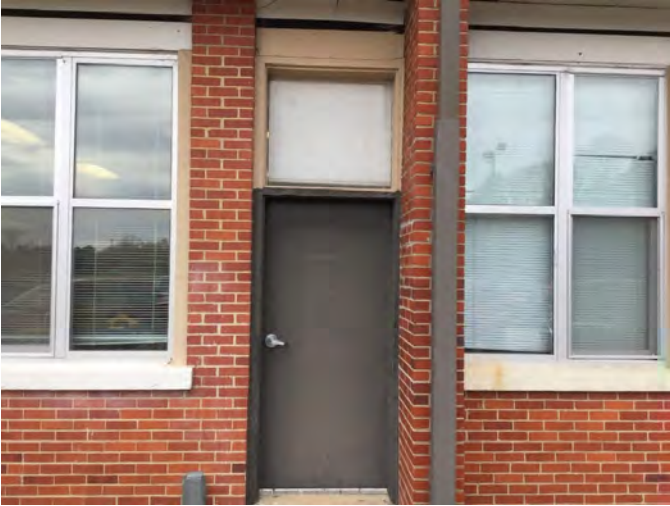
System: B2030 - Exterior Doors

Location: Exterior
Distress: Beyond Service Life
Category: Deferred Maintenance
Priority: 3 - Necessary/Not Yet Critical (Years 2-5)
Correction: Renew System
Qty: 12,000.00
Unit of Measure: S.F.
Estimate: \$14,124.00
Assessor Name: Terence Davis
Date Created: 01/13/2017

Notes: The original metal exterior doors are aged, rusted, damaged and should be replaced with energy efficient doors

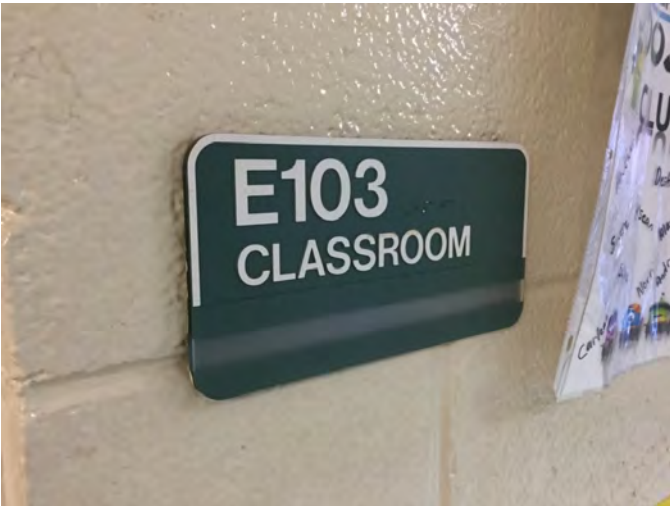
System: C1030 - Fittings

Location: Restrooms
Distress: Beyond Service Life
Category: Deferred Maintenance
Priority: 3 - Necessary/Not Yet Critical (Years 2-5)
Correction: Renew System
Qty: 12,000.00
Unit of Measure: S.F.
Estimate: \$131,208.00
Assessor Name: Terence Davis
Date Created: 01/12/2017

Notes: The bathroom fittings and toilet partitions are aged, worn, damaged and should be replaced. The original fittings are aged, and should be replaced. The room signs are inadequate, do not comply with present requirements and is recommended to replace them.

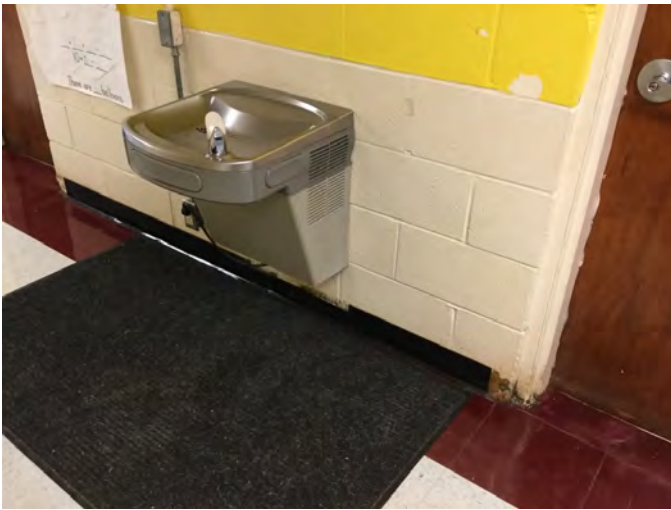
System: D2010 - Plumbing Fixtures

Location: Throughout the building
Distress: Beyond Service Life
Category: Deferred Maintenance
Priority: 3 - Necessary/Not Yet Critical (Years 2-5)
Correction: Renew System
Qty: 12,000.00
Unit of Measure: S.F.
Estimate: \$154,572.00
Assessor Name: Terence Davis
Date Created: 01/12/2017

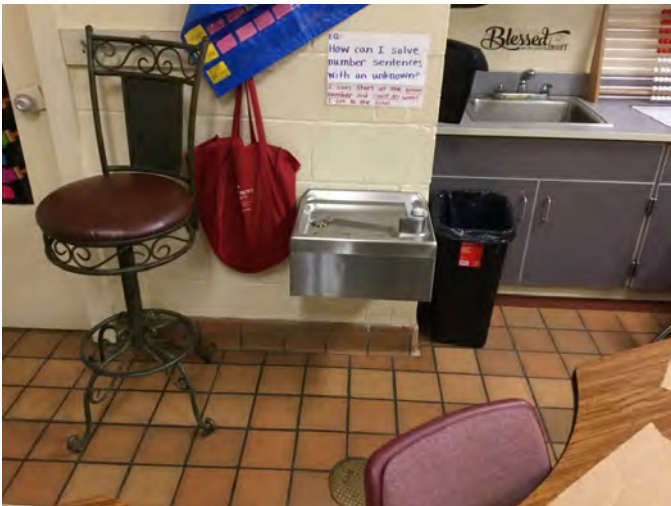
System: D2020 - Domestic Water Distribution

Location: Throughout the building.
Distress: Beyond Service Life
Category: Deferred Maintenance
Priority: 3 - Necessary/Not Yet Critical (Years 2-5)
Correction: Renew System
Qty: 12,000.00
Unit of Measure: S.F.
Estimate: \$13,068.00
Assessor Name: Terence Davis
Date Created: 01/13/2017

Notes: There are no reported issues or observed deficiencies with the domestic water piping. Due to the age of the pipe there can be internal pitting corrosion that may be a costly problem that leads to the formation of pinhole leaks and possible water contamination.

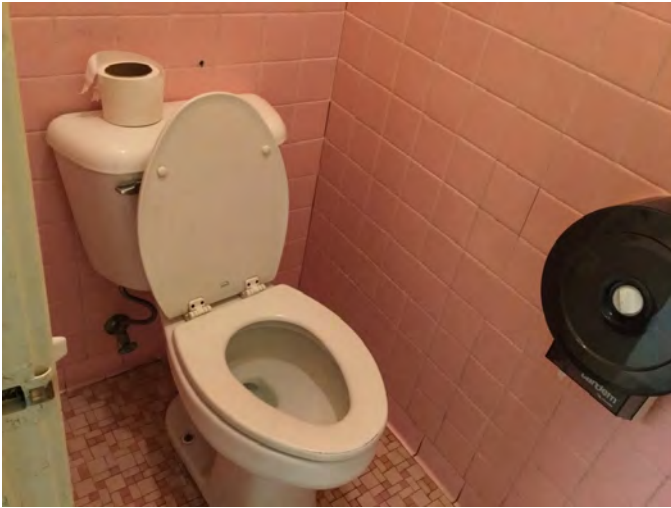
System: D2030 - Sanitary Waste

Location: Throughout the building
Distress: Beyond Service Life
Category: Deferred Maintenance
Priority: 3 - Necessary/Not Yet Critical (Years 2-5)
Correction: Renew System
Qty: 12,000.00
Unit of Measure: S.F.
Estimate: \$20,724.00
Assessor Name: Terence Davis
Date Created: 01/13/2017

Notes: There are no reported issues or observed deficiencies with the sanitary waste piping. The aging sanitary sewer piping is subject to leaks, infiltration, and it can even collapse in the interior walls. The system should be inspected with cameras to ensure that none of these deficiencies exist.

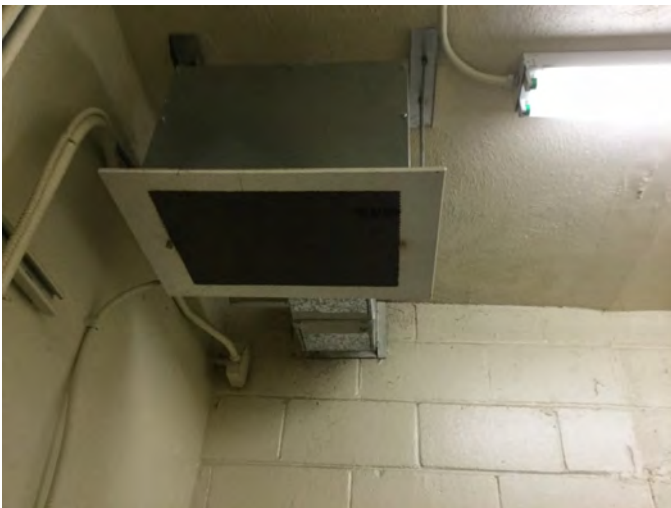
System: D3040 - Distribution Systems

Location: Throughout the building
Distress: Beyond Service Life
Category: Deferred Maintenance
Priority: 3 - Necessary/Not Yet Critical (Years 2-5)
Correction: Renew System
Qty: 12,000.00
Unit of Measure: S.F.
Estimate: \$82,632.00
Assessor Name: Terence Davis
Date Created: 01/13/2017

Notes: The exhaust fans, and hot water supply distribution system is aged, in marginal condition, and should be replaced.

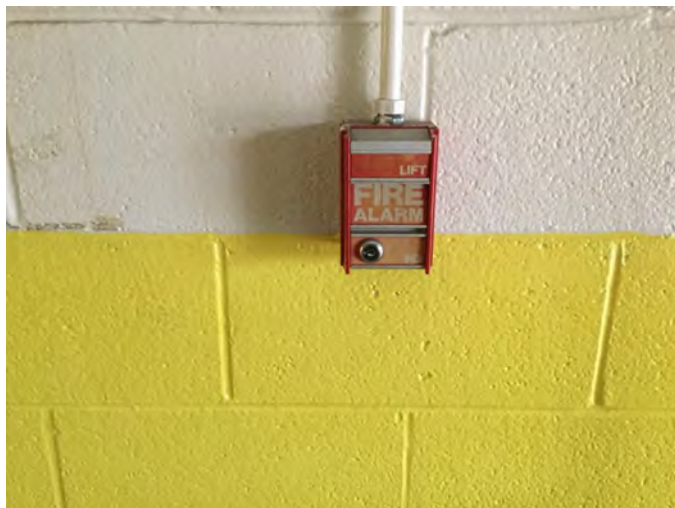
System: D5030910 - Fire Alarm Systems

Location: Throughout the building
Distress: Beyond Service Life
Category: Deferred Maintenance
Priority: 3 - Necessary/Not Yet Critical (Years 2-5)
Correction: Renew System
Qty: 12,000.00
Unit of Measure: S.F.
Estimate: \$45,672.00
Assessor Name: Terence Davis
Date Created: 01/13/2017

Notes: The original alarm system is operating but is aged. The system should be inspected and repaired or replaced to ensure that the life safety codes are preserved.

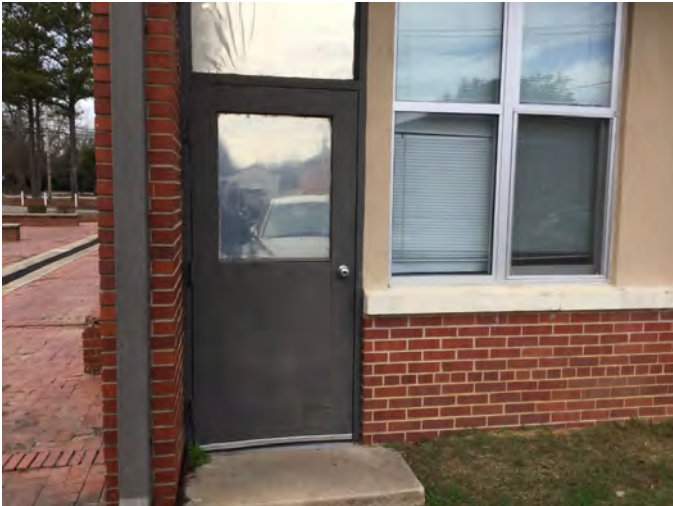
System: B2030 - Exterior Doors

Location: Throughout the building
Distress: Beyond Service Life
Category: Deferred Maintenance
Priority: 3 - Necessary/Not Yet Critical (Years 2-5)
Correction: Renew System
Qty: 33,000.00
Unit of Measure: S.F.
Estimate: \$37,026.00
Assessor Name: Terence Davis
Date Created: 01/10/2017

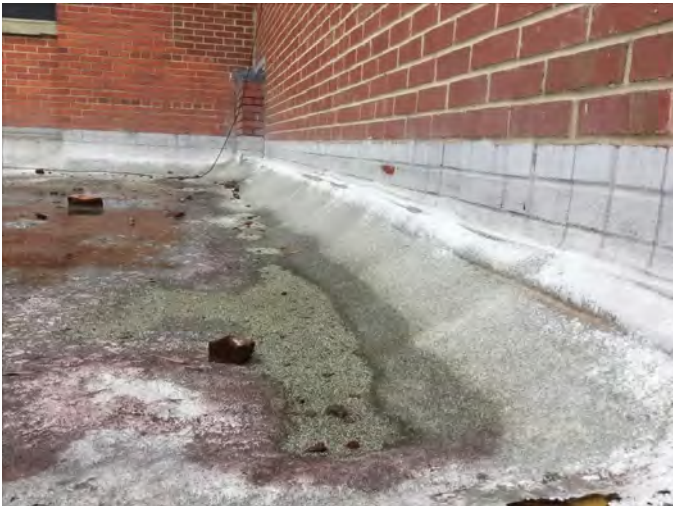
System: B3010105 - Foam Roofing

Location: Throughout the building
Distress: Beyond Service Life
Category: Deferred Maintenance
Priority: 3 - Necessary/Not Yet Critical (Years 2-5)
Correction: Renew System
Qty: 33,000.00
Unit of Measure: S.F.
Estimate: \$407,583.00
Assessor Name: Terence Davis
Date Created: 01/10/2017

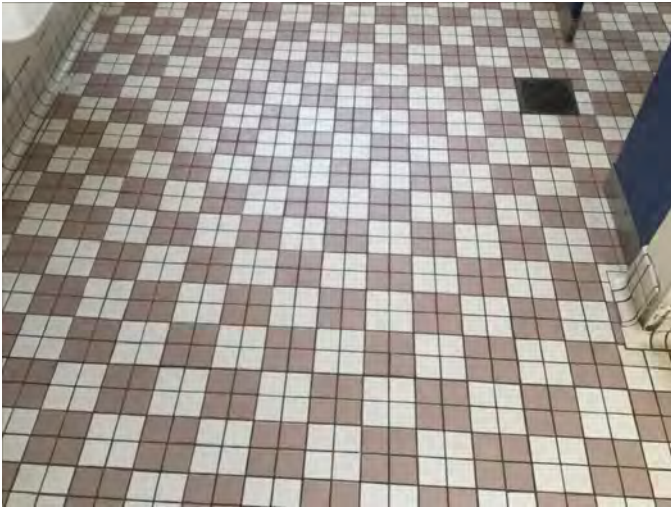
System: C3020 - Floor Finishes

Location: Throughout the building
Distress: Beyond Service Life
Category: Deferred Maintenance
Priority: 3 - Necessary/Not Yet Critical (Years 2-5)
Correction: Renew System
Qty: 33,000.00
Unit of Measure: S.F.
Estimate: \$404,745.00
Assessor Name: Terence Davis
Date Created: 01/13/2017

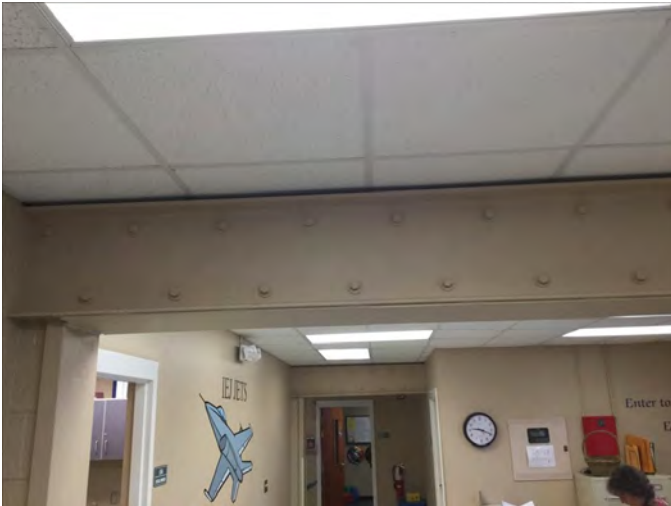
Location: Throughout the building
Distress: Beyond Service Life
Category: Deferred Maintenance
Priority: 3 - Necessary/Not Yet Critical (Years 2-5)
Correction: Renew System
Qty: 33,000.00
Unit of Measure: S.F.
Estimate: \$389,862.00
Assessor Name: Terence Davis
Date Created: 01/10/2017

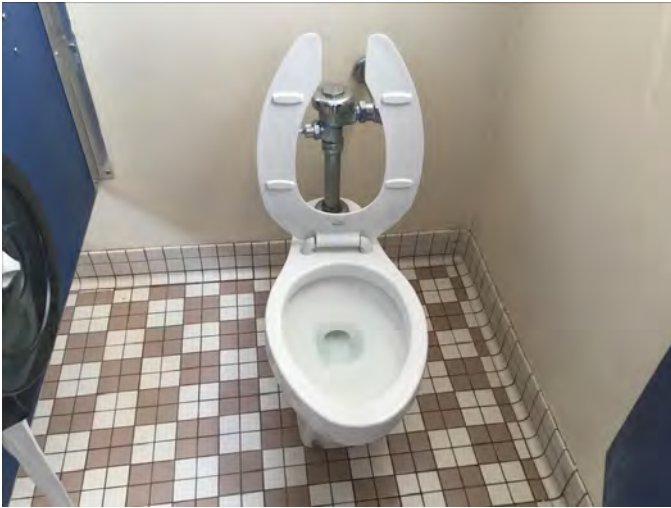
Location: Restrooms
Distress: Beyond Service Life
Category: Deferred Maintenance
Priority: 3 - Necessary/Not Yet Critical (Years 2-5)
Correction: Renew System
Qty: 33,000.00
Unit of Measure: S.F.
Estimate: \$408,738.00
Assessor Name: Terence Davis
Date Created: 01/13/2017

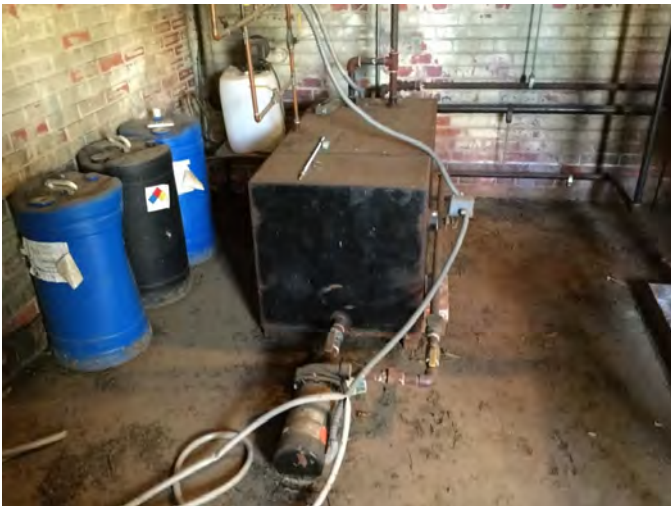
Location: Througihut the building
Distress: Beyond Service Life
Category: Deferred Maintenance
Priority: 3 - Necessary/Not Yet Critical (Years 2-5)
Correction: Renew System
Qty: 33,000.00
Unit of Measure: S.F.
Estimate: \$34,848.00
Assessor Name: Terence Davis
Date Created: 01/10/2017

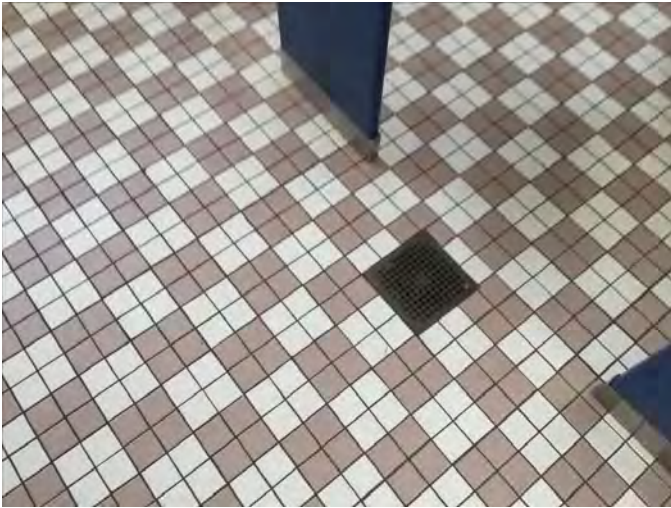
Location: Throughout the building
Distress: Beyond Service Life
Category: Deferred Maintenance
Priority: 3 - Necessary/Not Yet Critical (Years 2-5)
Correction: Renew System
Qty: 33,000.00
Unit of Measure: S.F.
Estimate: \$55,176.00
Assessor Name: Terence Davis
Date Created: 01/10/2017

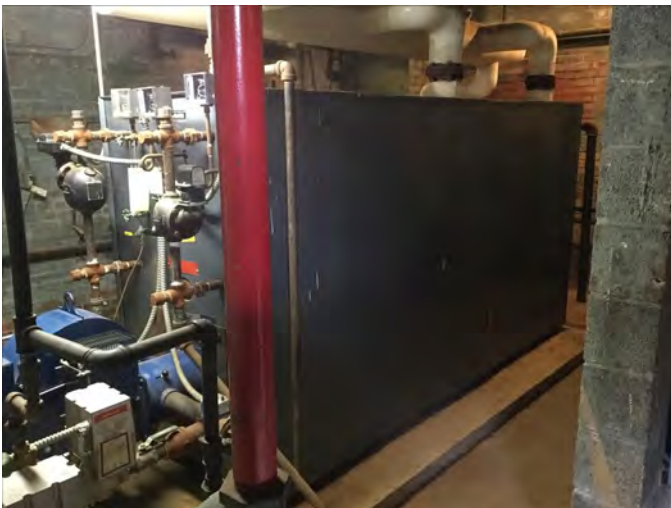
Location: Mechanical Room
Distress: Beyond Service Life
Category: Deferred Maintenance
Priority: 3 - Necessary/Not Yet Critical (Years 2-5)
Correction: Renew System
Qty: 33,000.00
Unit of Measure: S.F.
Estimate: \$180,774.00
Assessor Name: Terence Davis
Date Created: 01/11/2017

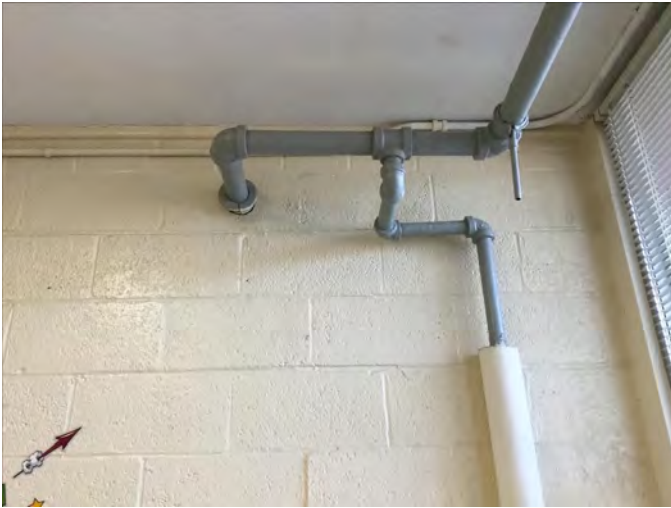
Location: Throughout the building
Distress: Beyond Service Life
Category: Deferred Maintenance
Priority: 3 - Necessary/Not Yet Critical (Years 2-5)
Correction: Renew System
Qty: 33,000.00
Unit of Measure: S.F.
Estimate: \$218,526.00
Assessor Name: Terence Davis
Date Created: 01/11/2017

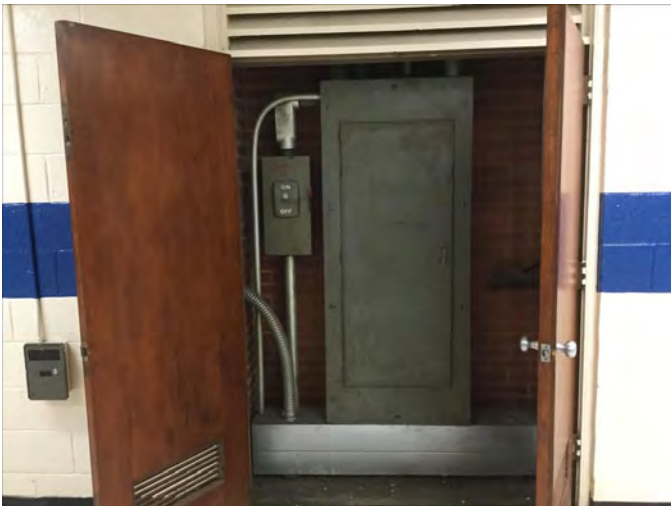
Location: Throughout the building
Distress: Beyond Service Life
Category: Deferred Maintenance
Priority: 3 - Necessary/Not Yet Critical (Years 2-5)
Correction: Renew System
Qty: 33,000.00
Unit of Measure: S.F.
Estimate: \$181,137.00
Assessor Name: Terence Davis
Date Created: 01/13/2017

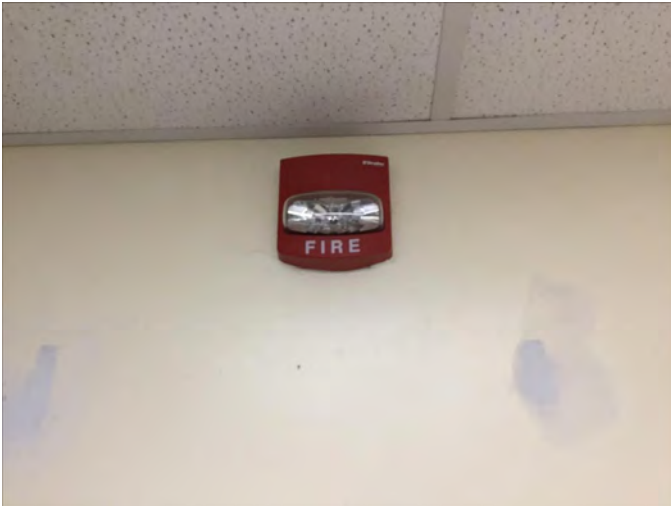
Location: Throughout
Distress: Beyond Service Life
Category: Deferred Maintenance
Priority: 3 - Necessary/Not Yet Critical (Years 2-5)
Correction: Renew System
Qty: 33,000.00
Unit of Measure: S.F.
Estimate: \$120,153.00
Assessor Name: Terence Davis
Date Created: 01/10/2017

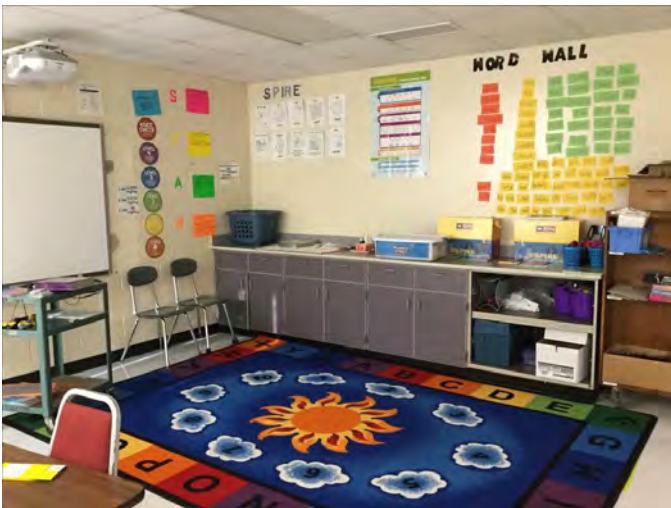
Location: Classroom
Distress: Beyond Service Life
Category: Deferred Maintenance
Priority: 3 - Necessary/Not Yet Critical (Years 2-5)
Correction: Renew System
Qty: 33,000.00
Unit of Measure: S.F.
Estimate: \$207,636.00
Assessor Name: Terence Davis
Date Created: 01/13/2017

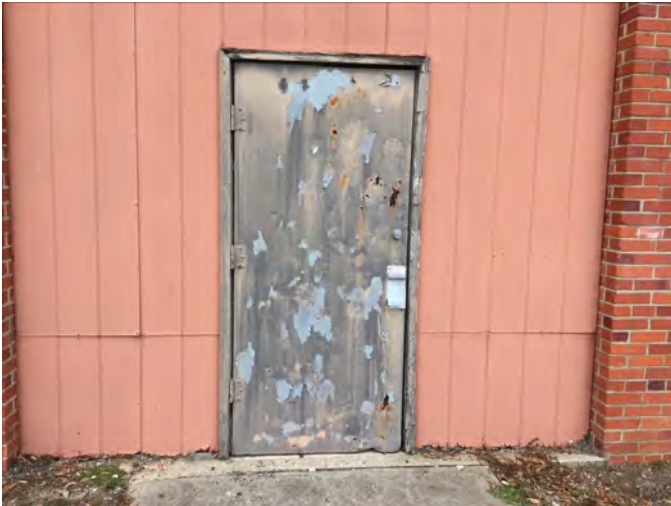
Location: Exterior
Distress: Damaged
Category: Deferred Maintenance
Priority: 1 - Currently Critical (Immediate)
Correction: Renew System
Qty: 3,584.00
Unit of Measure: S.F.
Estimate: \$4,021.00
Assessor Name: Eduardo Lopez
Date Created: 01/10/2017

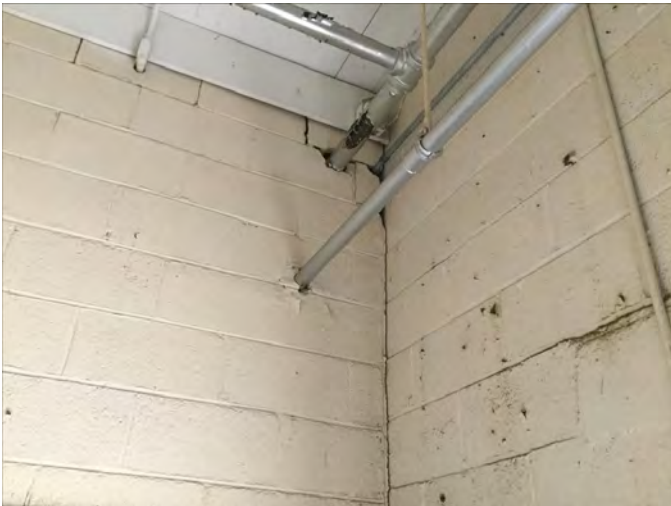
Location: Throughout the building
Distress: Damaged
Category: Deferred Maintenance
Priority: 1 - Currently Critical (Immediate)
Correction: Renew System
Qty: 3,584.00
Unit of Measure: S.F.
Estimate: \$10,763.00
Assessor Name: Eduardo Lopez
Date Created: 01/10/2017

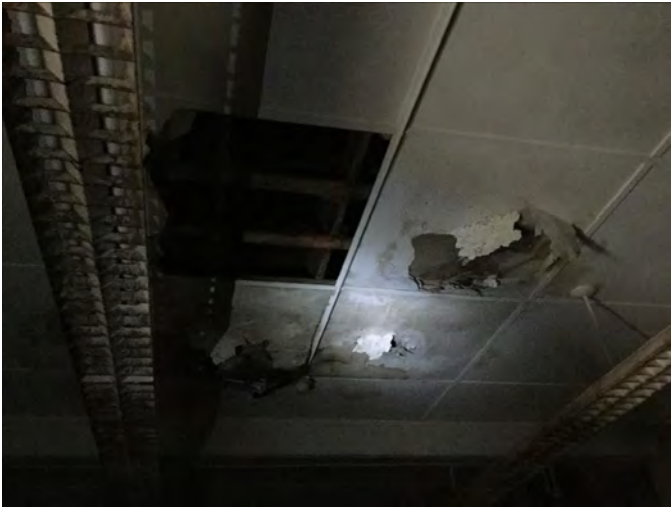
Location: Throughout the building
Distress: Damaged
Category: Deferred Maintenance
Priority: 1 - Currently Critical (Immediate)
Correction: Renew System
Qty: 3,584.00
Unit of Measure: S.F.
Estimate: \$42,341.00
Assessor Name: Eduardo Lopez
Date Created: 01/10/2017

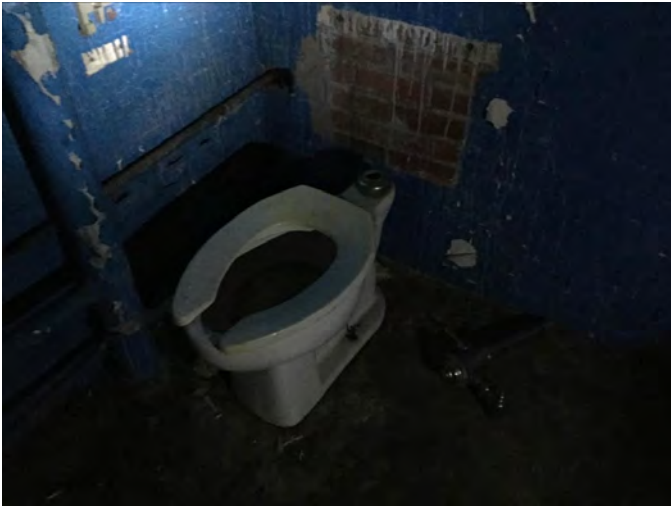
Location: Throughout the building
Distress: Beyond Service Life
Category: Deferred Maintenance
Priority: 1 - Currently Critical (Immediate)
Correction: Renew System
Qty: 3,584.00
Unit of Measure: S.F.
Estimate: \$44,391.00
Assessor Name: Eduardo Lopez
Date Created: 01/10/2017

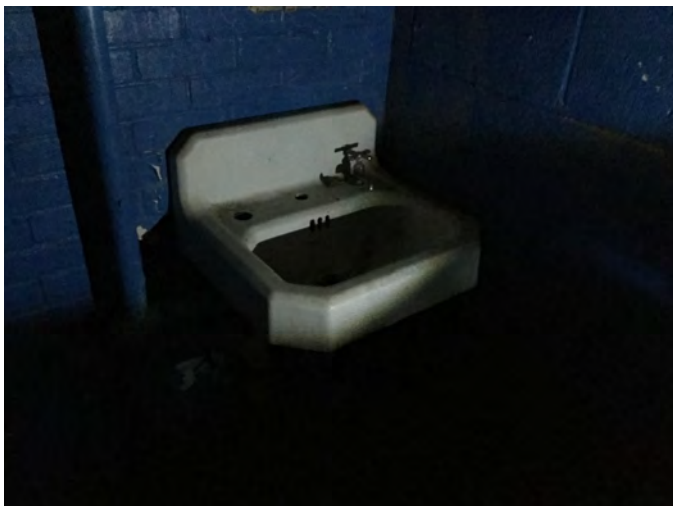
Location: Throughout the building
Distress: Failing
Category: Deferred Maintenance
Priority: 1 - Currently Critical (Immediate)
Correction: Renew System
Qty: 3,584.00
Unit of Measure: S.F.
Estimate: \$3,785.00
Assessor Name: Eduardo Lopez
Date Created: 01/10/2017

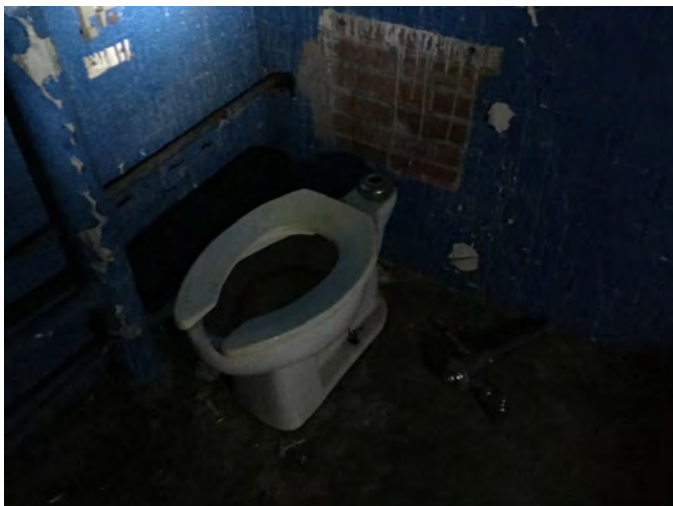
Location: Restroom
Distress: Beyond Service Life
Category: Deferred Maintenance
Priority: 1 - Currently Critical (Immediate)
Correction: Renew System
Qty: 3,584.00
Unit of Measure: S.F.
Estimate: \$5,992.00
Assessor Name: Eduardo Lopez
Date Created: 01/10/2017

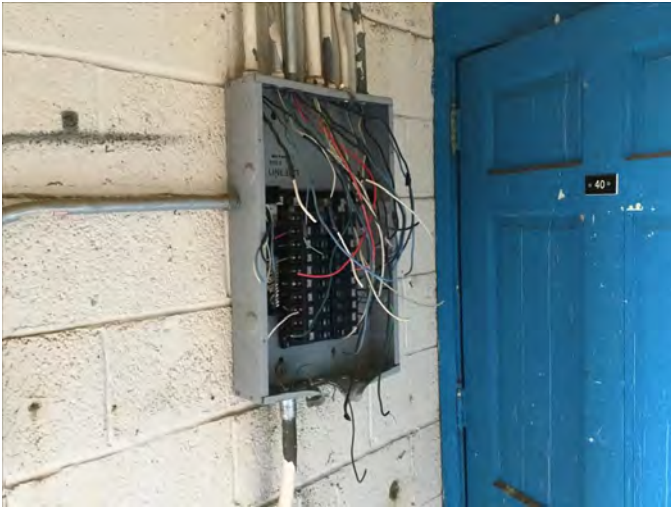
Location: Throughout
Distress: Damaged
Category: Deferred Maintenance
Priority: 1 - Currently Critical (Immediate)
Correction: Renew System
Qty: 3,584.00
Unit of Measure: S.F.
Estimate: \$6,505.00
Assessor Name: Eduardo Lopez
Date Created: 01/10/2017

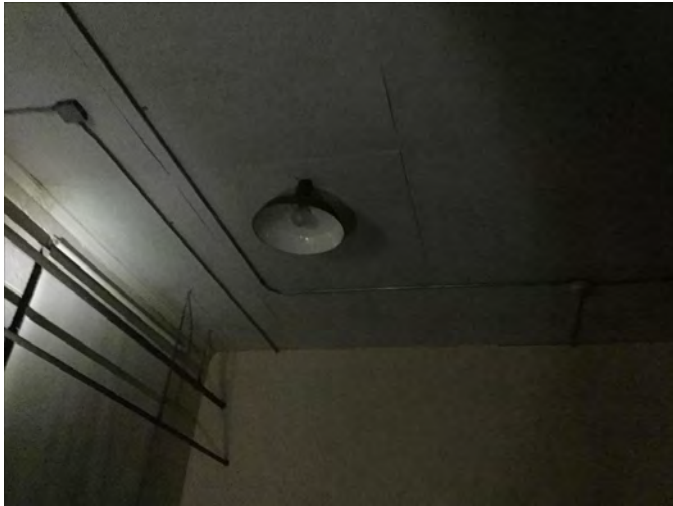
Location: Throughout the building
Distress: Beyond Service Life
Category: Deferred Maintenance
Priority: 1 - Currently Critical (Immediate)
Correction: Renew System
Qty: 3,584.00
Unit of Measure: S.F.
Estimate: \$45,890.00
Assessor Name: Eduardo Lopez
Date Created: 01/10/2017

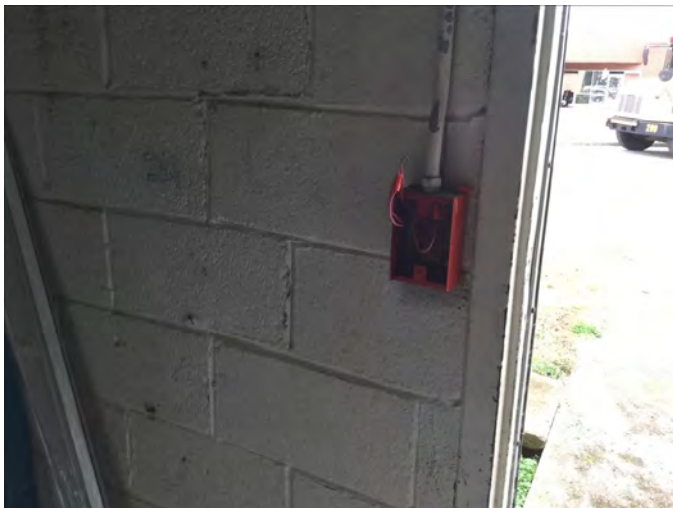
Location: Throughout the building
Distress: Beyond Service Life
Category: Building Code Compliance
Priority: 1 - Currently Critical (Immediate)
Correction: Renew System
Qty: 3,584.00
Unit of Measure: S.F.
Estimate: \$13,049.00
Assessor Name: Eduardo Lopez
Date Created: 01/10/2017

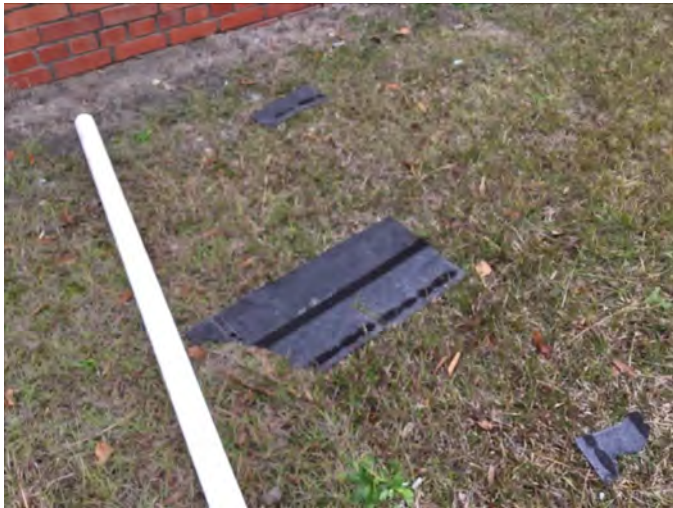
Location: Roof
Distress: Damaged
Category: Deferred Maintenance
Priority: 3 - Necessary/Not Yet Critical (Years 2-5)
Correction: Renew System
Qty: 3,584.00
Unit of Measure: S.F.
Estimate: \$22,605.00
Assessor Name: Eduardo Lopez
Date Created: 01/10/2017

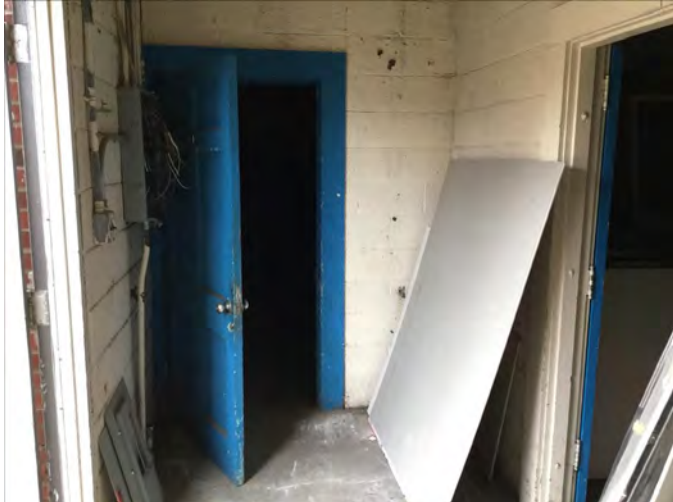
Location: Throughout the building
Distress: Damaged
Category: Deferred Maintenance
Priority: 3 - Necessary/Not Yet Critical (Years 2-5)
Correction: Renew System
Qty: 3,584.00
Unit of Measure: S.F.
Estimate: \$9,777.00
Assessor Name: Eduardo Lopez
Date Created: 01/10/2017

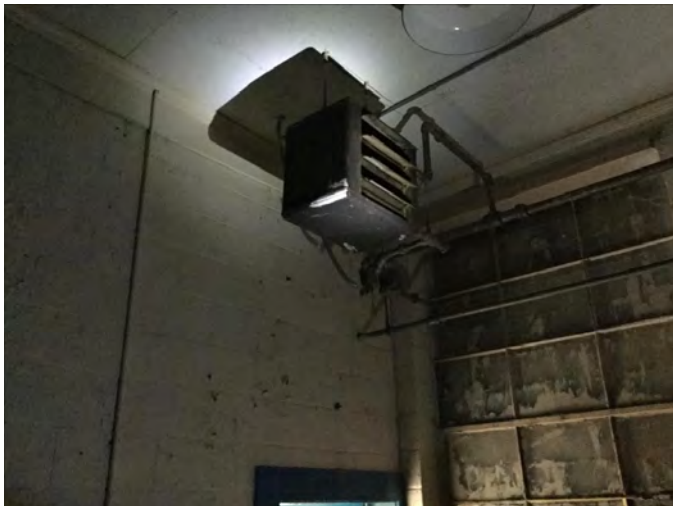
Location: Throughout the building
Distress: Failing
Category: Deferred Maintenance
Priority: 3 - Necessary/Not Yet Critical (Years 2-5)
Correction: Renew System
Qty: 3,584.00
Unit of Measure: S.F.
Estimate: \$23,733.00
Assessor Name: Eduardo Lopez
Date Created: 01/10/2017

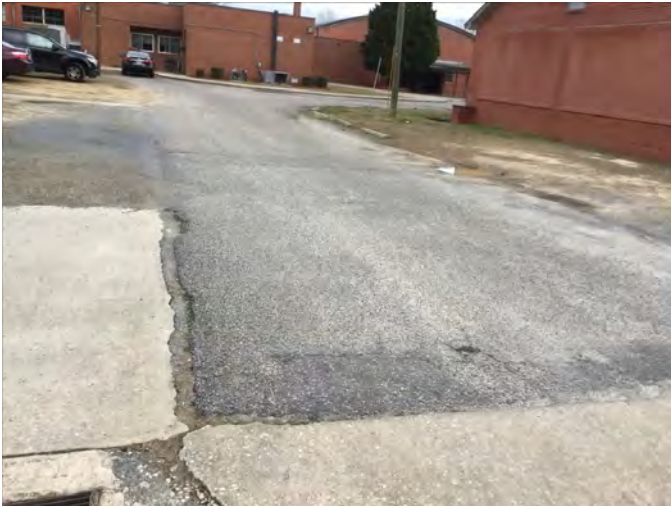
Location: Site
Distress: Damaged
Category: Deferred Maintenance
Priority: 3 - Necessary/Not Yet Critical (Years 2-5)
Correction: Renew System
Qty: 48,584.00
Unit of Measure: S.F.
Estimate: \$203,616.00
Assessor Name: Terence Davis
Date Created: 12/29/2016

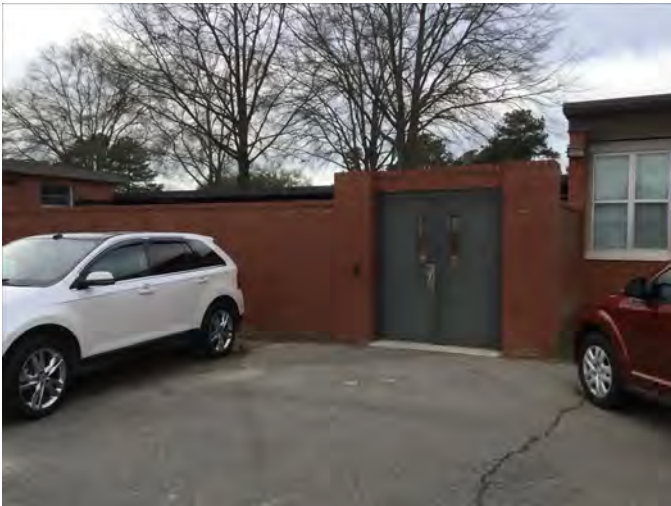
Location: Site
Distress: Damaged
Category: Deferred Maintenance
Priority: 3 - Necessary/Not Yet Critical (Years 2-5)
Correction: Renew System
Qty: 48,584.00
Unit of Measure: S.F.
Estimate: \$71,078.00
Assessor Name: Terence Davis
Date Created: 12/29/2016
