NC School District/830 Scotland County/Elementary School

North Laurinburg Elementary

Campus Assessment Report

March 11, 2017

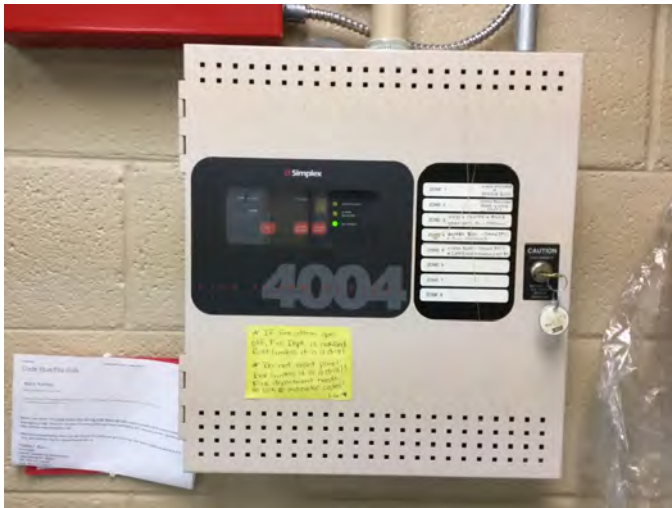
System: D5030910 - Fire Alarm Systems

Location: Throughout the building.
Distress: Beyond Service Life
Category: Building Code Compliance
Priority: 2 - Potentially Critical (Year 1)
Correction: Renew System
Qty: 20,692.00
Unit of Measure: S.F.
Estimate: \$78,754.00
Assessor Name: Eduardo Lopez
Date Created: 01/04/2017

Notes: The original fire alarm system operating as designed, but is beyond its service life and should be replaced.

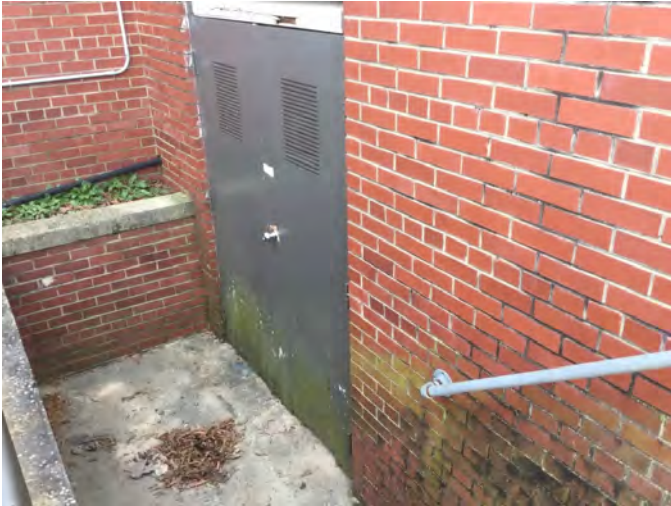
System: B2030 - Exterior Doors

Location: Exterior
Distress: Beyond Service Life
Category: Deferred Maintenance
Priority: 3 - Necessary/Not Yet Critical (Years 2-5)
Correction: Renew System
Qty: 20,692.00
Unit of Measure: S.F.
Estimate: \$24,354.00
Assessor Name: Eduardo Lopez
Date Created: 01/13/2017

Notes: The original metal exterior doors are aged, rusted, damaged and should be replaced with energy efficient doors

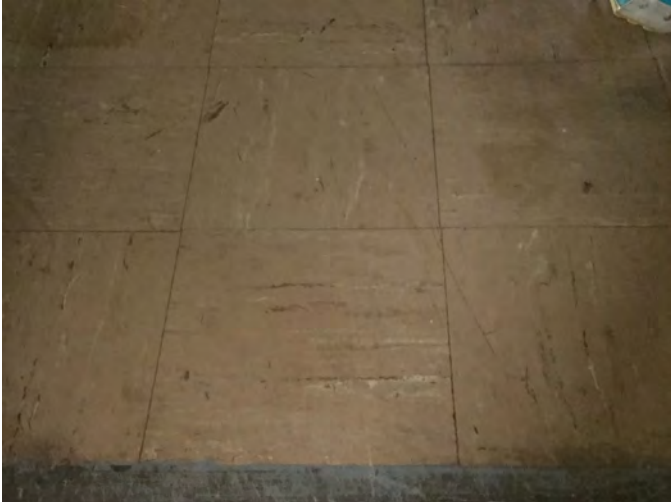
System: C3020 - Floor Finishes

Location: Throughout
Distress: Beyond Service Life
Category: Deferred Maintenance
Priority: 3 - Necessary/Not Yet Critical (Years 2-5)
Correction: Renew System
Qty: 20,692.00
Unit of Measure: S.F.
Estimate: \$264,030.00
Assessor Name: Eduardo Lopez
Date Created: 01/04/2017

Notes: The original flooring is in poor conditions, with different areas bubbling or separating seams, and should be replaced.

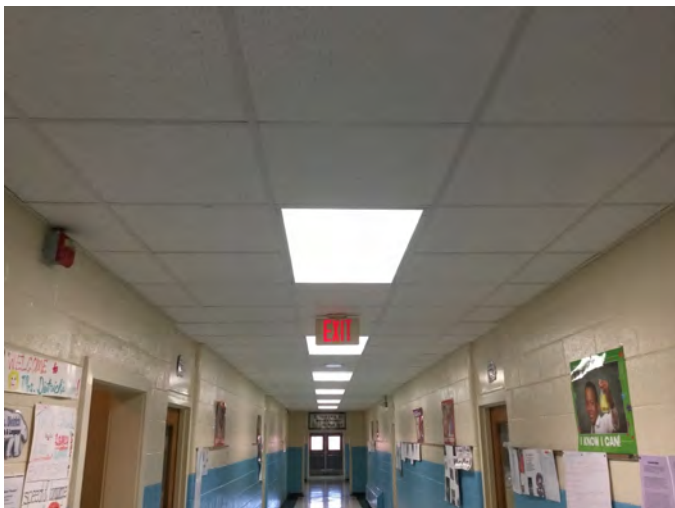
System: C3030 - Ceiling Finishes

Location: Throughout the building
Distress: Beyond Service Life
Category: Deferred Maintenance
Priority: 3 - Necessary/Not Yet Critical (Years 2-5)
Correction: Renew System
Qty: 20,692.00
Unit of Measure: S.F.
Estimate: \$254,698.00
Assessor Name: Eduardo Lopez
Date Created: 01/04/2017

Notes: The ceiling tiles have been replaced as needed. However the grid shows signs of aging and most tiles are sagging or damaged and should be replaced.

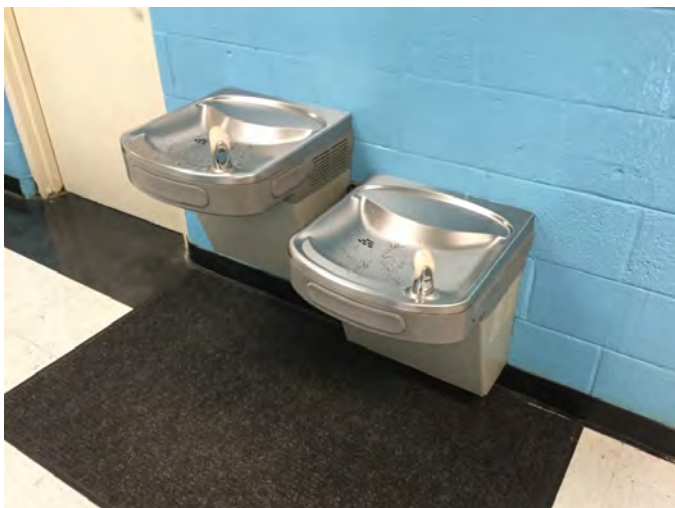
System: D2010 - Plumbing Fixtures

Location: Restroom/Classroom
Distress: Beyond Service Life
Category: Deferred Maintenance
Priority: 3 - Necessary/Not Yet Critical (Years 2-5)
Correction: Renew System
Qty: 20,692.00
Unit of Measure: S.F.
Estimate: \$266,534.00
Assessor Name: Eduardo Lopez
Date Created: 01/04/2017

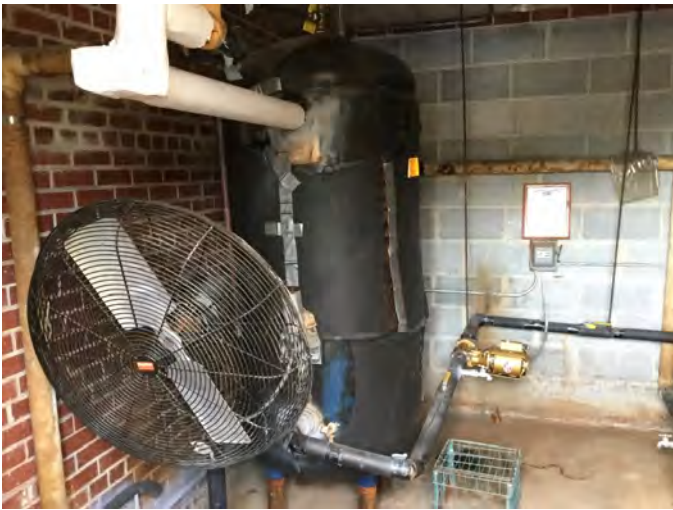
System: D2020 - Domestic Water Distribution

Location: Throughout the building.
Distress: Beyond Service Life
Category: Deferred Maintenance
Priority: 3 - Necessary/Not Yet Critical (Years 2-5)
Correction: Renew System
Qty: 20,692.00
Unit of Measure: S.F.
Estimate: \$22,534.00
Assessor Name: Eduardo Lopez
Date Created: 01/13/2017

Notes: There are no reported issues or observed deficiencies with the domestic water piping. Due to the age of the pipe there can be internal pitting corrosion that may be a costly problem that leads to the formation of pinhole leaks and possible water contamination.

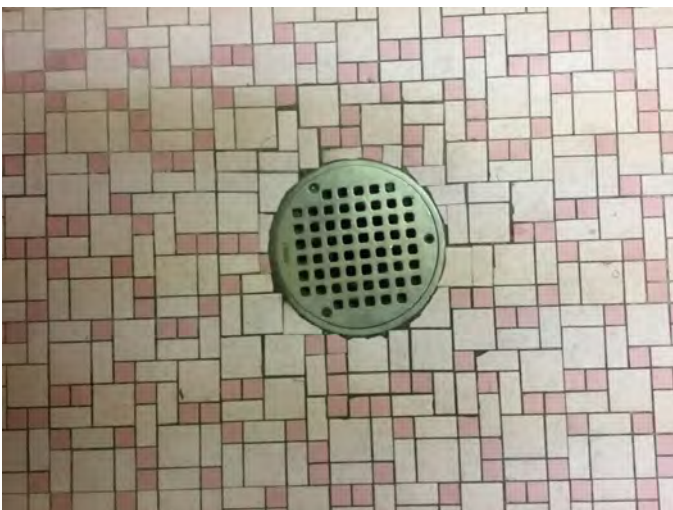
System: D2030 - Sanitary Waste

Location: Throughout the building
Distress: Beyond Service Life
Category: Deferred Maintenance
Priority: 3 - Necessary/Not Yet Critical (Years 2-5)
Correction: Renew System
Qty: 20,692.00
Unit of Measure: S.F.
Estimate: \$35,735.00
Assessor Name: Eduardo Lopez
Date Created: 01/13/2017

Notes: There are no reported issues or observed deficiencies with the sanitary waste piping. The aging sanitary sewer piping is subject to leaks, infiltration, and it can even collapse in the interior walls. The system should be inspected with cameras to ensure that none of these deficiencies exist.

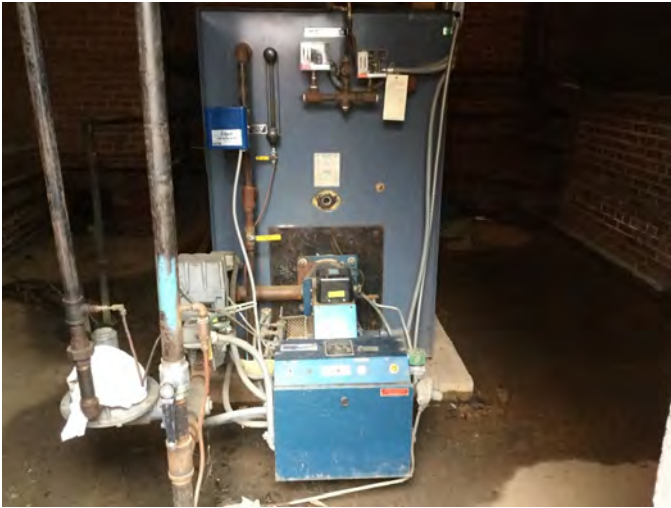
System: D3020 - Heat Generating Systems

Location: Mechanical Room
Distress: Beyond Service Life
Category: Deferred Maintenance
Priority: 3 - Necessary/Not Yet Critical (Years 2-5)
Correction: Renew System
Qty: 20,692.00
Unit of Measure: S.F.
Estimate: \$96,963.00
Assessor Name: Eduardo Lopez
Date Created: 01/09/2017

Notes: The original gas fired boiler is aged, rusted, inefficient, becoming logistically unsupportable and should be replaced with an energy efficient model.

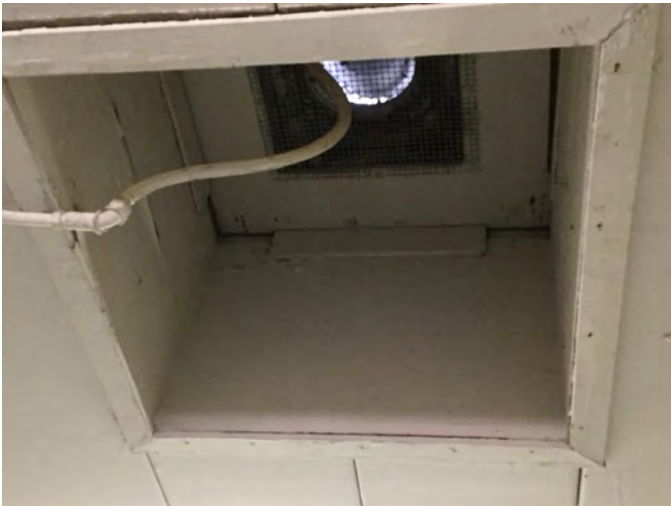
System: D3040 - Distribution Systems

Location: Throughout the building
Distress: Beyond Service Life
Category: Deferred Maintenance
Priority: 3 - Necessary/Not Yet Critical (Years 2-5)
Correction: Renew System
Qty: 20,692.00
Unit of Measure: S.F.
Estimate: \$142,485.00
Assessor Name: Eduardo Lopez
Date Created: 01/13/2017

Notes: The exhaust fans, and hot water supply distribution system is aged, in marginal condition, and should be replaced.

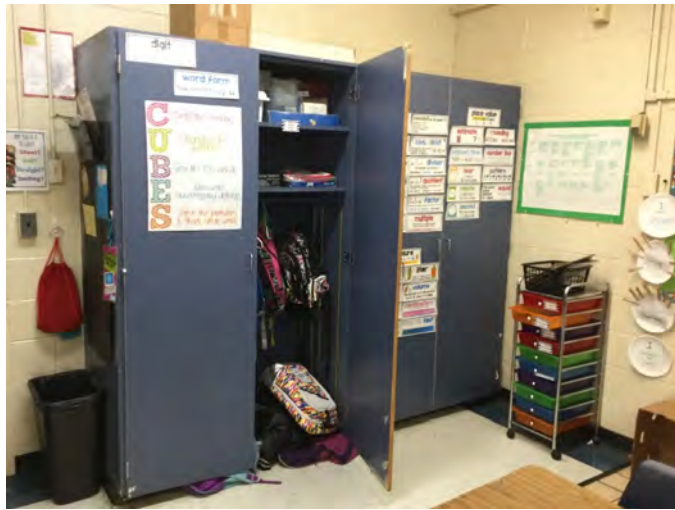
System: E2010 - Fixed Furnishings

Location: Classroom
Distress: Damaged
Category: Deferred Maintenance
Priority: 3 - Necessary/Not Yet Critical (Years 2-5)
Correction: Renew System
Qty: 20,692.00
Unit of Measure: S.F.
Estimate: \$135,429.00
Assessor Name: Eduardo Lopez
Date Created: 01/04/2017

Notes: The building casework is aged and worn and should be replaced.

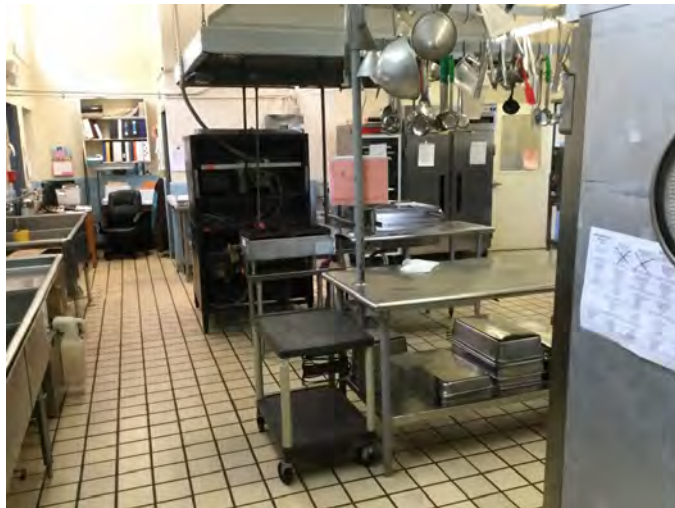
System: E1090 - Other Equipment

Location: Kitchen
Distress: Beyond Service Life
Category: Deferred Maintenance
Priority: 4 - Recommended (Years 6-10)
Correction: Renew System
Qty: 20,692.00
Unit of Measure: S.F.
Estimate: \$44,157.00
Assessor Name: Eduardo Lopez
Date Created: 01/04/2017

Notes: The kitchen equipment is beyond its expected service life, becoming logistically unsupportable and should be replaced.

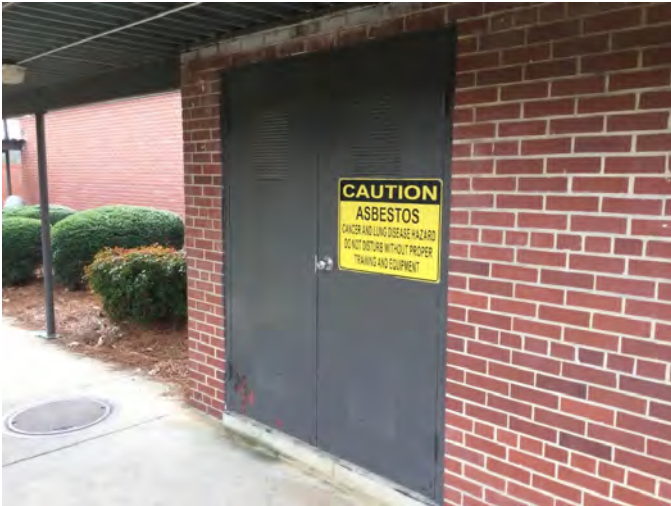
System: B2030 - Exterior Doors

Location: Exterior
Distress: Beyond Service Life
Category: Deferred Maintenance
Priority: 3 - Necessary/Not Yet Critical (Years 2-5)
Correction: Renew System
Qty: 10,300.00
Unit of Measure: S.F.
Estimate: \$12,123.00
Assessor Name: Eduardo Lopez
Date Created: 01/13/2017

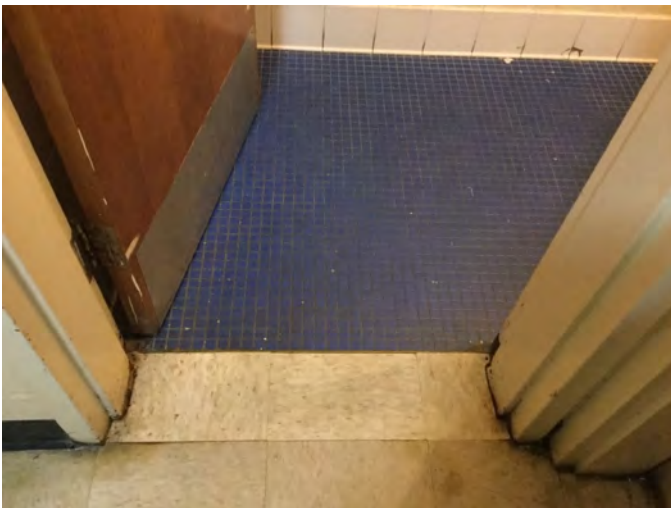
System: C3020 - Floor Finishes

Location: Throughout
Distress: Beyond Service Life
Category: Deferred Maintenance
Priority: 3 - Necessary/Not Yet Critical (Years 2-5)
Correction: Renew System
Qty: 10,300.00
Unit of Measure: S.F.
Estimate: \$131,428.00
Assessor Name: Eduardo Lopez
Date Created: 01/04/2017

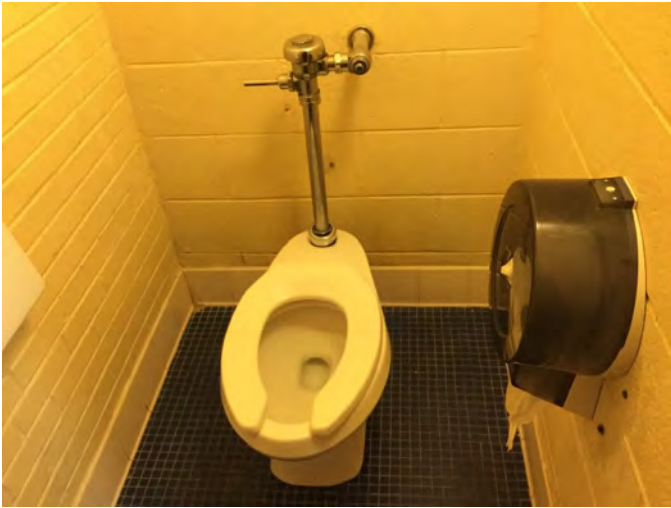
System: D2010 - Plumbing Fixtures

Location: Restrooms
Distress: Beyond Service Life
Category: Deferred Maintenance
Priority: 3 - Necessary/Not Yet Critical (Years 2-5)
Correction: Renew System
Qty: 10,300.00
Unit of Measure: S.F.
Estimate: \$132,674.00
Assessor Name: Eduardo Lopez
Date Created: 01/04/2017

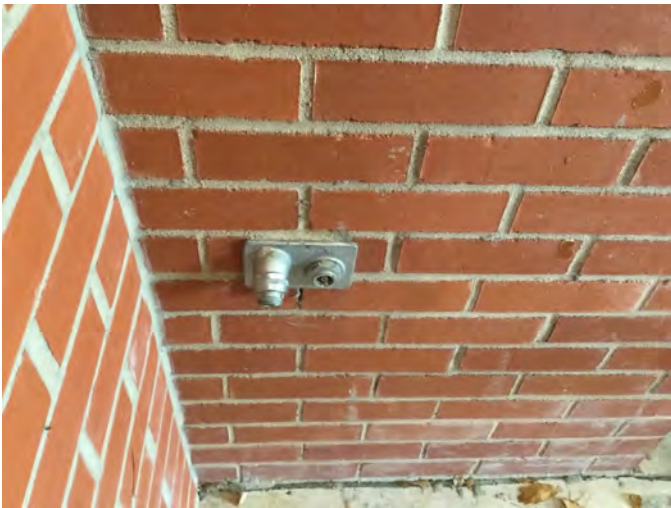
System: D2020 - Domestic Water Distribution

Location: Throughout the building
Distress: Beyond Service Life
Category: Deferred Maintenance
Priority: 3 - Necessary/Not Yet Critical (Years 2-5)
Correction: Renew System
Qty: 10,300.00
Unit of Measure: S.F.
Estimate: \$11,217.00
Assessor Name: Eduardo Lopez
Date Created: 01/13/2017

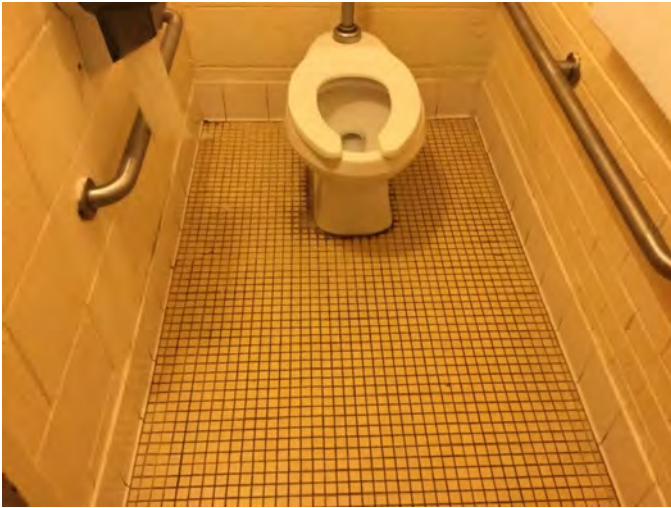
System: D2030 - Sanitary Waste

Location: Throughout the building
Distress: Beyond Service Life
Category: Deferred Maintenance
Priority: 3 - Necessary/Not Yet Critical (Years 2-5)
Correction: Renew System
Qty: 10,300.00
Unit of Measure: S.F.
Estimate: \$17,788.00
Assessor Name: Eduardo Lopez
Date Created: 01/13/2017

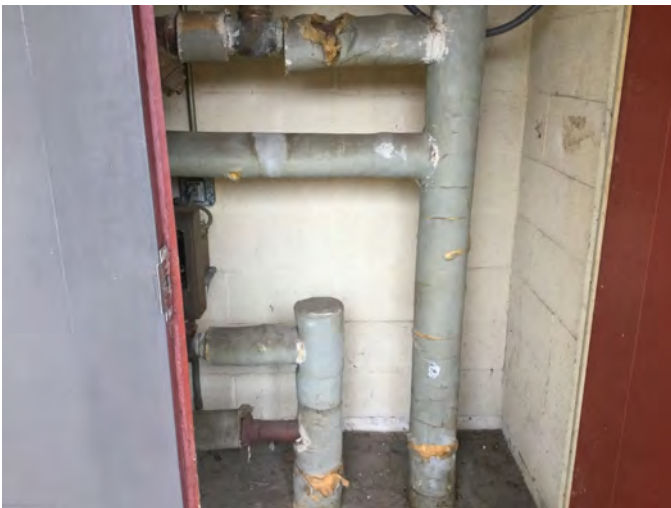
System: D3040 - Distribution Systems

Location: Throughout the building
Distress: Beyond Service Life
Category: Deferred Maintenance
Priority: 3 - Necessary/Not Yet Critical (Years 2-5)
Correction: Renew System
Qty: 10,300.00
Unit of Measure: S.F.
Estimate: \$70,926.00
Assessor Name: Eduardo Lopez
Date Created: 01/13/2017

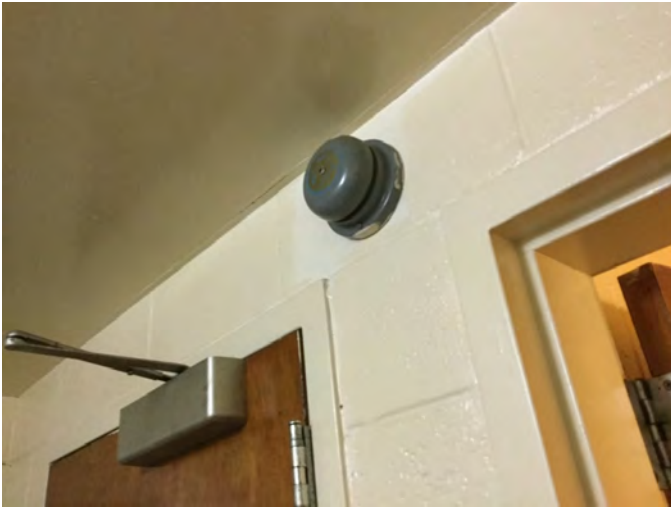
System: D5030910 - Fire Alarm Systems

Location: Throughout
Distress: Beyond Service Life
Category: Building Code Compliance
Priority: 3 - Necessary/Not Yet Critical (Years 2-5)
Correction: Renew System
Qty: 10,300.00
Unit of Measure: S.F.
Estimate: \$39,202.00
Assessor Name: Eduardo Lopez
Date Created: 01/04/2017

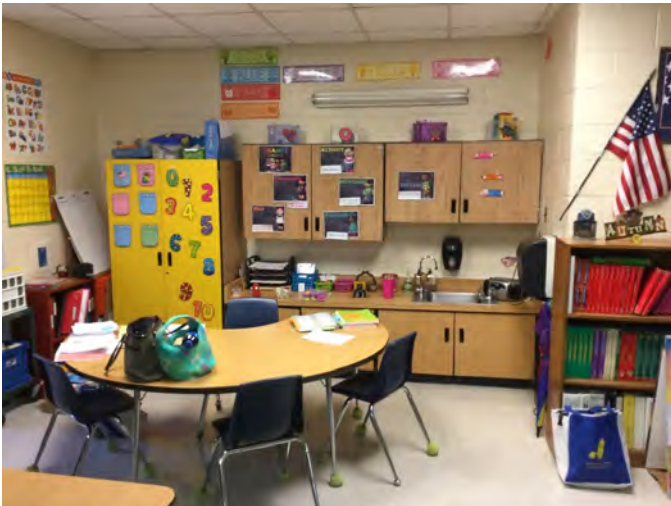
System: E2010 - Fixed Furnishings

Location: Classrooms
Distress: Damaged
Category: Deferred Maintenance
Priority: 3 - Necessary/Not Yet Critical (Years 2-5)
Correction: Renew System
Qty: 10,300.00
Unit of Measure: S.F.
Estimate: \$67,414.00
Assessor Name: Eduardo Lopez
Date Created: 01/04/2017

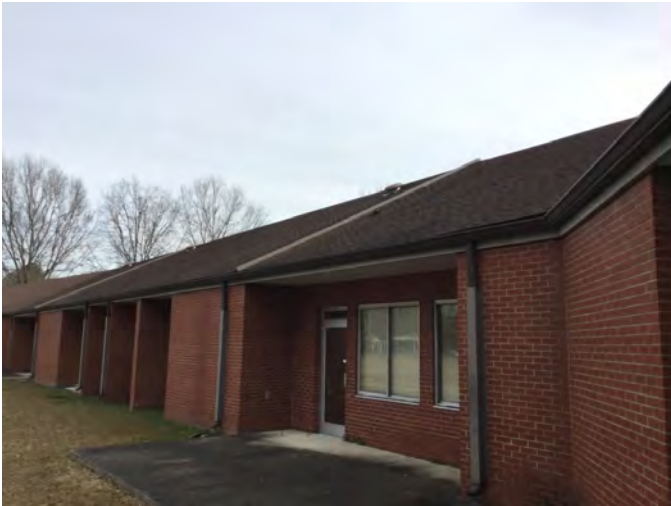
Location: Roof
Distress: Damaged
Category: Deferred Maintenance
Priority: 3 - Necessary/Not Yet Critical (Years 2-5)
Correction: Renew System
Qty: 16,000.00
Unit of Measure: S.F.
Estimate: \$100,915.00
Assessor Name: Terence Davis
Date Created: 01/10/2017

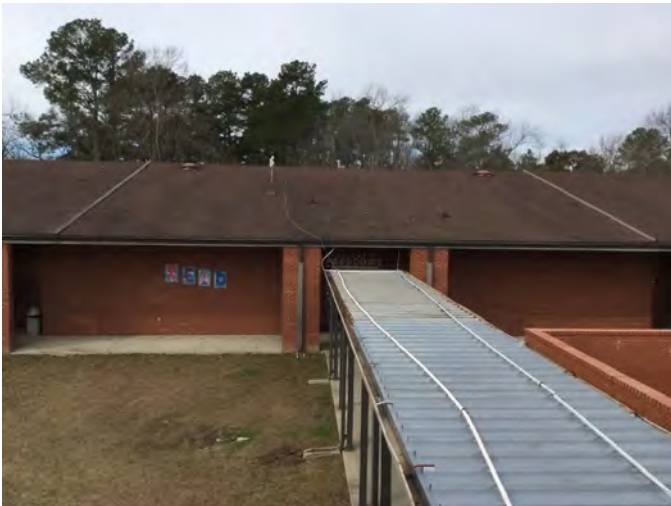
System: B3020 - Roof Openings

Location: 1983 Media Center
Distress: Beyond Service Life
Category: Deferred Maintenance
Priority: 3 - Necessary/Not Yet Critical (Years 2-5)
Correction: Renew System
Qty: 16,000.00
Unit of Measure: S.F.
Estimate: \$8,448.00
Assessor Name: Terence Davis
Date Created: 02/21/2017

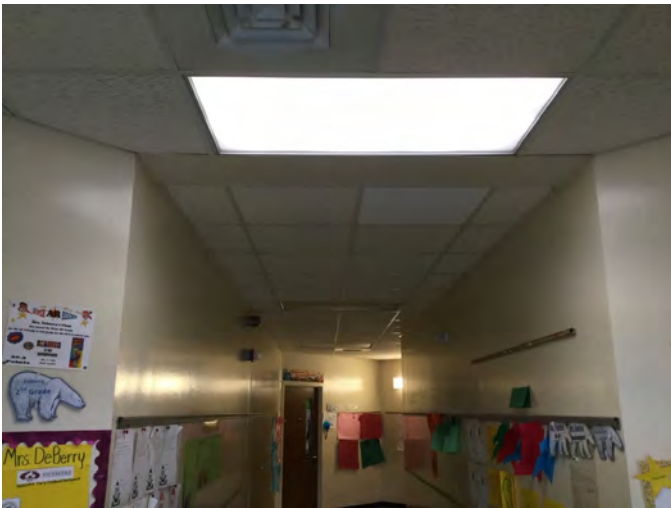
Location: Throughout the building
Distress: Beyond Service Life
Category: Deferred Maintenance
Priority: 3 - Necessary/Not Yet Critical (Years 2-5)
Correction: Renew System
Qty: 16,000.00
Unit of Measure: S.F.
Estimate: \$196,944.00
Assessor Name: Terence Davis
Date Created: 01/04/2017

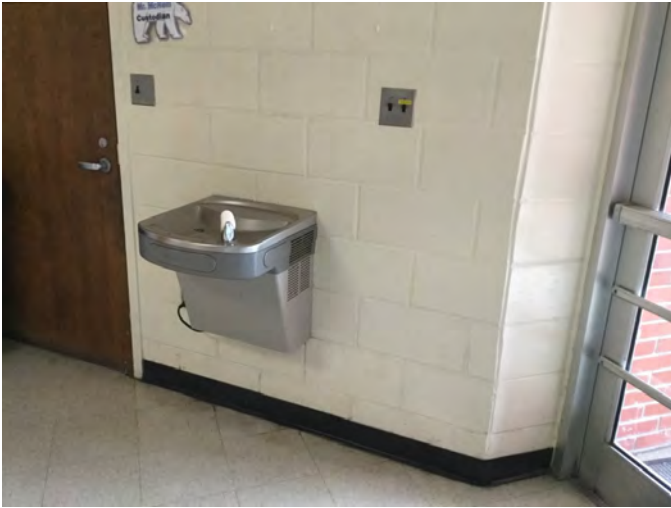
Location: Restroom
Distress: Beyond Service Life
Category: Deferred Maintenance
Priority: 3 - Necessary/Not Yet Critical (Years 2-5)
Correction: Renew System
Qty: 16,000.00
Unit of Measure: S.F.
Estimate: \$206,096.00
Assessor Name: Terence Davis
Date Created: 01/04/2017

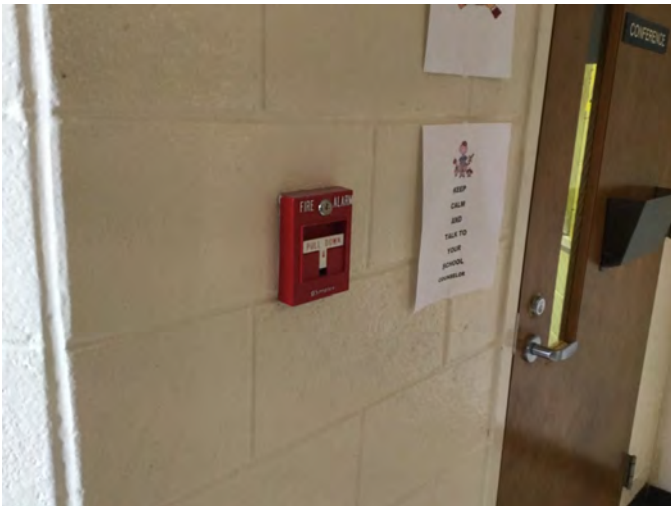
Location: Throughout
Distress: Beyond Service Life
Category: Deferred Maintenance
Priority: 3 - Necessary/Not Yet Critical (Years 2-5)
Correction: Renew System
Qty: 16,000.00
Unit of Measure: S.F.
Estimate: \$60,896.00
Assessor Name: Terence Davis
Date Created: 01/04/2017

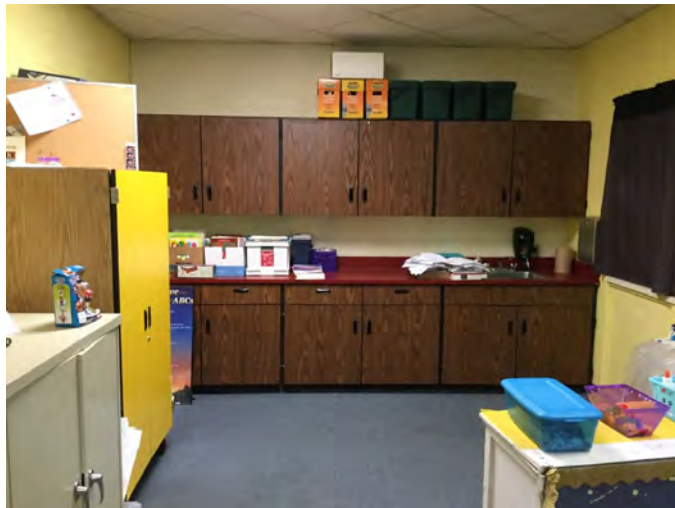
Location: Classrooms
Distress: Damaged
Category: Deferred Maintenance
Priority: 3 - Necessary/Not Yet Critical (Years 2-5)
Correction: Renew System
Qty: 16,000.00
Unit of Measure: S.F.
Estimate: \$104,720.00
Assessor Name: Terence Davis
Date Created: 01/04/2017
