NC School District/830 Scotland County/Elementary School

South Scotland Elementary

Campus Assessment Report

March 11, 2017

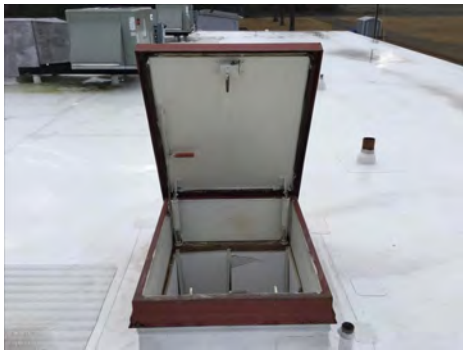
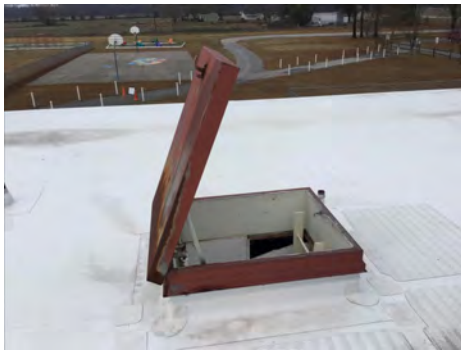
System: B3020 - Roof Openings

Note: The roof opening is beyond its service life and should be replaced with an OSHA compliant access hatch.

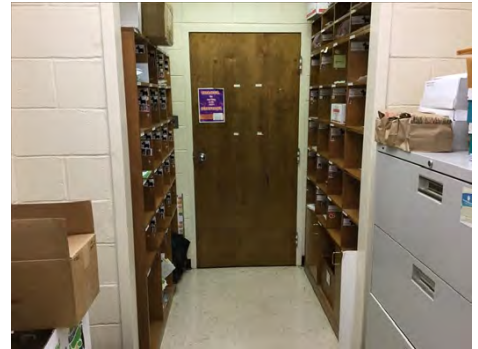
System: C1020 - Interior Doors

Note: The interior doors are beyond their service life and should be replaced.

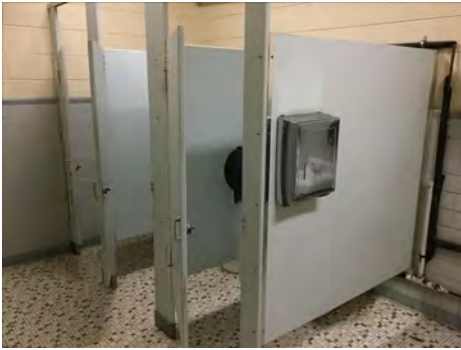
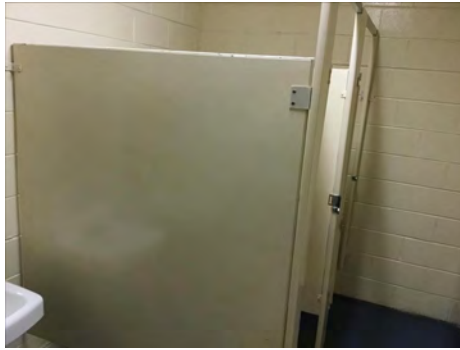
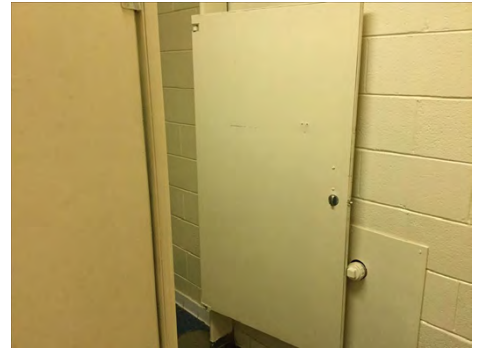
System: C1030 - Fittings

Note: The fittings are beyond their service life and should be replaced.

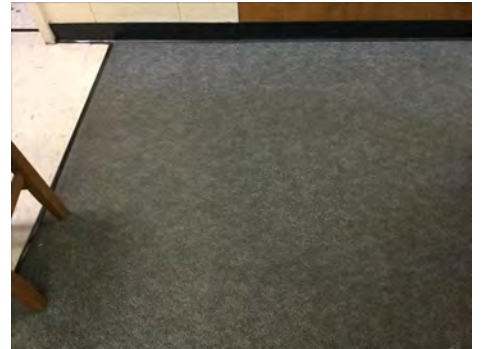
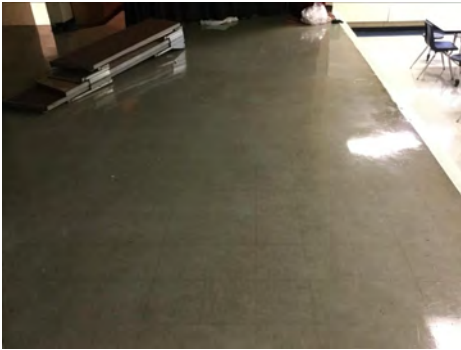
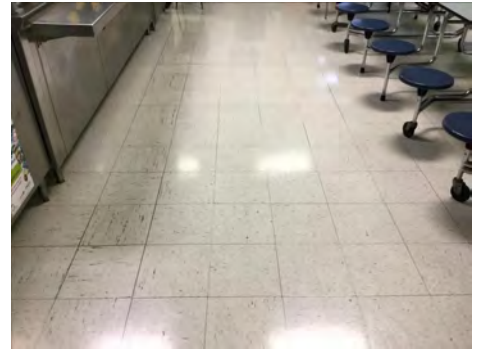
System: C3020 - Floor Finishes

Note: The carpet is beyond its service life and should be replaced.

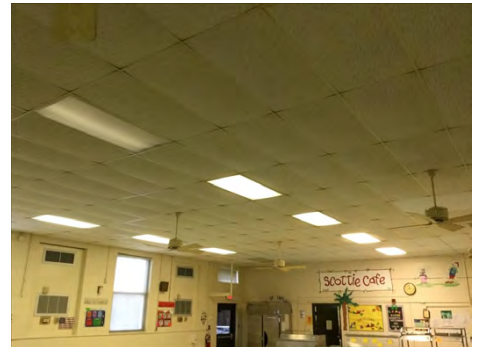
System: C3030 - Ceiling Finishes

Note: The acoustical ceiling tiles are beyond their service life and should be replaced.

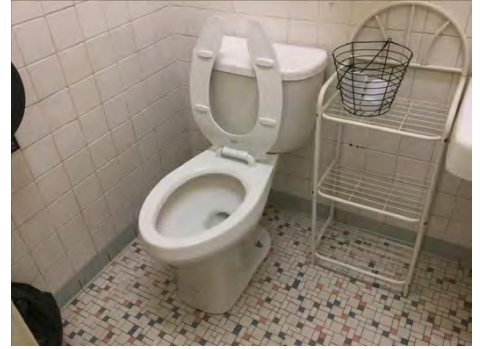
System: D2010 - Plumbing Fixtures

Note: The plumbing fixtures are beyond their service life and should be replaced.

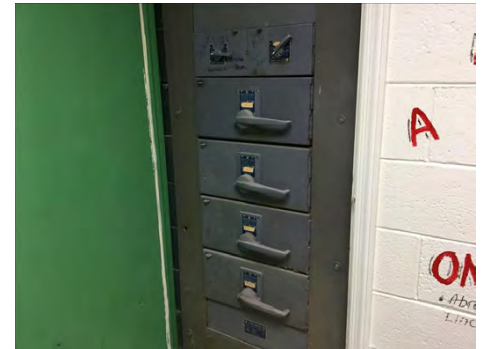
System: D5010 - Electrical Service/Distribution

Note: The main electrical system is beyond its service life and should be replaced.

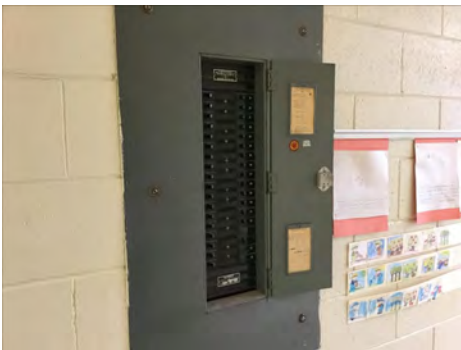
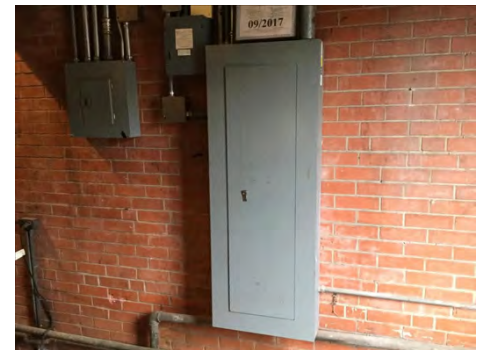
System: D5020 - Branch Wiring

Note: The branch wiring system is beyond its service life and should be replaced.

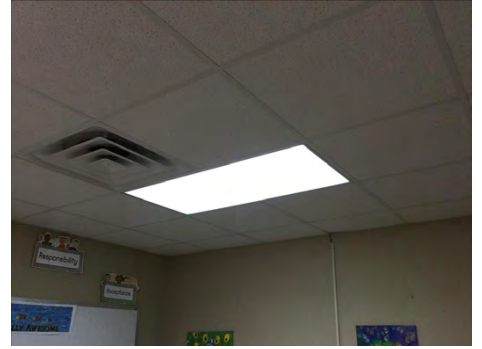
System: D5020 - Lighting

Note: The lights are primarily T-12's and are beyond their service life and they get replaced by T-8's as per needs basis.

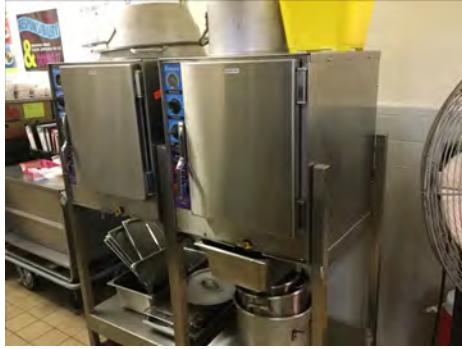
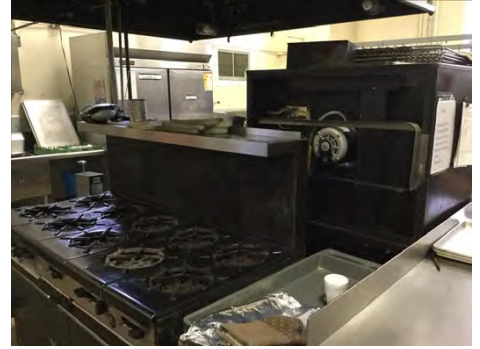
System: E1090 - Other Equipment

Note: The kitchen equipment is beyond its service life and should be replaced.

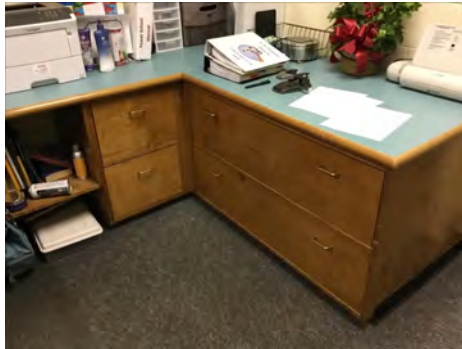
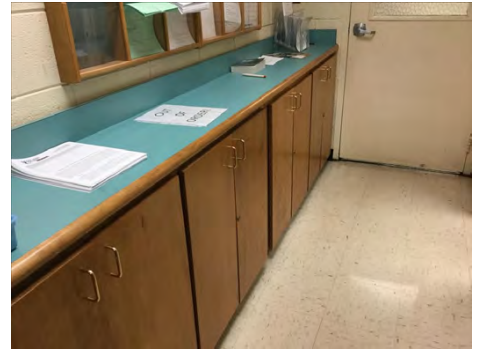
System: E2010 - Fixed Furnishings

Note: The fixed furnishings are beyond their service life and should be replaced.

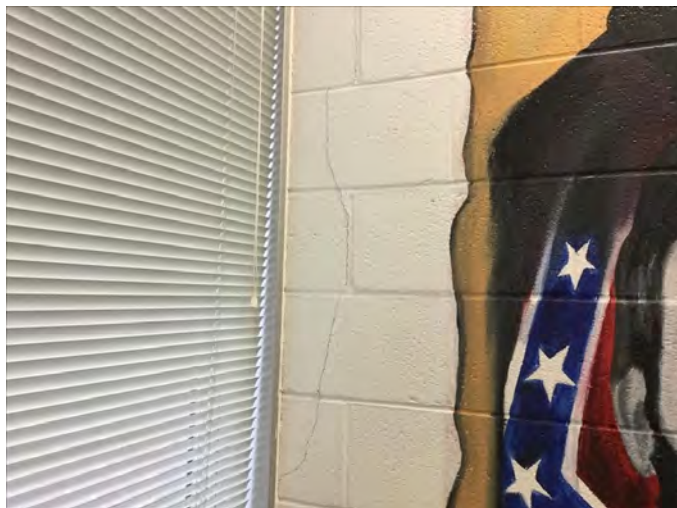
System: C1010 - Partitions

Location: Media Center
Distress: Failing
Category: Safety / Building Code Compliance
Priority: 1 - Currently Critical (Immediate)
Correction: Engineering Study
Qty: 1.00
Unit of Measure: Ea.
Estimate: \$13,200.00
Assessor Name: Terence Davis
Date Created: 01/04/2017

Notes: There are visible cracks on the partition wall which should be studied by a professional engineer.

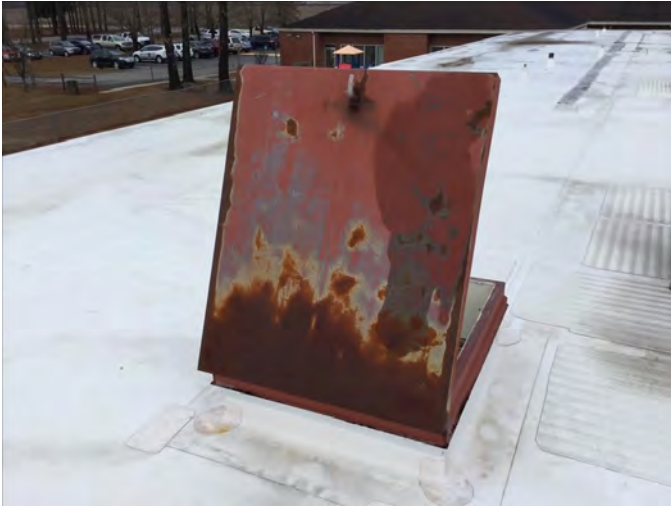
System: B3020 - Roof Openings

Location: Roof
Distress: Beyond Service Life
Category: Deferred Maintenance
Priority: 3 - Necessary/Not Yet Critical (Years 2-5)
Correction: Renew System
Qty: 42,369.00
Unit of Measure: S.F.
Estimate: \$13,516.00
Assessor Name: Terence Davis
Date Created: 12/30/2016

Notes: The roof opening is beyond its service life and should be replaced with an OSHA compliant access hatch.

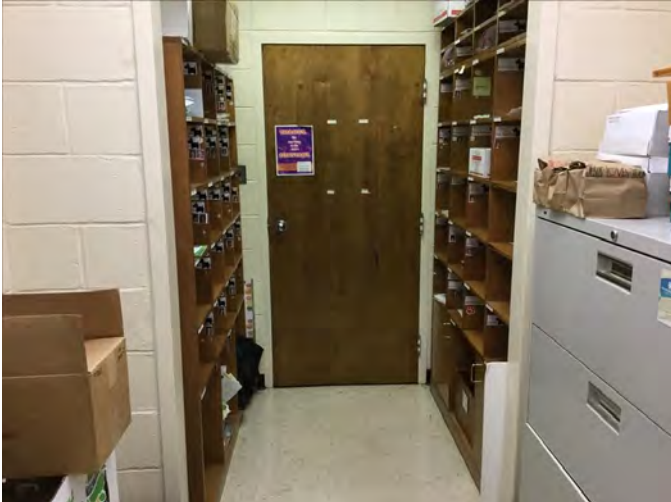
System: C1020 - Interior Doors

Location: Throughout Building
Distress: Beyond Service Life
Category: Deferred Maintenance
Priority: 3 - Necessary/Not Yet Critical (Years 2-5)
Correction: Renew System
Qty: 42,369.00
Unit of Measure: S.F.
Estimate: \$117,913.00
Assessor Name: Terence Davis
Date Created: 12/30/2016

Notes: The interior doors are beyond their service life and should be replaced.

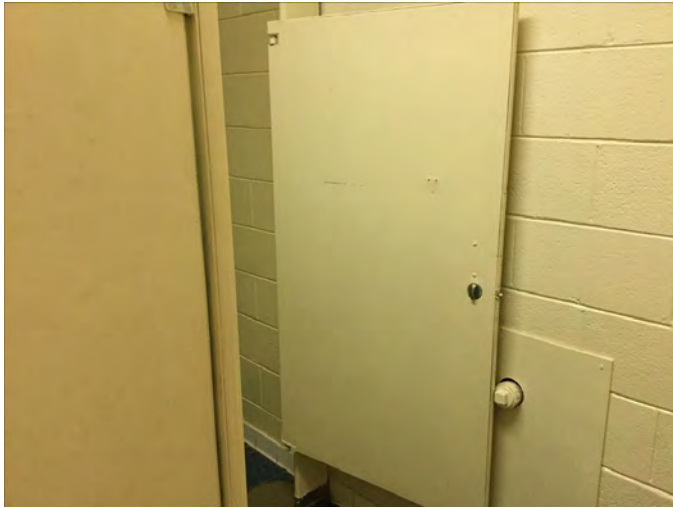
System: C1030 - Fittings

Location: Throughout Building
Distress: Beyond Service Life
Category: Deferred Maintenance
Priority: 3 - Necessary/Not Yet Critical (Years 2-5)
Correction: Renew System
Qty: 42,369.00
Unit of Measure: S.F.
Estimate: \$453,941.00
Assessor Name: Terence Davis
Date Created: 12/30/2016

Notes: The fittings are beyond their service life and should be replaced.

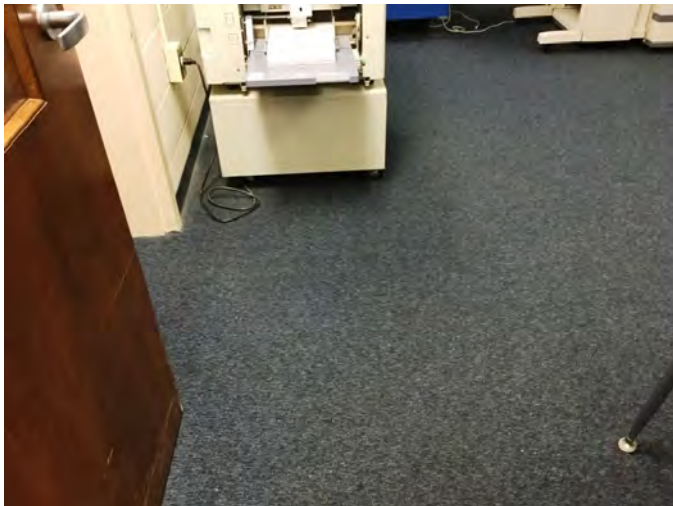
System: C3020 - Floor Finishes

Location: Media Center
Distress: Beyond Service Life
Category: Deferred Maintenance
Priority: 3 - Necessary/Not Yet Critical (Years 2-5)
Correction: Replace carpet
Qty: 100.00
Unit of Measure: S.Y.
Estimate: \$8,548.32
Assessor Name: Terence Davis
Date Created: 02/10/2017

Notes: The carpet is beyond its service life and should be replaced.

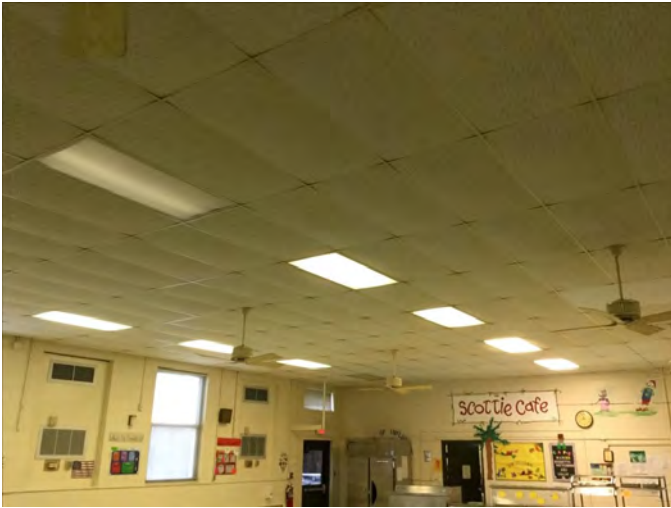
System: C3030 - Ceiling Finishes

Location: Throughout Building
Distress: Beyond Service Life
Category: Deferred Maintenance
Priority: 3 - Necessary/Not Yet Critical (Years 2-5)
Correction: Renew System
Qty: 42,369.00
Unit of Measure: S.F.
Estimate: \$511,267.00
Assessor Name: Terence Davis
Date Created: 12/30/2016

Notes: The acoustical ceiling tiles are beyond their service life and should be replaced.

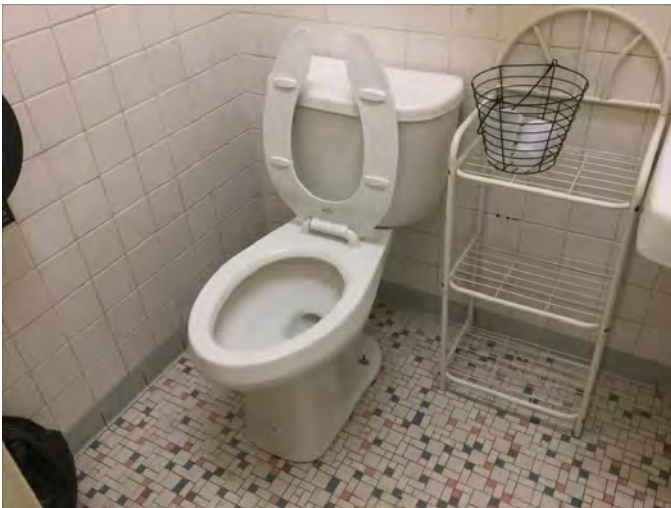
System: D2010 - Plumbing Fixtures

Location: Throughout Building
Distress: Beyond Service Life
Category: Deferred Maintenance
Priority: 3 - Necessary/Not Yet Critical (Years 2-5)
Correction: Renew System
Qty: 42,369.00
Unit of Measure: S.F.
Estimate: \$535,036.00
Assessor Name: Terence Davis
Date Created: 12/30/2016

Notes: The plumbing fixtures are beyond their service life and should be replaced.

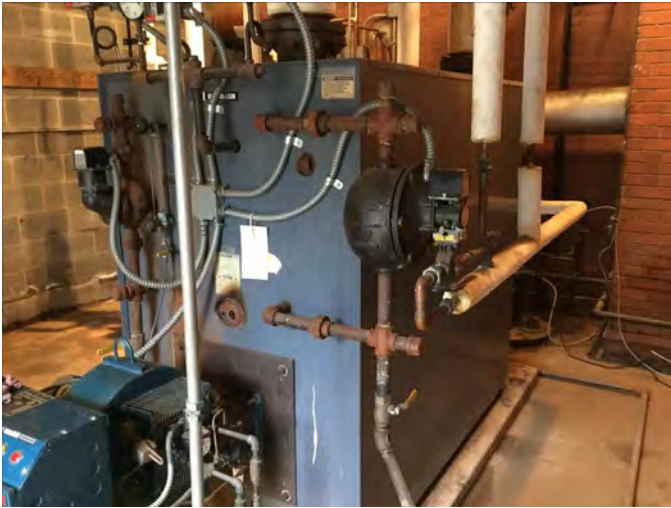
System: D3020 - Heat Generating Systems

Location: Mechanical Room
Distress: Beyond Service Life
Category: Deferred Maintenance
Priority: 3 - Necessary/Not Yet Critical (Years 2-5)
Correction: Renew System
Qty: 42,369.00
Unit of Measure: S.F.
Estimate: \$236,758.00
Assessor Name: Terence Davis
Date Created: 12/30/2016

Notes: The heat generating systems is beyond their service life and should be replaced.

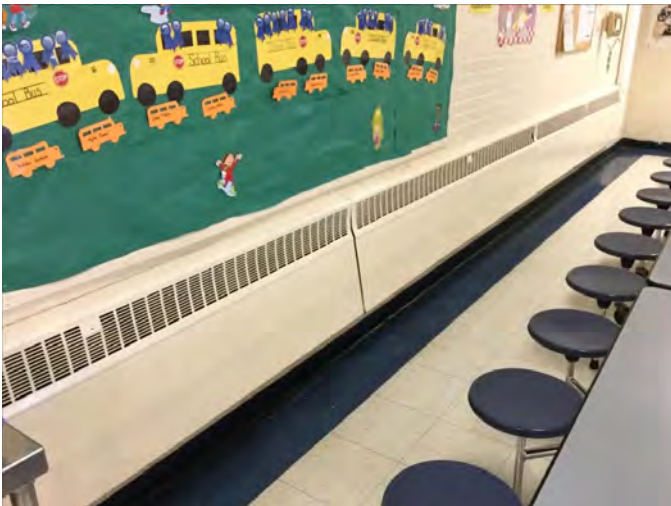
System: D3050 - Terminal & Package Units

Location: Throughout the building
Distress: Beyond Service Life
Category: Deferred Maintenance
Priority: 3 - Necessary/Not Yet Critical (Years 2-5)
Correction: Replace baseboard heater units
Qty: 25.00
Unit of Measure: Ea.
Estimate: \$9,042.00
Assessor Name: Terence Davis
Date Created: 01/04/2017

Notes: The unit heaters and the radiating heaters are beyond their service life and should be replaced.

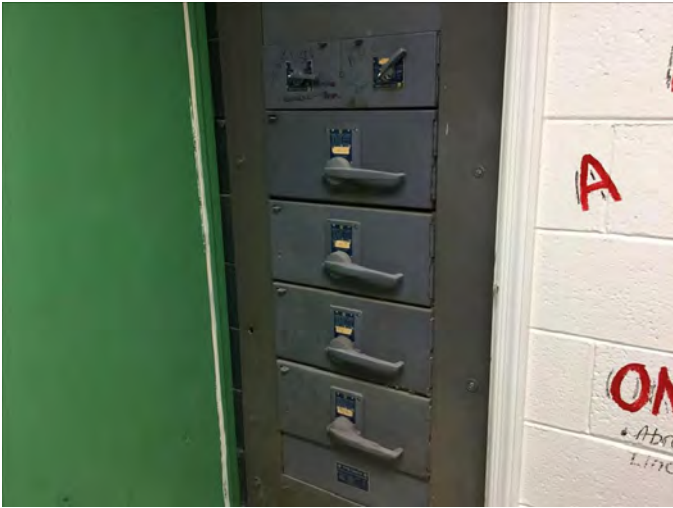
System: D5010 - Electrical Service/Distribution

Location: Throughout Building
Distress: Beyond Service Life
Category: Deferred Maintenance
Priority: 3 - Necessary/Not Yet Critical (Years 2-5)
Correction: Renew System
Qty: 42,369.00
Unit of Measure: S.F.
Estimate: \$78,764.00
Assessor Name: Terence Davis
Date Created: 12/30/2016

Notes: The main electrical system is beyond its service life and should be replaced.

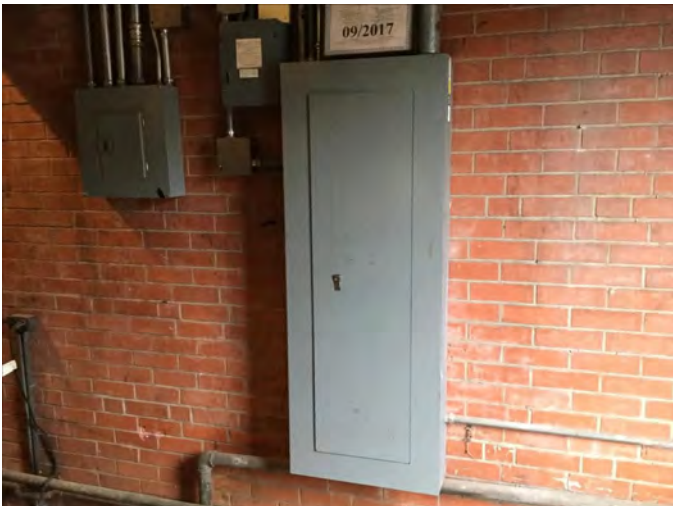
System: D5020 - Branch Wiring

Location: Throughout Building
Distress: Beyond Service Life
Category: Deferred Maintenance
Priority: 3 - Necessary/Not Yet Critical (Years 2-5)
Correction: Renew System
Qty: 42,369.00
Unit of Measure: S.F.
Estimate: \$235,826.00
Assessor Name: Terence Davis
Date Created: 12/30/2016

Notes: The branch wiring system is beyond its service life and should be replaced.

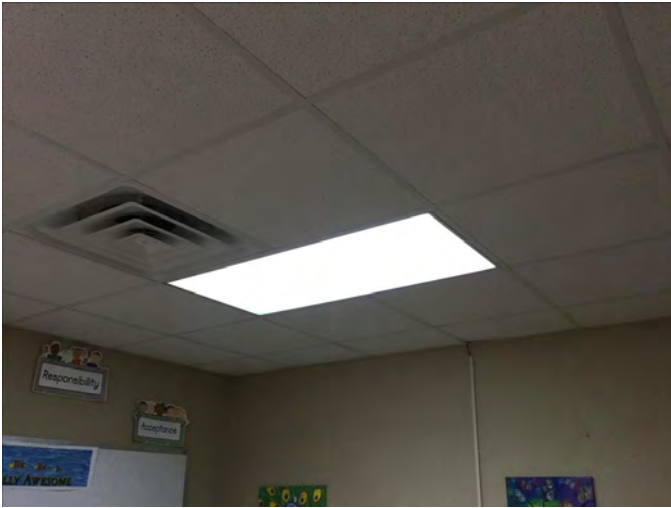
System: D5020 - Lighting

Location: Throughout Building
Distress: Beyond Service Life
Category: Deferred Maintenance
Priority: 3 - Necessary/Not Yet Critical (Years 2-5)
Correction: Renew System
Qty: 42,369.00
Unit of Measure: S.F.
Estimate: \$555,542.00
Assessor Name: Terence Davis
Date Created: 12/30/2016

Notes: The lights are primarily T-12's and are beyond their service life and they get replaced by T-8's as per needs basis.

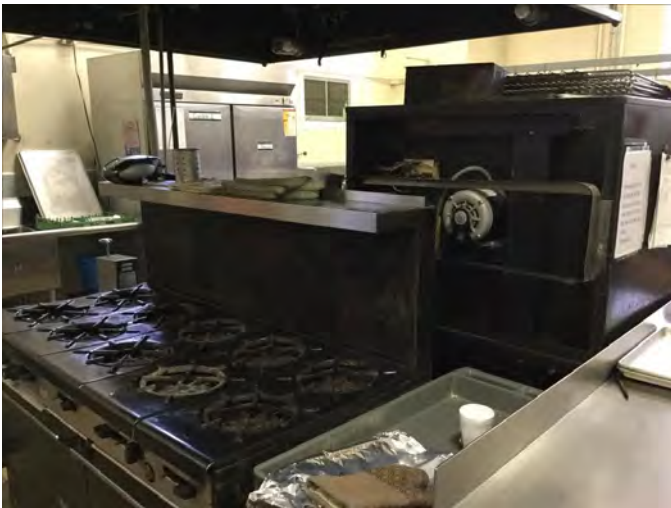
System: E1090 - Other Equipment

Location: Kitchen
Distress: Beyond Service Life
Category: Deferred Maintenance
Priority: 3 - Necessary/Not Yet Critical (Years 2-5)
Correction: Renew System
Qty: 42,369.00
Unit of Measure: S.F.
Estimate: \$88,551.00
Assessor Name: Terence Davis
Date Created: 12/30/2016

Notes: The kitchen equipment is beyond its service life and should be replaced.

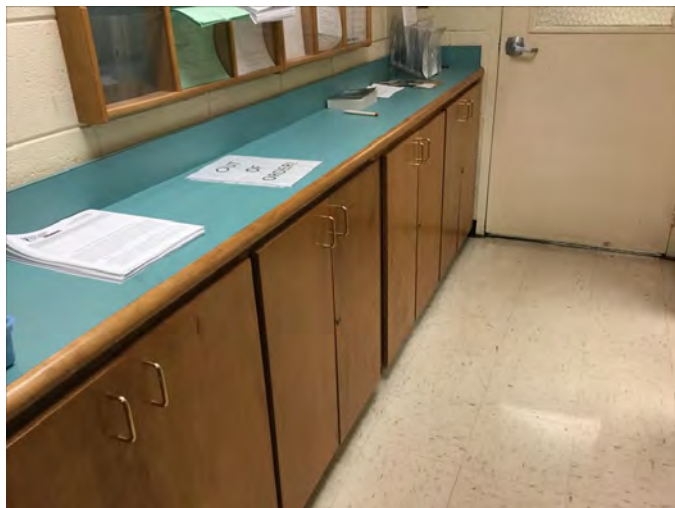
System: E2010 - Fixed Furnishings

Location: Throughout Building
Distress: Beyond Service Life
Category: Deferred Maintenance
Priority: 3 - Necessary/Not Yet Critical (Years 2-5)
Correction: Renew System
Qty: 42,369.00
Unit of Measure: S.F.
Estimate: \$271,712.00
Assessor Name: Terence Davis
Date Created: 12/30/2016

Notes: The fixed furnishings are beyond their service life and should be replaced.

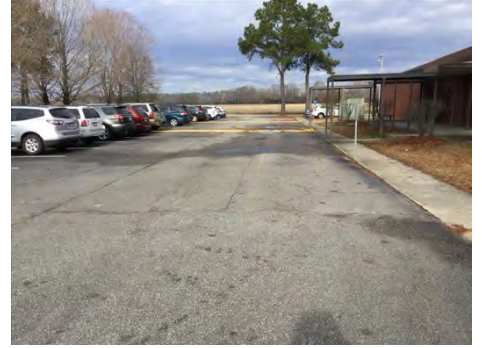
System: G2010 - Roadways

Note: The roads need to be resealed.

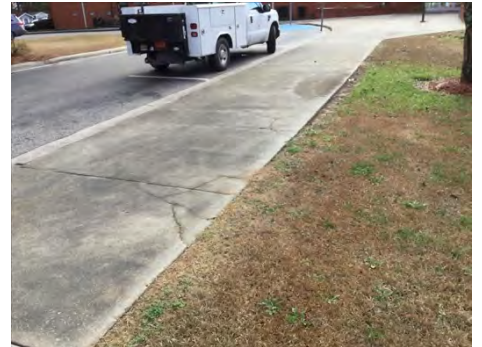
System: G2030 - Pedestrian Paving

Note: The pedestrian paving is cracked and beyond its service life and should be replaced.

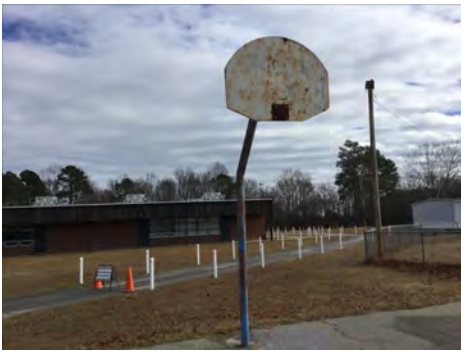
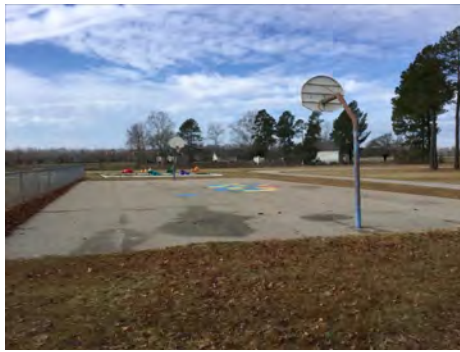
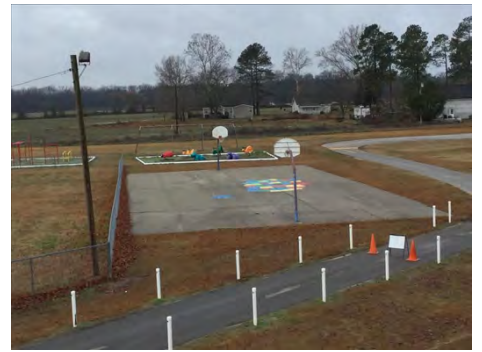
System: G2040950 - Hard Surface Play Area

Note: The hard surface is beyond its service life and should be replaced.

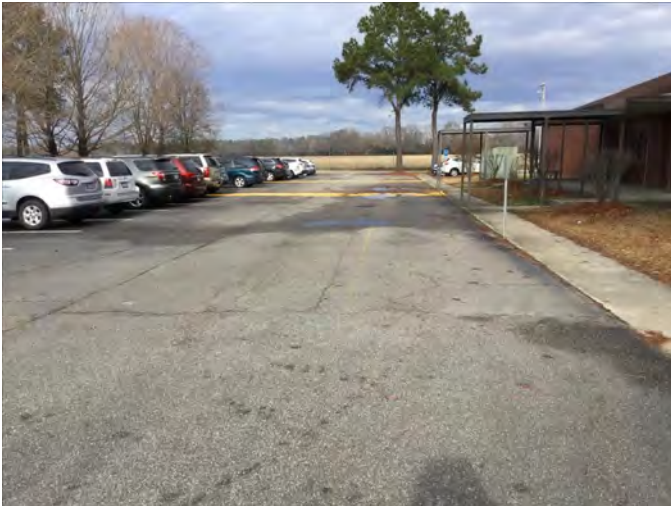
System: G2010 - Roadways

Location: Site
Distress: Failing
Category: Deferred Maintenance
Priority: 3 - Necessary/Not Yet Critical (Years 2-5)
Correction: Resurface the roadway
Qty: 100.00
Unit of Measure: L.F.
Estimate: \$17,160.00
Assessor Name: Eduardo Lopez
Date Created: 01/05/2017

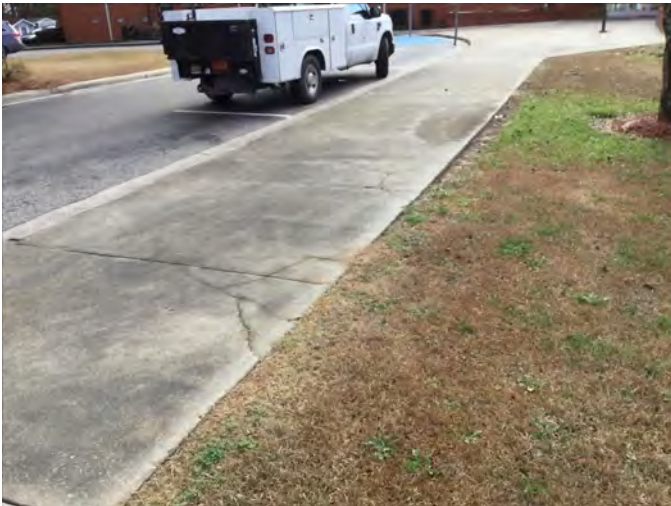
System: G2030 - Pedestrian Paving

Location: Site
Distress: Beyond Service Life
Category: Deferred Maintenance
Priority: 3 - Necessary/Not Yet Critical (Years 2-5)
Correction: Renew System
Qty: 42,369.00
Unit of Measure: S.F.
Estimate: \$89,017.00
Assessor Name: Eduardo Lopez
Date Created: 02/10/2017

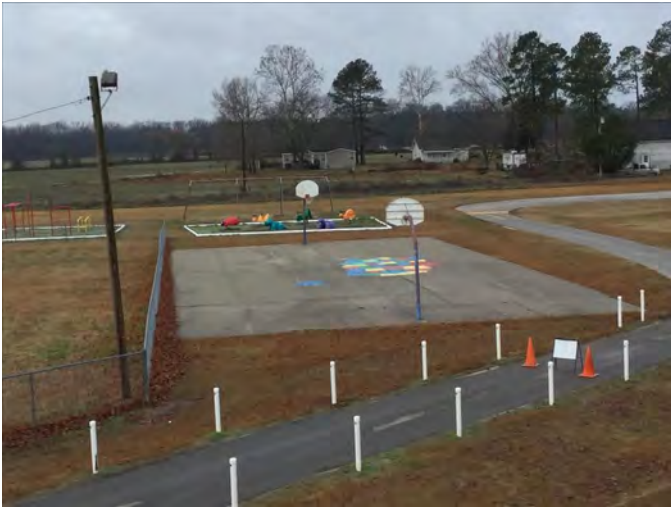
System: G2040950 - Hard Surface Play Area

Location: Site
Distress: Beyond Service Life
Category: Deferred Maintenance
Priority: 3 - Necessary/Not Yet Critical (Years 2-5)
Correction: Renew System
Qty: 42,369.00
Unit of Measure: S.F.
Estimate: \$34,954.00
Assessor Name: Eduardo Lopez
Date Created: 02/10/2017

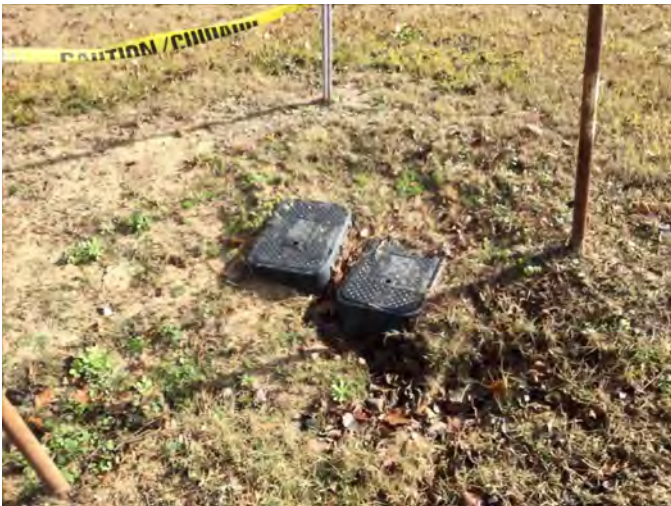
System: G3010 - Water Supply

Location: Site
Distress: Beyond Service Life
Category: Deferred Maintenance
Priority: 3 - Necessary/Not Yet Critical (Years 2-5)
Correction: Renew System
Qty: 42,369.00
Unit of Measure: S.F.
Estimate: \$109,058.00
Assessor Name: Eduardo Lopez
Date Created: 02/10/2017
