Sycamore Lane Elementary

Campus Assessment Report

March 11, 2017

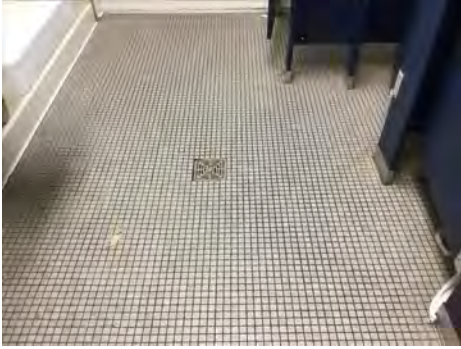
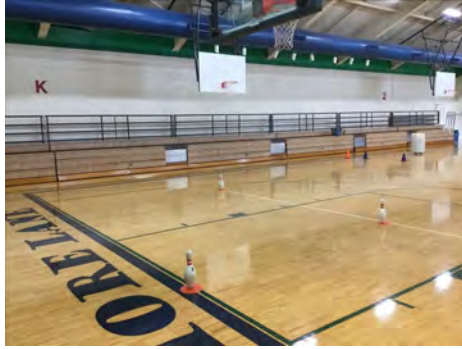
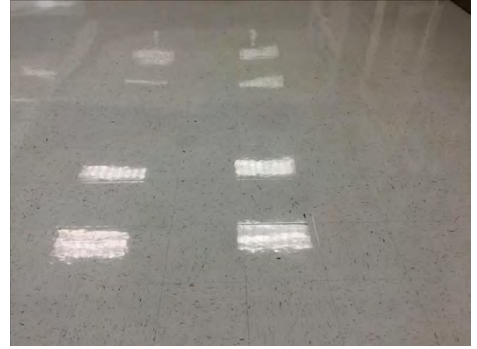
System: C3020 - Floor Finishes

Note: Replace as needed. Entire system need to be upgraded.

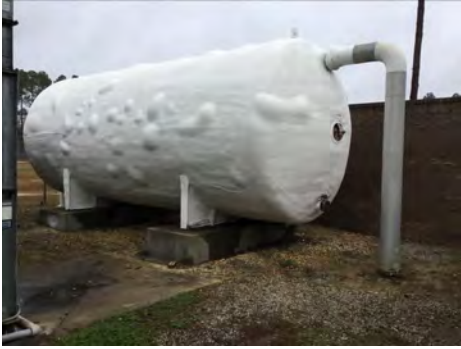
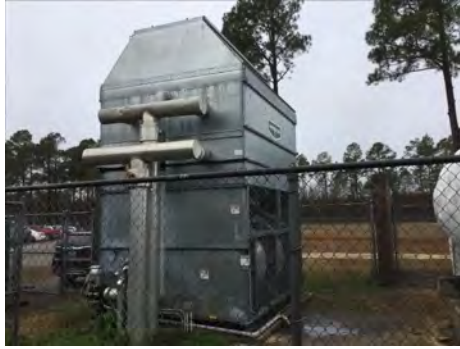
System: D3030 - Cooling Generating Systems

Note: Cooling tower replaced around 2011

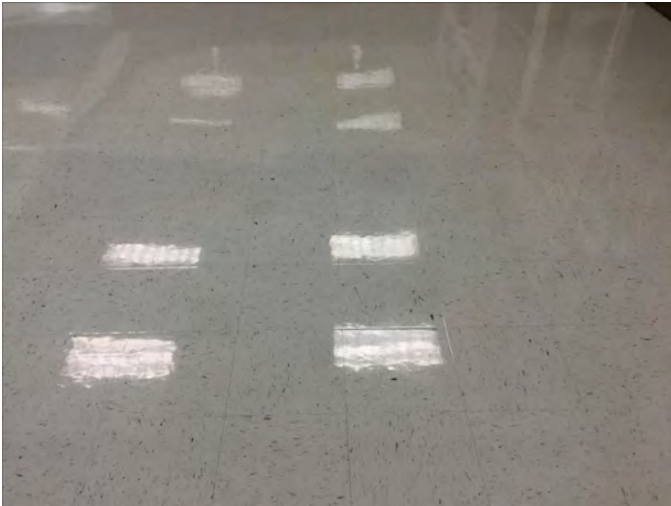
System: C3020 - Floor Finishes

Location: Throughout the building
Distress: Beyond Service Life
Category: Deferred Maintenance
Priority: 3 - Necessary/Not Yet Critical (Years 2-5)
Correction: Renew System
Qty: 80,000.00
Unit of Measure: S.F.
Estimate: \$1,001,440.00
Assessor Name: Eduardo Lopez
Date Created: 01/12/2017

Notes: The original floor finishes are aged, failing and should be replaced.

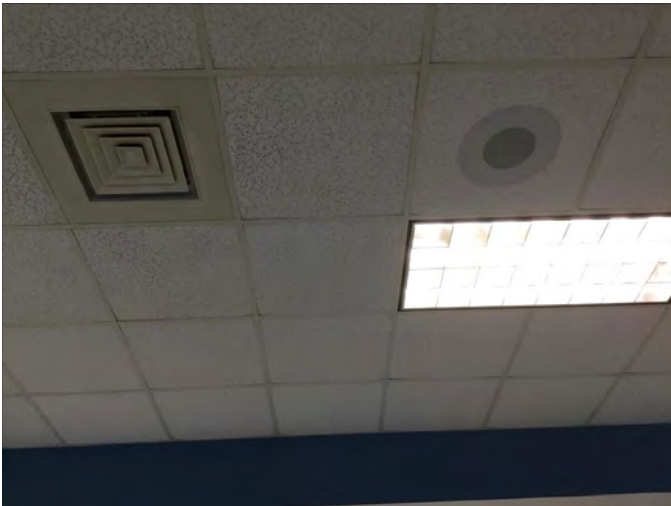
System: C3030 - Ceiling Finishes

Location: Throughout the building
Distress: Failing
Category: Deferred Maintenance
Priority: 3 - Necessary/Not Yet Critical (Years 2-5)
Correction: Renew System
Qty: 80,000.00
Unit of Measure: S.F.
Estimate: \$965,360.00
Assessor Name: Eduardo Lopez
Date Created: 01/12/2017

Notes: The original ceiling finishes are aged, failing and should be replaced.

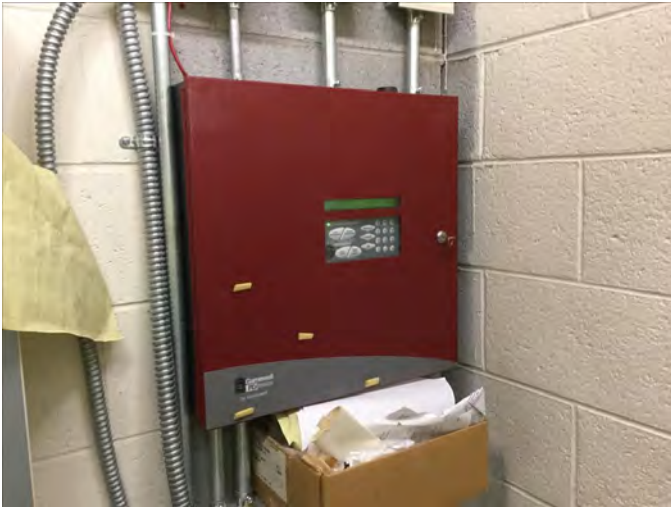
System: D5030910 - Fire Alarm Systems

Location: Throughout the building
Distress: Beyond Service Life
Category: Deferred Maintenance
Priority: 3 - Necessary/Not Yet Critical (Years 2-5)
Correction: Renew System
Qty: 80,000.00
Unit of Measure: S.F.
Estimate: \$298,320.00
Assessor Name: Eduardo Lopez
Date Created: 01/12/2017

Notes: The original alarm system is operating but is aged. The system should be inspected and repaired or replaced to ensure that the life safety codes are preserved.

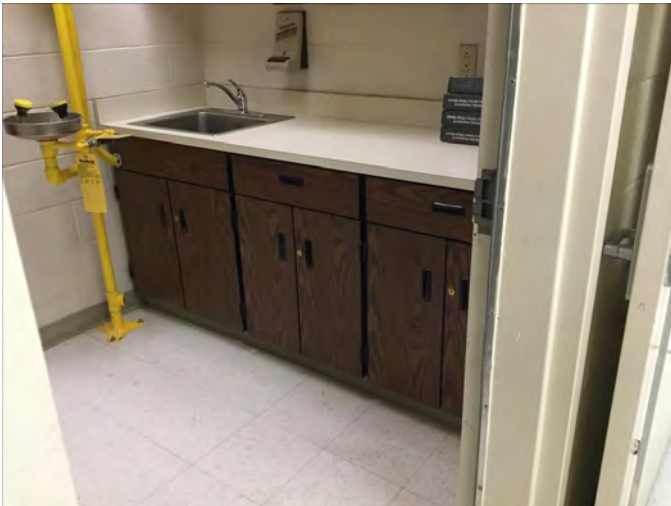
System: E2010 - Fixed Furnishings

Location: Throughout the building
Distress: Damaged
Category: Deferred Maintenance
Priority: 3 - Necessary/Not Yet Critical (Years 2-5)
Correction: Renew System
Qty: 80,000.00
Unit of Measure: S.F.
Estimate: \$513,040.00
Assessor Name: Eduardo Lopez
Date Created: 01/12/2017

Notes: The building casework is aged and worn and should be replaced.

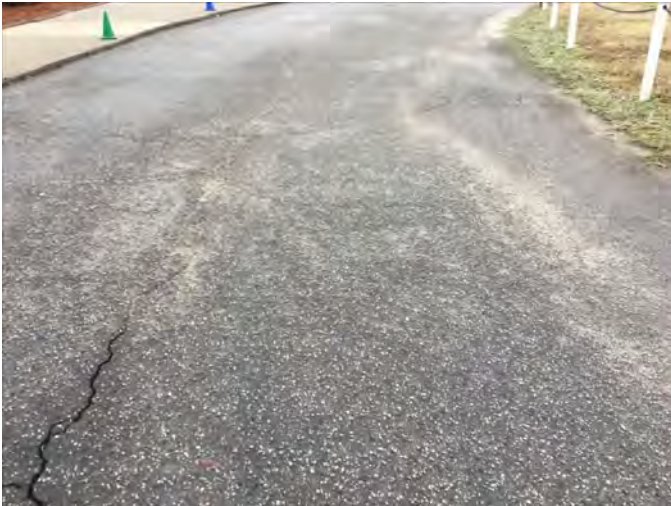
System: G2010 - Roadways

Location: Site
Distress: Beyond Service Life
Category: Deferred Maintenance
Priority: 3 - Necessary/Not Yet Critical (Years 2-5)
Correction: Renew System
Qty: 80,000.00
Unit of Measure: S.F.
Estimate: \$335,280.00
Assessor Name: Eduardo Lopez
Date Created: 01/12/2017

Notes: The asphalt roadways are aged, have many road cuts, significant cracking, and need re-surfacing.

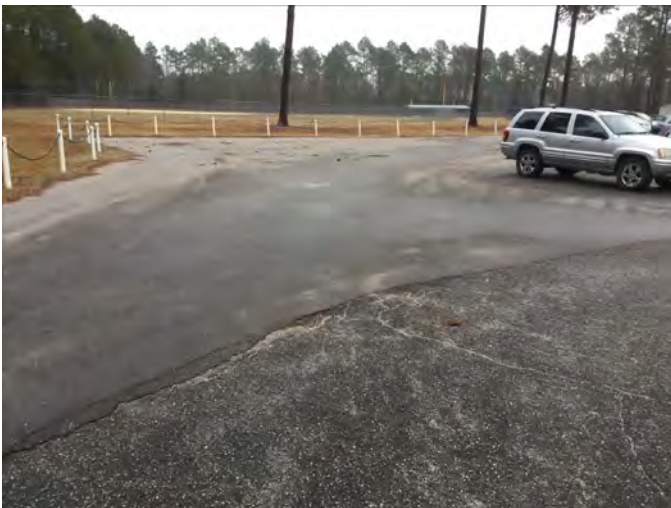
System: G2020 - Parking Lots

Location: Site
Distress: Beyond Service Life
Category: Deferred Maintenance
Priority: 3 - Necessary/Not Yet Critical (Years 2-5)
Correction: Renew System
Qty: 80,000.00
Unit of Measure: S.F.
Estimate: \$117,040.00
Assessor Name: Eduardo Lopez
Date Created: 01/12/2017

Notes: The asphalt parking lots are aged, have cuts and repairs, and should be re-surfaced and re striped.
