NC School District/830 Scotland County/Elementary School

Wagram Elementary

Campus Assessment Report

March 11, 2017

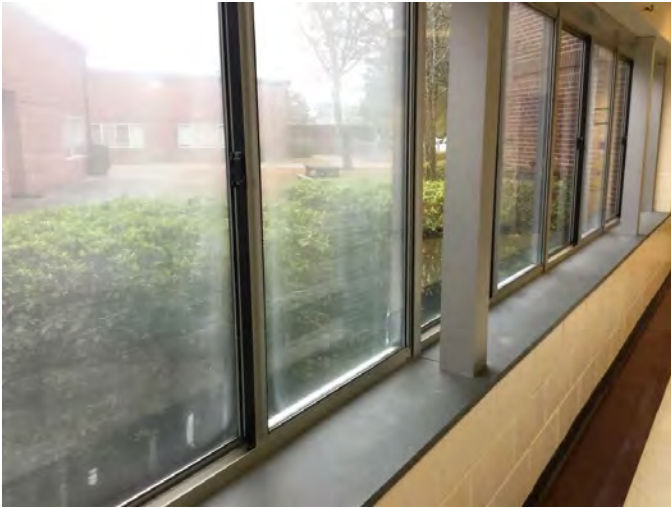
System: B2020 - Exterior Windows

Location: Throughout
Distress: Beyond Service Life
Category: Deferred Maintenance / Energy
Priority: 3 - Necessary/Not Yet Critical (Years 2-5)
Correction: Renew System
Qty: 48,960.00
Unit of Measure: S.F.
Estimate: \$495,475.00
Assessor Name: Terence Davis
Date Created: 01/11/2017

Notes: The aluminum frame, operable, single pane windows are aged, not energy efficient, and should be replaced.

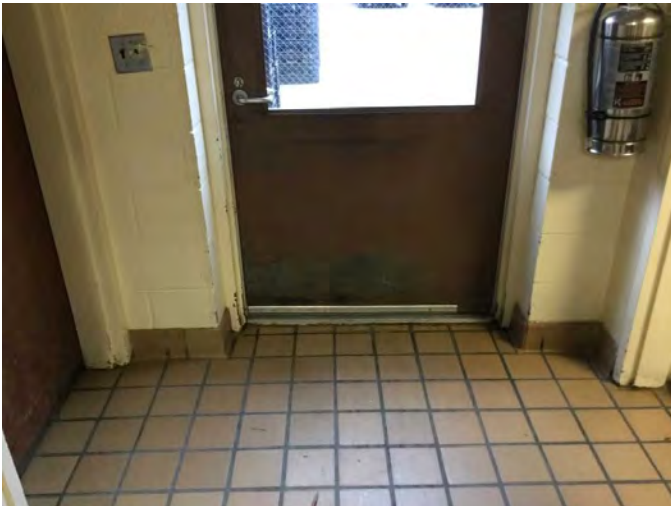
System: B2030 - Exterior Doors

Location: Throughout
Distress: Beyond Service Life
Category: Deferred Maintenance
Priority: 3 - Necessary/Not Yet Critical (Years 2-5)
Correction: Renew System
Qty: 48,960.00
Unit of Measure: S.F.
Estimate: \$54,933.00
Assessor Name: Terence Davis
Date Created: 01/11/2017

Notes: The original exterior doors are aged, rusted, and should be replaced.

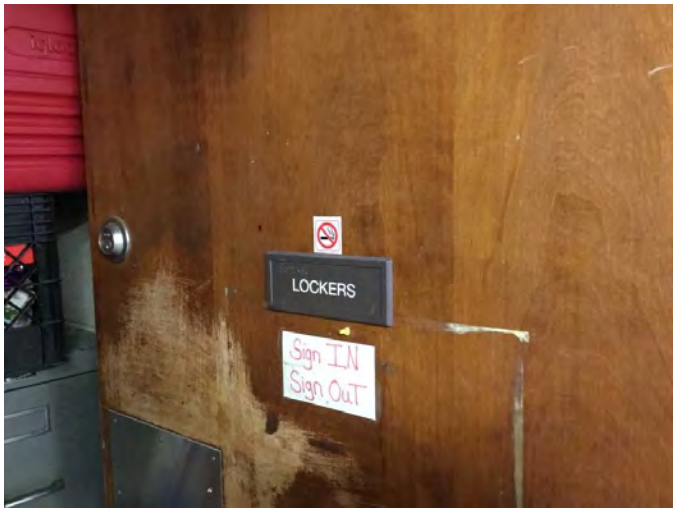
System: C1020 - Interior Doors

Location: Throughout
Distress: Beyond Service Life
Category: Deferred Maintenance
Priority: 3 - Necessary/Not Yet Critical (Years 2-5)
Correction: Renew System
Qty: 48,960.00
Unit of Measure: S.F.
Estimate: \$133,563.00
Assessor Name: Terence Davis
Date Created: 01/11/2017

Notes: The interior doors are aged and should be replaced

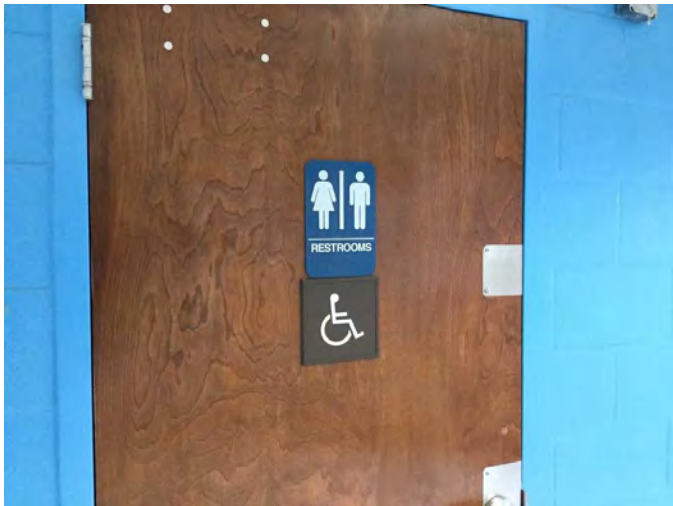
System: C1030 - Fittings

Location: Throughout
Distress: Beyond Service Life
Category: Deferred Maintenance
Priority: 3 - Necessary/Not Yet Critical (Years 2-5)
Correction: Renew System
Qty: 48,960.00
Unit of Measure: S.F.
Estimate: \$513,786.00
Assessor Name: Terence Davis
Date Created: 01/11/2017

Notes: The original fittings are aged, rusted and should be replaced.

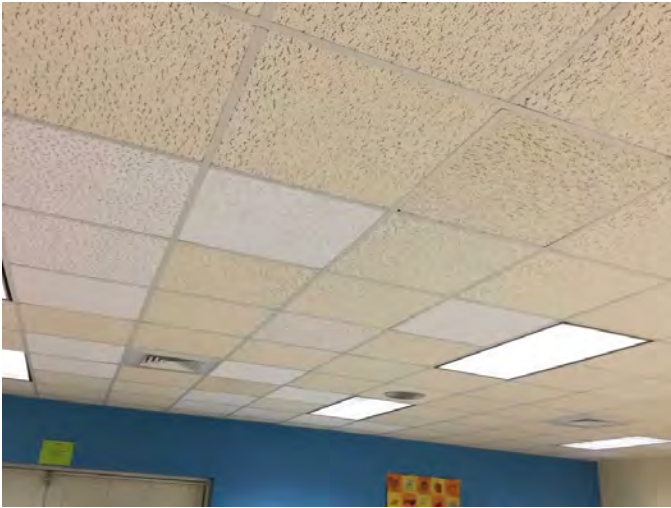
System: C3030 - Ceiling Finishes

Location: Throughout
Distress: Beyond Service Life
Category: Deferred Maintenance / Appearance
Priority: 3 - Necessary/Not Yet Critical (Years 2-5)
Correction: Renew System
Qty: 48,960.00
Unit of Measure: S.F.
Estimate: \$578,413.00
Assessor Name: Terence Davis
Date Created: 01/11/2017

Notes: The ceiling tiles have been replaced as needed. However the grid shows signs of aging and most tiles are sagging or damaged and should be replaced.

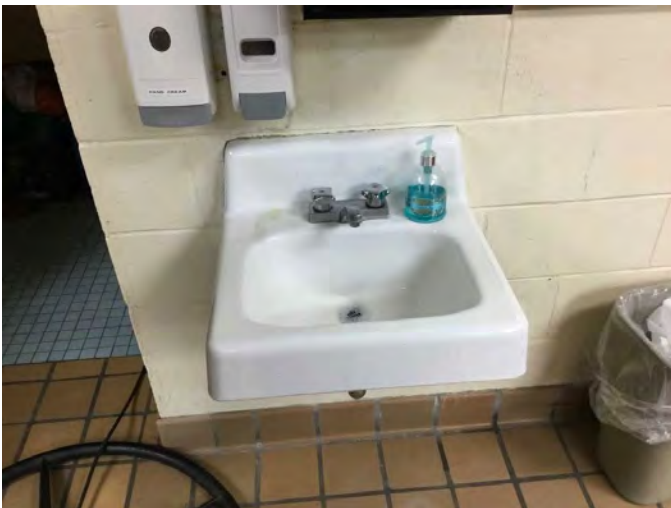
System: D2010 - Plumbing Fixtures

Location: Throughout
Distress: Beyond Service Life
Category: Deferred Maintenance / Energy
Priority: 3 - Necessary/Not Yet Critical (Years 2-5)
Correction: Renew System
Qty: 48,960.00
Unit of Measure: S.F.
Estimate: \$606,419.00
Assessor Name: Terence Davis
Date Created: 01/11/2017

Notes: Plumbing fixtures are in operational conditions. However, they are aged and should be replaced with a low-flow water fixtures.

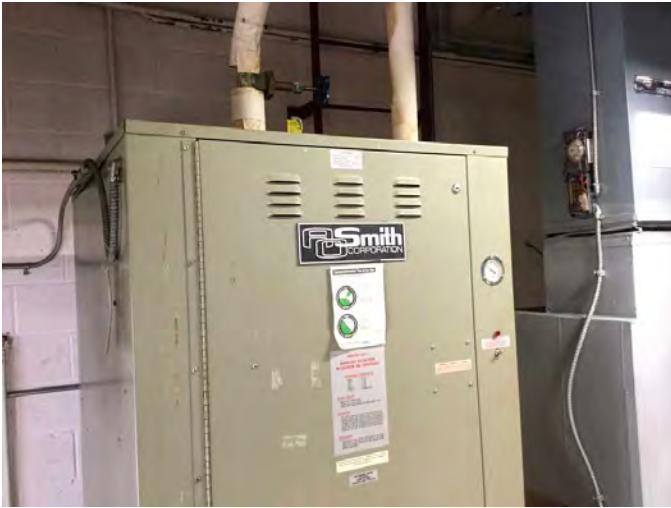
System: D2020 - Domestic Water Distribution

Location: Throughout
Distress: Beyond Service Life
Category: Deferred Maintenance
Priority: 3 - Necessary/Not Yet Critical (Years 2-5)
Correction: Renew System
Qty: 48,960.00
Unit of Measure: S.F.
Estimate: \$51,702.00
Assessor Name: Terence Davis
Date Created: 01/11/2017

Notes: The domestic water distribution system is aged and should be replaced.

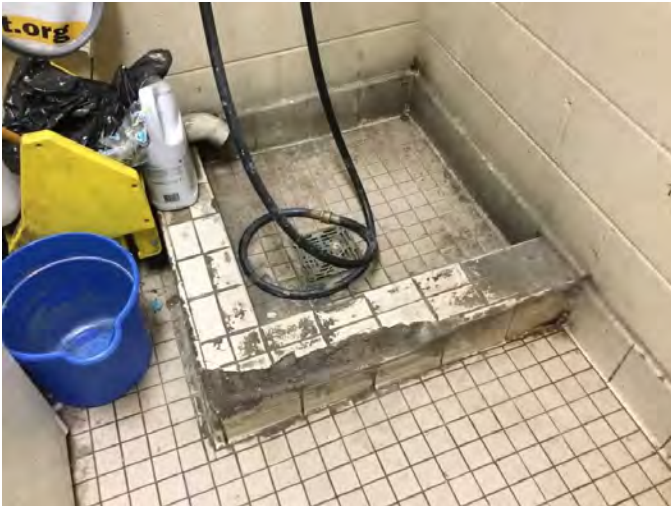
System: D2030 - Sanitary Waste

Location: Throughout
Distress: Beyond Service Life
Category: Deferred Maintenance
Priority: 3 - Necessary/Not Yet Critical (Years 2-5)
Correction: Renew System
Qty: 48,960.00
Unit of Measure: S.F.
Estimate: \$81,861.00
Assessor Name: Terence Davis
Date Created: 01/11/2017

Notes: The sanitary waste system is aged, has reported periodic failures, and should be replaced.

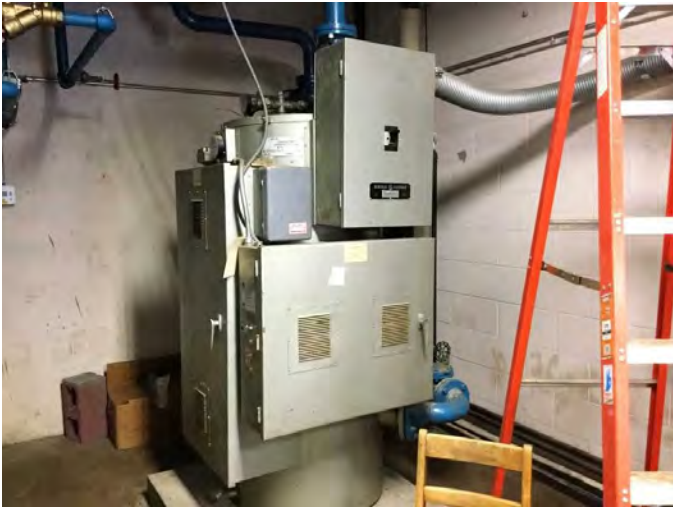
System: D3020 - Heat Generating Systems

Location: Mechanical Room
Distress: Beyond Service Life
Category: Deferred Maintenance
Priority: 3 - Necessary/Not Yet Critical (Years 2-5)
Correction: Renew System
Qty: 48,960.00
Unit of Measure: S.F.
Estimate: \$268,203.00
Assessor Name: Terence Davis
Date Created: 01/11/2017

Notes: The electric boiler is operating properly and are in fair condition but; is aging, inefficient, becoming logistically unsupportable, and should be replaced with energy efficient model.

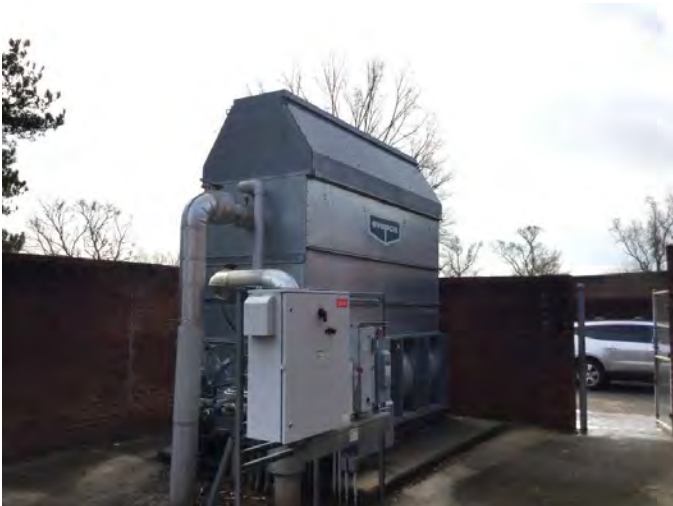
System: D3030 - Cooling Generating Systems

Location: Chiller yard
Distress: Beyond Service Life
Category: Deferred Maintenance
Priority: 3 - Necessary/Not Yet Critical (Years 2-5)
Correction: Renew System
Qty: 48,960.00
Unit of Measure: S.F.
Estimate: \$277,897.00
Assessor Name: Terence Davis
Date Created: 01/11/2017

Notes: Chiller is aging and logistically unsupportable, and should be replaced with an energy efficient model.

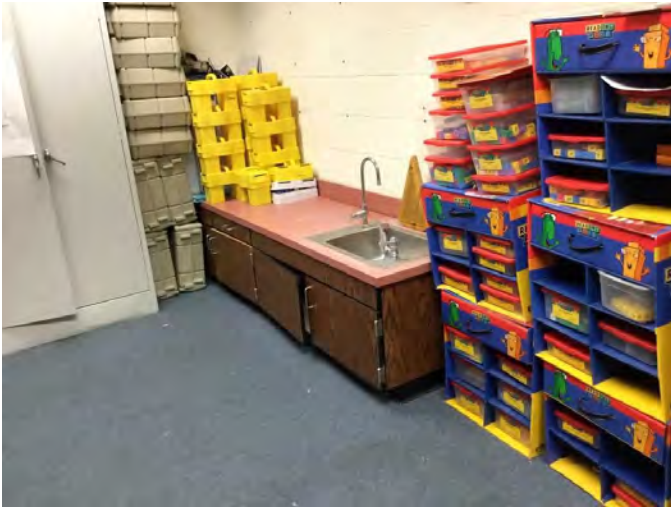
System: E2010 - Fixed Furnishings

Location: Throughout
Distress: Beyond Service Life
Category: Deferred Maintenance / Appearance
Priority: 3 - Necessary/Not Yet Critical (Years 2-5)
Correction: Renew System
Qty: 48,960.00
Unit of Measure: S.F.
Estimate: \$308,056.00
Assessor Name: Terence Davis
Date Created: 01/11/2017

Notes: The fixed furnishings are aged, in marginal condition, and should be replaced.

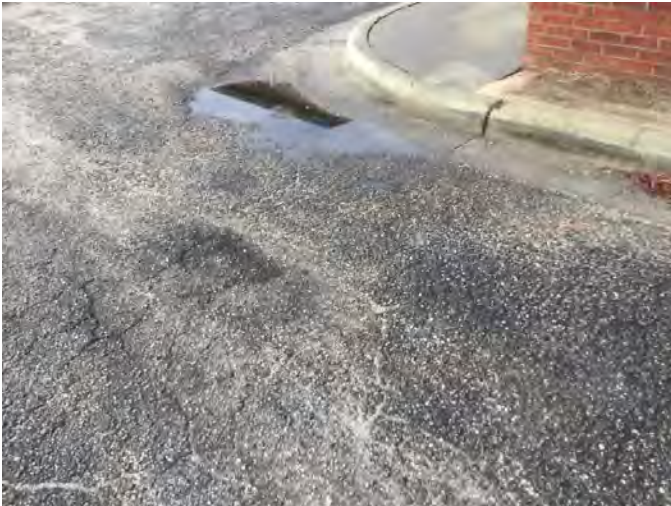
System: G2010 - Roadways

Location: Entire site
Distress: Beyond Service Life
Category: Deferred Maintenance
Priority: 3 - Necessary/Not Yet Critical (Years 2-5)
Correction: Renew System
Qty: 73,960.00
Unit of Measure: S.F.
Estimate: \$309,966.00
Assessor Name: Terence Davis
Date Created: 01/11/2017

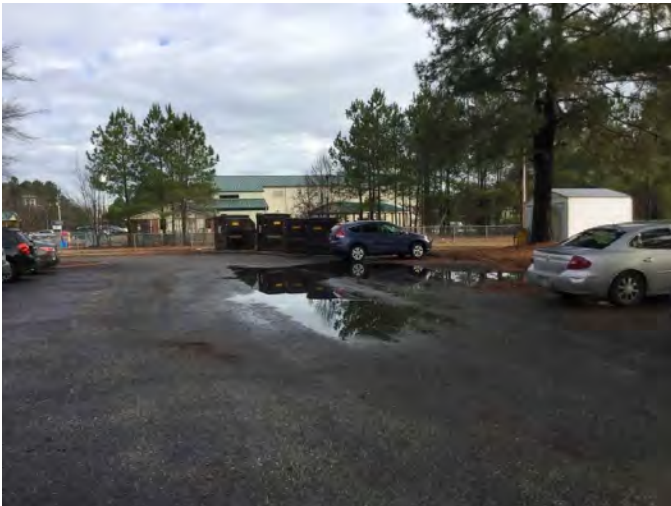
System: G2020 - Parking Lots

Location: North and East sides
Distress: Beyond Service Life
Category: Deferred Maintenance
Priority: 3 - Necessary/Not Yet Critical (Years 2-5)
Correction: Renew System
Qty: 73,960.00
Unit of Measure: S.F.
Estimate: \$108,203.00
Assessor Name: Terence Davis
Date Created: 01/11/2017
