NC School District/830 Scotland County/High School

Shaw Academy

Campus Assessment Report

March 11, 2017

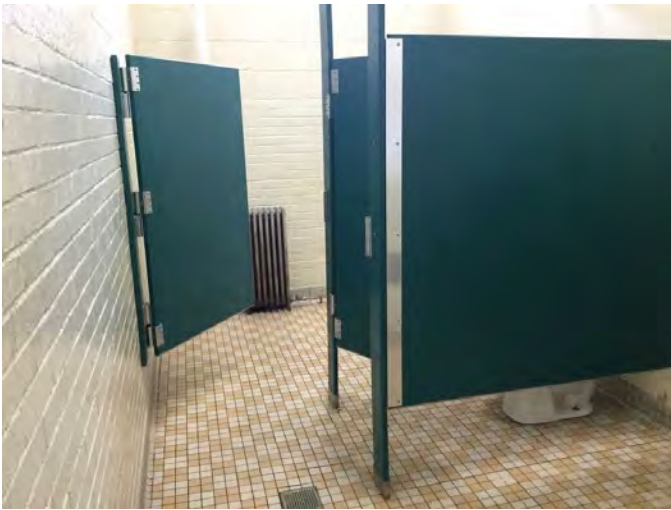
System: C1030 - Fittings

Location: Throughout
Distress: Beyond Service Life
Category: Deferred Maintenance / Accessibility Code Compliance
Priority: 3 - Necessary/Not Yet Critical (Years 2-5)
Correction: Renew System
Qty: 28,806.00
Unit of Measure: S.F.
Estimate: \$308,627.00
Assessor Name: Terence Davis
Date Created: 12/23/2016

Notes: The fittings throughout the building are aged, in marginal condition, and should be replaced.
Room signage is missing or non-ADA compliant.

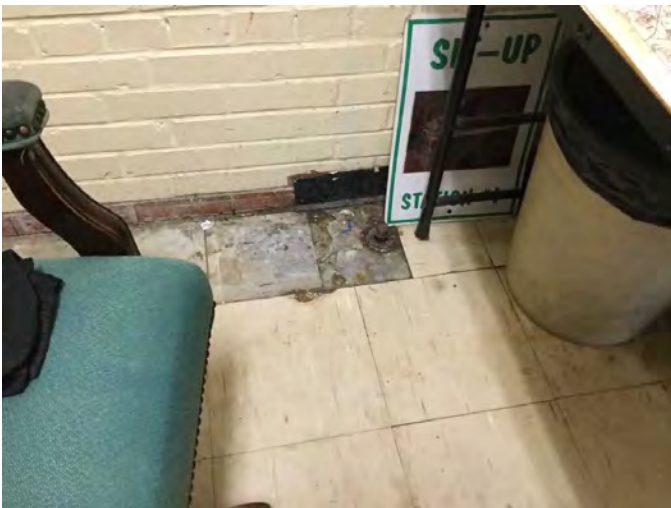
System: C3020 - Floor Finishes

Location: Throughout
Distress: Beyond Service Life
Category: Deferred Maintenance / Appearance
Priority: 3 - Necessary/Not Yet Critical (Years 2-5)
Correction: Renew System
Qty: 28,806.00
Unit of Measure: S.F.
Estimate: \$360,594.00
Assessor Name: Terence Davis
Date Created: 12/23/2016

Notes: The VCT flooring is aged, cracked, worn, and should be replaced.
The carpet is also aged, stained, frayed, and should be replace.

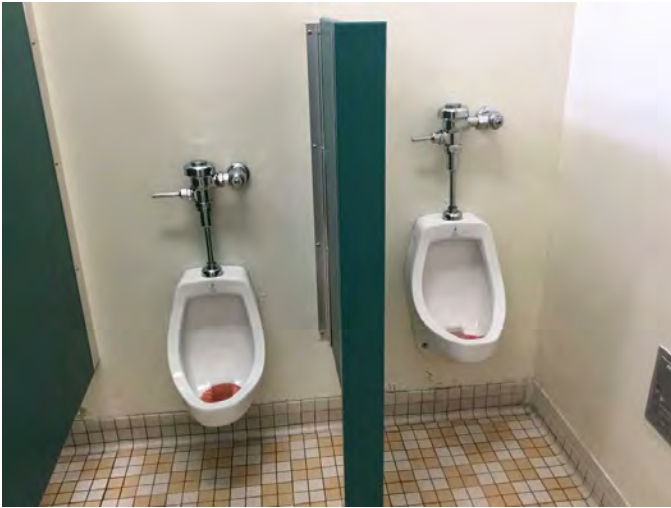
System: D2010 - Plumbing Fixtures

Location: Throughout
Distress: Beyond Service Life
Category: Deferred Maintenance
Priority: 3 - Necessary/Not Yet Critical (Years 2-5)
Correction: Renew System
Qty: 28,806.00
Unit of Measure: S.F.
Estimate: \$363,762.00
Assessor Name: Terence Davis
Date Created: 12/23/2016

Notes: Plumbing fixtures are in operational conditions. However, they are aged and should be replaced with a low-flow water fixtures.

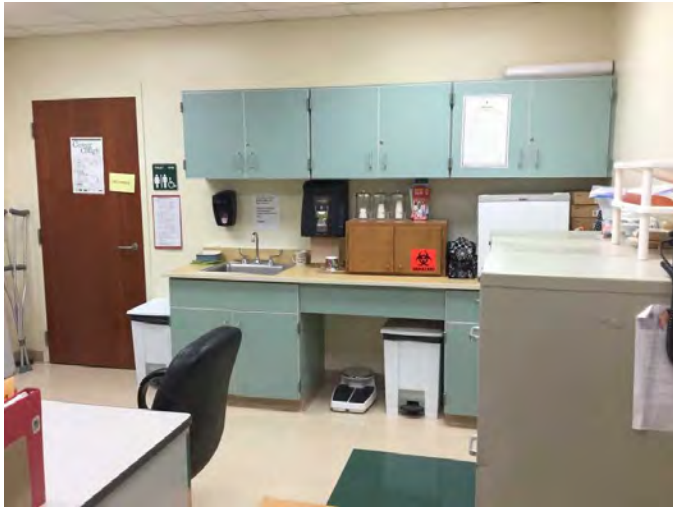
System: E2010 - Fixed Furnishings

Location: Throughout
Distress: Beyond Service Life
Category: Deferred Maintenance / Appearance
Priority: 3 - Necessary/Not Yet Critical (Years 2-5)
Correction: Renew System
Qty: 28,806.00
Unit of Measure: S.F.
Estimate: \$184,733.00
Assessor Name: Terence Davis
Date Created: 12/23/2016

Notes: The fixed furnishings are aged, in marginal condition, and should be replaced.

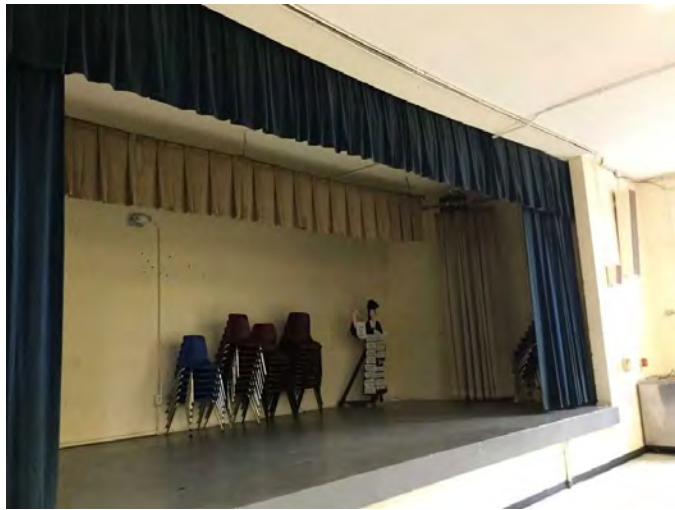
System: E1020 - Institutional Equipment

Location: Stage
Distress: Beyond Service Life
Category: Deferred Maintenance / Appearance
Priority: 4 - Recommended (Years 6-10)
Correction: Renew System
Qty: 28,806.00
Unit of Measure: S.F.
Estimate: \$9,506.00
Assessor Name: Terence Davis
Date Created: 12/23/2016

Notes: Theater equipment is aged and damaged and should be replaced.

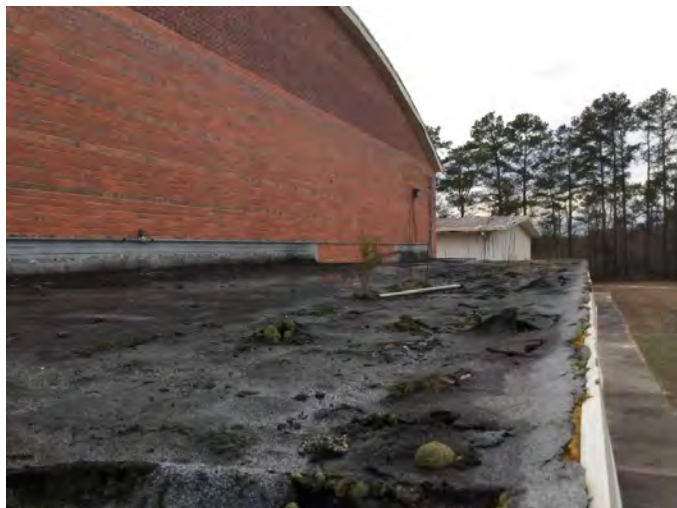
System: B3010105 - Built-Up

Location: Entry foyer
Distress: Beyond Service Life
Category: Deferred Maintenance
Priority: 2 - Potentially Critical (Year 1)
Correction: Renew System
Qty: 588.00
Unit of Measure: S.F.
Estimate: \$7,262.00
Assessor Name: Terence Davis
Date Created: 12/23/2016

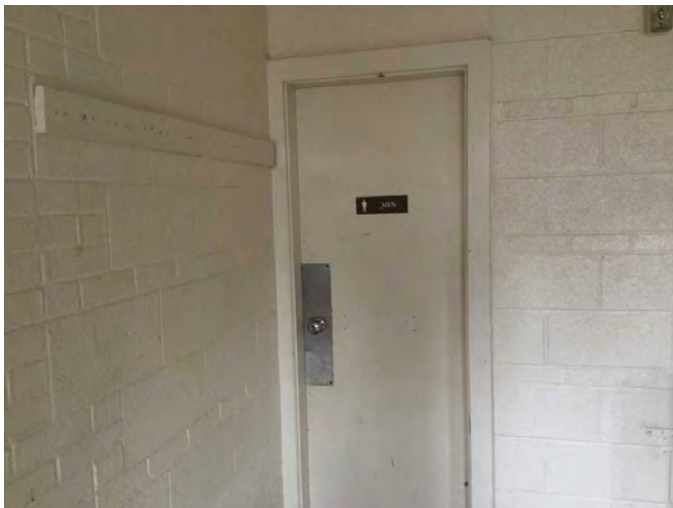
System: C1020 - Interior Doors

Location: Throughout
Distress: Beyond Service Life
Category: Deferred Maintenance / Accessibility Code Compliance
Priority: 3 - Necessary/Not Yet Critical (Years 2-5)
Correction: Renew System
Qty: 8,688.00
Unit of Measure: S.F.
Estimate: \$24,179.00
Assessor Name: Terence Davis
Date Created: 12/23/2016

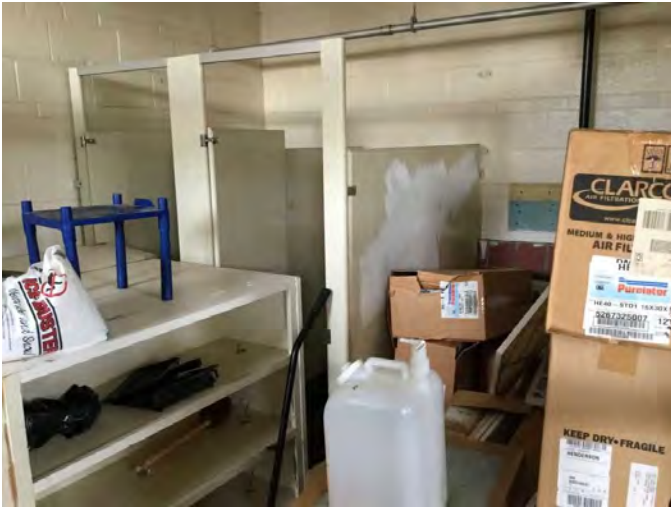
System: C1030 - Fittings

Location: Throughout
Distress: Beyond Service Life
Category: Deferred Maintenance / Accessibility Code Compliance
Priority: 3 - Necessary/Not Yet Critical (Years 2-5)
Correction: Renew System
Qty: 8,688.00
Unit of Measure: S.F.
Estimate: \$93,083.00
Assessor Name: Terence Davis
Date Created: 12/23/2016

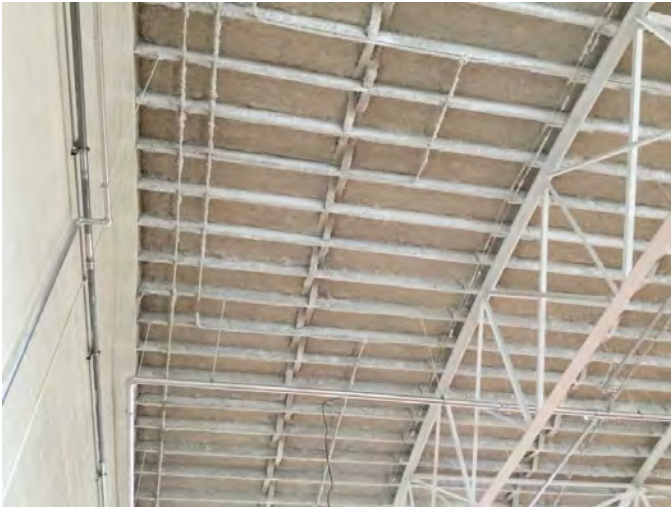
System: C3030 - Ceiling Finishes

Location: Gym
Distress: Beyond Service Life
Category: Deferred Maintenance / Appearance
Priority: 3 - Necessary/Not Yet Critical (Years 2-5)
Correction: Renew System
Qty: 8,688.00
Unit of Measure: S.F.
Estimate: \$104,838.00
Assessor Name: Terence Davis
Date Created: 12/23/2016

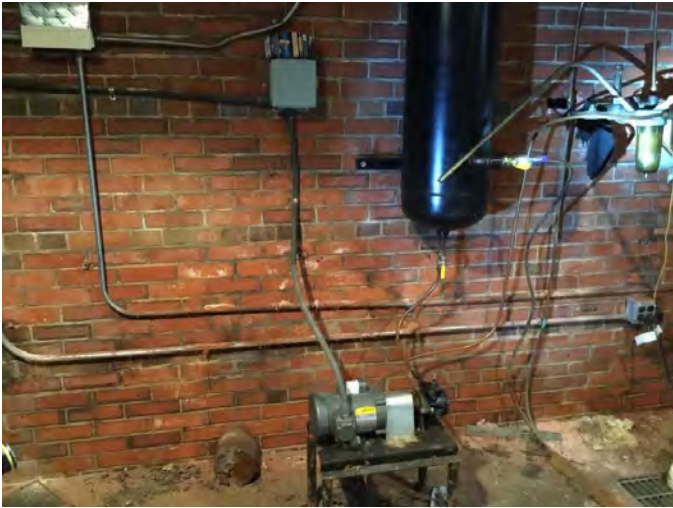
System: D2020 - Domestic Water Distribution

Location: Throughout
Distress: Beyond Service Life
Category: Deferred Maintenance
Priority: 3 - Necessary/Not Yet Critical (Years 2-5)
Correction: Renew System
Qty: 8,688.00
Unit of Measure: S.F.
Estimate: \$9,366.00
Assessor Name: Terence Davis
Date Created: 12/23/2016

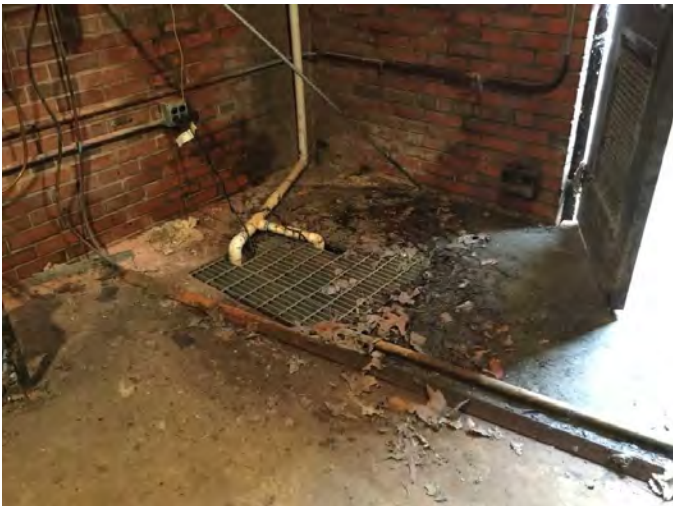
System: D2030 - Sanitary Waste

Location: Throughout
Distress: Beyond Service Life
Category: Deferred Maintenance
Priority: 3 - Necessary/Not Yet Critical (Years 2-5)
Correction: Renew System
Qty: 8,688.00
Unit of Measure: S.F.
Estimate: \$14,717.00
Assessor Name: Terence Davis
Date Created: 12/23/2016

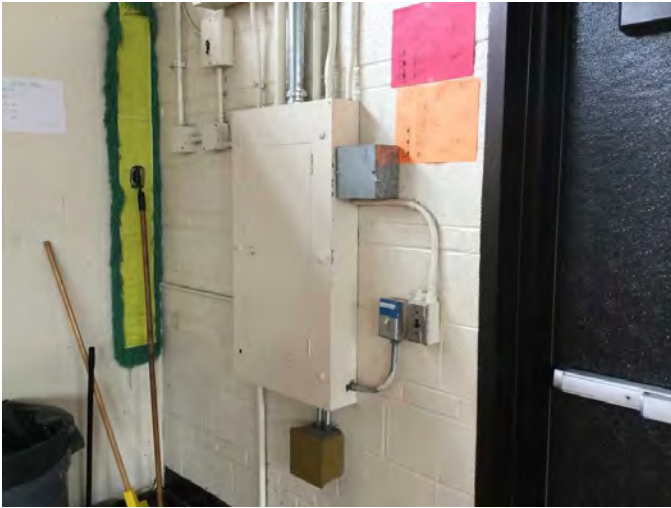
System: D5010 - Electrical Service/Distribution

Location: Throughout
Distress: Beyond Service Life
Category: Deferred Maintenance
Priority: 3 - Necessary/Not Yet Critical (Years 2-5)
Correction: Renew System
Qty: 8,688.00
Unit of Measure: S.F.
Estimate: \$16,151.00
Assessor Name: Terence Davis
Date Created: 12/23/2016

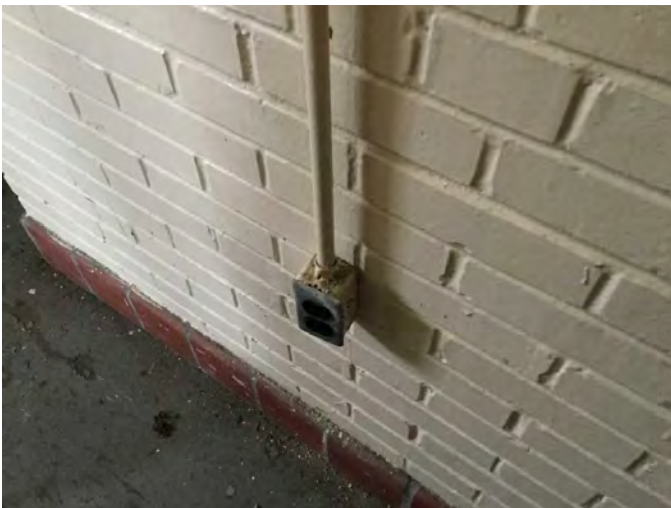
System: D5020 - Branch Wiring

Location: Throughout
Distress: Beyond Service Life
Category: Deferred Maintenance
Priority: 3 - Necessary/Not Yet Critical (Years 2-5)
Correction: Renew System
Qty: 8,688.00
Unit of Measure: S.F.
Estimate: \$48,357.00
Assessor Name: Terence Davis
Date Created: 12/23/2016

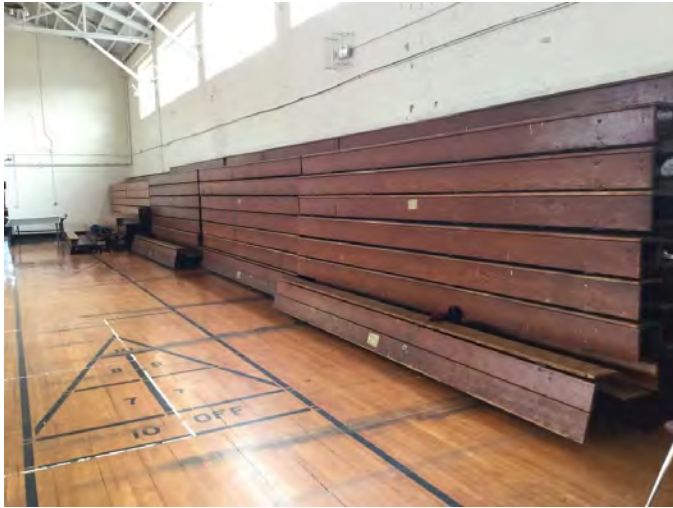
System: E1090 - Other Equipment

Location: Gym
Distress: Beyond Service Life
Category: Deferred Maintenance / Appearance
Priority: 3 - Necessary/Not Yet Critical (Years 2-5)
Correction: Renew System
Qty: 8,688.00
Unit of Measure: S.F.
Estimate: \$18,158.00
Assessor Name: Terence Davis
Date Created: 12/23/2016

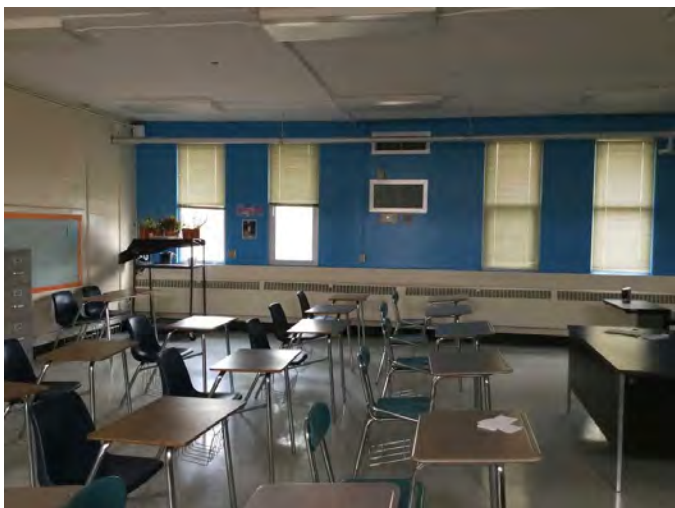
System: B2020 - Exterior Windows

Location: Throughout
Distress: Beyond Service Life
Category: Deferred Maintenance / Energy
Priority: 3 - Necessary/Not Yet Critical (Years 2-5)
Correction: Renew System
Qty: 6,120.00
Unit of Measure: S.F.
Estimate: \$63,213.00
Assessor Name: Terence Davis
Date Created: 01/11/2017

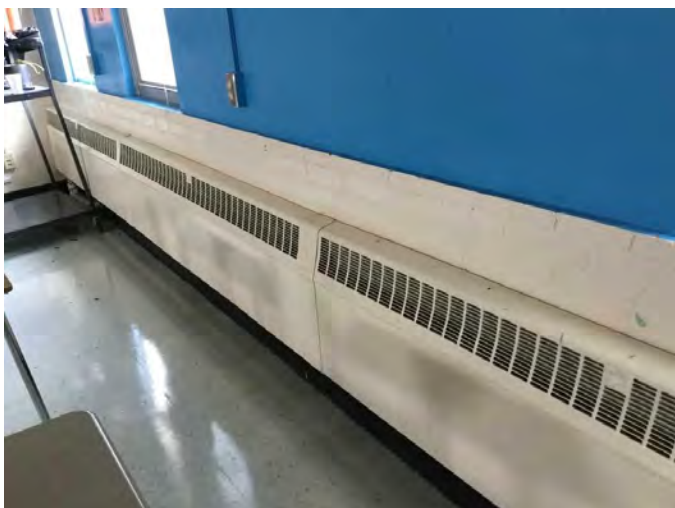
Location: Throughout
Distress: Beyond Service Life
Category: Deferred Maintenance / Appearance
Priority: 3 - Necessary/Not Yet Critical (Years 2-5)
Correction: Renew System
Qty: 6,120.00
Unit of Measure: S.F.
Estimate: \$18,782.00
Assessor Name: Terence Davis
Date Created: 01/11/2017

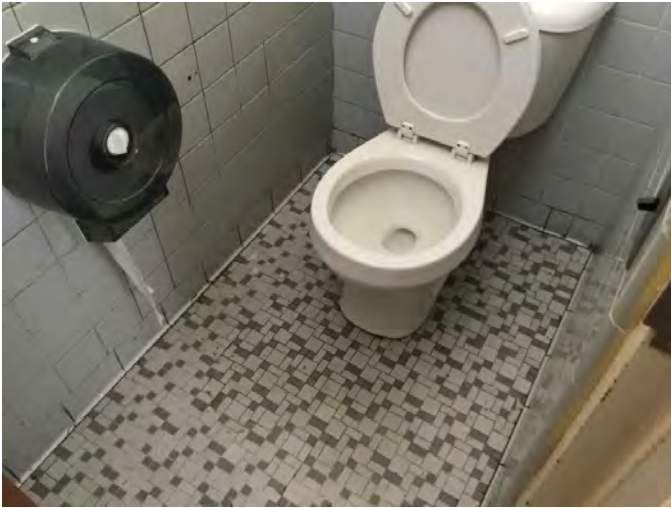
Location: Throughout
Distress: Beyond Service Life
Category: Deferred Maintenance / Accessibility Code Compliance
Priority: 3 - Necessary/Not Yet Critical (Years 2-5)
Correction: Renew System
Qty: 6,120.00
Unit of Measure: S.F.
Estimate: \$77,283.00
Assessor Name: Terence Davis
Date Created: 01/11/2017

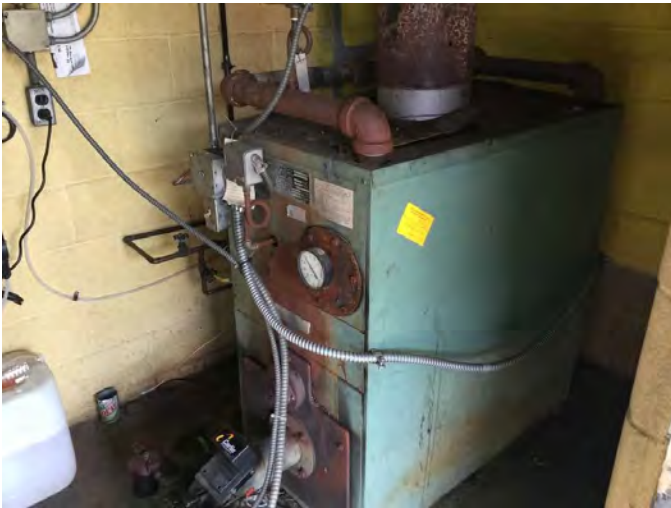
Location: Boiler Rm
Distress: Beyond Service Life
Category: Deferred Maintenance / Energy
Priority: 3 - Necessary/Not Yet Critical (Years 2-5)
Correction: Renew System
Qty: 6,120.00
Unit of Measure: S.F.
Estimate: \$34,199.00
Assessor Name: Terence Davis
Date Created: 01/11/2017

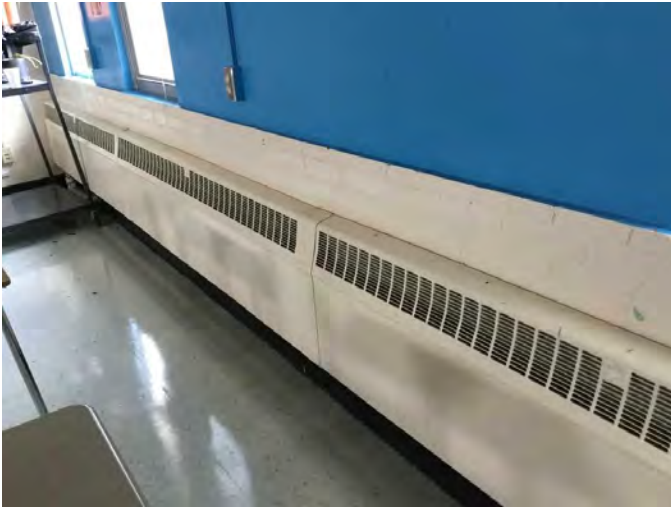
Location: Throughout
Distress: Beyond Service Life
Category: Deferred Maintenance / Energy
Priority: 3 - Necessary/Not Yet Critical (Years 2-5)
Correction: Renew System
Qty: 6,120.00
Unit of Measure: S.F.
Estimate: \$41,334.00
Assessor Name: Terence Davis
Date Created: 01/11/2017

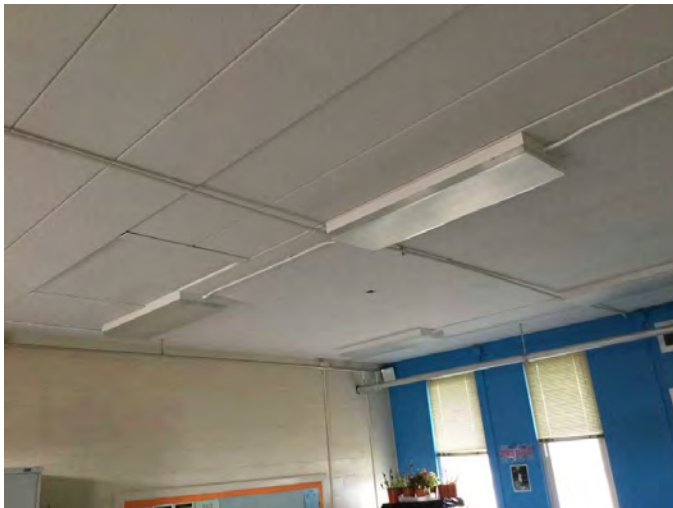
Location: Throughout
Distress: Beyond Service Life
Category: Deferred Maintenance / Energy
Priority: 3 - Necessary/Not Yet Critical (Years 2-5)
Correction: Renew System
Qty: 6,120.00
Unit of Measure: S.F.
Estimate: \$80,245.00
Assessor Name: Terence Davis
Date Created: 01/11/2017

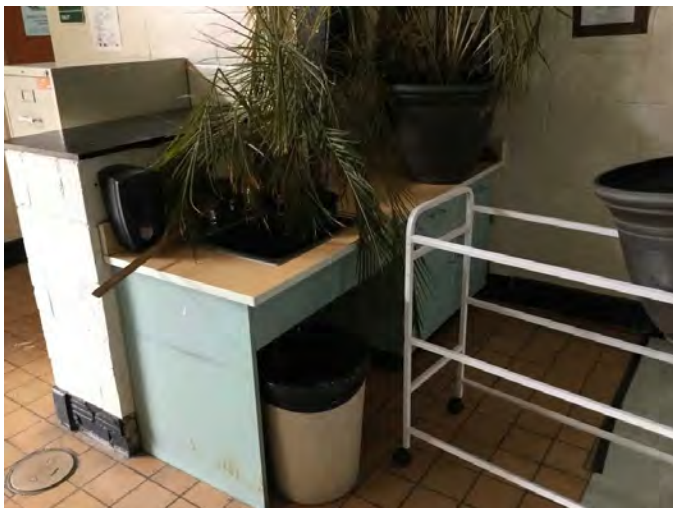
Location: Throughout
Distress: Beyond Service Life
Category: Deferred Maintenance / Appearance
Priority: 3 - Necessary/Not Yet Critical (Years 2-5)
Correction: Renew System
Qty: 6,120.00
Unit of Measure: S.F.
Estimate: \$39,248.00
Assessor Name: Terence Davis
Date Created: 01/11/2017

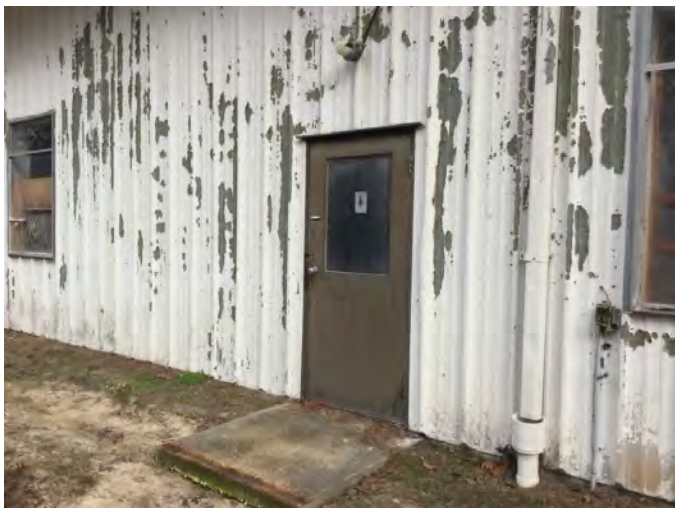
Location: Throughout
Distress: Beyond Service Life
Category: Deferred Maintenance / Appearance
Priority: 3 - Necessary/Not Yet Critical (Years 2-5)
Correction: Renew System
Qty: 7,520.00
Unit of Measure: S.F.
Estimate: \$71,636.00
Assessor Name: Terence Davis
Date Created: 01/11/2017

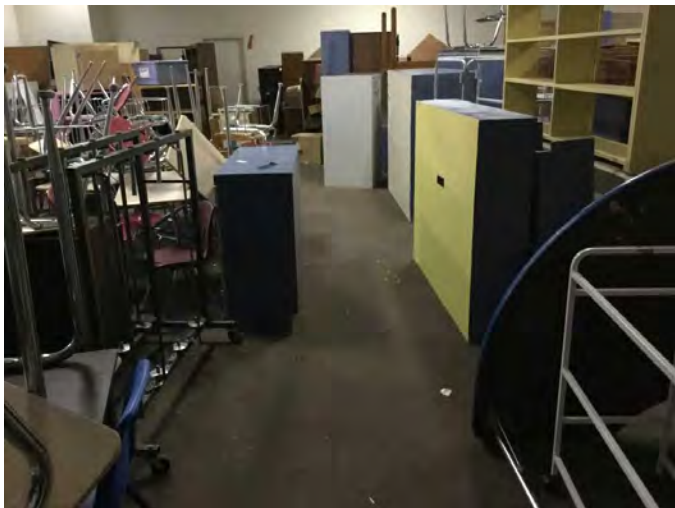
Location: Portions of building
Distress: Beyond Service Life
Category: Deferred Maintenance / Appearance
Priority: 3 - Necessary/Not Yet Critical (Years 2-5)
Correction: Renew System
Qty: 7,520.00
Unit of Measure: S.F.
Estimate: \$172,223.00
Assessor Name: Terence Davis
Date Created: 01/11/2017

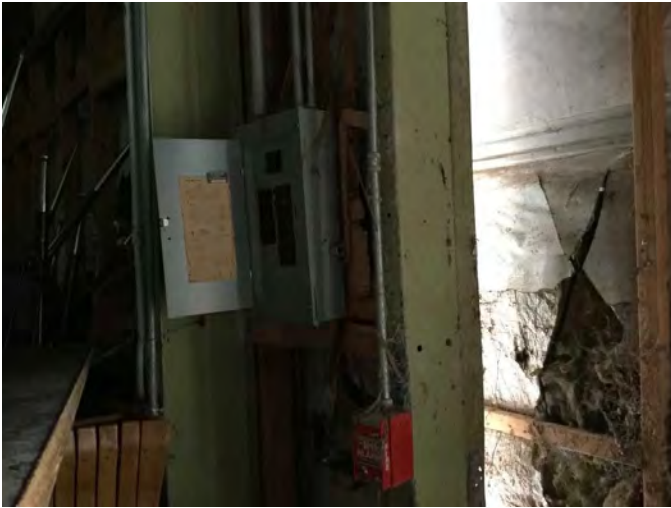
Location: Throughout
Distress: Beyond Service Life
Category: Deferred Maintenance
Priority: 3 - Necessary/Not Yet Critical (Years 2-5)
Correction: Renew System
Qty: 7,520.00
Unit of Measure: S.F.
Estimate: \$29,614.00
Assessor Name: Terence Davis
Date Created: 01/11/2017

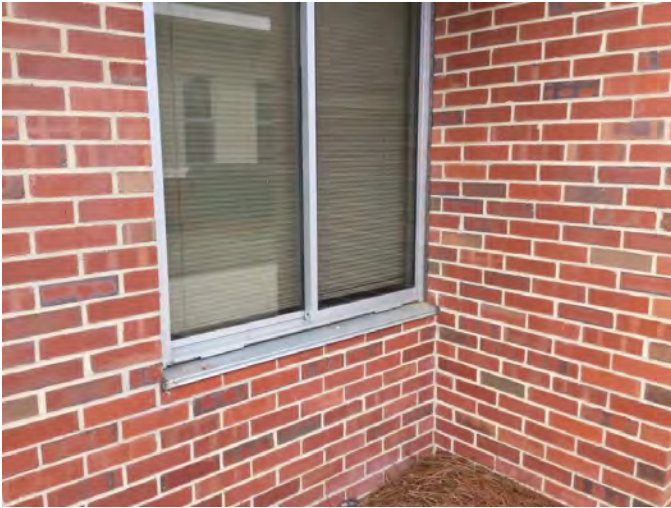
Location: Throughout
Distress: Beyond Service Life
Category: Deferred Maintenance / Energy
Priority: 3 - Necessary/Not Yet Critical (Years 2-5)
Correction: Renew System
Qty: 3,762.00
Unit of Measure: S.F.
Estimate: \$38,858.00
Assessor Name: Terence Davis
Date Created: 01/11/2017

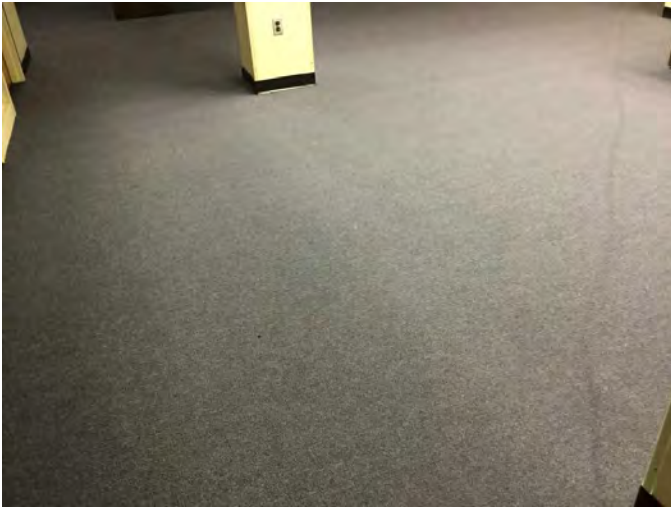
Location: Media center
Distress: Beyond Service Life
Category: Deferred Maintenance / Appearance
Priority: 3 - Necessary/Not Yet Critical (Years 2-5)
Correction: Renew System
Qty: 3,762.00
Unit of Measure: S.F.
Estimate: \$47,093.00
Assessor Name: Terence Davis
Date Created: 01/11/2017

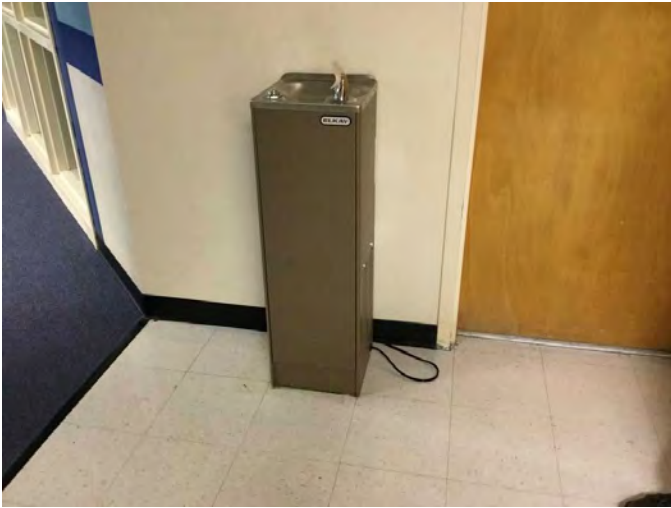
Location: Throughout
Distress: Beyond Service Life
Category: Deferred Maintenance / Accessibility Code Compliance
Priority: 3 - Necessary/Not Yet Critical (Years 2-5)
Correction: Renew System
Qty: 3,762.00
Unit of Measure: S.F.
Estimate: \$47,507.00
Assessor Name: Terence Davis
Date Created: 01/11/2017

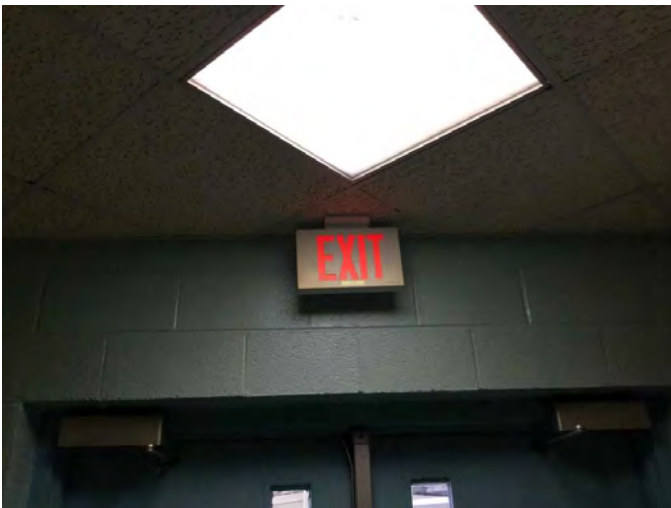
Location: Throughout
Distress: Beyond Service Life
Category: Deferred Maintenance / Energy
Priority: 3 - Necessary/Not Yet Critical (Years 2-5)
Correction: Renew System
Qty: 3,762.00
Unit of Measure: S.F.
Estimate: \$49,327.00
Assessor Name: Terence Davis
Date Created: 01/11/2017

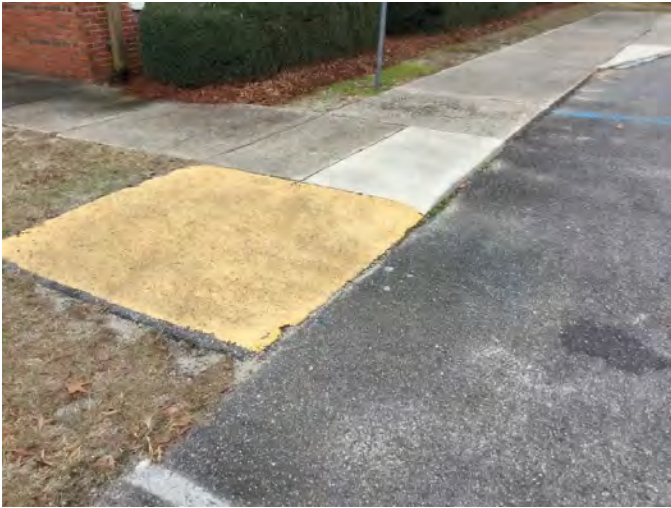
Location: Entire site
Distress: Beyond Service Life
Category: Deferred Maintenance / Accessibility Code Compliance
Priority: 3 - Necessary/Not Yet Critical (Years 2-5)
Correction: Renew System
Qty: 54,896.00
Unit of Measure: S.F.
Estimate: \$115,337.00
Assessor Name: Eduardo Lopez
Date Created: 01/11/2017

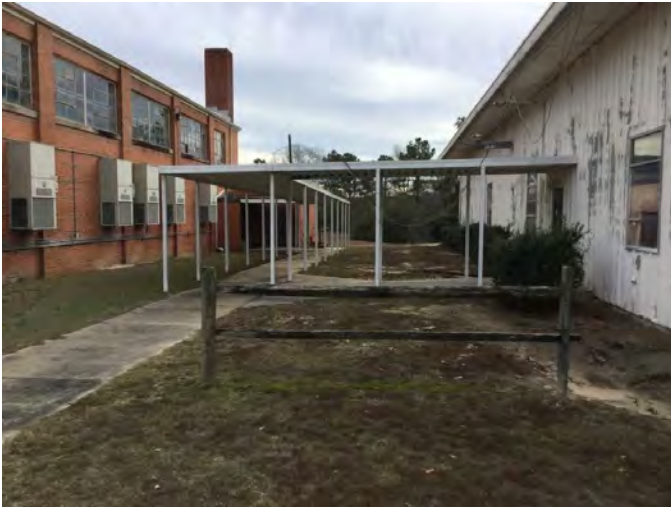
Location: Site
Distress: Beyond Service Life
Category: Deferred Maintenance / Appearance
Priority: 3 - Necessary/Not Yet Critical (Years 2-5)
Correction: Renew System
Qty: 54,896.00
Unit of Measure: S.F.
Estimate: \$91,786.00
Assessor Name: Eduardo Lopez
Date Created: 01/11/2017
