NC School District/830 Scotland County/Middle School

Carver Middle

Campus Assessment Report

March 11, 2017

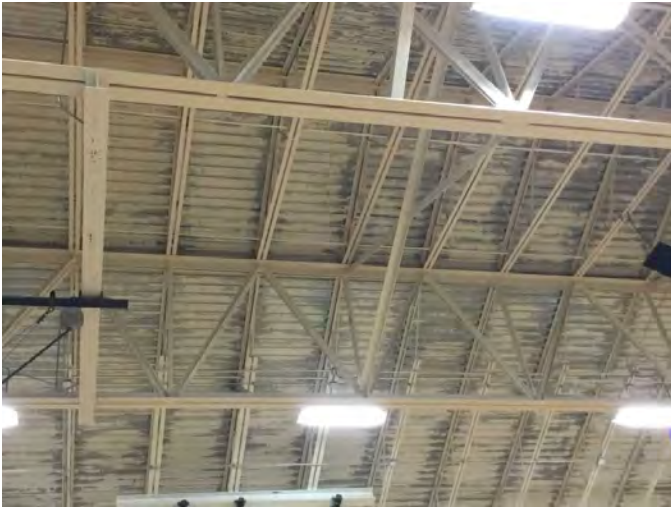
System: C3030 - Ceiling Finishes

Location: Throughout
Distress: Beyond Service Life
Category: Deferred Maintenance
Priority: 4 - Recommended (Years 6-10)
Correction: Renew System
Qty: 88,486.00
Unit of Measure: S.F.
Estimate: \$1,106,694.00
Assessor Name: Eduardo Lopez
Date Created: 01/06/2017

Notes: Painted ceiling in gym is chipping and flaking and should be repainted. The ceiling tiles have been replaced as needed. However the grid shows signs of aging and most tiles are sagging or damaged and should be replaced.
