NC School District/995 Yancey County/Elementary School

Micaville Elementary

Campus Assessment Report

March 11, 2017

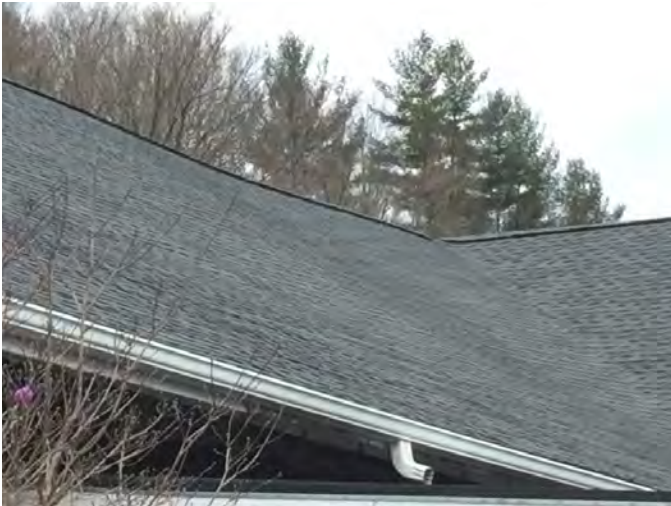
System: B1020 - Roof Construction

Location: Main roof
Distress: Failing
Category: Deferred Maintenance / Safety
Priority: 1 - Currently Critical (Immediate)
Correction: Renew System
Qty: 22,350.00
Unit of Measure: S.F.
Estimate: \$395,327.00
Assessor Name: Terence Davis
Date Created: 02/10/2017

Notes: The original wood roof construction is failing and should be replaced. It was recommended that no person should get on the roof for fear of falling through. Roofing structure failure is also causing roof deck failure.

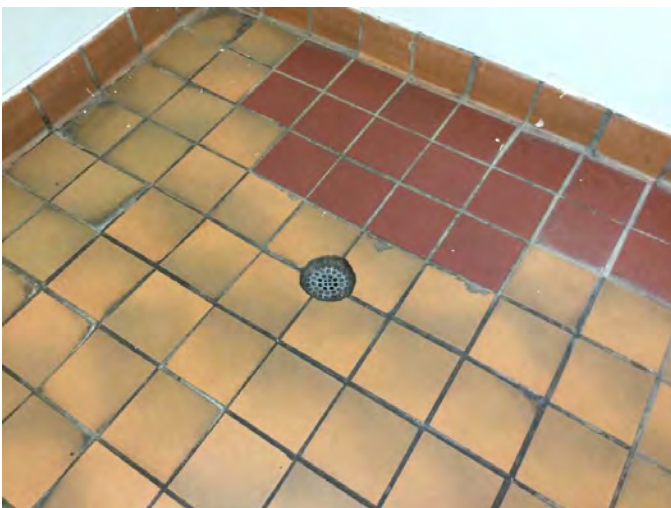
System: D2030 - Sanitary Waste

Location: Throughout
Distress: Failing
Category: Deferred Maintenance / Safety
Priority: 1 - Currently Critical (Immediate)
Correction: Renew System
Qty: 22,350.00
Unit of Measure: S.F.
Estimate: \$38,598.00
Assessor Name: Terence Davis
Date Created: 01/27/2017

Notes: The sanitary waste system is aged, has reported periodic failures, and should be replaced. System requires daily pump-out.

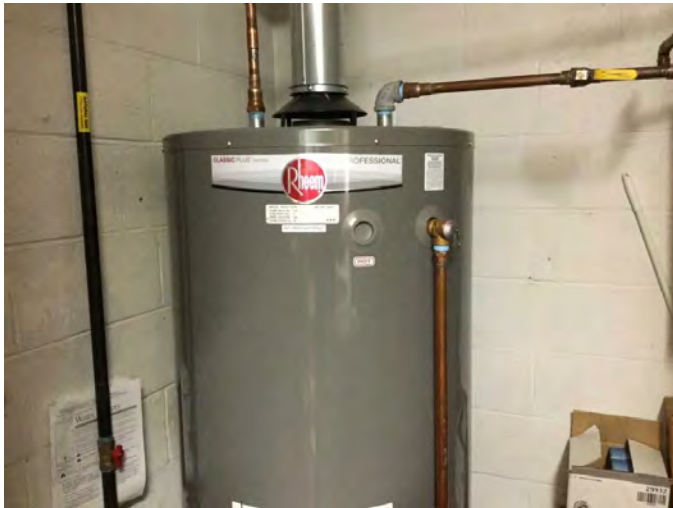
System: D2020 - Domestic Water Distribution

Location: Throughout
Distress: Beyond Service Life
Category: Deferred Maintenance / Energy
Priority: 2 - Potentially Critical (Year 1)
Correction: Renew System
Qty: 22,350.00
Unit of Measure: S.F.
Estimate: \$24,339.00
Assessor Name: Terence Davis
Date Created: 01/27/2017

Notes: The domestic water distribution system is aged and should be replaced.

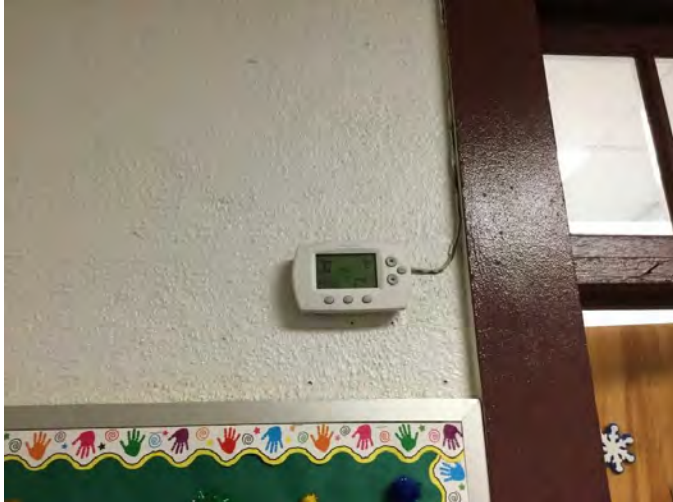
System: D3060 - Controls & Instrumentation

Location: Throughout
Distress: Inadequate
Category: Deferred Maintenance / Life Safety Code Compliance
Priority: 2 - Potentially Critical (Year 1)
Correction: Renew System
Qty: 22,350.00
Unit of Measure: S.F.
Estimate: \$48,678.00
Assessor Name: Terence Davis
Date Created: 01/27/2017

Notes: HVAC controls are limited to one thermostat near the front door and is unreliable and should be replaced.

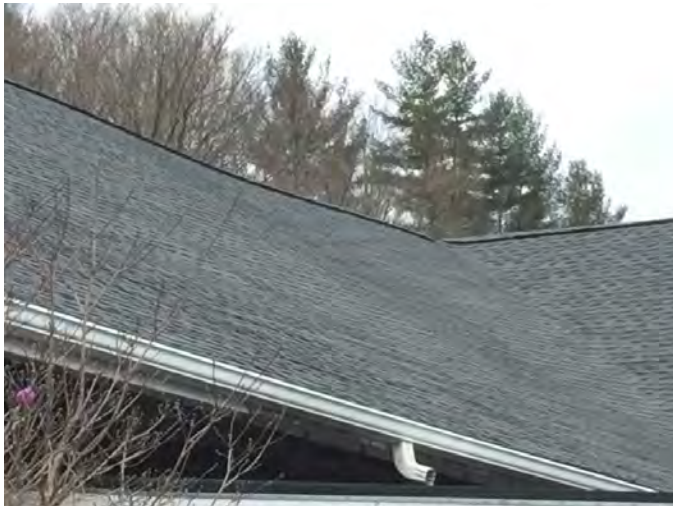
System: B3010140 - Asphalt Shingles

Location: Throughout
Distress: Beyond Service Life
Category: Deferred Maintenance / Appearance
Priority: 3 - Necessary/Not Yet Critical (Years 2-5)
Correction: Renew System
Qty: 22,350.00
Unit of Measure: S.F.
Estimate: \$140,966.00
Assessor Name: Terence Davis
Date Created: 03/01/2017

Notes: The asphalt shingle roofing is aged, damaged and should be replaced.

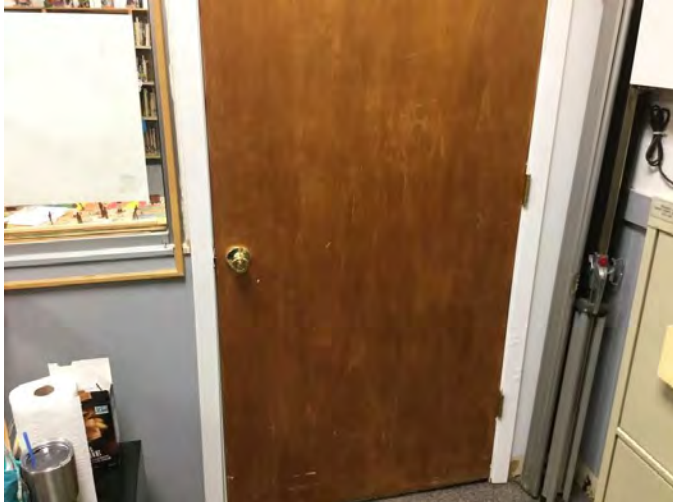
System: C1020 - Interior Doors

Location: Throughout
Distress: Beyond Service Life
Category: Deferred Maintenance / Accessibility Code Compliance
Priority: 3 - Necessary/Not Yet Critical (Years 2-5)
Correction: Renew System
Qty: 22,350.00
Unit of Measure: S.F.
Estimate: \$63,675.00
Assessor Name: Terence Davis
Date Created: 01/27/2017

Notes: The interior doors are aged, failing, most hardware is not ADA or code compliant and should be replaced

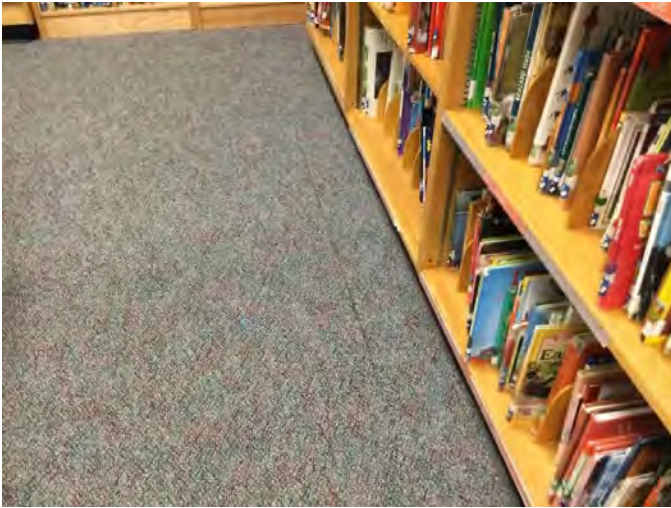
System: C3020 - Floor Finishes

Location: Throughout
Distress: Failing
Category: Deferred Maintenance / Appearance
Priority: 3 - Necessary/Not Yet Critical (Years 2-5)
Correction: Renew System
Qty: 22,350.00
Unit of Measure: S.F.
Estimate: \$285,186.00
Assessor Name: Terence Davis
Date Created: 01/27/2017

Notes: The carpet is aged, stained, frayed, and should be replaced.
The VCT flooring is aged, cracked, worn, and should be replaced.

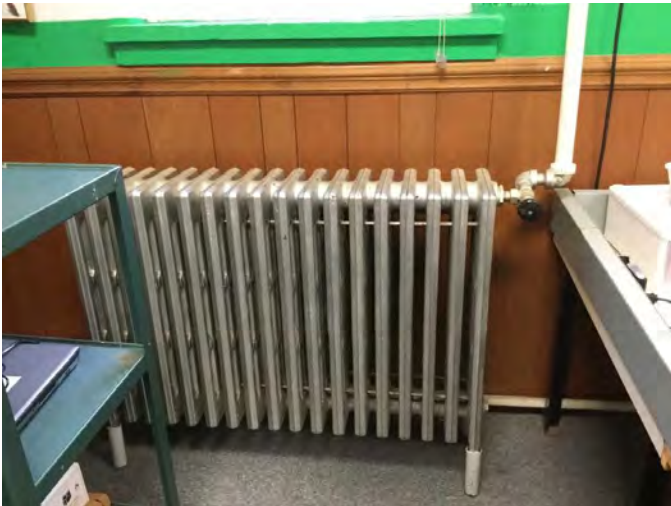
System: D3040 - Distribution Systems

Location: Throughout
Distress: Beyond Service Life
Category: Deferred Maintenance / Energy
Priority: 3 - Necessary/Not Yet Critical (Years 2-5)
Correction: Renew System
Qty: 22,350.00
Unit of Measure: S.F.
Estimate: \$153,902.00
Assessor Name: Terence Davis
Date Created: 01/27/2017

Notes: The steam and hot water supply distribution system is aged, in marginal condition, and should be replaced.

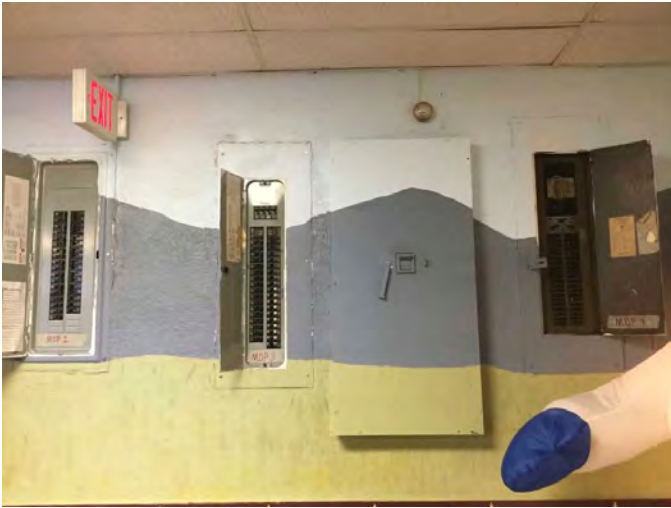
System: D5010 - Electrical Service/Distribution

Location: Throughout
Distress: Beyond Service Life
Category: Deferred Maintenance / Energy
Priority: 3 - Necessary/Not Yet Critical (Years 2-5)
Correction: Renew System
Qty: 22,350.00
Unit of Measure: S.F.
Estimate: \$42,532.00
Assessor Name: Terence Davis
Date Created: 01/27/2017

Notes: The original electrical distribution system is operating properly due to an aggressive maintenance program but is aged, in marginal condition, and should be replaced.

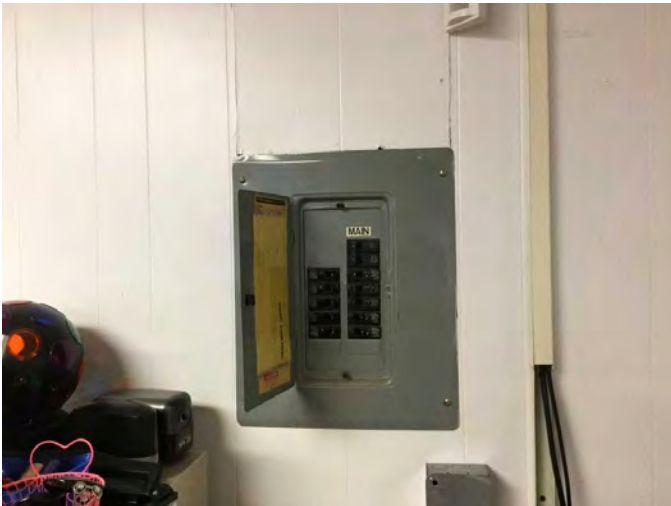
System: D5020 - Branch Wiring

Location: Throughout
Distress: Beyond Service Life
Category: Deferred Maintenance / Energy
Priority: 3 - Necessary/Not Yet Critical (Years 2-5)
Correction: Renew System
Qty: 22,350.00
Unit of Measure: S.F.
Estimate: \$127,842.00
Assessor Name: Terence Davis
Date Created: 01/27/2017

Notes: The original branch wiring system is operating, but is aged, in poor condition, and should be replaced.

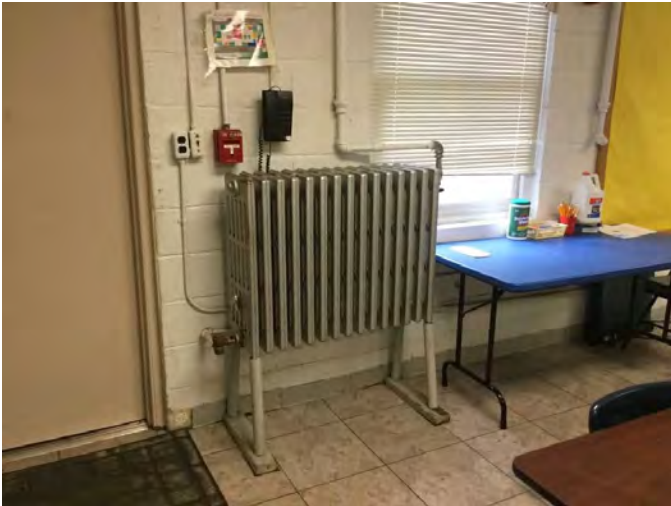
System: D3040 - Distribution Systems

Location: Throughout
Distress: Failing
Category: Deferred Maintenance / Safety
Priority: 2 - Potentially Critical (Year 1)
Correction: Renew System
Qty: 2,000.00
Unit of Measure: S.F.
Estimate: \$13,772.00
Assessor Name: Terence Davis
Date Created: 01/27/2017

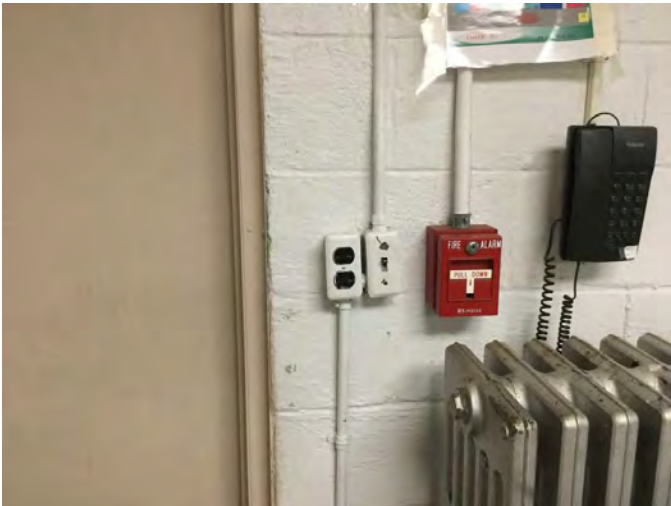
System: D5020 - Branch Wiring

Location: Throughout
Distress: Beyond Service Life
Category: Deferred Maintenance / Safety
Priority: 2 - Potentially Critical (Year 1)
Correction: Renew System
Qty: 2,000.00
Unit of Measure: S.F.
Estimate: \$11,440.00
Assessor Name: Terence Davis
Date Created: 01/27/2017

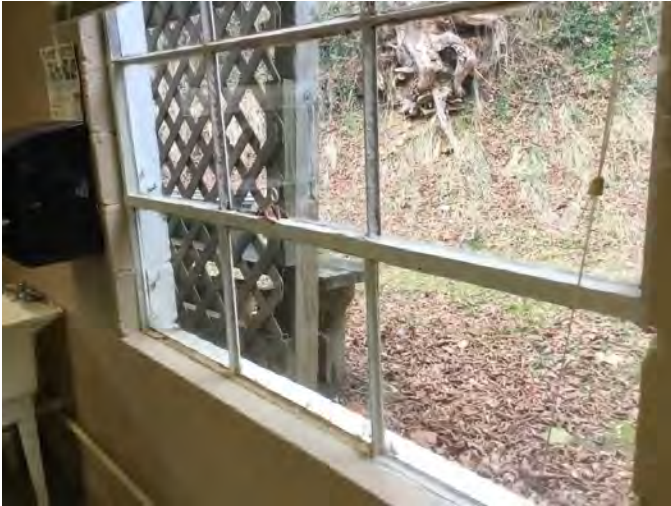
System: B2020 - Exterior Windows

Location: Throughout
Distress: Beyond Service Life
Category: Deferred Maintenance / Energy
Priority: 3 - Necessary/Not Yet Critical (Years 2-5)
Correction: Renew System
Qty: 2,000.00
Unit of Measure: S.F.
Estimate: \$21,054.00
Assessor Name: Terence Davis
Date Created: 01/27/2017

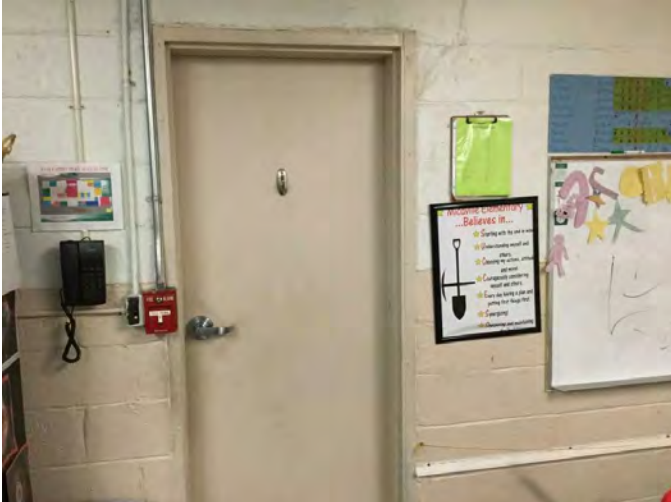
System: B2030 - Exterior Doors

Location: Throughout
Distress: Beyond Service Life
Category: Deferred Maintenance / Appearance
Priority: 3 - Necessary/Not Yet Critical (Years 2-5)
Correction: Renew System
Qty: 2,000.00
Unit of Measure: S.F.
Estimate: \$2,354.00
Assessor Name: Terence Davis
Date Created: 01/27/2017

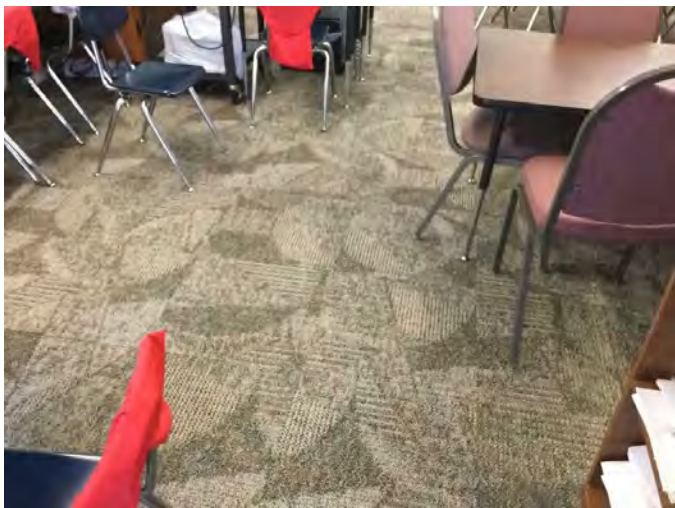
System: C3020 - Floor Finishes

Location: Throughout
Distress: Beyond Service Life
Category: Deferred Maintenance
Priority: 3 - Necessary/Not Yet Critical (Years 2-5)
Correction: Renew System
Qty: 2,000.00
Unit of Measure: S.F.
Estimate: \$25,520.00
Assessor Name: Terence Davis
Date Created: 01/27/2017

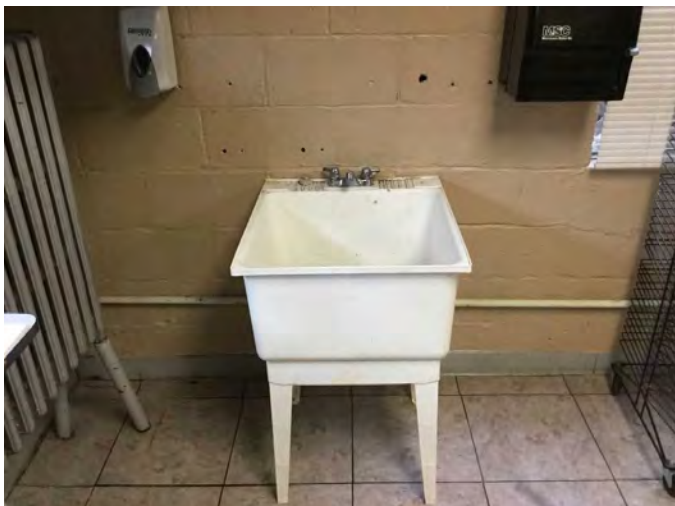
System: D2010 - Plumbing Fixtures

Location: Throughout
Distress: Beyond Service Life
Category: Deferred Maintenance / Accessibility Code Compliance
Priority: 3 - Necessary/Not Yet Critical (Years 2-5)
Correction: Renew System
Qty: 2,000.00
Unit of Measure: S.F.
Estimate: \$25,762.00
Assessor Name: Terence Davis
Date Created: 01/27/2017

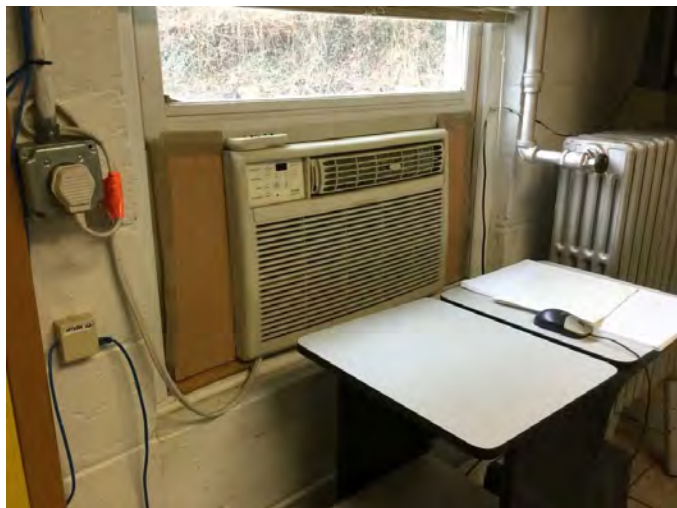
System: D3050 - Terminal & Package Units

Location: Throughout
Distress: Beyond Service Life
Category: Deferred Maintenance / Energy
Priority: 3 - Necessary/Not Yet Critical (Years 2-5)
Correction: Renew System
Qty: 2,000.00
Unit of Measure: S.F.
Estimate: \$16,368.00
Assessor Name: Terence Davis
Date Created: 01/27/2017

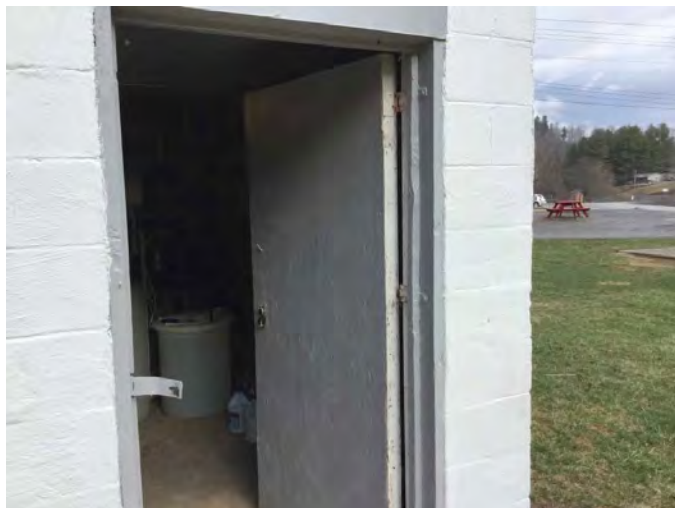
Location: Entrance
Distress: Failing
Category: Deferred Maintenance / Appearance
Priority: 2 - Potentially Critical (Year 1)
Correction: Renew System
Qty: 64.00
Unit of Measure: S.F.
Estimate: \$610.00
Assessor Name: Eduardo Lopez
Date Created: 01/27/2017

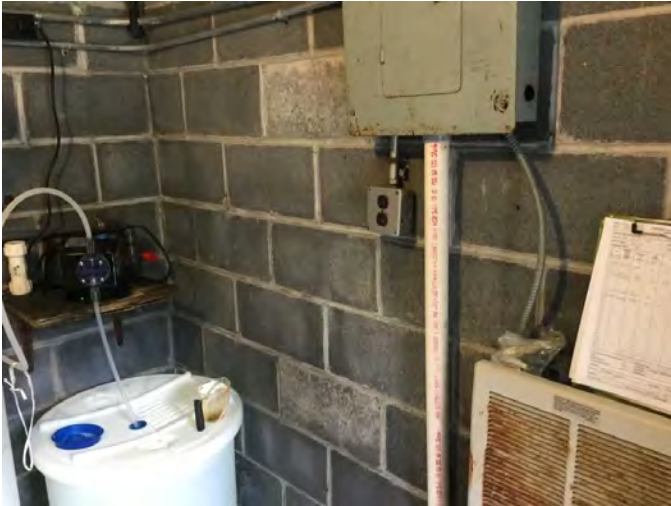
Location: Throughout
Distress: Inadequate
Category: Deferred Maintenance / Energy
Priority: 3 - Necessary/Not Yet Critical (Years 2-5)
Correction: Renew System
Qty: 64.00
Unit of Measure: S.F.
Estimate: \$360.00
Assessor Name: Eduardo Lopez
Date Created: 01/27/2017

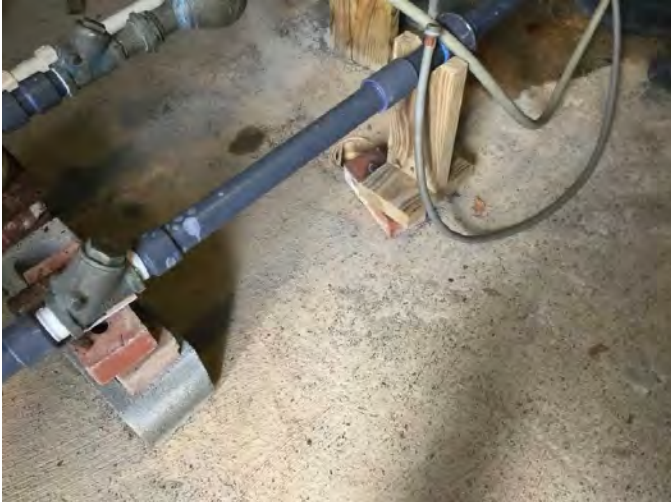
Location: Throughout
Distress: Inadequate
Category: Deferred Maintenance / Safety
Priority: 3 - Necessary/Not Yet Critical (Years 2-5)
Correction: Renew System
Qty: 64.00
Unit of Measure: S.F.
Estimate: \$1,466.00
Assessor Name: Eduardo Lopez
Date Created: 01/27/2017

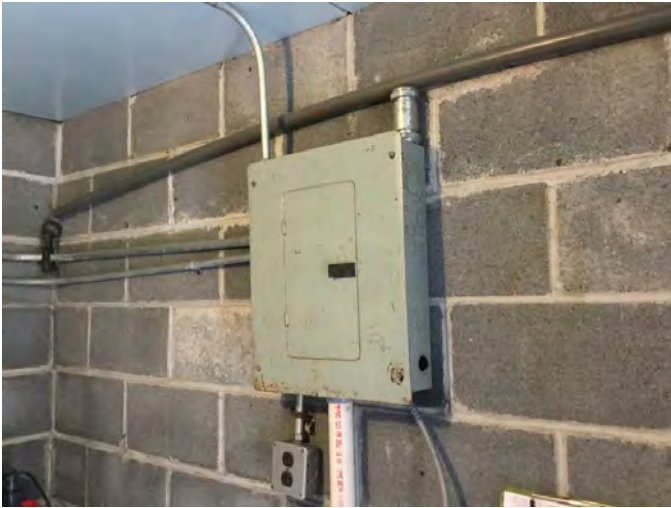
Location: Throughout
Distress: Beyond Service Life
Category: Deferred Maintenance
Priority: 3 - Necessary/Not Yet Critical (Years 2-5)
Correction: Renew System
Qty: 64.00
Unit of Measure: S.F.
Estimate: \$252.00
Assessor Name: Eduardo Lopez
Date Created: 01/27/2017

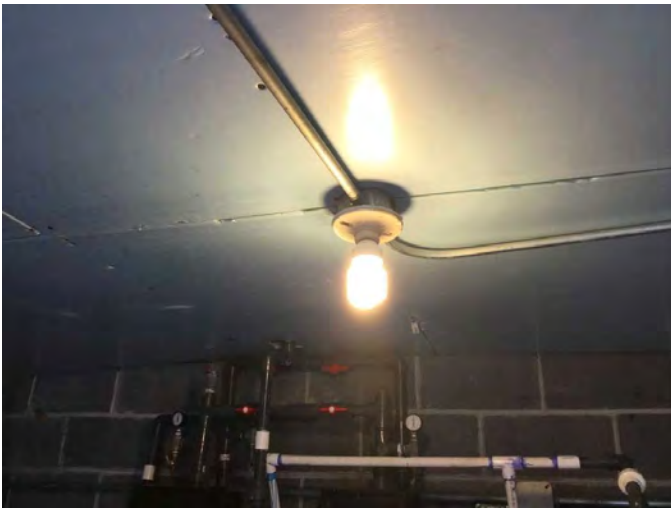
Location: Throughout
Distress: Inadequate
Category: Deferred Maintenance / Safety
Priority: 3 - Necessary/Not Yet Critical (Years 2-5)
Correction: Renew System
Qty: 64.00
Unit of Measure: S.F.
Estimate: \$674.00
Assessor Name: Eduardo Lopez
Date Created: 01/27/2017

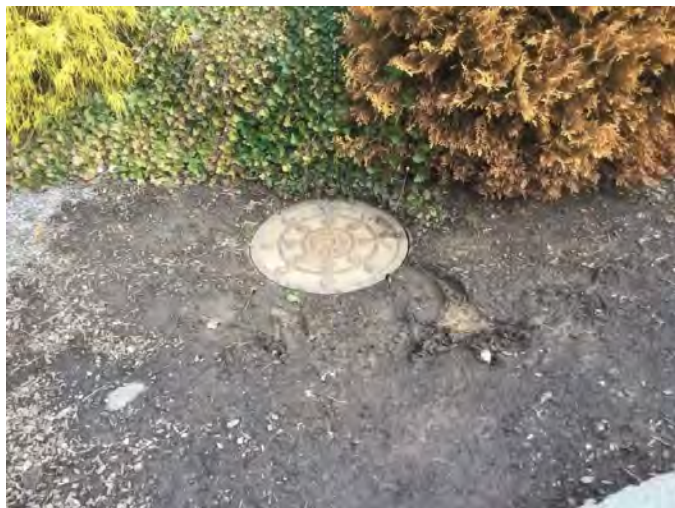
Location: Septic
Distress: Failing
Category: Deferred Maintenance / Environmental
Priority: 1 - Currently Critical (Immediate)
Correction: Renew System
Qty: 24,414.00
Unit of Measure: S.F.
Estimate: \$38,940.00
Assessor Name: Eduardo Lopez
Date Created: 01/27/2017

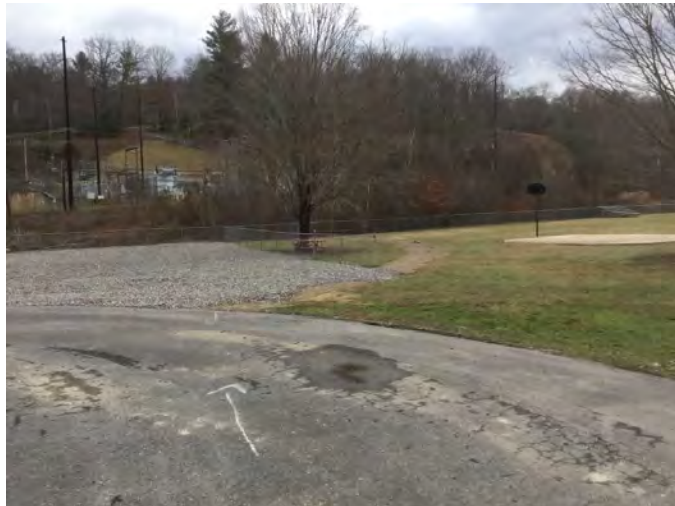
Location: Parking
Distress: Failing
Category: Deferred Maintenance / Accessibility Code Compliance
Priority: 2 - Potentially Critical (Year 1)
Correction: Renew System
Qty: 24,414.00
Unit of Measure: S.F.
Estimate: \$35,718.00
Assessor Name: Eduardo Lopez
Date Created: 01/27/2017

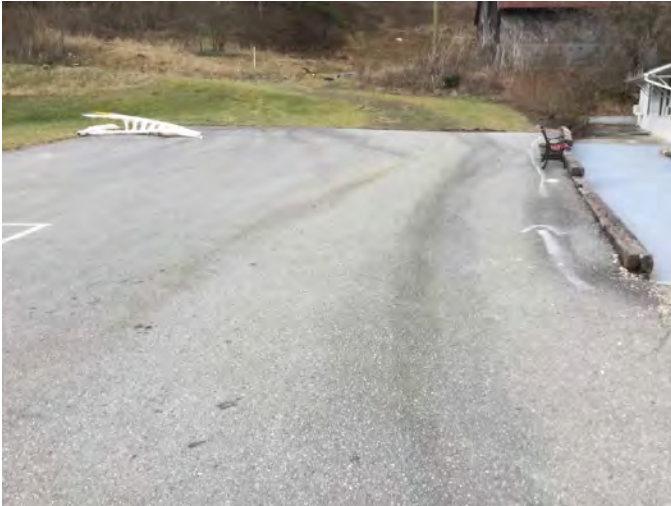
Location: Site entrance
Distress: Beyond Service Life
Category: Deferred Maintenance / Appearance
Priority: 3 - Necessary/Not Yet Critical (Years 2-5)
Correction: Renew System
Qty: 24,414.00
Unit of Measure: S.F.
Estimate: \$102,319.00
Assessor Name: Eduardo Lopez
Date Created: 01/27/2017

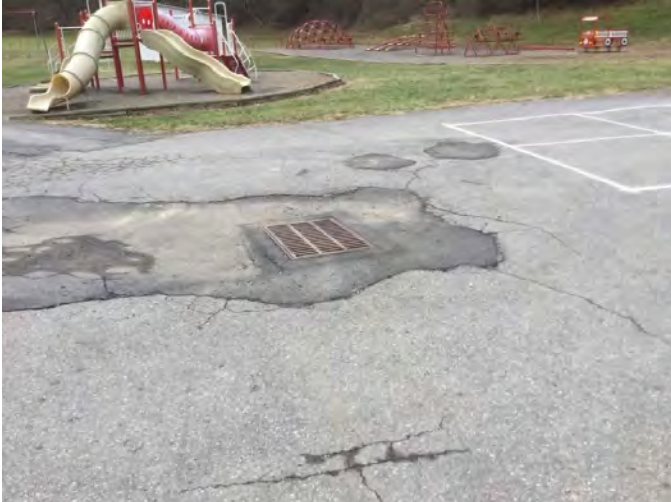
Location: Throughout
Distress: Beyond Service Life
Category: Deferred Maintenance / Environmental
Priority: 3 - Necessary/Not Yet Critical (Years 2-5)
Correction: Renew System
Qty: 24,414.00
Unit of Measure: S.F.
Estimate: \$121,924.00
Assessor Name: Eduardo Lopez
Date Created: 01/27/2017

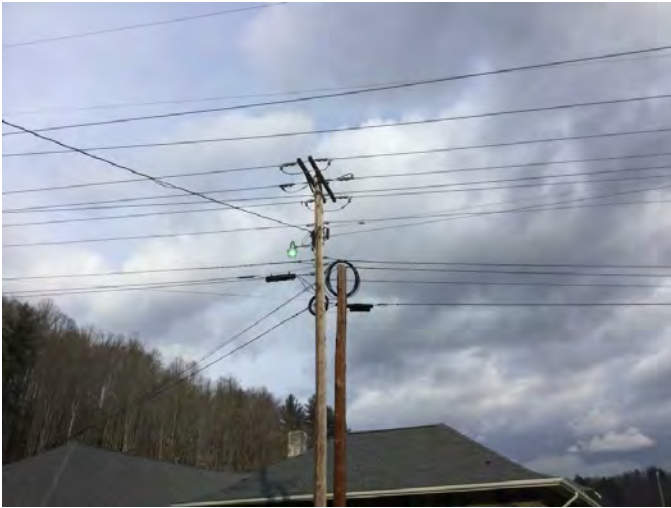
Location: Throughout
Distress: Beyond Service Life
Category: Deferred Maintenance / Energy
Priority: 3 - Necessary/Not Yet Critical (Years 2-5)
Correction: Renew System
Qty: 24,414.00
Unit of Measure: S.F.
Estimate: \$63,110.00
Assessor Name: Eduardo Lopez
Date Created: 01/27/2017

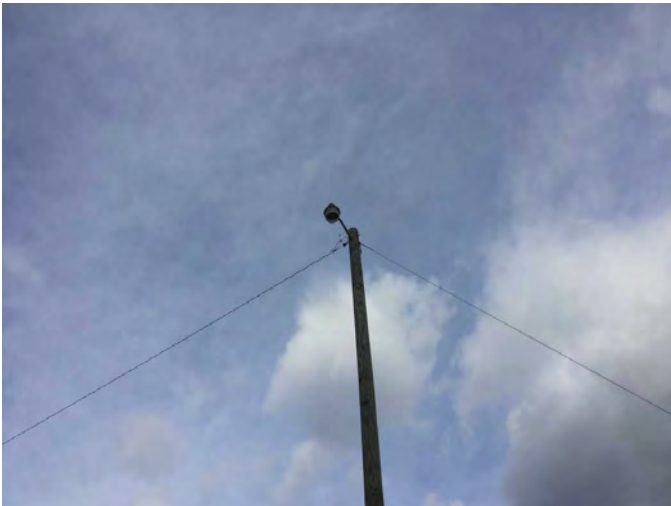
Location: Throughout
Distress: Inadequate
Category: Deferred Maintenance / Safety
Priority: 3 - Necessary/Not Yet Critical (Years 2-5)
Correction: Renew System
Qty: 24,414.00
Unit of Measure: S.F.
Estimate: \$39,477.00
Assessor Name: Eduardo Lopez
Date Created: 01/27/2017

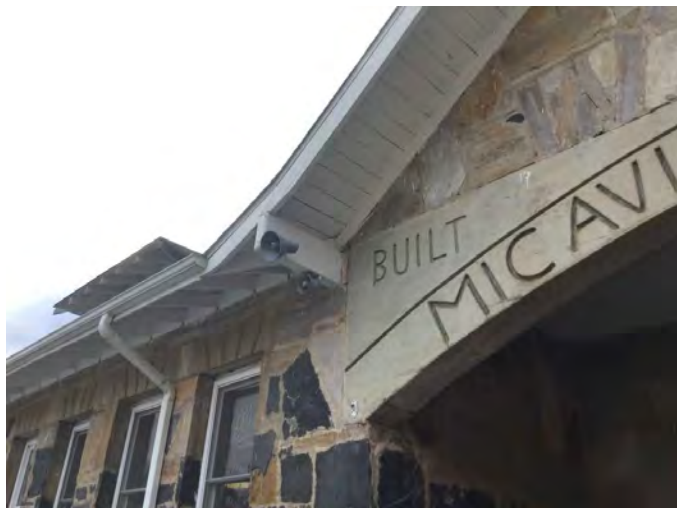
Location: Throughout
Distress: Inadequate
Category: Deferred Maintenance / Safety
Priority: 3 - Necessary/Not Yet Critical (Years 2-5)
Correction: Renew System
Qty: 24,414.00
Unit of Measure: S.F.
Estimate: \$22,559.00
Assessor Name: Eduardo Lopez
Date Created: 01/27/2017
