NC School District/995 Yancey County/Elementary School

South Toe Elementary

Campus Assessment Report

March 11, 2017

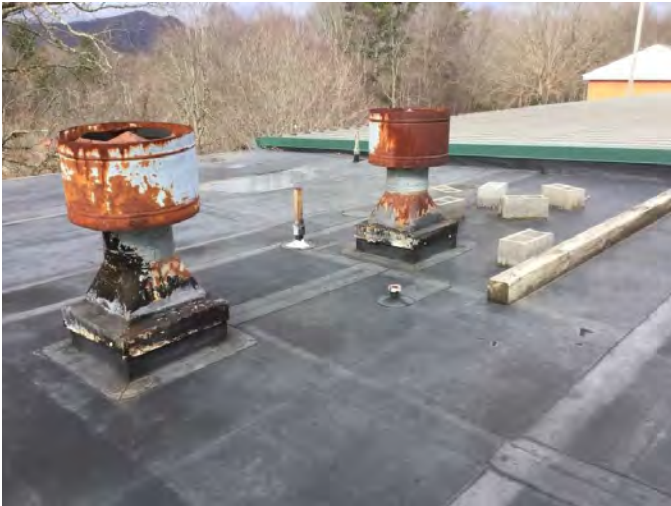
System: B3010120 - Single Ply Membrane

Location: Cafeteria
Distress: Failing
Category: Deferred Maintenance
Priority: 3 - Necessary/Not Yet Critical (Years 2-5)
Correction: Renew System
Qty: 4,560.00
Unit of Measure: S.F.
Estimate: \$47,743.00
Assessor Name: Terence Davis
Date Created: 01/30/2017

Notes: The EPDM adhered roof coverings are aging, showing signs of failure and should be replaced.

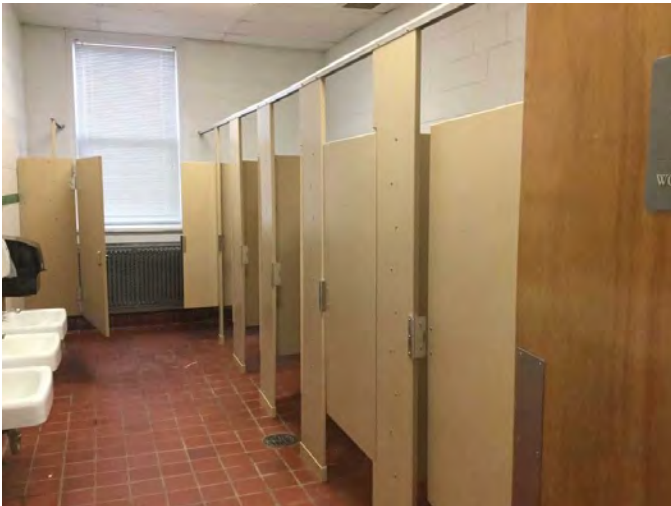
System: C1030 - Fittings

Location: Throughout
Distress: Beyond Service Life
Category: Deferred Maintenance / Accessibility Code Compliance
Priority: 3 - Necessary/Not Yet Critical (Years 2-5)
Correction: Renew System
Qty: 20,420.00
Unit of Measure: S.F.
Estimate: \$223,272.00
Assessor Name: Terence Davis
Date Created: 01/30/2017

Notes: The fittings throughout the building are aged, in marginal condition, handrails and room signage are ADA non-compliance and system should be replaced.

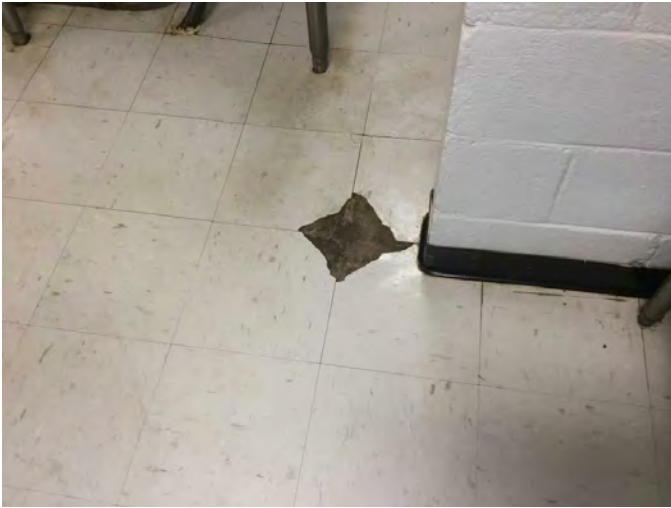
System: C3020 - Floor Finishes

Location: Throughout
Distress: Beyond Service Life
Category: Deferred Maintenance / Appearance
Priority: 3 - Necessary/Not Yet Critical (Years 2-5)
Correction: Renew System
Qty: 20,420.00
Unit of Measure: S.F.
Estimate: \$260,559.00
Assessor Name: Terence Davis
Date Created: 01/30/2017

Notes: The original flooring is in poor conditions, with different areas bubbling or separating from the substrate, and should be replaced.
The quarry tile in the kitchen spaces is aged, chipped, cracked, patched, worn and should be replaced.
The VCT flooring is aged, cracked, worn, and should be replaced. Some ACM remains.

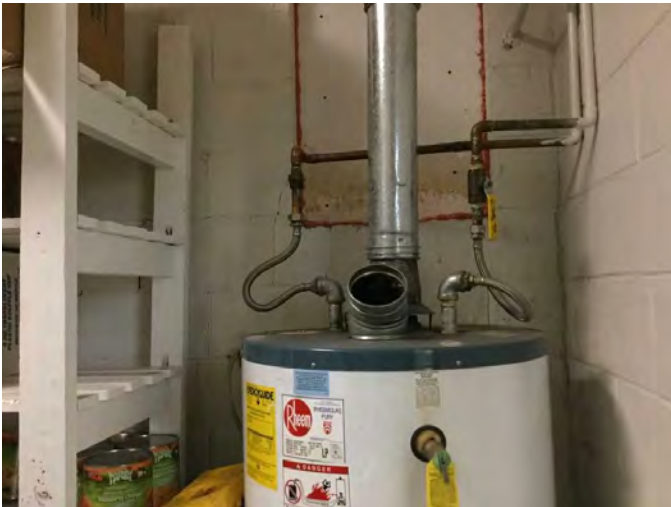
System: D2020 - Domestic Water Distribution

Location: Throughout
Distress: Beyond Service Life
Category: Deferred Maintenance
Priority: 3 - Necessary/Not Yet Critical (Years 2-5)
Correction: Renew System
Qty: 20,420.00
Unit of Measure: S.F.
Estimate: \$22,237.00
Assessor Name: Terence Davis
Date Created: 01/30/2017

Notes: The domestic water distribution system is aged and should be replaced.

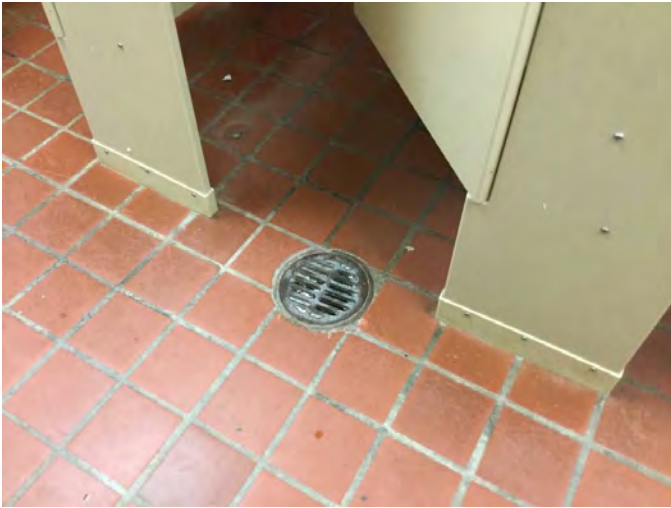
System: D2030 - Sanitary Waste

Location: Throughout
Distress: Beyond Service Life
Category: Deferred Maintenance / Environmental
Priority: 3 - Necessary/Not Yet Critical (Years 2-5)
Correction: Renew System
Qty: 20,420.00
Unit of Measure: S.F.
Estimate: \$35,265.00
Assessor Name: Terence Davis
Date Created: 01/30/2017

Notes: The sanitary waste system is aged, has reported periodic failures, and should be replaced.

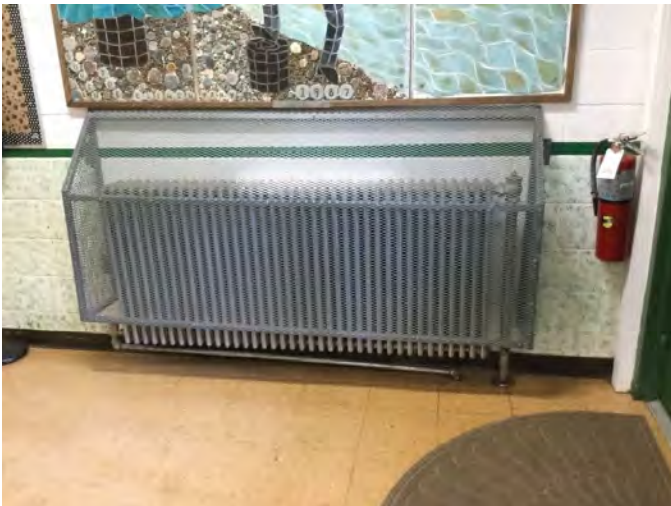
System: D3040 - Distribution Systems

Location: Throughout
Distress: Beyond Service Life
Category: Deferred Maintenance / Energy
Priority: 3 - Necessary/Not Yet Critical (Years 2-5)
Correction: Renew System
Qty: 20,420.00
Unit of Measure: S.F.
Estimate: \$140,612.00
Assessor Name: Terence Davis
Date Created: 01/30/2017

Notes: The steam and hot water supply distribution system is aged, in marginal condition, and should be replaced.

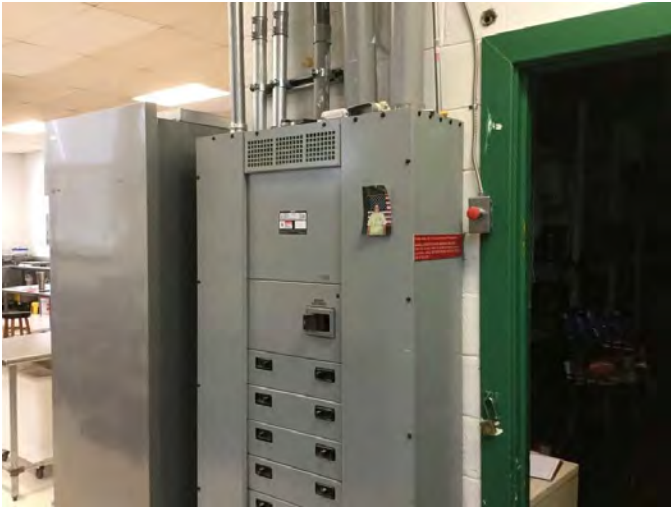
System: D5010 - Electrical Service/Distribution

Location: Throughout
Distress: Beyond Service Life
Category: Deferred Maintenance
Priority: 3 - Necessary/Not Yet Critical (Years 2-5)
Correction: Renew System
Qty: 20,420.00
Unit of Measure: S.F.
Estimate: \$38,859.00
Assessor Name: Terence Davis
Date Created: 01/30/2017

Notes: The original electrical distribution system is operating properly due to an aggressive maintenance program but is aged, in marginal condition, and should be replaced.

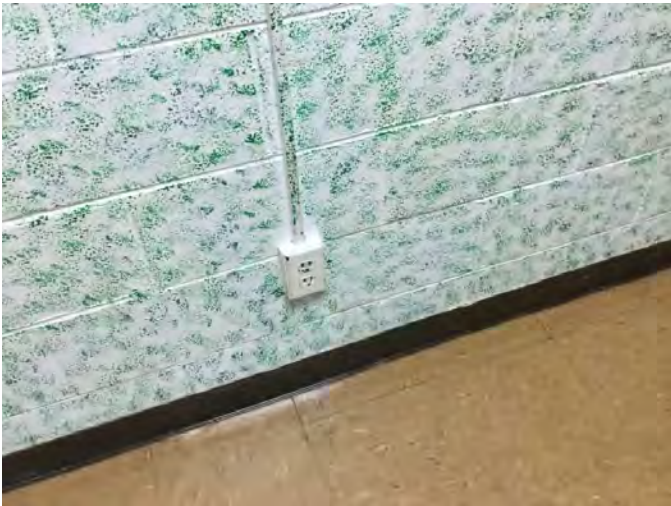
System: D5020 - Branch Wiring

Location: Throughout
Distress: Beyond Service Life
Category: Deferred Maintenance / Safety
Priority: 3 - Necessary/Not Yet Critical (Years 2-5)
Correction: Renew System
Qty: 20,420.00
Unit of Measure: S.F.
Estimate: \$116,802.00
Assessor Name: Terence Davis
Date Created: 01/30/2017

Notes: The original branch wiring system is operating, but is aged, in poor condition, and should be replaced.

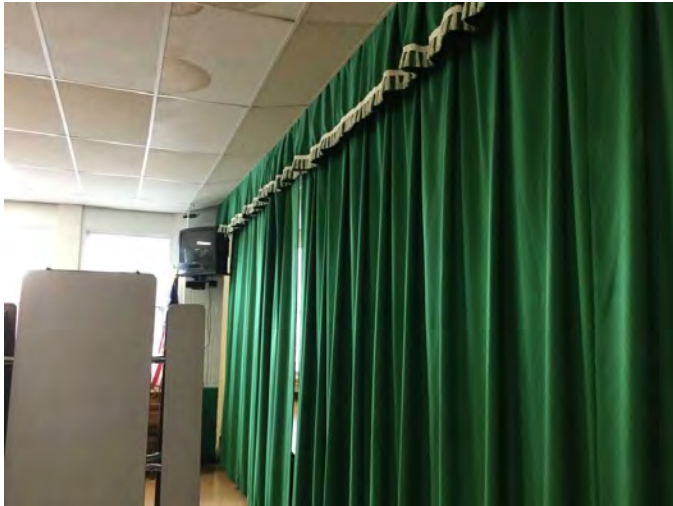
System: E1020 - Institutional Equipment

Location: Stage
Distress: Beyond Service Life
Category: Deferred Maintenance / Appearance
Priority: 3 - Necessary/Not Yet Critical (Years 2-5)
Correction: Renew System
Qty: 20,420.00
Unit of Measure: S.F.
Estimate: \$6,739.00
Assessor Name: Terence Davis
Date Created: 01/30/2017

Notes: Theater equipment is aging and worn and should be replaced.

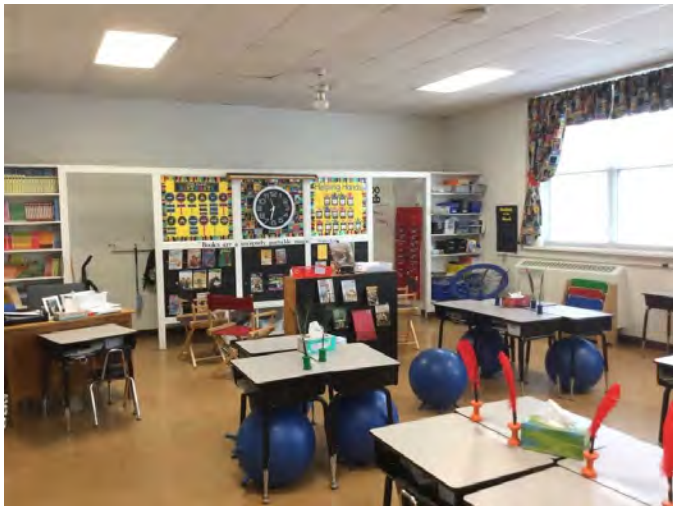
System: E2010 - Fixed Furnishings

Location: Throughout
Distress: Beyond Service Life
Category: Deferred Maintenance / Appearance
Priority: 3 - Necessary/Not Yet Critical (Years 2-5)
Correction: Renew System
Qty: 20,420.00
Unit of Measure: S.F.
Estimate: \$133,649.00
Assessor Name: Terence Davis
Date Created: 01/30/2017

Notes: The fixed furnishings are aged, in marginal condition, and should be replaced.

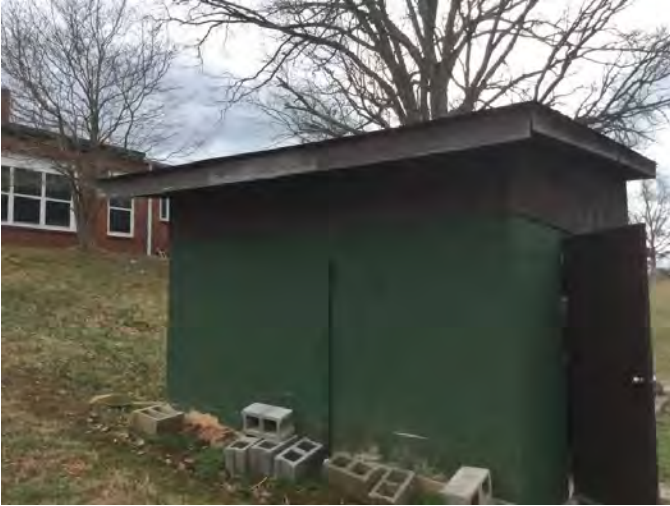
System: B2030 - Exterior Doors

Location: Entry
Distress: Beyond Service Life
Category: Deferred Maintenance / Appearance
Priority: 3 - Necessary/Not Yet Critical (Years 2-5)
Correction: Renew System
Qty: 200.00
Unit of Measure: S.F.
Estimate: \$1,905.00
Assessor Name: Terence Davis
Date Created: 01/30/2017

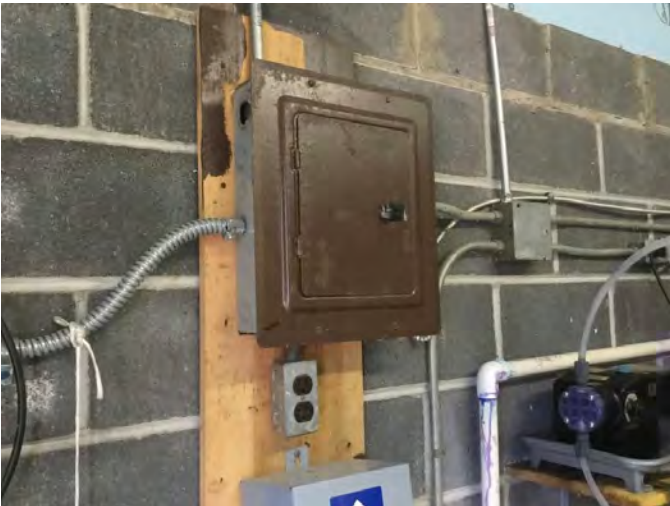
System: D5020 - Branch Wiring

Location: Throughout
Distress: Beyond Service Life
Category: Deferred Maintenance / Safety
Priority: 3 - Necessary/Not Yet Critical (Years 2-5)
Correction: Renew System
Qty: 200.00
Unit of Measure: S.F.
Estimate: \$788.00
Assessor Name: Terence Davis
Date Created: 01/30/2017

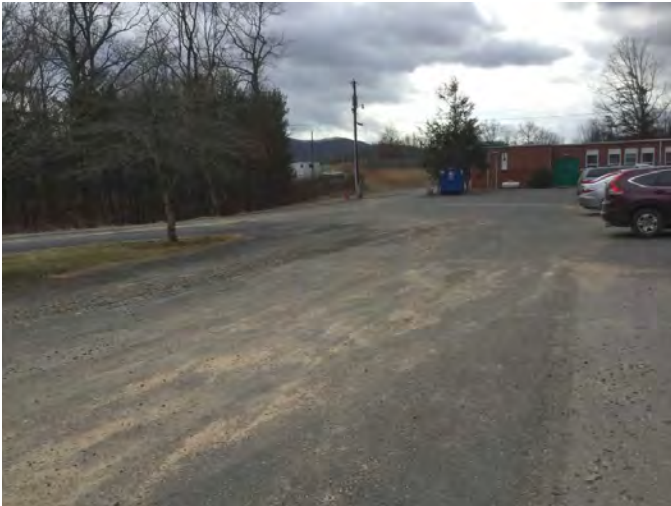
System: G2010 - Roadways

Location: Throughout
Distress: Failing
Category: Deferred Maintenance / Accessibility Code Compliance
Priority: 3 - Necessary/Not Yet Critical (Years 2-5)
Correction: Renew System
Qty: 22,744.00
Unit of Measure: S.F.
Estimate: \$95,320.00
Assessor Name: Eduardo Lopez
Date Created: 01/30/2017

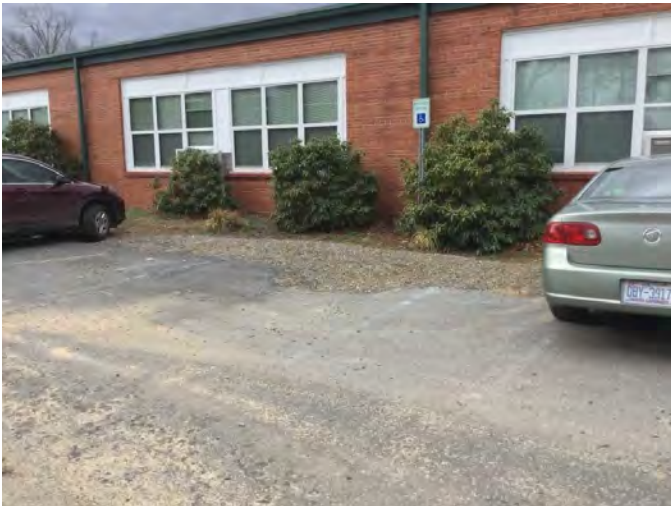
System: G2020 - Parking Lots

Location: Throughout
Distress: Failing
Category: Deferred Maintenance / Accessibility Code Compliance
Priority: 3 - Necessary/Not Yet Critical (Years 2-5)
Correction: Renew System
Qty: 22,744.00
Unit of Measure: S.F.
Estimate: \$33,274.00
Assessor Name: Eduardo Lopez
Date Created: 01/30/2017

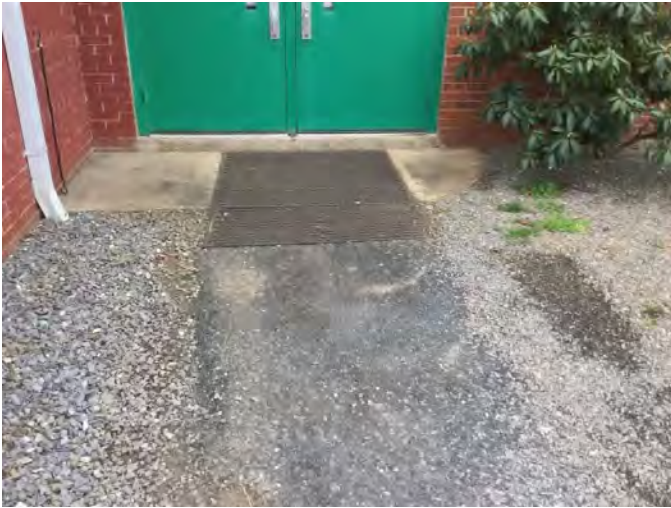
System: G2030 - Pedestrian Paving

Location: Throughout
Distress: Beyond Service Life
Category: Deferred Maintenance / Accessibility Code Compliance
Priority: 3 - Necessary/Not Yet Critical (Years 2-5)
Correction: Renew System
Qty: 22,744.00
Unit of Measure: S.F.
Estimate: \$47,785.00
Assessor Name: Eduardo Lopez
Date Created: 01/30/2017

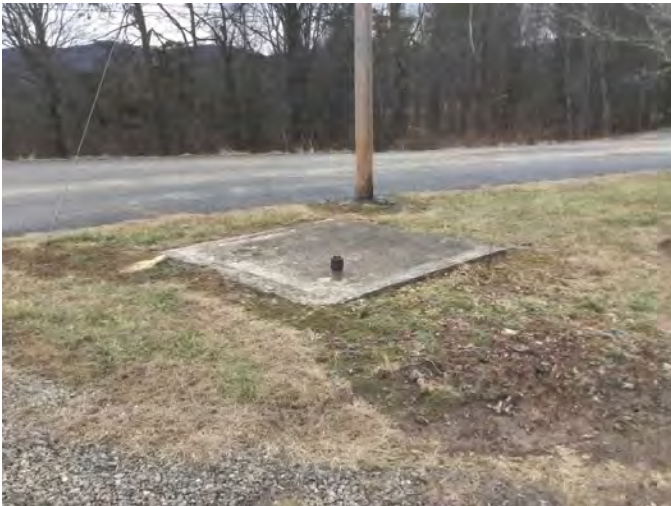
System: G3060 - Fuel Distribution

Location: Boiler Exterior
Distress: Failing
Category: Deferred Maintenance / Safety
Priority: 3 - Necessary/Not Yet Critical (Years 2-5)
Correction: Renew System
Qty: 22,744.00
Unit of Measure: S.F.
Estimate: \$24,518.00
Assessor Name: Eduardo Lopez
Date Created: 01/30/2017
