NC School District/995 Yancey County/High School

Mountain Heritage High

Campus Assessment Report

March 12, 2017

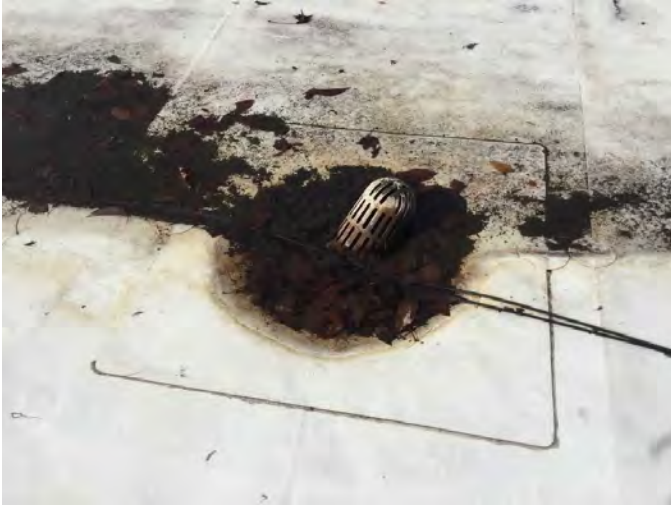
System: D2040 - Rain Water Drainage

Location: Throughout
Distress: Failing
Category: Deferred Maintenance
Priority: 2 - Potentially Critical (Year 1)
Correction: Renew System
Qty: 112,000.00
Unit of Measure: S.F.
Estimate: \$80,080.00
Assessor Name: Terence Davis
Date Created: 01/25/2017

Notes: The rain water drainage system is aged, in poor condition, and should be replaced.
Roof drains were not replaced with latest roof replacement and are causing interior leaks.

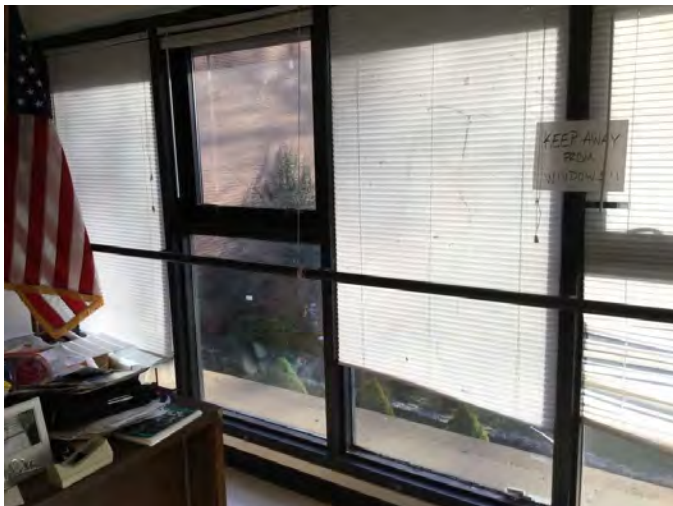
System: B2020 - Exterior Windows

Location: Throughout
Distress: Beyond Service Life
Category: Deferred Maintenance / Energy
Priority: 3 - Necessary/Not Yet Critical (Years 2-5)
Correction: Renew System
Qty: 112,000.00
Unit of Measure: S.F.
Estimate: \$1,606,528.00
Assessor Name: Terence Davis
Date Created: 01/25/2017

Notes: The aluminum frame, operable, single pane windows are aged, rusted, not energy efficient, and should be replaced.

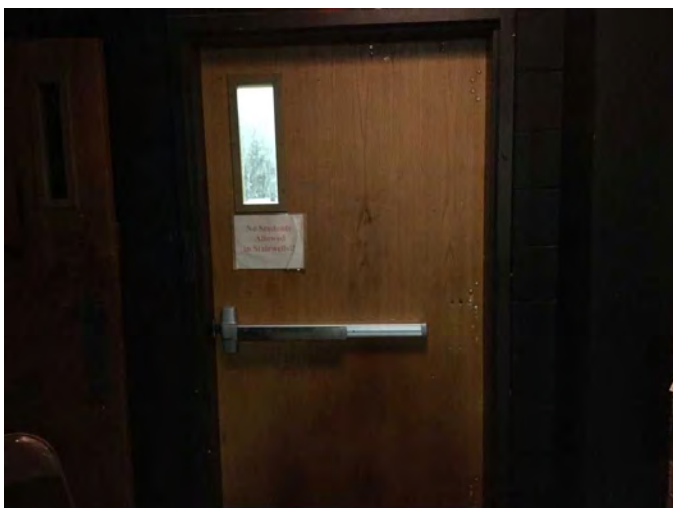
System: B2030 - Exterior Doors

Location: Throughout
Distress: Failing
Category: Deferred Maintenance / Appearance
Priority: 3 - Necessary/Not Yet Critical (Years 2-5)
Correction: Renew System
Qty: 112,000.00
Unit of Measure: S.F.
Estimate: \$101,024.00
Assessor Name: Terence Davis
Date Created: 01/25/2017

Notes: The original exterior doors are aged, rusted, and should be replaced.

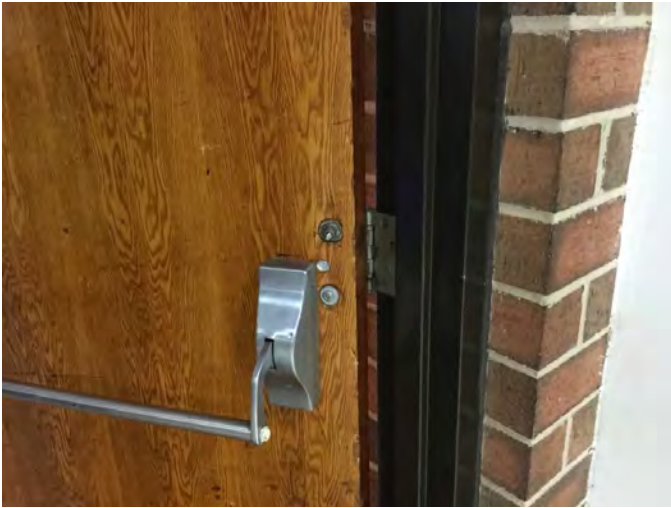
System: C1020 - Interior Doors

Location: Throughout
Distress: Failing
Category: Deferred Maintenance / Appearance
Priority: 3 - Necessary/Not Yet Critical (Years 2-5)
Correction: Renew System
Qty: 112,000.00
Unit of Measure: S.F.
Estimate: \$306,768.00
Assessor Name: Terence Davis
Date Created: 01/25/2017

Notes: The interior doors are aged, failing, most hardware is not ADA or code compliant and should be replaced.

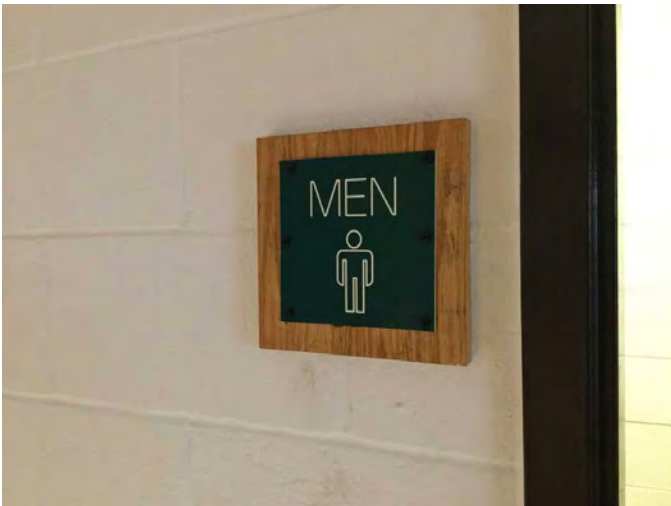
System: C1030 - Fittings

Location: Throughout
Distress: Beyond Service Life
Category: Deferred Maintenance / Accessibility Code Compliance
Priority: 3 - Necessary/Not Yet Critical (Years 2-5)
Correction: Renew System
Qty: 112,000.00
Unit of Measure: S.F.
Estimate: \$184,800.00
Assessor Name: Terence Davis
Date Created: 01/25/2017

Notes: The fittings throughout the building are aged, in marginal condition, handrails and room signage are ADA non-compliance and system should be replaced.

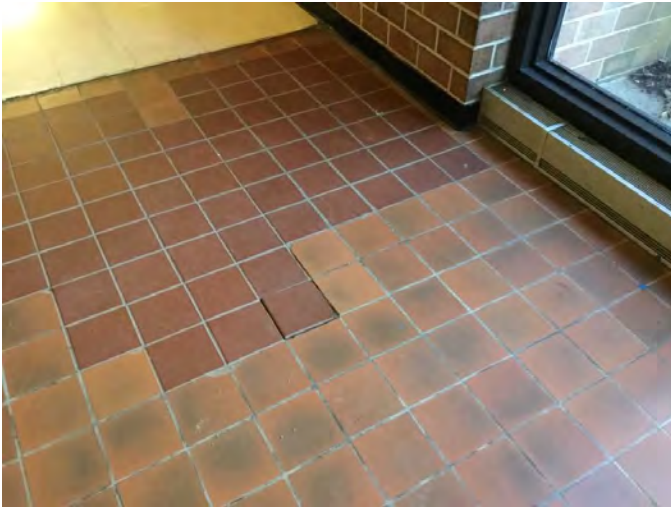
System: C3020 - Floor Finishes

Location: Throughout
Distress: Beyond Service Life
Category: Deferred Maintenance
Priority: 3 - Necessary/Not Yet Critical (Years 2-5)
Correction: Renew System
Qty: 112,000.00
Unit of Measure: S.F.
Estimate: \$1,376,144.00
Assessor Name: Terence Davis
Date Created: 01/25/2017

Notes: The quarry tile in corridor spaces is chipped, cracked, and failing due to installation over existing damaged VCT. Full removal and replacement is recommended.
The carpet is aged, stained, frayed, and should be replaced.
The VCT flooring is aged, cracked, worn, and should be replaced.

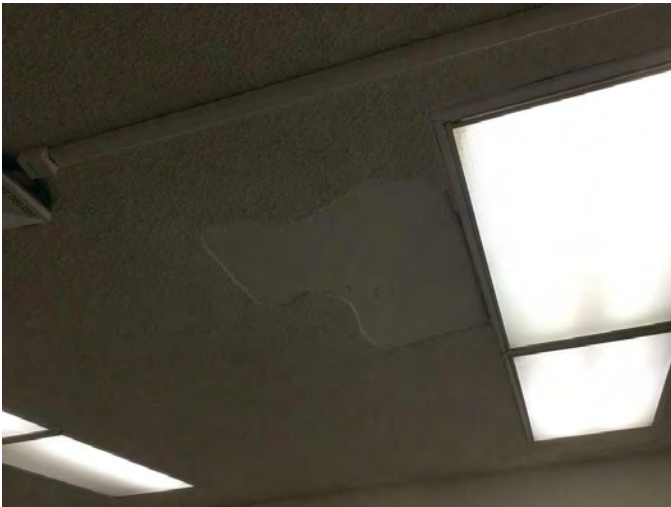
System: C3030 - Ceiling Finishes

Location: Throughout
Distress: Beyond Service Life
Category: Deferred Maintenance / Appearance
Priority: 3 - Necessary/Not Yet Critical (Years 2-5)
Correction: Renew System
Qty: 112,000.00
Unit of Measure: S.F.
Estimate: \$1,326,864.00
Assessor Name: Terence Davis
Date Created: 01/25/2017

Notes: The original ceiling finishes are aged, failing and should be replaced.

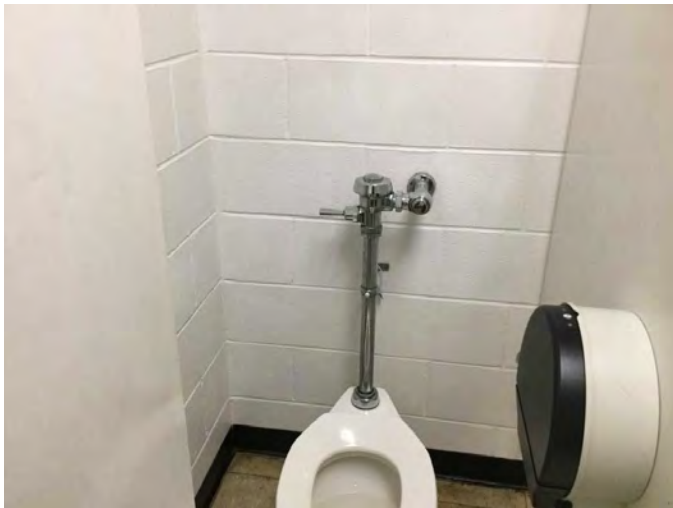
System: D2010 - Plumbing Fixtures

Location: Throughout
Distress: Beyond Service Life
Category: Deferred Maintenance / Accessibility Code Compliance
Priority: 3 - Necessary/Not Yet Critical (Years 2-5)
Correction: Renew System
Qty: 112,000.00
Unit of Measure: S.F.
Estimate: \$1,111,264.00
Assessor Name: Terence Davis
Date Created: 01/25/2017

Notes: Plumbing fixtures are in operational conditions. However, they are aged, not ADA compliant and should be replaced with a low-flow water fixtures.

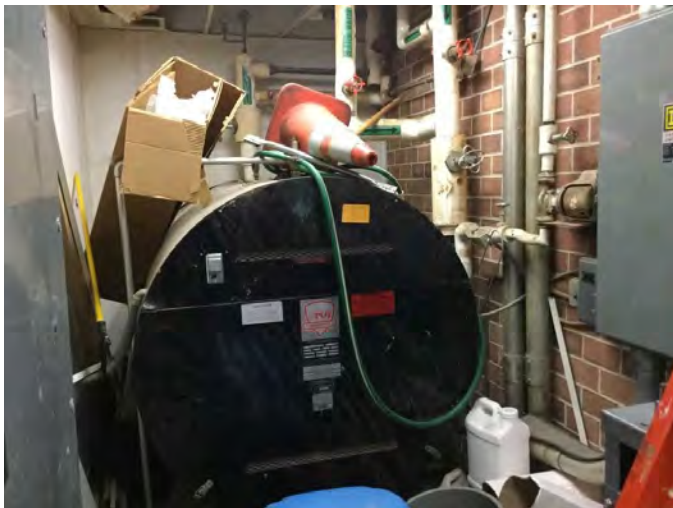
System: D2020 - Domestic Water Distribution

Location: Various
Distress: Beyond Service Life
Category: Deferred Maintenance
Priority: 3 - Necessary/Not Yet Critical (Years 2-5)
Correction: Renew System
Qty: 112,000.00
Unit of Measure: S.F.
Estimate: \$206,976.00
Assessor Name: Terence Davis
Date Created: 01/25/2017

Notes: The domestic water distribution system is aged and should be replaced.
Some hot water heating systems have failed and are abandoned in place and service not restored in those areas.

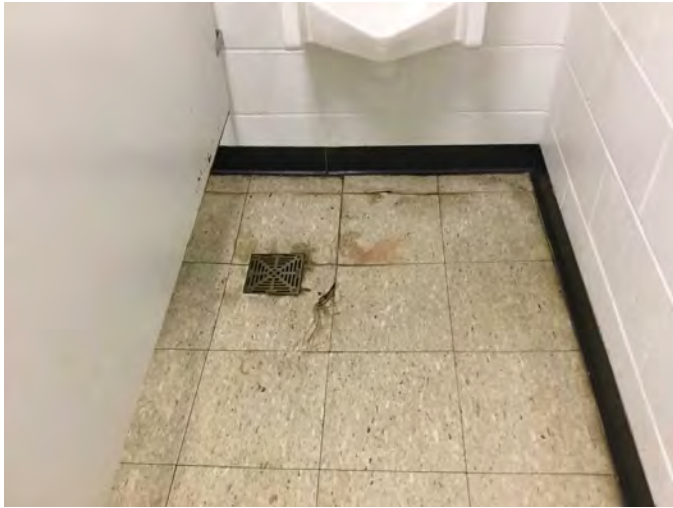
System: D2030 - Sanitary Waste

Location: Throughout
Distress: Beyond Service Life
Category: Deferred Maintenance / Appearance
Priority: 3 - Necessary/Not Yet Critical (Years 2-5)
Correction: Renew System
Qty: 112,000.00
Unit of Measure: S.F.
Estimate: \$325,248.00
Assessor Name: Terence Davis
Date Created: 01/25/2017

Notes: The sanitary waste system is aged, has reported periodic failures, and should be replaced.

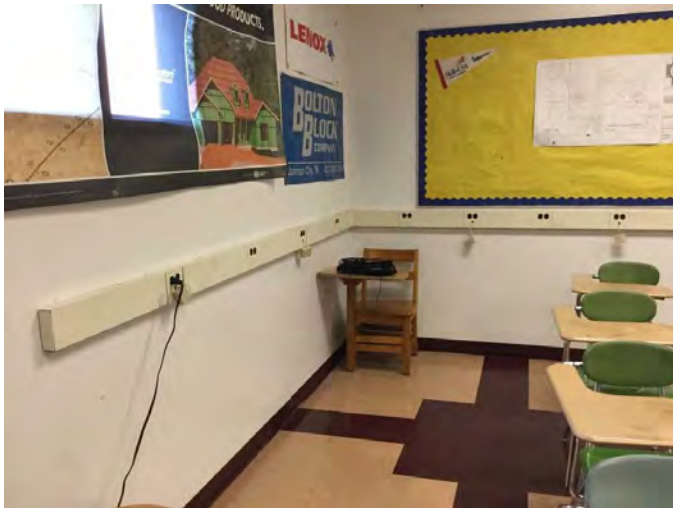
System: D5020 - Branch Wiring

Location: Throughout
Distress: Beyond Service Life
Category: Deferred Maintenance
Priority: 3 - Necessary/Not Yet Critical (Years 2-5)
Correction: Renew System
Qty: 112,000.00
Unit of Measure: S.F.
Estimate: \$572,880.00
Assessor Name: Terence Davis
Date Created: 01/25/2017

Notes: The branch wiring system is operating, but is aged, in poor condition, and should be replaced.

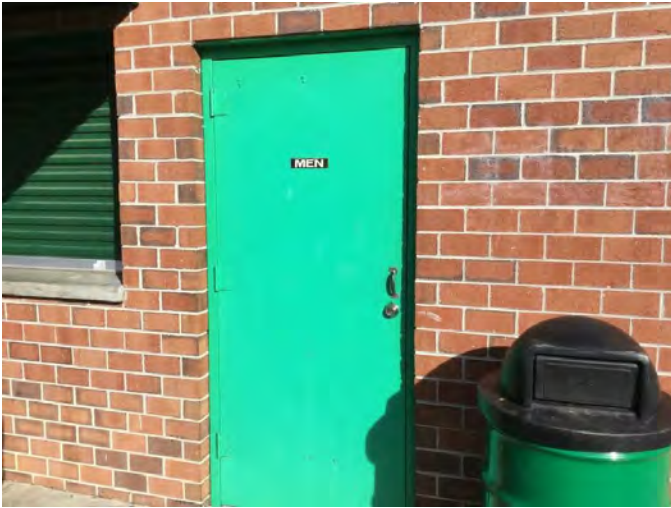
System: B2030 - Exterior Doors

Location: Concession
Distress: Failing
Category: Deferred Maintenance / Appearance
Priority: 3 - Necessary/Not Yet Critical (Years 2-5)
Correction: Renew System
Qty: 1,954.00
Unit of Measure: S.F.
Estimate: \$1,956.00
Assessor Name: Eduardo Lopez
Date Created: 01/25/2017

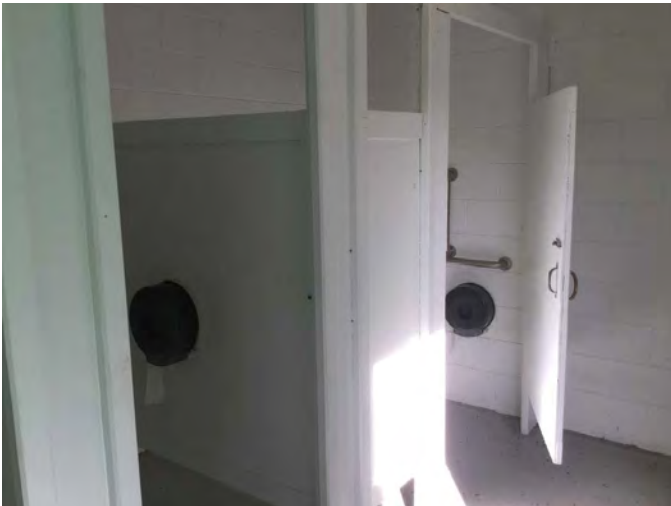
System: C1030 - Fittings

Location: Throughout
Distress: Beyond Service Life
Category: Deferred Maintenance / Appearance
Priority: 3 - Necessary/Not Yet Critical (Years 2-5)
Correction: Renew System
Qty: 1,954.00
Unit of Measure: S.F.
Estimate: \$18,205.00
Assessor Name: Eduardo Lopez
Date Created: 01/25/2017

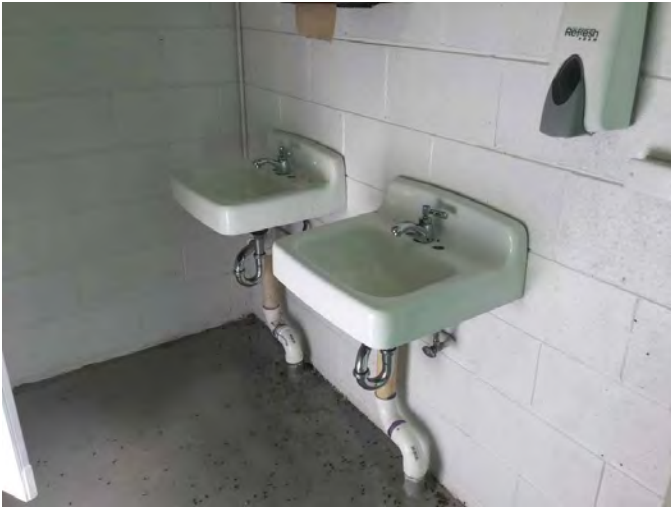
System: D2010 - Plumbing Fixtures

Location: Throughout
Distress: Beyond Service Life
Category: Deferred Maintenance / Accessibility Code Compliance
Priority: 3 - Necessary/Not Yet Critical (Years 2-5)
Correction: Renew System
Qty: 1,954.00
Unit of Measure: S.F.
Estimate: \$21,451.00
Assessor Name: Eduardo Lopez
Date Created: 01/25/2017

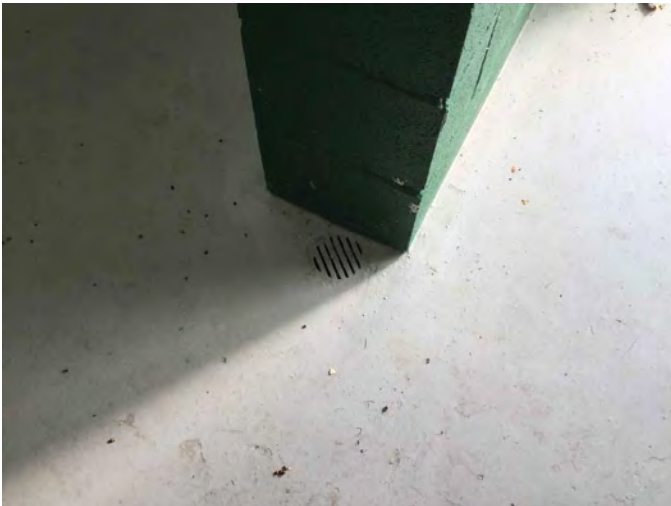
System: D2030 - Sanitary Waste

Location: Throughout
Distress: Beyond Service Life
Category: Deferred Maintenance
Priority: 3 - Necessary/Not Yet Critical (Years 2-5)
Correction: Renew System
Qty: 1,954.00
Unit of Measure: S.F.
Estimate: \$12,767.00
Assessor Name: Eduardo Lopez
Date Created: 01/25/2017

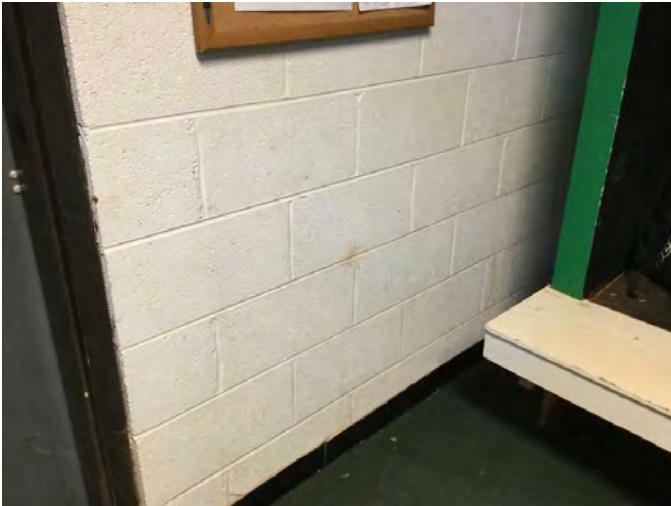
System: C3010 - Wall Finishes

Location: Throughout
Distress: Beyond Service Life
Category: Deferred Maintenance / Appearance
Priority: 3 - Necessary/Not Yet Critical (Years 2-5)
Correction: Renew System
Qty: 1,200.00
Unit of Measure: S.F.
Estimate: \$9,847.00
Assessor Name: Eduardo Lopez
Date Created: 01/25/2017

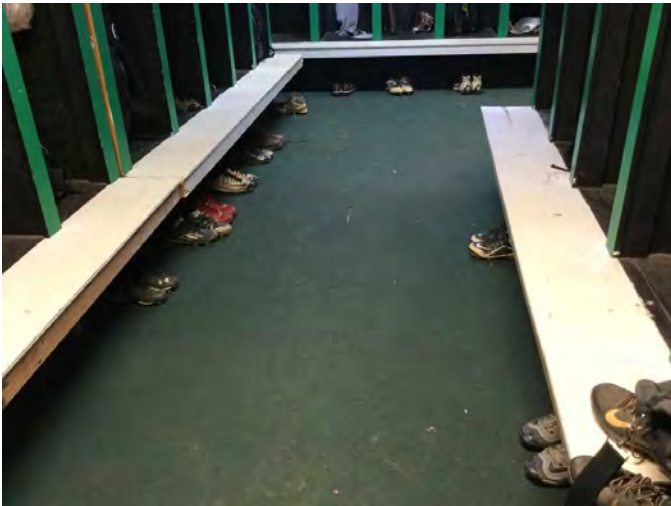
System: C3020 - Floor Finishes

Location: Locker rooms
Distress: Beyond Service Life
Category: Deferred Maintenance / Appearance
Priority: 3 - Necessary/Not Yet Critical (Years 2-5)
Correction: Renew System
Qty: 1,200.00
Unit of Measure: S.F.
Estimate: \$16,817.00
Assessor Name: Eduardo Lopez
Date Created: 01/25/2017

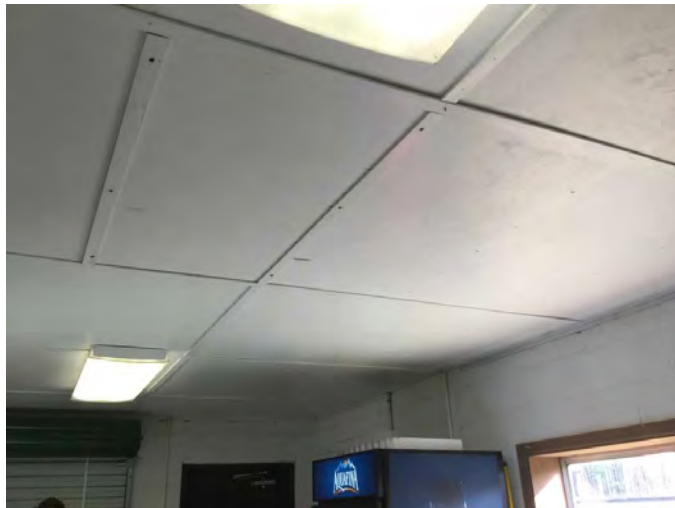
System: C3030 - Ceiling Finishes

Location: Throughout
Distress: Beyond Service Life
Category: Deferred Maintenance / Appearance
Priority: 3 - Necessary/Not Yet Critical (Years 2-5)
Correction: Renew System
Qty: 1,200.00
Unit of Measure: S.F.
Estimate: \$12,580.00
Assessor Name: Eduardo Lopez
Date Created: 01/25/2017

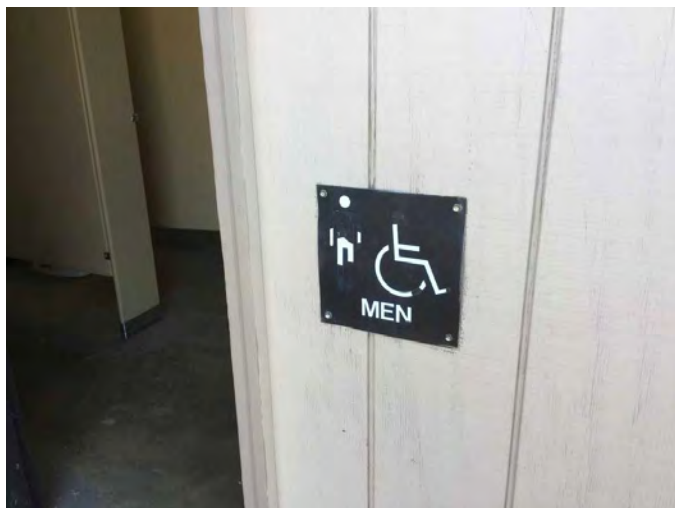
System: C1030 - Fittings

Location: Throughout
Distress: Inadequate
Category: Deferred Maintenance / Building Code Compliance
Priority: 4 - Recommended (Years 6-10)
Correction: Renew System
Qty: 1,200.00
Unit of Measure: S.F.
Estimate: \$11,180.00
Assessor Name: Eduardo Lopez
Date Created: 01/25/2017

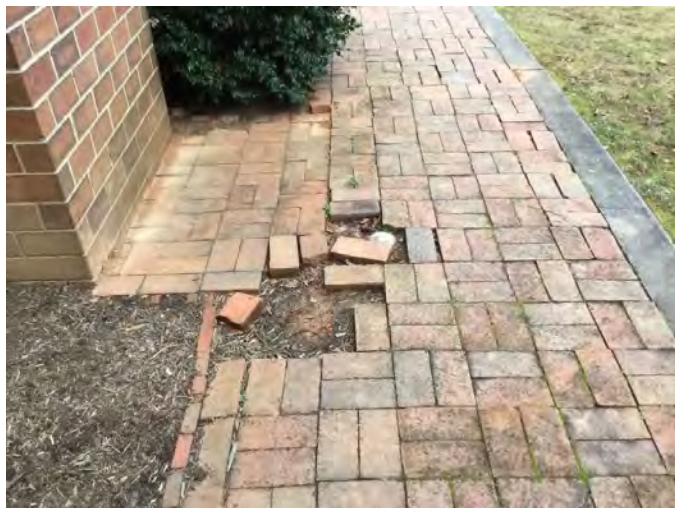
Location: Multiple areas
Distress: Failing
Category: Deferred Maintenance / Safety
Priority: 3 - Necessary/Not Yet Critical (Years 2-5)
Correction: Renew System
Qty: 153,113.00
Unit of Measure: S.F.
Estimate: \$333,480.00
Assessor Name: Matt Mahaffey
Date Created: 01/25/2017
