NC School District/995 Yancey County/Middle School

Cane River Middle

Campus Assessment Report

March 11, 2017

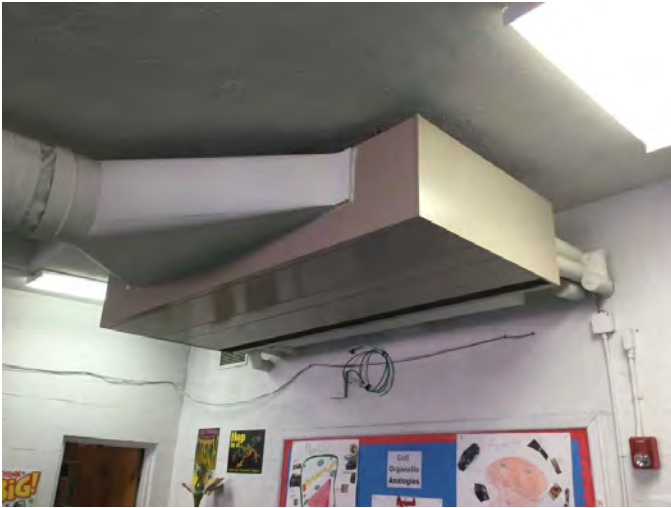
System: D3040 - Distribution Systems

Location: Throughout
Distress: Failing
Category: Deferred Maintenance / Energy
Priority: 2 - Potentially Critical (Year 1)
Correction: Renew System
Qty: 44,433.00
Unit of Measure: S.F.
Estimate: \$536,173.00
Assessor Name: Terence Davis
Date Created: 02/01/2017

Notes: The air distribution system is aged, becoming logistically unsupportable, and should be replaced.

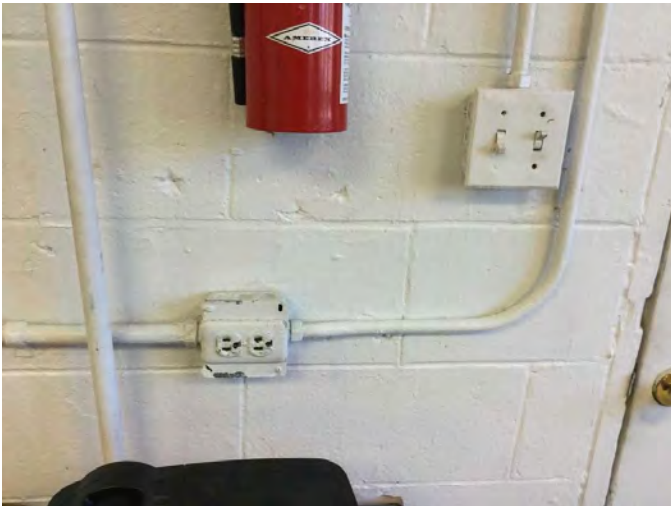
System: D5020 - Branch Wiring

Location: Throughout
Distress: Beyond Service Life
Category: Deferred Maintenance / Safety
Priority: 2 - Potentially Critical (Year 1)
Correction: Renew System
Qty: 44,433.00
Unit of Measure: S.F.
Estimate: \$247,314.00
Assessor Name: Terence Davis
Date Created: 02/01/2017

Notes: The original branch wiring system is operating, but is aged, in poor condition, and should be replaced.

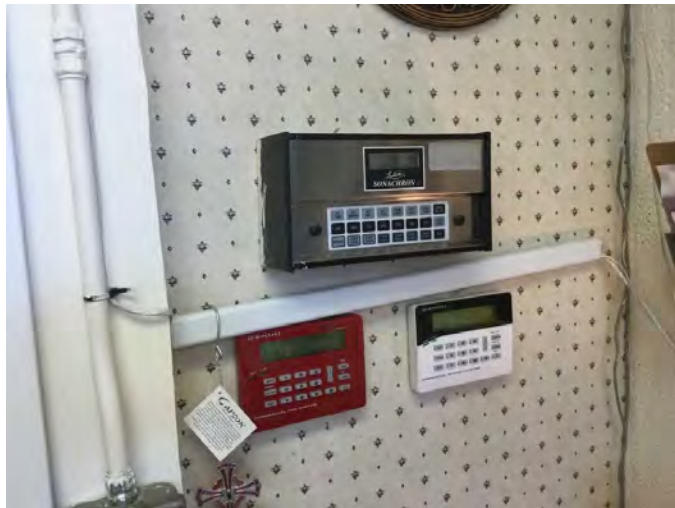
System: D5030910 - Fire Alarm Systems

Location: Office
Distress: Beyond Service Life
Category: Deferred Maintenance / Building Code Compliance
Priority: 2 - Potentially Critical (Year 1)
Correction: Renew System
Qty: 44,433.00
Unit of Measure: S.F.
Estimate: \$206,258.00
Assessor Name: Terence Davis
Date Created: 02/01/2017

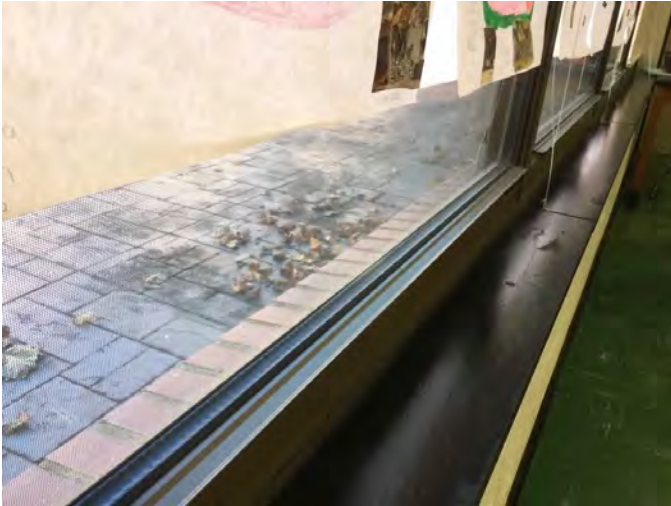
System: B2020 - Exterior Windows

Location: Throughout
Distress: Beyond Service Life
Category: Deferred Maintenance / Energy
Priority: 3 - Necessary/Not Yet Critical (Years 2-5)
Correction: Renew System
Qty: 44,433.00
Unit of Measure: S.F.
Estimate: \$529,819.00
Assessor Name: Terence Davis
Date Created: 02/01/2017

Notes: The aluminum frame, operable, windows are aged, rusted, not energy efficient, and should be replaced.

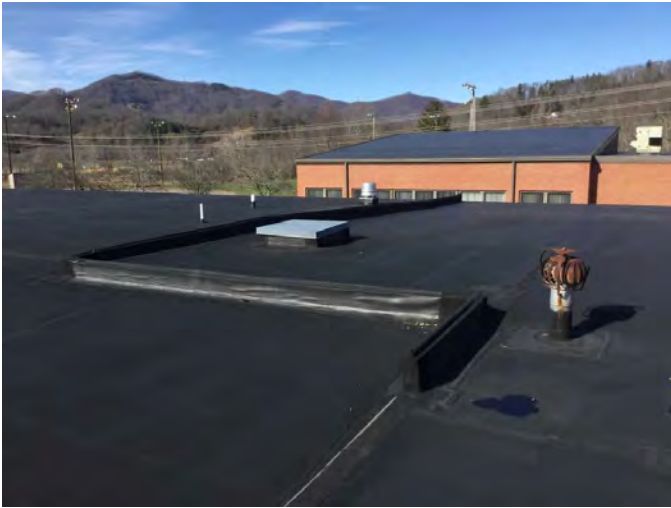
System: B3010120 - Single Ply Membrane

Location: Throughout
Distress: Beyond Service Life
Category: Deferred Maintenance
Priority: 3 - Necessary/Not Yet Critical (Years 2-5)
Correction: Renew System
Qty: 44,433.00
Unit of Measure: S.F.
Estimate: \$465,214.00
Assessor Name: Terence Davis
Date Created: 02/01/2017

Notes: The EPDM adhered roof coverings are aging, showing signs of failure and should be replaced.

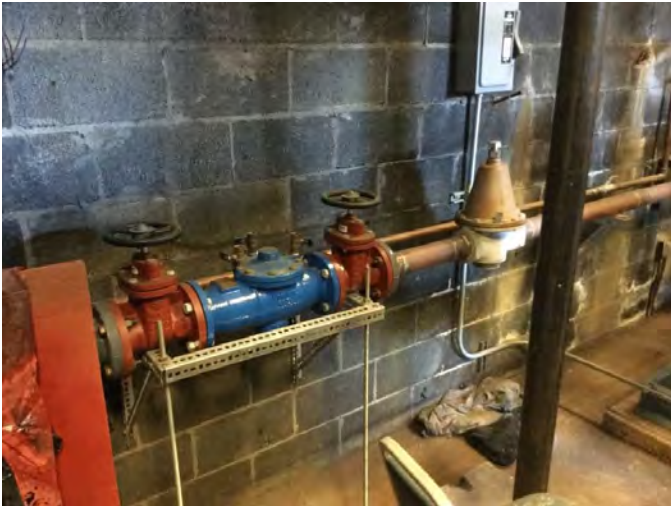
System: D2020 - Domestic Water Distribution

Location: Throughout
Distress: Beyond Service Life
Category: Deferred Maintenance / Building Code Compliance
Priority: 3 - Necessary/Not Yet Critical (Years 2-5)
Correction: Renew System
Qty: 44,433.00
Unit of Measure: S.F.
Estimate: \$51,809.00
Assessor Name: Terence Davis
Date Created: 02/01/2017

Notes: The domestic water distribution system is aged, does not include a back-flow preventer, and should be replaced.

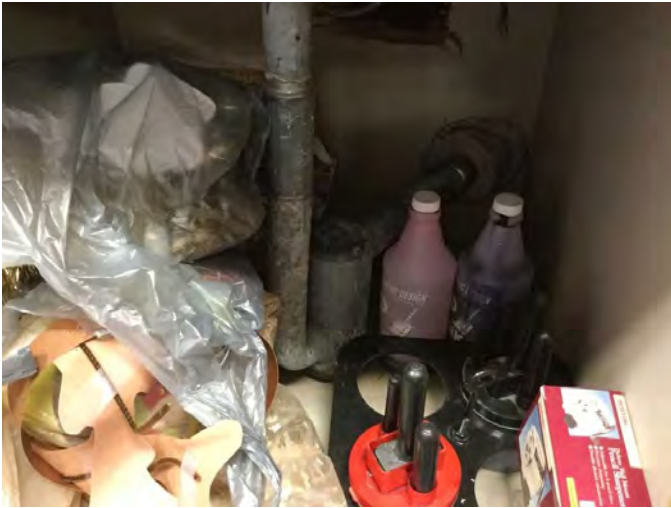
System: D2030 - Sanitary Waste

Location: Throughout
Distress: Beyond Service Life
Category: Deferred Maintenance
Priority: 3 - Necessary/Not Yet Critical (Years 2-5)
Correction: Renew System
Qty: 44,433.00
Unit of Measure: S.F.
Estimate: \$82,112.00
Assessor Name: Terence Davis
Date Created: 02/01/2017

Notes: The sanitary waste system is aged, has reported periodic failures, and should be replaced.

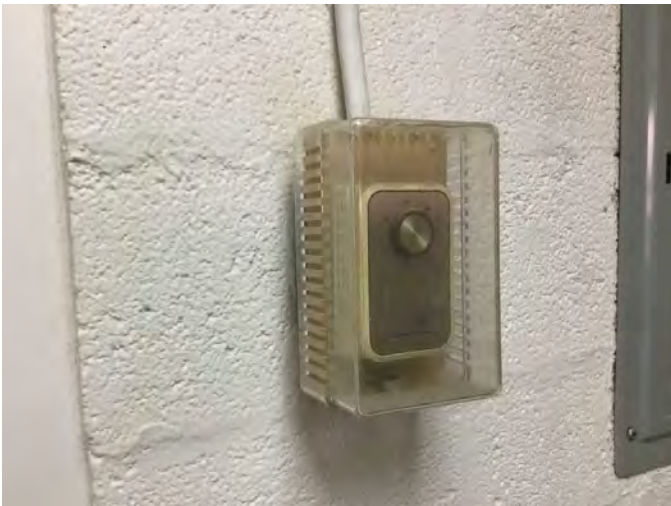
System: D3060 - Controls & Instrumentation

Location: Throughout
Distress: Beyond Service Life
Category: Deferred Maintenance / Energy
Priority: 3 - Necessary/Not Yet Critical (Years 2-5)
Correction: Renew System
Qty: 44,433.00
Unit of Measure: S.F.
Estimate: \$166,668.00
Assessor Name: Terence Davis
Date Created: 02/01/2017

Notes: The HVAC controls system is aged, becoming logistically unsupportable, and should be replaced.

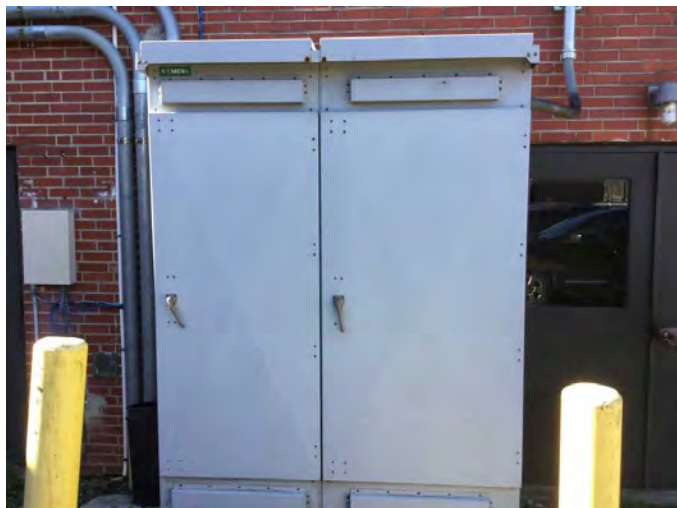
System: D5010 - Electrical Service/Distribution

Location: Throughout
Distress: Beyond Service Life
Category: Deferred Maintenance / Energy
Priority: 3 - Necessary/Not Yet Critical (Years 2-5)
Correction: Renew System
Qty: 44,433.00
Unit of Measure: S.F.
Estimate: \$82,601.00
Assessor Name: Terence Davis
Date Created: 02/01/2017

Notes: The original electrical distribution system is operating properly due to an aggressive maintenance program but is aged, in marginal condition, and should be replaced.

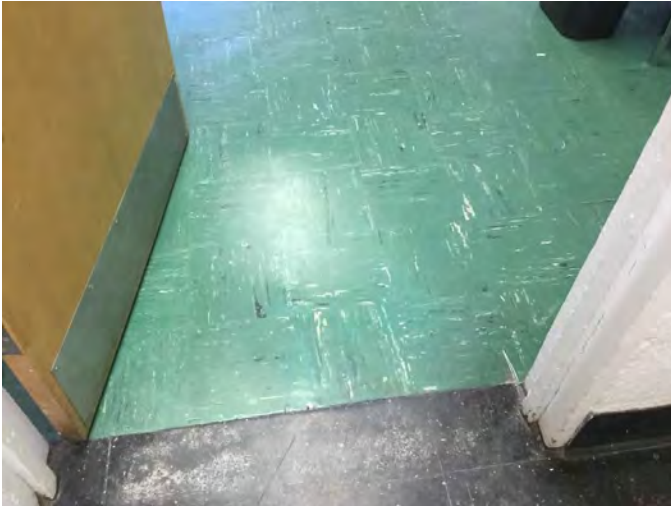
System: C3020 - Floor Finishes

Location: Throughout
Distress: Beyond Service Life
Category: Deferred Maintenance / Safety
Priority: 4 - Recommended (Years 6-10)
Correction: Renew System
Qty: 44,433.00
Unit of Measure: S.F.
Estimate: \$524,443.00
Assessor Name: Terence Davis
Date Created: 02/01/2017

Notes: The VCT flooring is aged, cracked, worn, and should be replaced and ACM tile removed.

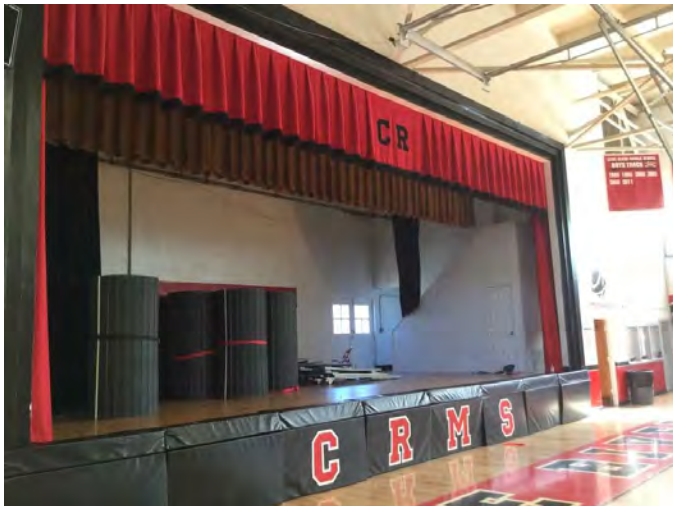
System: E1020 - Institutional Equipment

Location: Stage
Distress: Beyond Service Life
Category: Deferred Maintenance / Appearance
Priority: 4 - Recommended (Years 6-10)
Correction: Renew System
Qty: 44,433.00
Unit of Measure: S.F.
Estimate: \$137,342.00
Assessor Name: Terence Davis
Date Created: 02/01/2017

Notes: Theater and stage equipment is aged and should be replaced.

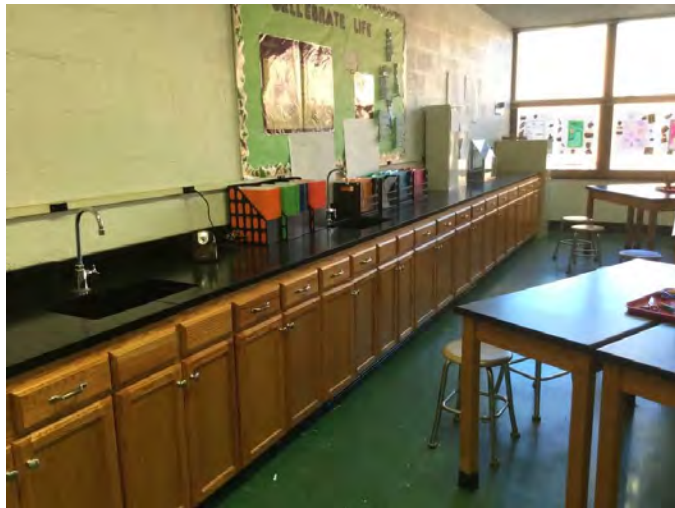
System: E2010 - Fixed Furnishings

Location: Throughout
Distress: Beyond Service Life
Category: Deferred Maintenance / Appearance
Priority: 4 - Recommended (Years 6-10)
Correction: Renew System
Qty: 44,433.00
Unit of Measure: S.F.
Estimate: \$274,196.00
Assessor Name: Terence Davis
Date Created: 02/01/2017

Notes: The fixed furnishings are aged, in marginal condition, and should be replaced.

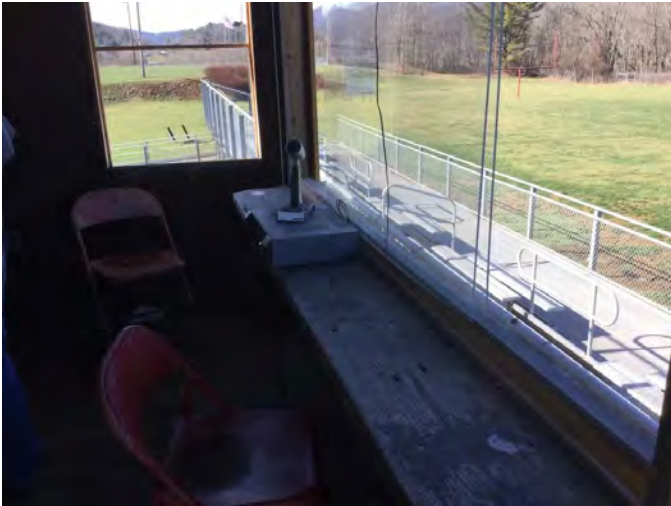
System: B2020 - Exterior Windows

Location: Throughout
Distress: Failing
Category: Deferred Maintenance / Appearance
Priority: 3 - Necessary/Not Yet Critical (Years 2-5)
Correction: Renew System
Qty: 600.00
Unit of Measure: S.F.
Estimate: \$11,332.00
Assessor Name: Eduardo Lopez
Date Created: 02/01/2017

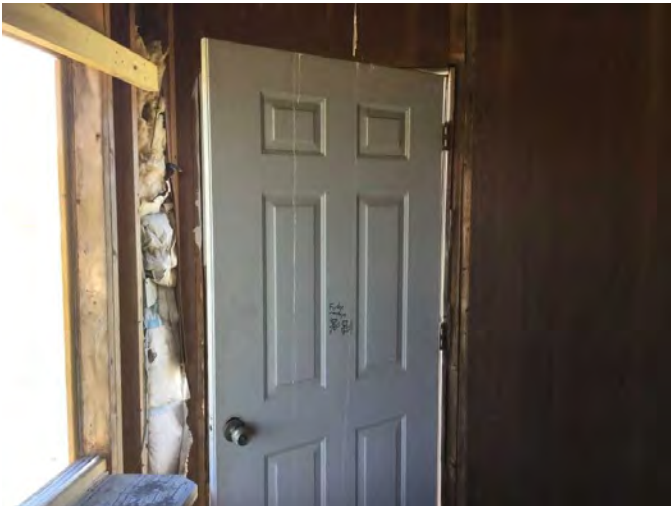
System: B2030 - Exterior Doors

Location: Entrance
Distress: Damaged
Category: Deferred Maintenance / Appearance
Priority: 3 - Necessary/Not Yet Critical (Years 2-5)
Correction: Renew System
Qty: 600.00
Unit of Measure: S.F.
Estimate: \$5,716.00
Assessor Name: Eduardo Lopez
Date Created: 02/01/2017

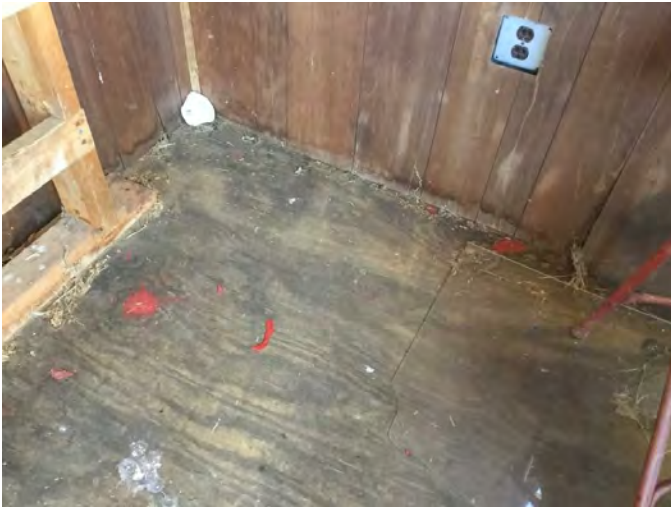
System: C3020 - Floor Finishes

Location: Throughout
Distress: Beyond Service Life
Category: Deferred Maintenance
Priority: 3 - Necessary/Not Yet Critical (Years 2-5)
Correction: Renew System
Qty: 600.00
Unit of Measure: S.F.
Estimate: \$8,164.00
Assessor Name: Eduardo Lopez
Date Created: 02/01/2017

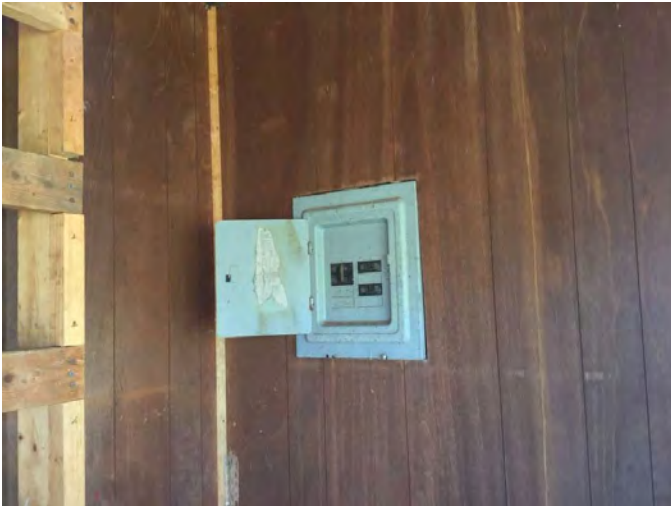
System: D5010 - Electrical Service/Distribution

Location: Throughout
Distress: Beyond Service Life
Category: Deferred Maintenance
Priority: 3 - Necessary/Not Yet Critical (Years 2-5)
Correction: Renew System
Qty: 600.00
Unit of Measure: S.F.
Estimate: \$2,039.00
Assessor Name: Eduardo Lopez
Date Created: 02/01/2017

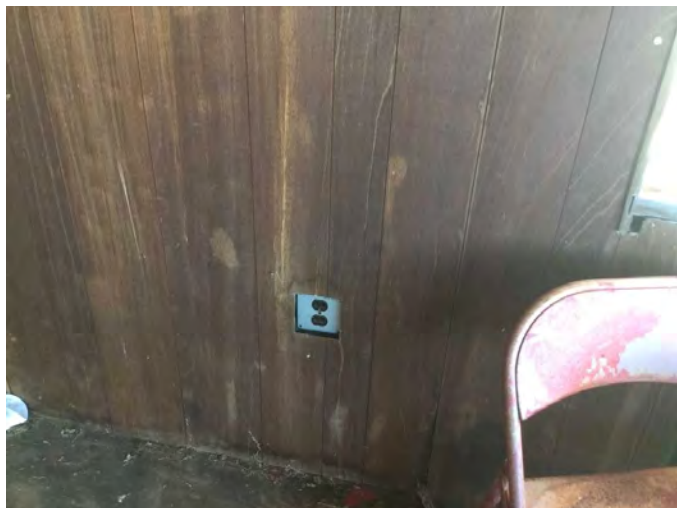
System: D5020 - Branch Wiring

Location: Throughout
Distress: Beyond Service Life
Category: Deferred Maintenance
Priority: 3 - Necessary/Not Yet Critical (Years 2-5)
Correction: Renew System
Qty: 600.00
Unit of Measure: S.F.
Estimate: \$6,098.00
Assessor Name: Eduardo Lopez
Date Created: 02/01/2017

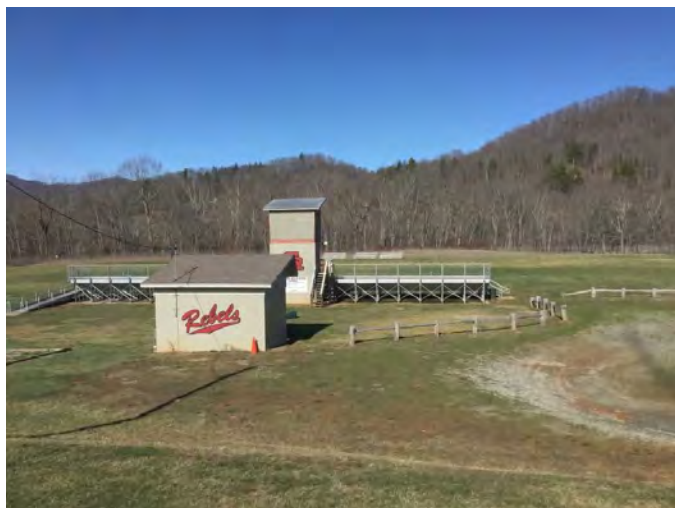
System: B3010140 - Asphalt Shingles

Location: Roof
Distress: Beyond Service Life
Category: Deferred Maintenance / Appearance
Priority: 4 - Recommended (Years 6-10)
Correction: Renew System
Qty: 600.00
Unit of Measure: S.F.
Estimate: \$3,784.00
Assessor Name: Eduardo Lopez
Date Created: 02/01/2017

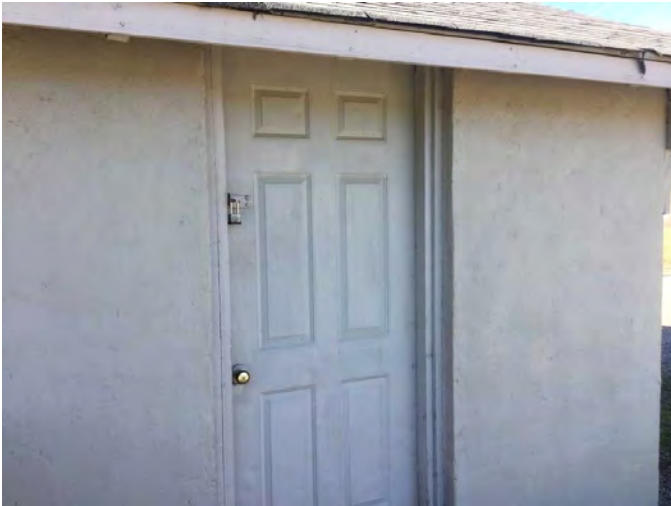
Location: Throughout
Distress: Damaged
Category: Deferred Maintenance / Appearance
Priority: 3 - Necessary/Not Yet Critical (Years 2-5)
Correction: Renew System
Qty: 400.00
Unit of Measure: S.F.
Estimate: \$400.00
Assessor Name: Eduardo Lopez
Date Created: 02/01/2017

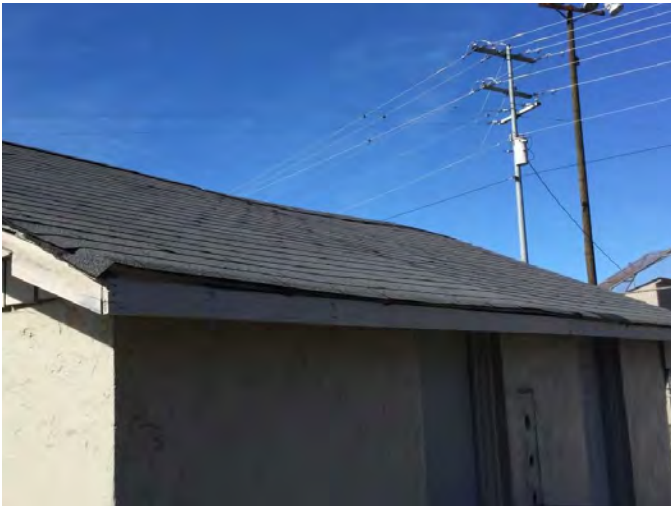
Location: Roof
Distress: Failing
Category: Deferred Maintenance / Appearance
Priority: 3 - Necessary/Not Yet Critical (Years 2-5)
Correction: Renew System
Qty: 400.00
Unit of Measure: S.F.
Estimate: \$2,523.00
Assessor Name: Eduardo Lopez
Date Created: 02/01/2017

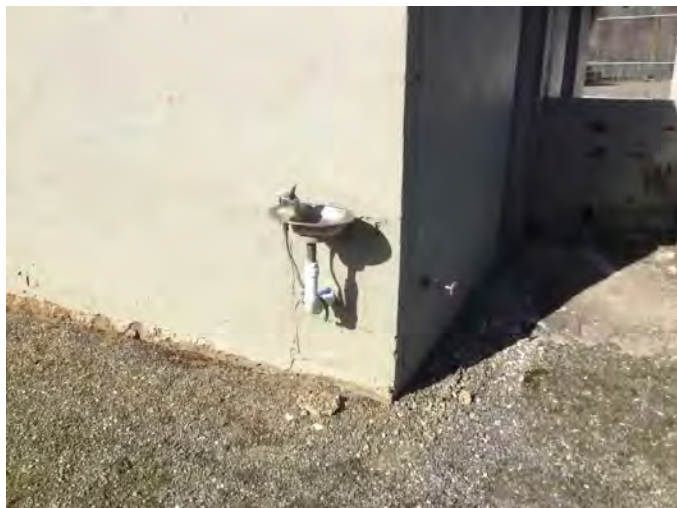
Location: Exterior
Distress: Beyond Service Life
Category: Deferred Maintenance / Safety
Priority: 3 - Necessary/Not Yet Critical (Years 2-5)
Correction: Renew System
Qty: 400.00
Unit of Measure: S.F.
Estimate: \$4,391.00
Assessor Name: Eduardo Lopez
Date Created: 02/01/2017

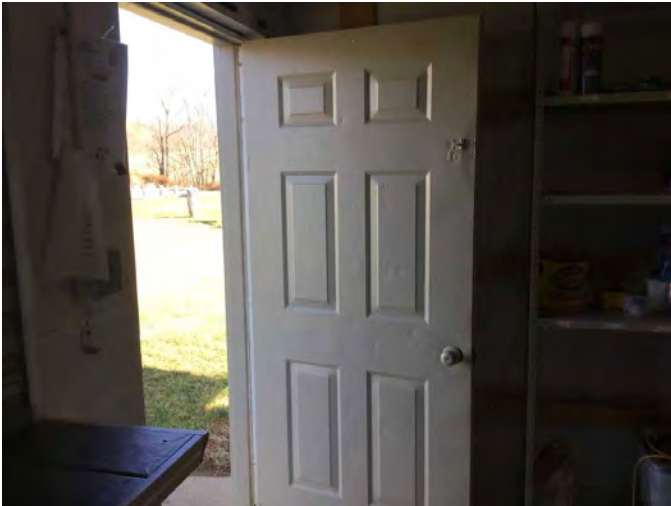
Location: Entrances
Distress: Beyond Service Life
Category: Deferred Maintenance / Appearance
Priority: 3 - Necessary/Not Yet Critical (Years 2-5)
Correction: Renew System
Qty: 250.00
Unit of Measure: S.F.
Estimate: \$250.00
Assessor Name: Eduardo Lopez
Date Created: 02/01/2017

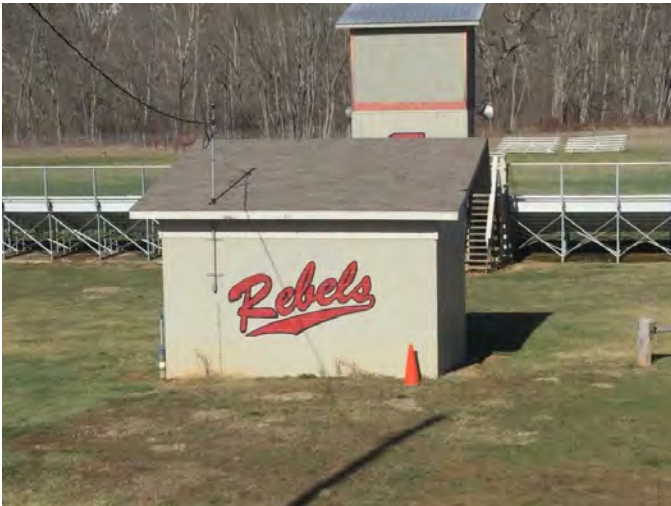
Location: Roof
Distress: Beyond Service Life
Category: Deferred Maintenance / Appearance
Priority: 3 - Necessary/Not Yet Critical (Years 2-5)
Correction: Renew System
Qty: 250.00
Unit of Measure: S.F.
Estimate: \$1,577.00
Assessor Name: Eduardo Lopez
Date Created: 02/01/2017

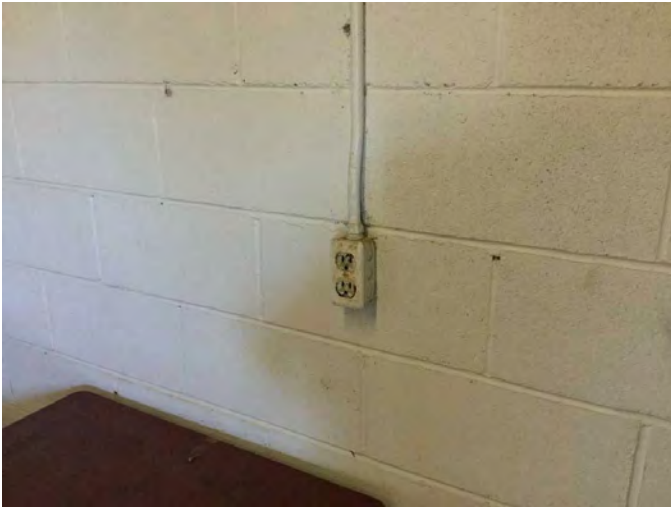
Location: Throughout
Distress: Beyond Service Life
Category: Deferred Maintenance / Appearance
Priority: 3 - Necessary/Not Yet Critical (Years 2-5)
Correction: Renew System
Qty: 250.00
Unit of Measure: S.F.
Estimate: \$2,052.00
Assessor Name: Eduardo Lopez
Date Created: 02/01/2017

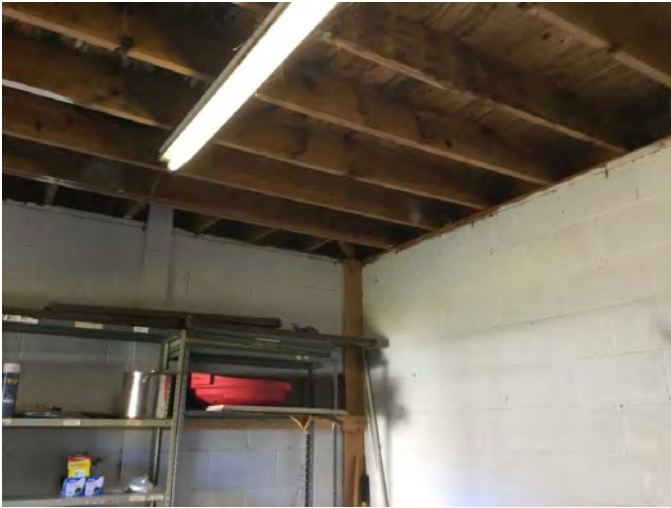
Location: Throughout
Distress: Missing
Category: Deferred Maintenance / Energy
Priority: 3 - Necessary/Not Yet Critical (Years 2-5)
Correction: Renew System
Qty: 250.00
Unit of Measure: S.F.
Estimate: \$2,621.00
Assessor Name: Eduardo Lopez
Date Created: 02/01/2017

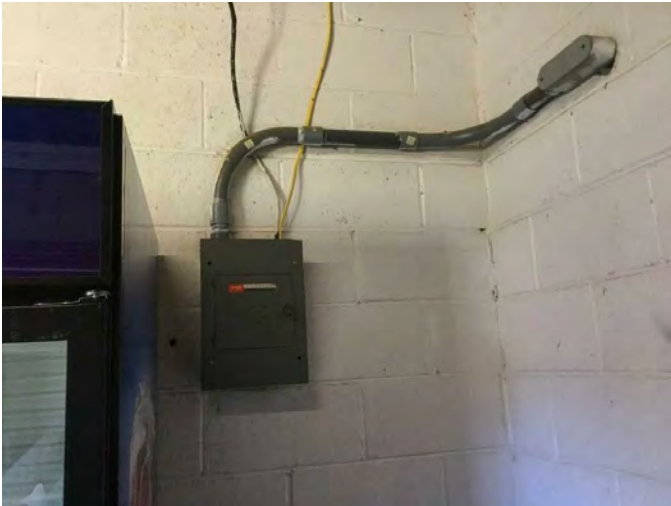
Location: Throughout
Distress: Beyond Service Life
Category: Deferred Maintenance
Priority: 3 - Necessary/Not Yet Critical (Years 2-5)
Correction: Renew System
Qty: 250.00
Unit of Measure: S.F.
Estimate: \$404.00
Assessor Name: Eduardo Lopez
Date Created: 02/01/2017

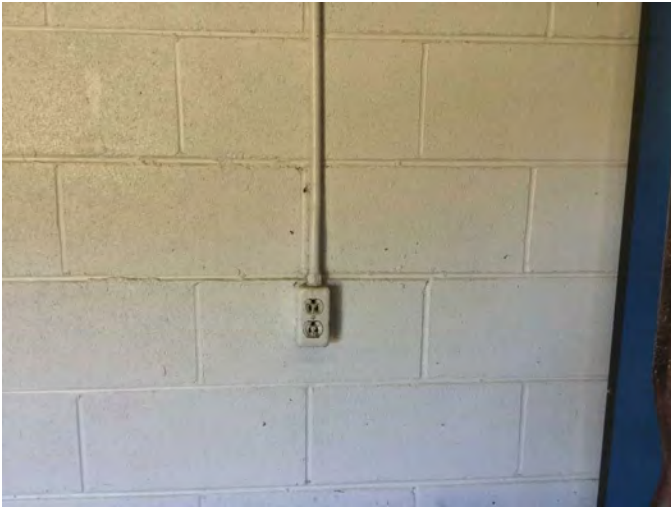
Location: Throughout
Distress: Beyond Service Life
Category: Deferred Maintenance
Priority: 3 - Necessary/Not Yet Critical (Years 2-5)
Correction: Renew System
Qty: 250.00
Unit of Measure: S.F.
Estimate: \$701.00
Assessor Name: Eduardo Lopez
Date Created: 02/01/2017

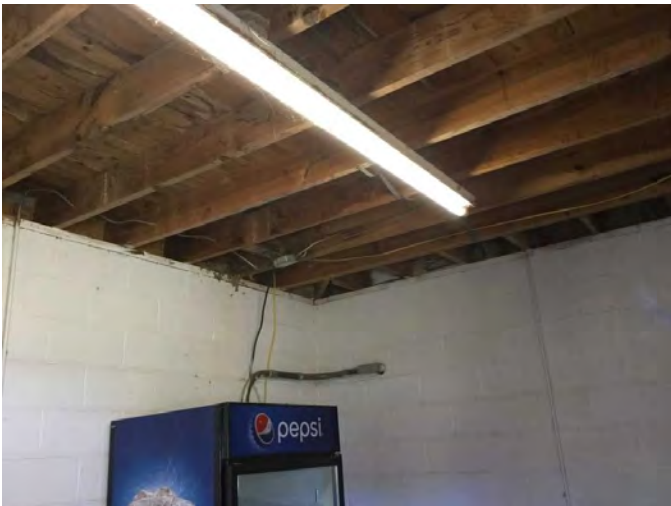
Location: Throughout
Distress: Beyond Service Life
Category: Deferred Maintenance
Priority: 3 - Necessary/Not Yet Critical (Years 2-5)
Correction: Renew System
Qty: 250.00
Unit of Measure: S.F.
Estimate: \$985.00
Assessor Name: Eduardo Lopez
Date Created: 02/01/2017

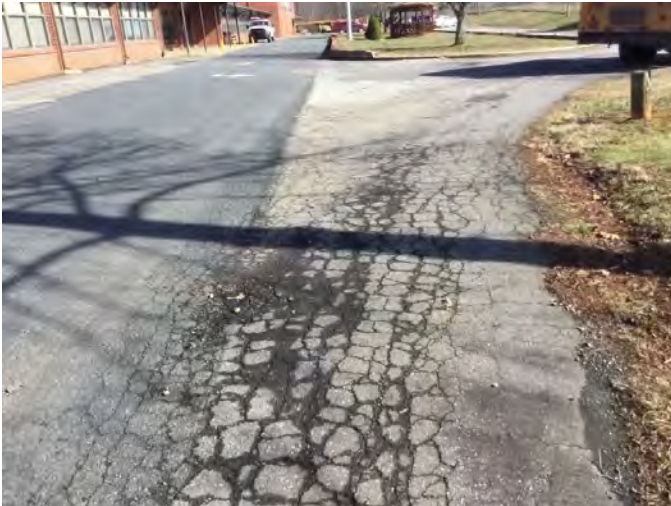
Location: Roadway
Distress: Failing
Category: Deferred Maintenance / Safety
Priority: 3 - Necessary/Not Yet Critical (Years 2-5)
Correction: Renew System
Qty: 54,577.00
Unit of Measure: S.F.
Estimate: \$253,346.00
Assessor Name: Matt Mahaffey
Date Created: 02/01/2017

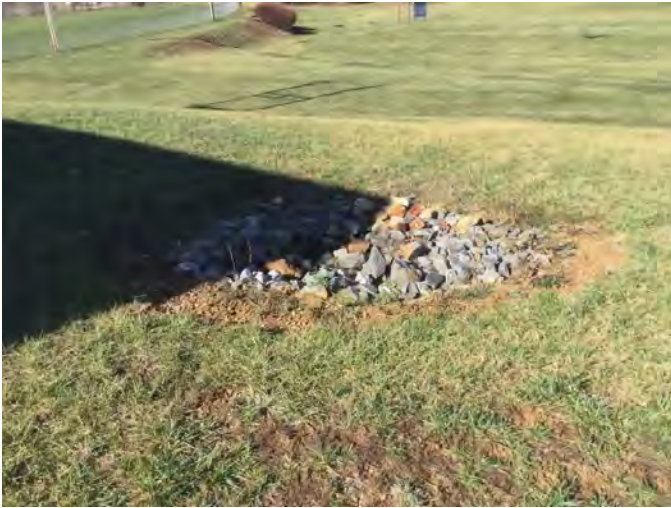
Location: Throughout
Distress: Inadequate
Category: Deferred Maintenance / Environmental
Priority: 3 - Necessary/Not Yet Critical (Years 2-5)
Correction: Renew System
Qty: 54,577.00
Unit of Measure: S.F.
Estimate: \$280,362.00
Assessor Name: Matt Mahaffey
Date Created: 02/01/2017
