NC School District/995 Yancey County/Middle School

East Yancey Middle

Campus Assessment Report

March 11, 2017

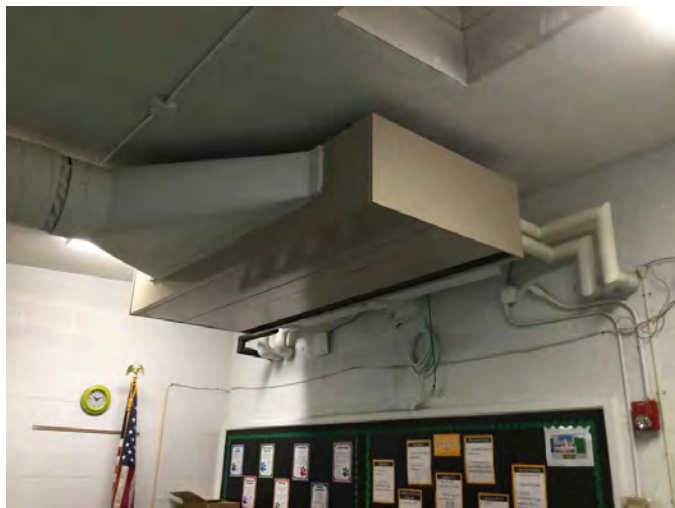
System: D3040 - Distribution Systems

Location: Throughout
Distress: Failing
Category: Deferred Maintenance / Energy
Priority: 2 - Potentially Critical (Year 1)
Correction: Renew System
Qty: 44,433.00
Unit of Measure: S.F.
Estimate: \$536,173.00
Assessor Name: Matt Mahaffey
Date Created: 02/01/2017

Notes: The air distribution system is aged, becoming logistically unsupportable, and should be replaced.

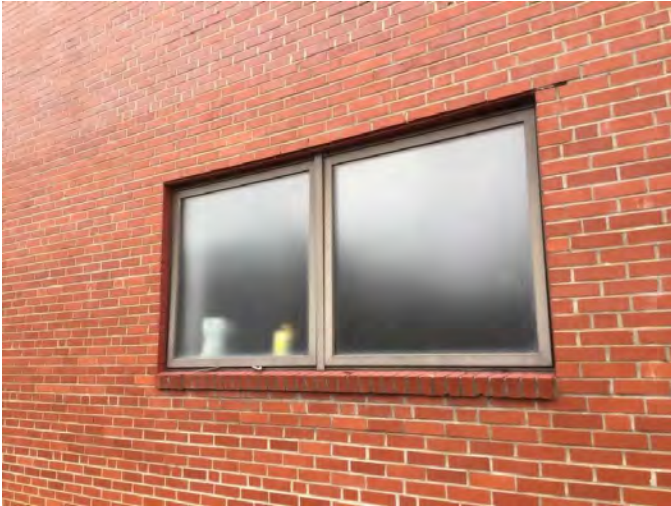
System: B2020 - Exterior Windows

Location: Throughout
Distress: Beyond Service Life
Category: Deferred Maintenance / Energy
Priority: 3 - Necessary/Not Yet Critical (Years 2-5)
Correction: Renew System
Qty: 44,433.00
Unit of Measure: S.F.
Estimate: \$529,819.00
Assessor Name: Matt Mahaffey
Date Created: 02/01/2017

Notes: The aluminum frame, operable, single pane windows are aged, rusted, not energy efficient, and should be replaced.

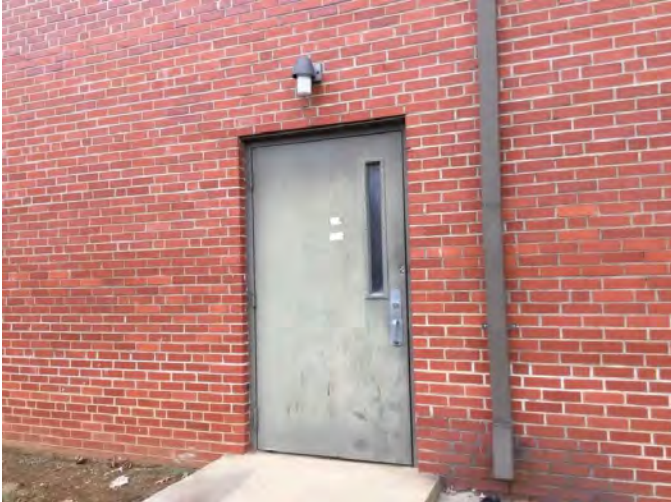
System: B2030 - Exterior Doors

Location: Throughout
Distress: Beyond Service Life
Category: Deferred Maintenance / Appearance
Priority: 3 - Necessary/Not Yet Critical (Years 2-5)
Correction: Renew System
Qty: 44,433.00
Unit of Measure: S.F.
Estimate: \$50,831.00
Assessor Name: Matt Mahaffey
Date Created: 02/01/2017

Notes: The original exterior doors are aged, rusted, and should be replaced.

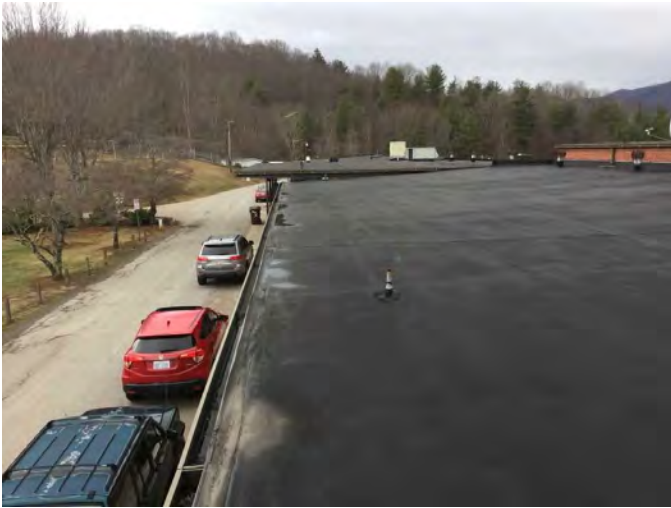
System: B3010120 - Single Ply Membrane

Location: Roof
Distress: Beyond Service Life
Category: Deferred Maintenance / Environmental
Priority: 3 - Necessary/Not Yet Critical (Years 2-5)
Correction: Renew System
Qty: 44,433.00
Unit of Measure: S.F.
Estimate: \$465,214.00
Assessor Name: Matt Mahaffey
Date Created: 02/01/2017

Notes: The EPDM adhered roof coverings are aging, showing signs of failure and should be replaced.

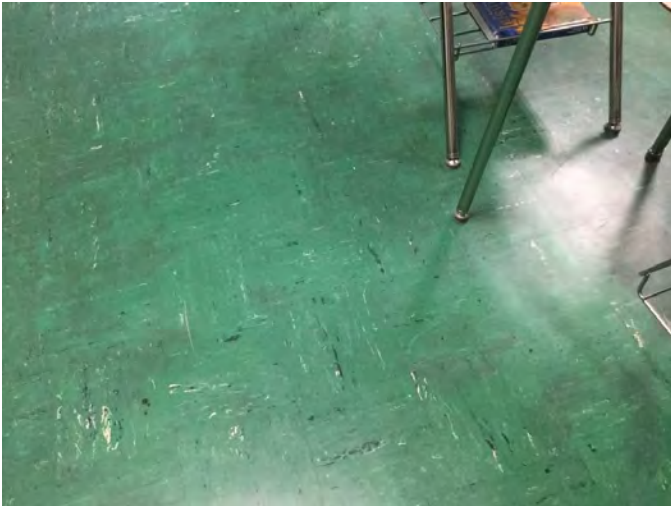
System: C3020 - Floor Finishes

Location: Throughout
Distress: Beyond Service Life
Category: Deferred Maintenance / Appearance
Priority: 3 - Necessary/Not Yet Critical (Years 2-5)
Correction: Renew System
Qty: 44,433.00
Unit of Measure: S.F.
Estimate: \$524,443.00
Assessor Name: Matt Mahaffey
Date Created: 02/01/2017

Notes: The VCT flooring is aged, cracked, worn, and should be replaced.
ACM tiles should be replaced where accessible.

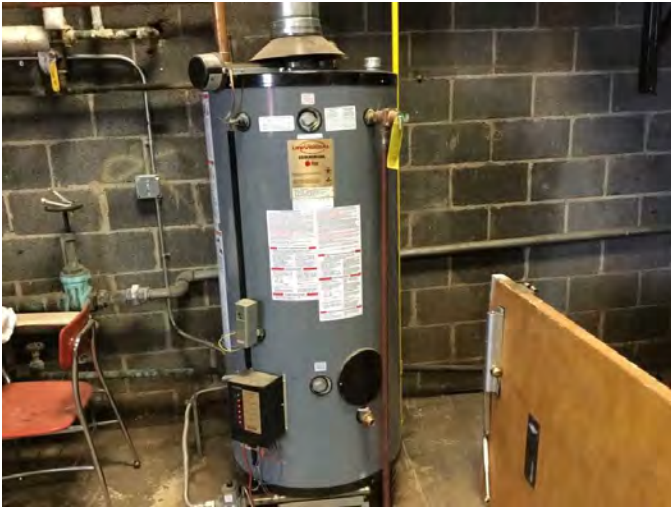
System: D2020 - Domestic Water Distribution

Location: Throughout
Distress: Beyond Service Life
Category: Deferred Maintenance / Energy
Priority: 3 - Necessary/Not Yet Critical (Years 2-5)
Correction: Renew System
Qty: 44,433.00
Unit of Measure: S.F.
Estimate: \$51,809.00
Assessor Name: Matt Mahaffey
Date Created: 02/01/2017

Notes: The domestic water distribution system is aged and should be replaced.

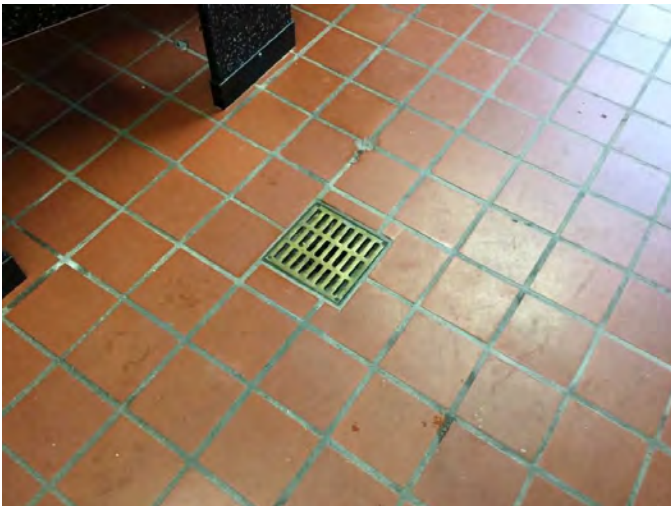
System: D2030 - Sanitary Waste

Location: Throughout
Distress: Beyond Service Life
Category: Deferred Maintenance
Priority: 3 - Necessary/Not Yet Critical (Years 2-5)
Correction: Renew System
Qty: 44,433.00
Unit of Measure: S.F.
Estimate: \$82,112.00
Assessor Name: Matt Mahaffey
Date Created: 02/01/2017

Notes: The sanitary waste system is aged, has reported periodic failures, and should be replaced.

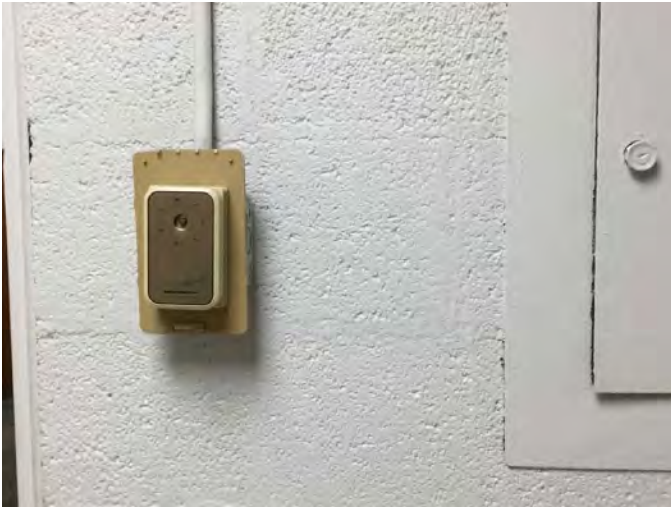
System: D3060 - Controls & Instrumentation

Location: Throughout
Distress: Beyond Service Life
Category: Deferred Maintenance / Energy
Priority: 3 - Necessary/Not Yet Critical (Years 2-5)
Correction: Renew System
Qty: 44,433.00
Unit of Measure: S.F.
Estimate: \$166,668.00
Assessor Name: Matt Mahaffey
Date Created: 02/01/2017

Notes: The HVAC controls system is aged, becoming logistically unsupportable, and should be replaced.

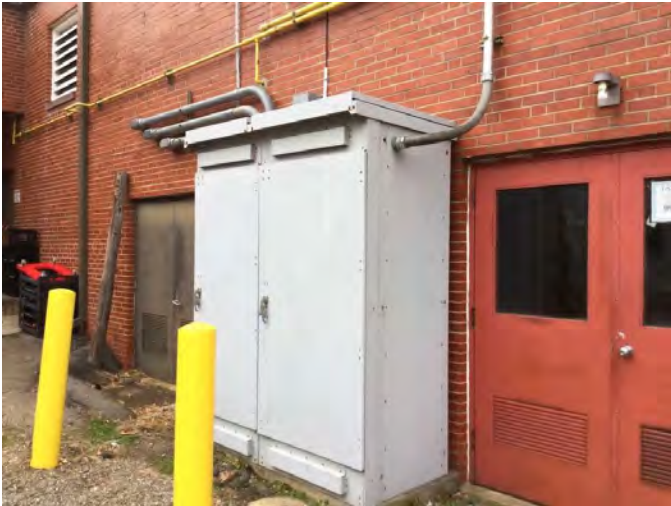
System: D5010 - Electrical Service/Distribution

Location: Throughout
Distress: Beyond Service Life
Category: Deferred Maintenance
Priority: 3 - Necessary/Not Yet Critical (Years 2-5)
Correction: Renew System
Qty: 44,433.00
Unit of Measure: S.F.
Estimate: \$82,601.00
Assessor Name: Matt Mahaffey
Date Created: 02/01/2017

Notes: The original electrical distribution system is operating properly due to an aggressive maintenance program but is aged, in marginal condition, and should be replaced.

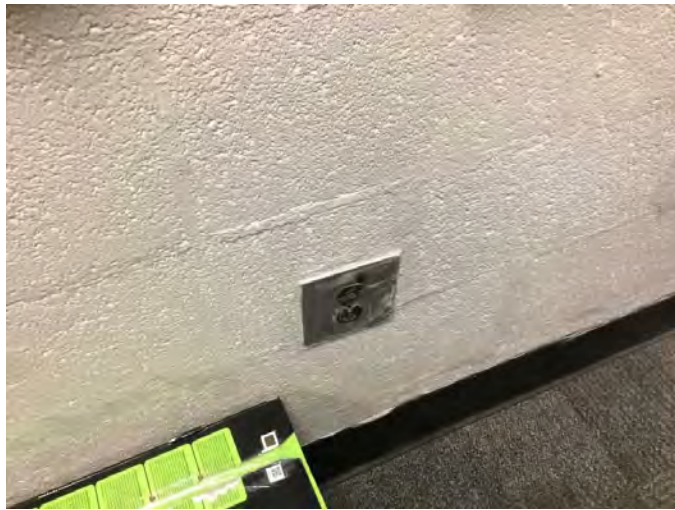
System: D5020 - Branch Wiring

Location: Throughout
Distress: Beyond Service Life
Category: Deferred Maintenance / Energy
Priority: 3 - Necessary/Not Yet Critical (Years 2-5)
Correction: Renew System
Qty: 44,433.00
Unit of Measure: S.F.
Estimate: \$247,314.00
Assessor Name: Matt Mahaffey
Date Created: 02/01/2017

Notes: The original branch wiring system is operating, but is aged, in poor condition, and should be replaced.

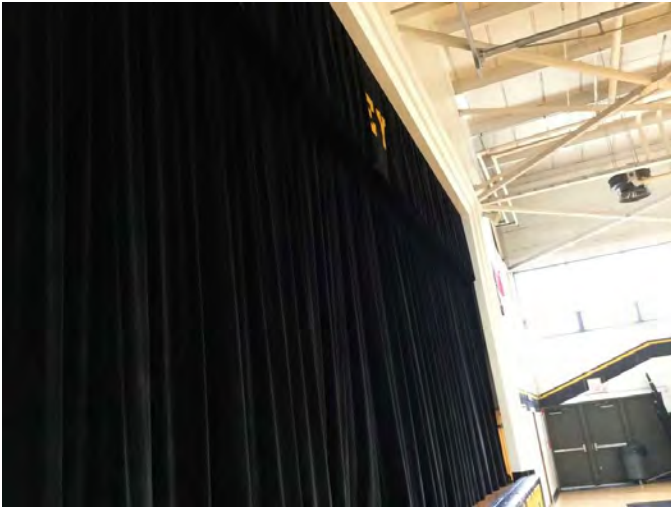
System: E1020 - Institutional Equipment

Location: Stage
Distress: Beyond Service Life
Category: Deferred Maintenance / Appearance
Priority: 4 - Recommended (Years 6-10)
Correction: Renew System
Qty: 44,433.00
Unit of Measure: S.F.
Estimate: \$137,342.00
Assessor Name: Matt Mahaffey
Date Created: 02/01/2017

Notes: Theater and stage equipment is aged and should be replaced.

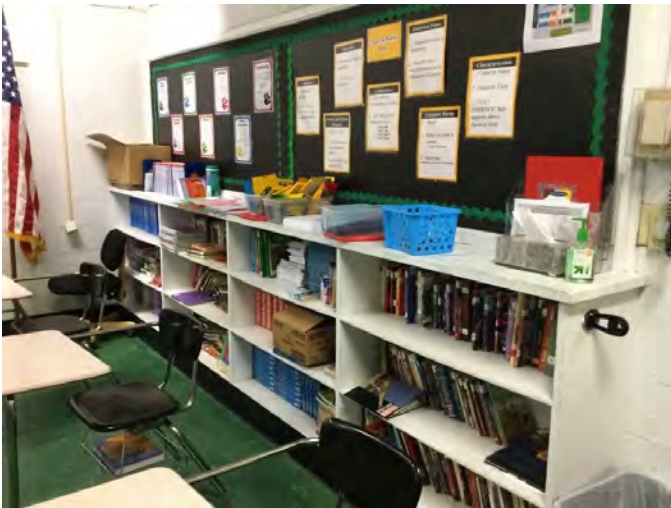
System: E2010 - Fixed Furnishings

Location: Throughout
Distress: Beyond Service Life
Category: Deferred Maintenance / Appearance
Priority: 4 - Recommended (Years 6-10)
Correction: Renew System
Qty: 44,433.00
Unit of Measure: S.F.
Estimate: \$274,196.00
Assessor Name: Matt Mahaffey
Date Created: 02/01/2017

Notes: The fixed furnishings are aged, in marginal condition, and should be replaced.

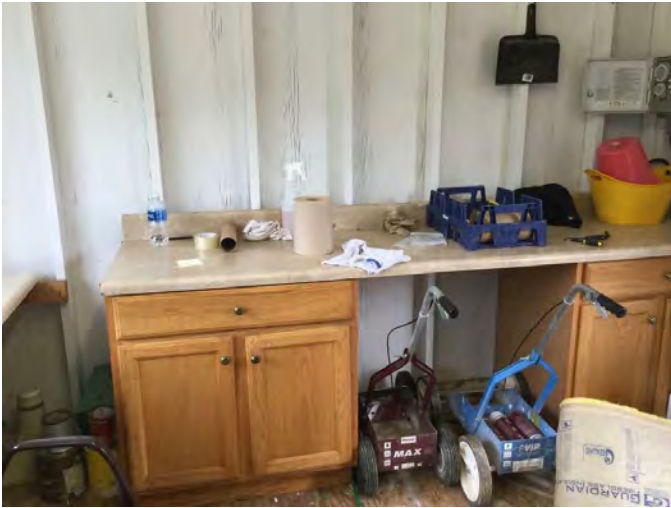
System: C3010 - Wall Finishes

Location: Throughout
Distress: Beyond Service Life
Category: Deferred Maintenance / Appearance
Priority: 3 - Necessary/Not Yet Critical (Years 2-5)
Correction: Renew System
Qty: 500.00
Unit of Measure: S.F.
Estimate: \$4,103.00
Assessor Name: Eduardo Lopez
Date Created: 02/01/2017

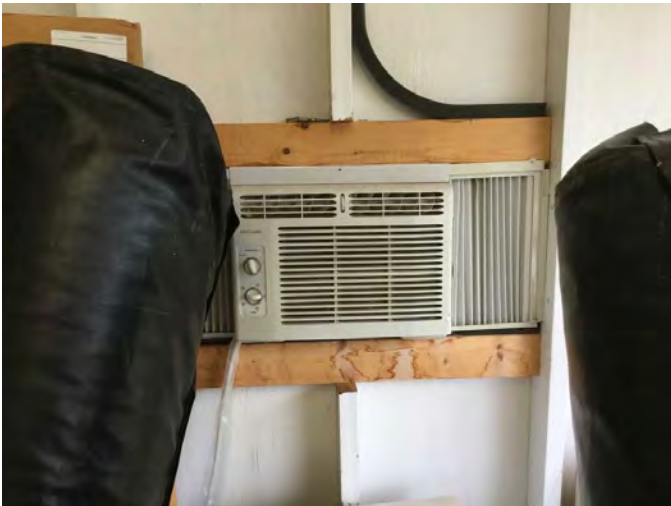
System: D3050 - Terminal & Package Units

Location: Throughout
Distress: Beyond Service Life
Category: Deferred Maintenance
Priority: 3 - Necessary/Not Yet Critical (Years 2-5)
Correction: Renew System
Qty: 500.00
Unit of Measure: S.F.
Estimate: \$9,328.00
Assessor Name: Eduardo Lopez
Date Created: 02/01/2017

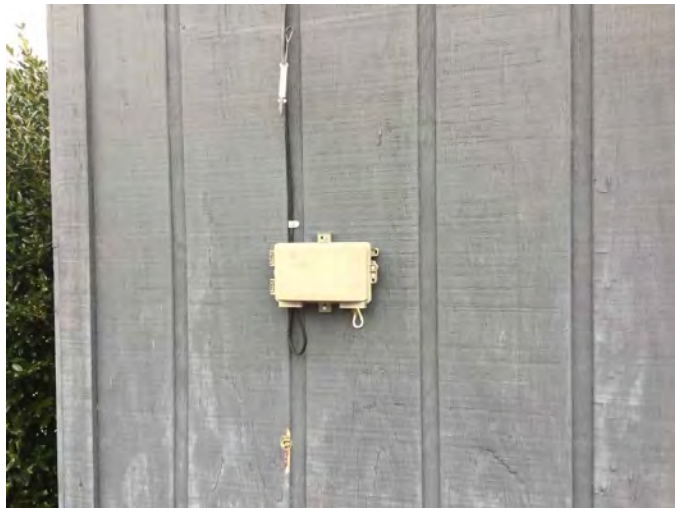
System: D5030920 - Data Communication

Location: Throughout
Distress: Failing
Category: Deferred Maintenance
Priority: 3 - Necessary/Not Yet Critical (Years 2-5)
Correction: Renew System
Qty: 500.00
Unit of Measure: S.F.
Estimate: \$1,370.00
Assessor Name: Eduardo Lopez
Date Created: 02/01/2017

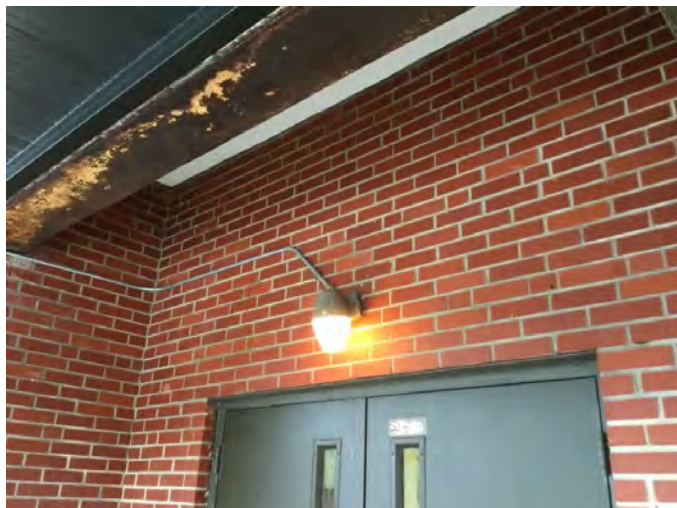
System: G4020 - Site Lighting

Location: Site
Distress: Beyond Service Life
Category: Deferred Maintenance / Energy
Priority: 2 - Potentially Critical (Year 1)
Correction: Renew System
Qty: 53,827.00
Unit of Measure: S.F.
Estimate: \$89,999.00
Assessor Name: Eduardo Lopez
Date Created: 02/01/2017

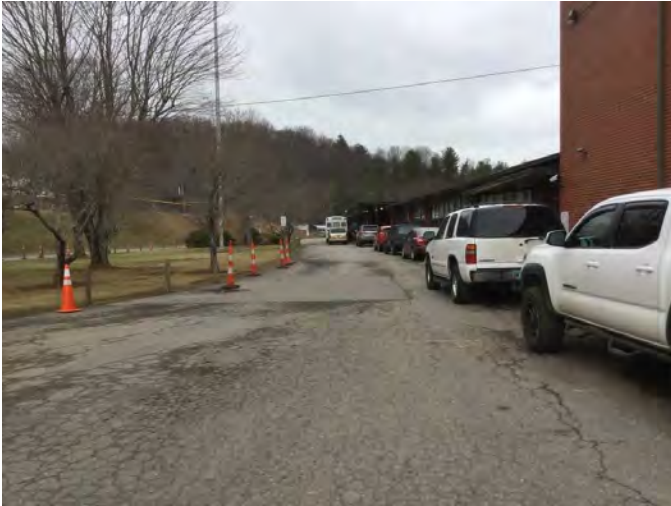
System: G2010 - Roadways

Location: Roadway
Distress: Beyond Service Life
Category: Deferred Maintenance / Environmental
Priority: 3 - Necessary/Not Yet Critical (Years 2-5)
Correction: Renew System
Qty: 53,827.00
Unit of Measure: S.F.
Estimate: \$249,865.00
Assessor Name: Eduardo Lopez
Date Created: 02/01/2017

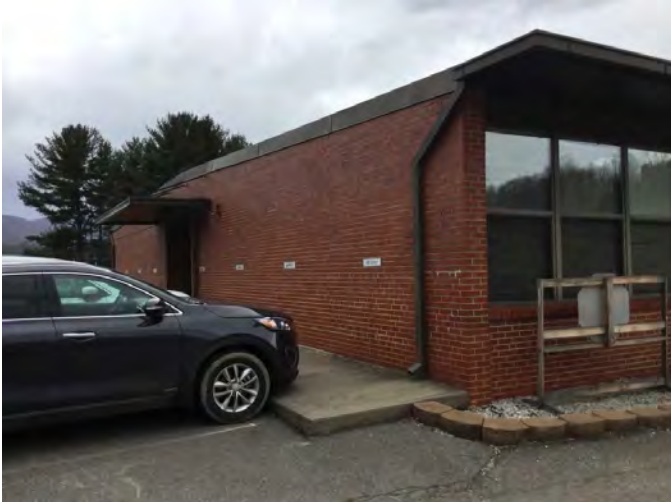
System: G2020 - Parking Lots

Location: Parking
Distress: Beyond Service Life
Category: Deferred Maintenance / Accessibility Code Compliance
Priority: 3 - Necessary/Not Yet Critical (Years 2-5)
Correction: Renew System
Qty: 53,827.00
Unit of Measure: S.F.
Estimate: \$82,301.00
Assessor Name: Eduardo Lopez
Date Created: 02/01/2017

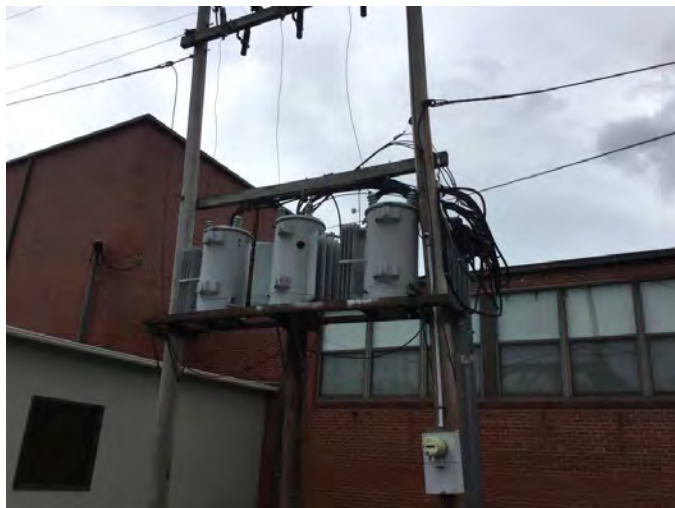
System: G4010 - Electrical Distribution

Location: Site
Distress: Beyond Service Life
Category: Deferred Maintenance
Priority: 3 - Necessary/Not Yet Critical (Years 2-5)
Correction: Renew System
Qty: 53,827.00
Unit of Measure: S.F.
Estimate: \$153,353.00
Assessor Name: Eduardo Lopez
Date Created: 02/01/2017
