# Pinebrook Elementary

## Campus Assessment Report

March 10, 2017

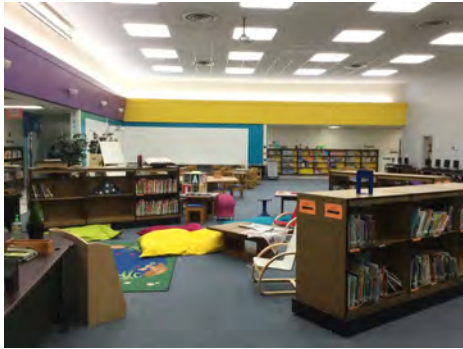
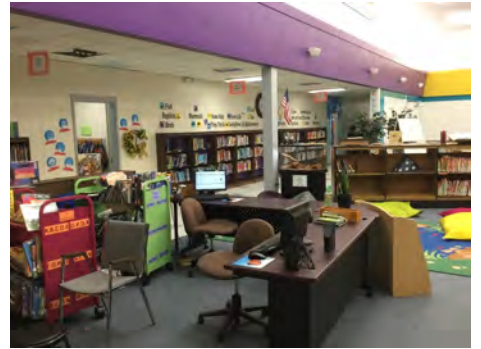
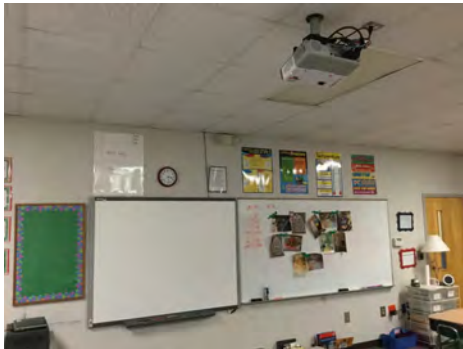
**System:** E1020 - Institutional Equipment

**Notes:** The institutional equipment is in deteriorating conditions and should be replaced.

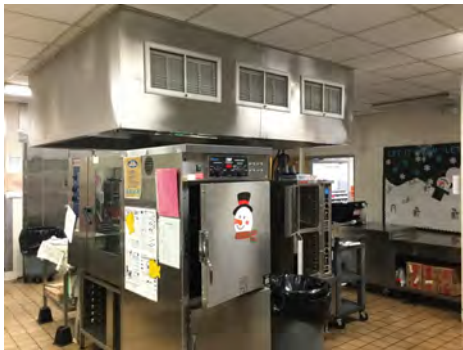
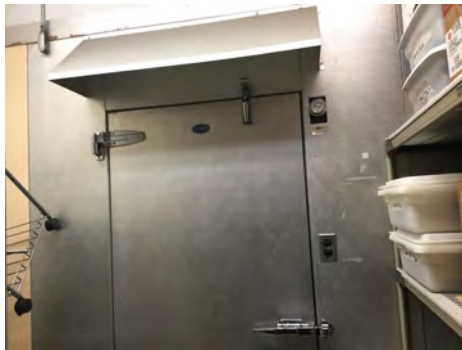
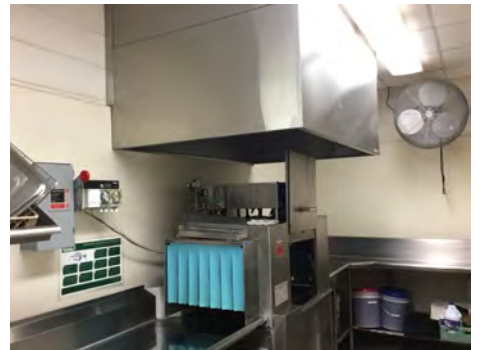
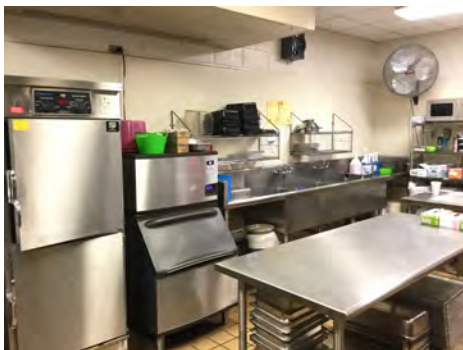
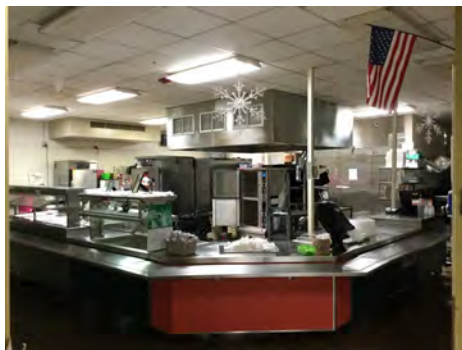
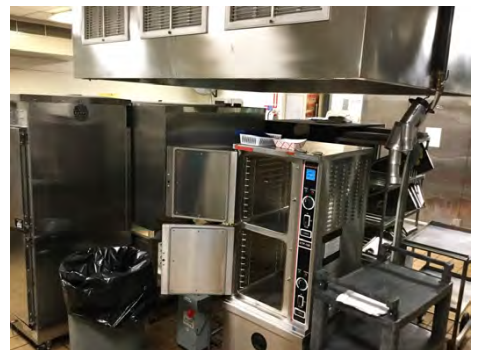
**System:** E1090 - Other Equipment

**Notes:** The other equipment system is beyond its expected service life and should be scheduled for replacement.

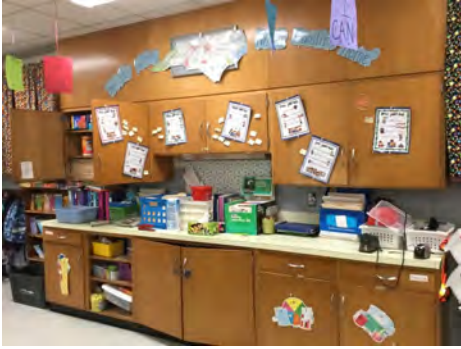
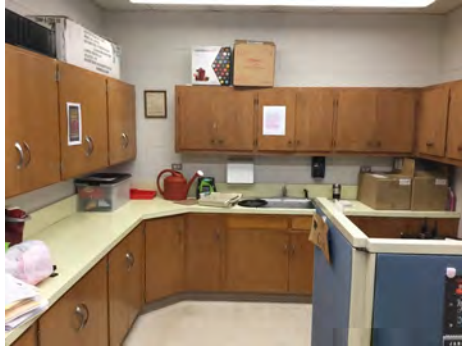
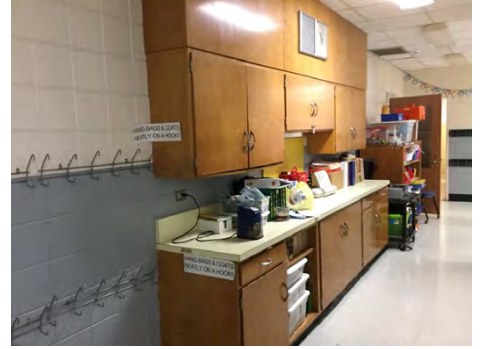
**System:** E2010 - Fixed Furnishings

**Notes:** The fixed furnishings are aged, in marginal condition, and should be replaced.

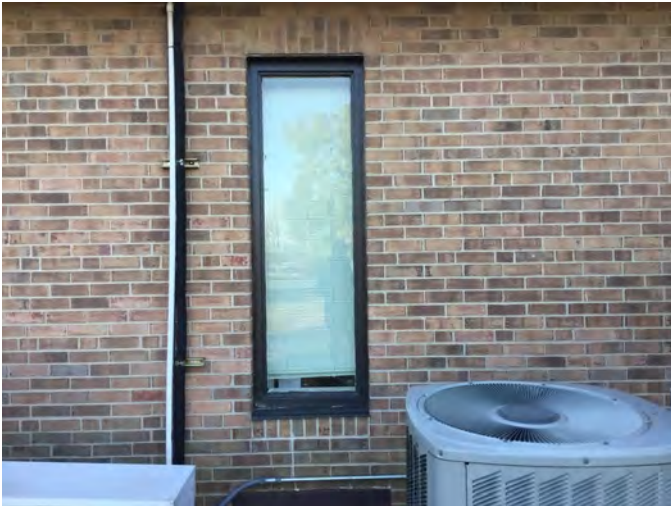
#### System: B2020 - Exterior Windows

**Location:** Exterior Walls  
**Distress:** Beyond Service Life  
**Category:** Deferred Maintenance  
**Priority:** 3 - Necessary/Not Yet Critical (Years 2-5)  
**Correction:** Renew System  
**Qty:** 50,152.00  
**Unit of Measure:** S.F.  
**Estimate:** \$507,538.00  
**Assessor Name:** Somnath Das  
**Date Created:** 01/19/2017

**Notes:** The exterior windows are aged, rusted, not energy efficient and should be replaced.

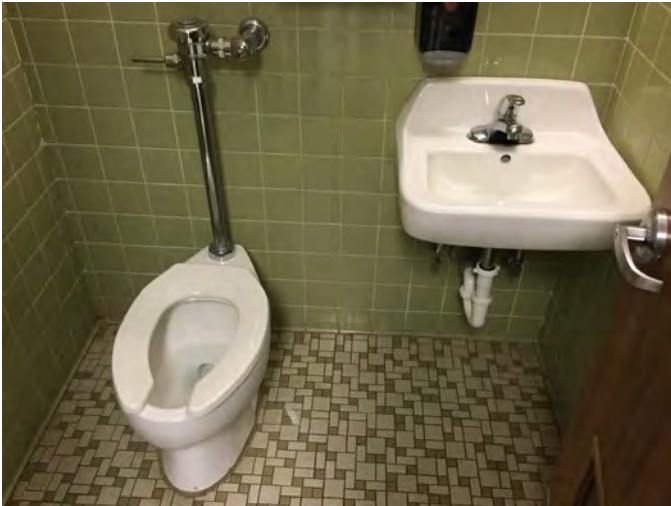
**System: D2010 - Plumbing Fixtures**

**Location:** Throughout the Building  
**Distress:** Beyond Service Life  
**Category:** Deferred Maintenance  
**Priority:** 3 - Necessary/Not Yet Critical (Years 2-5)  
**Correction:** Renew System  
**Qty:** 50,152.00  
**Unit of Measure:** S.F.  
**Estimate:** \$621,183.00  
**Assessor Name:** Somnath Das  
**Date Created:** 01/19/2017

**Notes:** Plumbing fixtures are in operational conditions. However, they are aged, not ADA compliant, and should be scheduled for replacement.

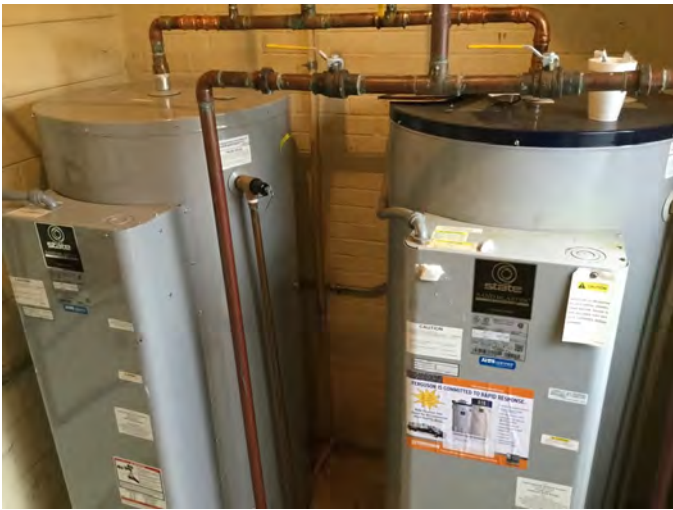
**System: D2020 - Domestic Water Distribution**

**Location:** Throughout the Building  
**Distress:** Beyond Service Life  
**Category:** Deferred Maintenance  
**Priority:** 3 - Necessary/Not Yet Critical (Years 2-5)  
**Correction:** Renew System  
**Qty:** 50,152.00  
**Unit of Measure:** S.F.  
**Estimate:** \$52,961.00  
**Assessor Name:** Somnath Das  
**Date Created:** 01/19/2017

**Notes:** The domestic water distribution system is aged and should be replaced.

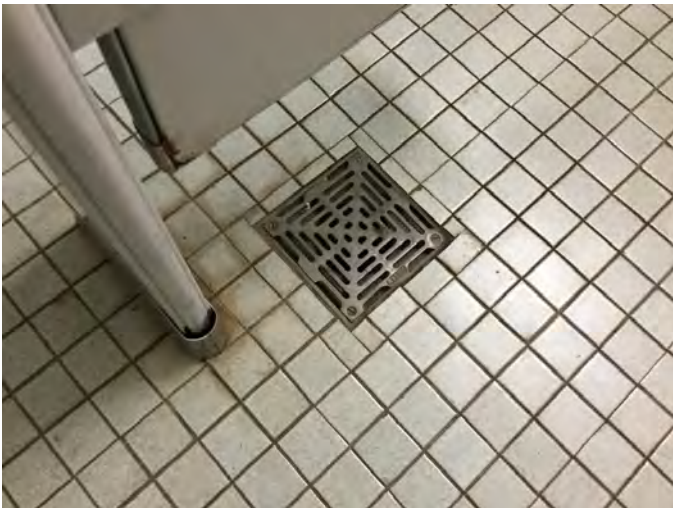
**System: D2030 - Sanitary Waste**

**Location:** Throughout the Building  
**Distress:** Beyond Service Life  
**Category:** Deferred Maintenance  
**Priority:** 3 - Necessary/Not Yet Critical (Years 2-5)  
**Correction:** Renew System  
**Qty:** 50,152.00  
**Unit of Measure:** S.F.  
**Estimate:** \$83,854.00  
**Assessor Name:** Somnath Das  
**Date Created:** 01/19/2017

**Notes:** The sanitary waste system is beyond its expected service life and should be replaced.

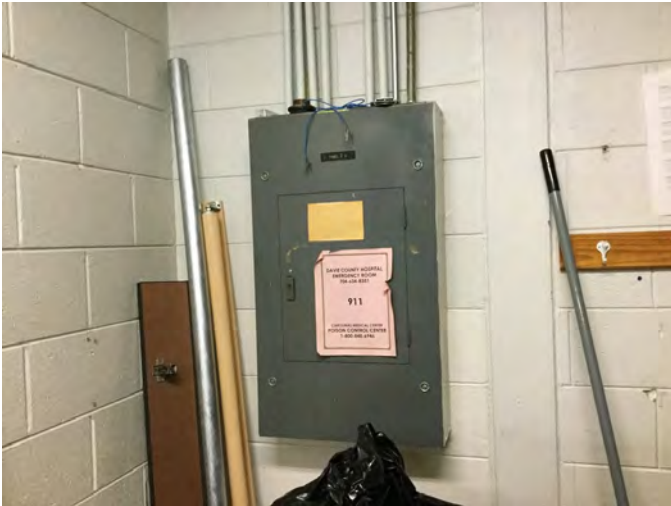
**System: D5020 - Branch Wiring**

**Location:** Throughout the Building  
**Distress:** Beyond Service Life  
**Category:** Deferred Maintenance  
**Priority:** 3 - Necessary/Not Yet Critical (Years 2-5)  
**Correction:** Renew System  
**Qty:** 50,152.00  
**Unit of Measure:** S.F.  
**Estimate:** \$275,284.00  
**Assessor Name:** Somnath Das  
**Date Created:** 01/19/2017

**Notes:** The original branch wiring system is operating but is aged, in marginal condition, and should be replaced.

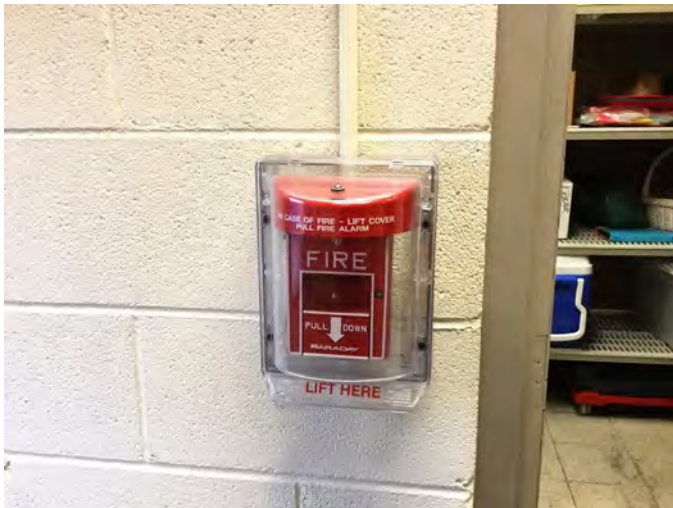
**System: D5030910 - Fire Alarm Systems**

**Location:** Throughout the Building  
**Distress:** Beyond Service Life  
**Category:** Deferred Maintenance  
**Priority:** 3 - Necessary/Not Yet Critical (Years 2-5)  
**Correction:** Renew System  
**Qty:** 50,152.00  
**Unit of Measure:** S.F.  
**Estimate:** \$182,603.00  
**Assessor Name:** Somnath Das  
**Date Created:** 01/19/2017

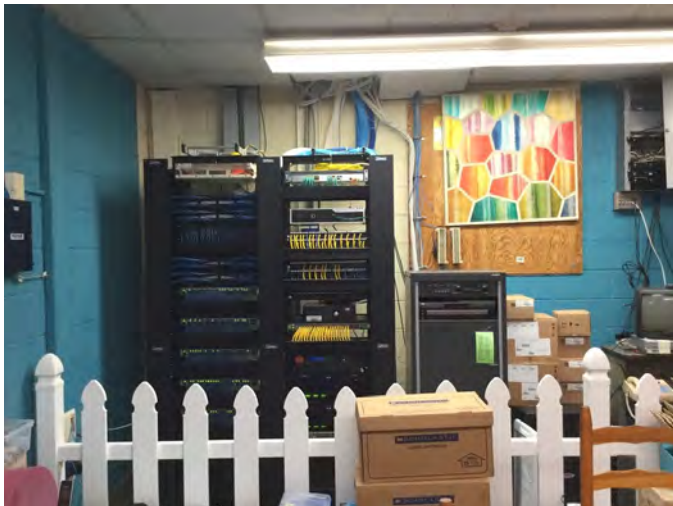
**System: D5030920 - Data Communication**

**Location:** Throughout the Building  
**Distress:** Beyond Service Life  
**Category:** Deferred Maintenance  
**Priority:** 3 - Necessary/Not Yet Critical (Years 2-5)  
**Correction:** Renew System  
**Qty:** 50,152.00  
**Unit of Measure:** S.F.  
**Estimate:** \$237,219.00  
**Assessor Name:** Somnath Das  
**Date Created:** 01/19/2017

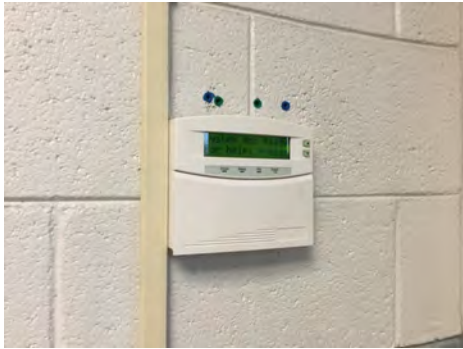
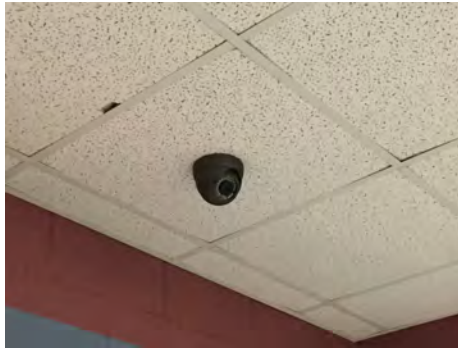
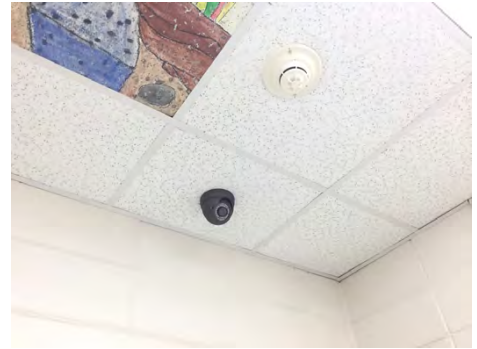
**System:** D5030810 - Security & Detection Systems

**Notes:** The security and detection system is beyond its expected service life and should be scheduled for replacement.

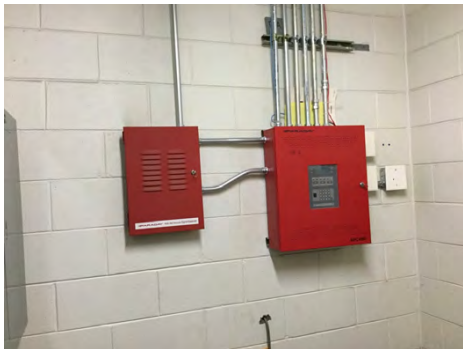
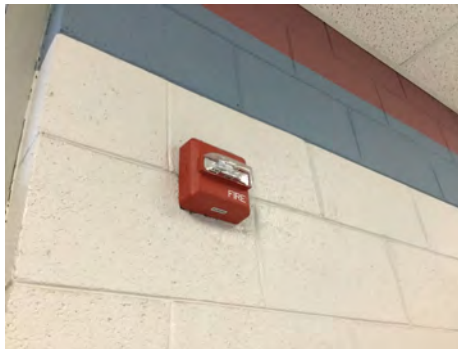
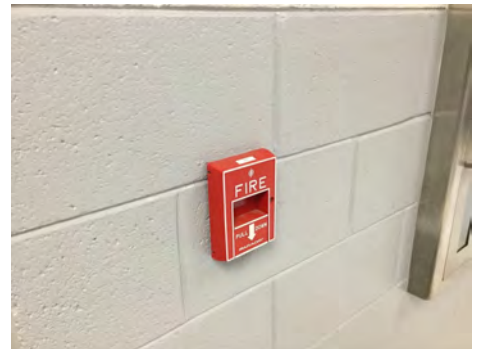
**System:** D5030910 - Fire Alarm Systems

**Notes:** The fire alarm system is beyond its expected service life and should be scheduled for replacement.

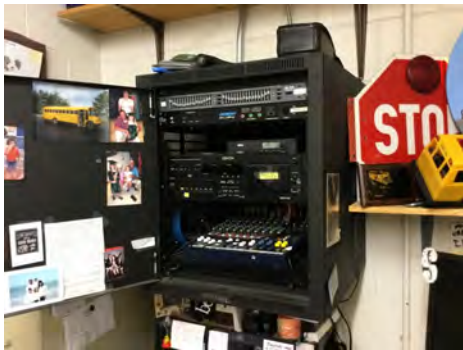
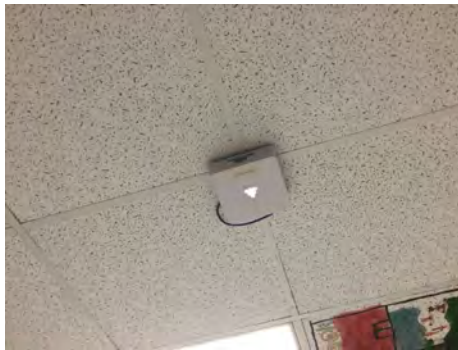
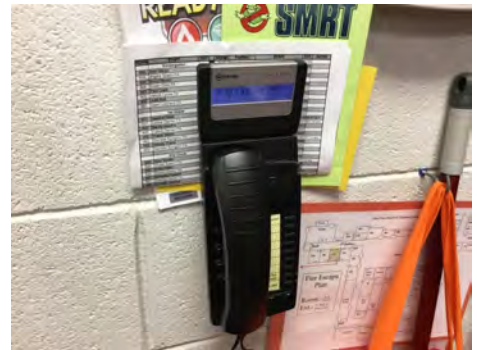
**System:** D5030920 - Data Communication

**Notes:** The data communication system is beyond its expected service life and should be scheduled for replacement.

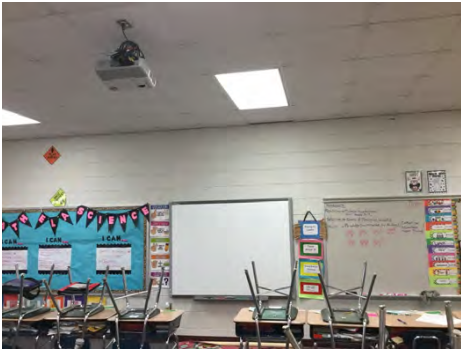
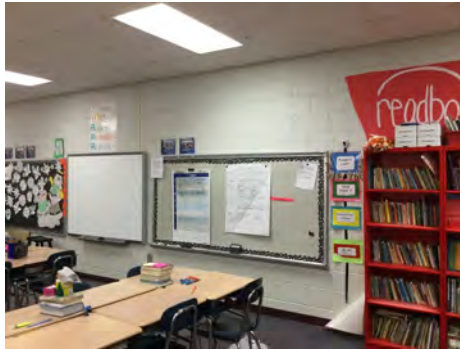
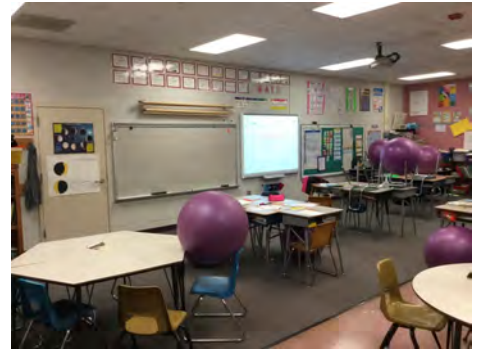
**System:** E1020 - Institutional Equipment

**Notes:** The institutional equipment is in deteriorating conditions and should be replaced.

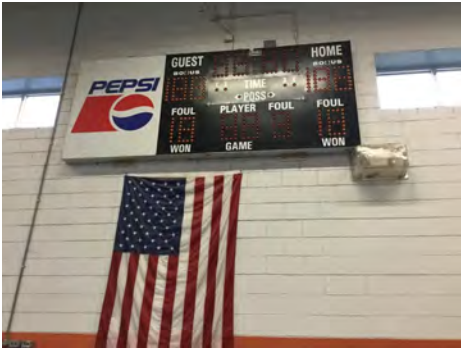
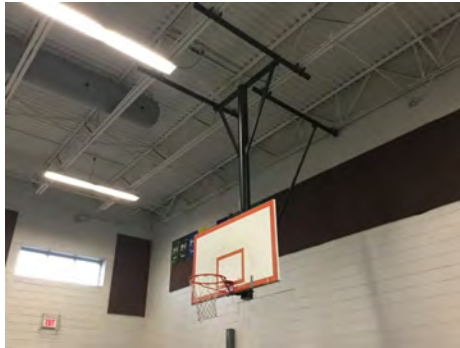
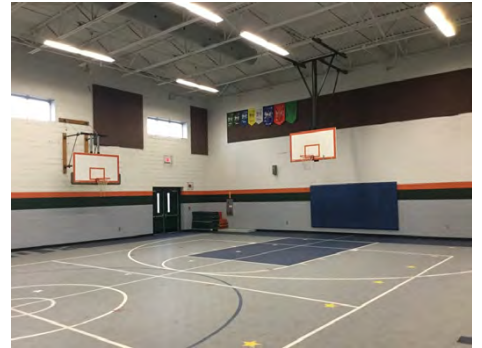
**System:** E1090 - Other Equipment

**Notes:** The other equipment is in deteriorating conditions and should be replaced.

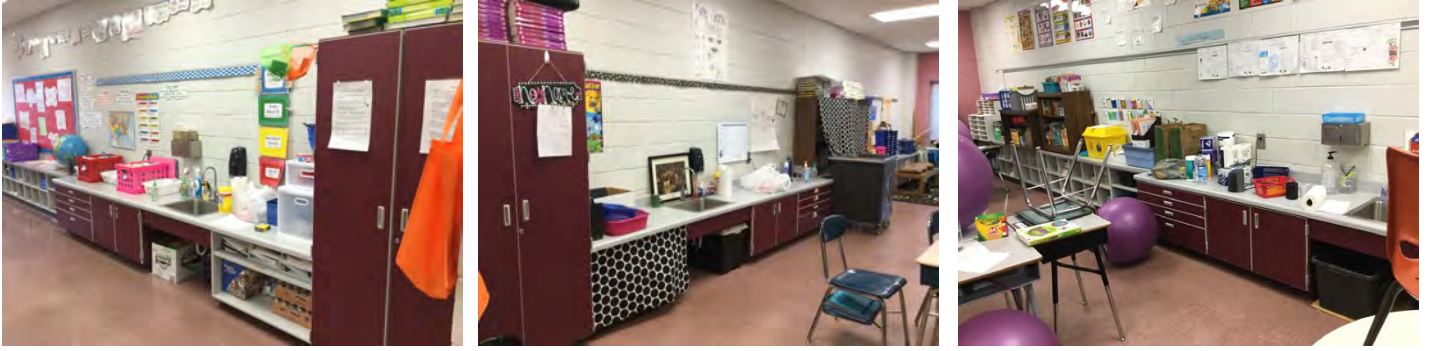
**System:** E2010 - Fixed Furnishings

**Notes:** The fixed furnishings are aged, in marginal condition, and should be replaced.

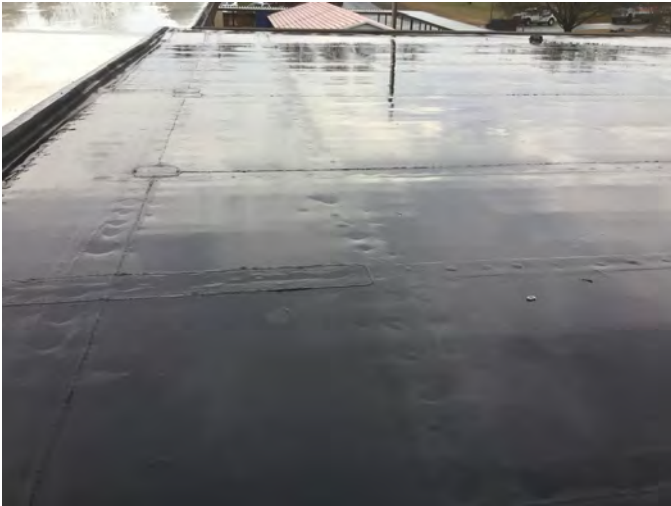
#### **System: B3010120 - Single Ply Membrane**

**Location:** Roof  
**Distress:** Beyond Service Life  
**Category:** Deferred Maintenance  
**Priority:** 3 - Necessary/Not Yet Critical (Years 2-5)  
**Correction:** Renew System  
**Qty:** 16,956.00  
**Unit of Measure:** S.F.  
**Estimate:** \$177,529.00  
**Assessor Name:** Eduardo Lopez  
**Date Created:** 01/19/2017

**Notes:** The membrane roof covering is aged, showing signs of failure and should be replaced.

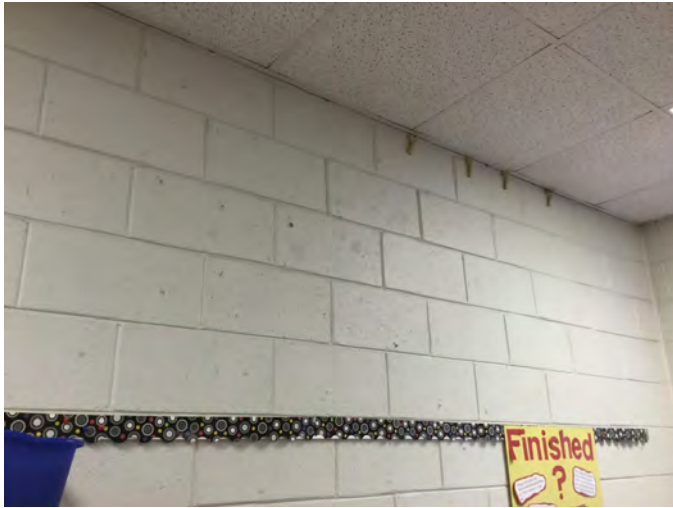
**System: C3010 - Wall Finishes**

**Location:** Throughout the Building  
**Distress:** Beyond Service Life  
**Category:** Deferred Maintenance  
**Priority:** 3 - Necessary/Not Yet Critical (Years 2-5)  
**Correction:** Renew System  
**Qty:** 16,956.00  
**Unit of Measure:** S.F.  
**Estimate:** \$50,919.00  
**Assessor Name:** Eduardo Lopez  
**Date Created:** 01/19/2017

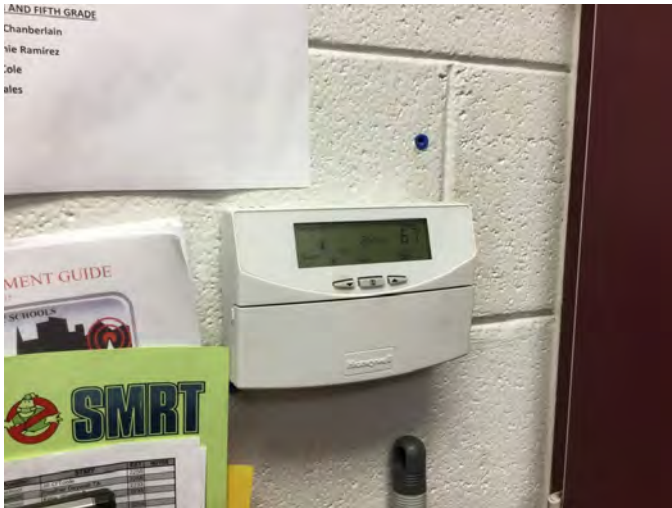
**System: D3060 - Controls & Instrumentation**

**Location:** Throughout the Building  
**Distress:** Beyond Service Life  
**Category:** Deferred Maintenance  
**Priority:** 3 - Necessary/Not Yet Critical (Years 2-5)  
**Correction:** Renew System  
**Qty:** 16,956.00  
**Unit of Measure:** S.F.  
**Estimate:** \$35,625.00  
**Assessor Name:** Eduardo Lopez  
**Date Created:** 01/19/2017

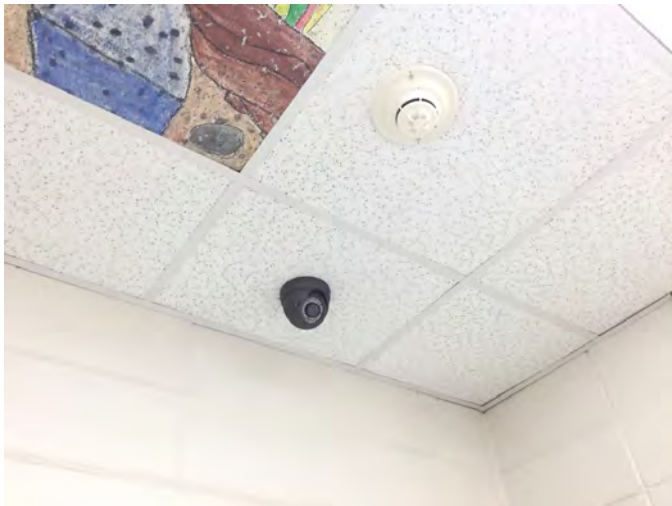
**System: D5030810 - Security & Detection Systems**

**Location:** Throughout the Building  
**Distress:** Beyond Service Life  
**Category:** Deferred Maintenance  
**Priority:** 3 - Necessary/Not Yet Critical (Years 2-5)  
**Correction:** Renew System  
**Qty:** 16,956.00  
**Unit of Measure:** S.F.  
**Estimate:** \$34,132.00  
**Assessor Name:** Eduardo Lopez  
**Date Created:** 01/19/2017

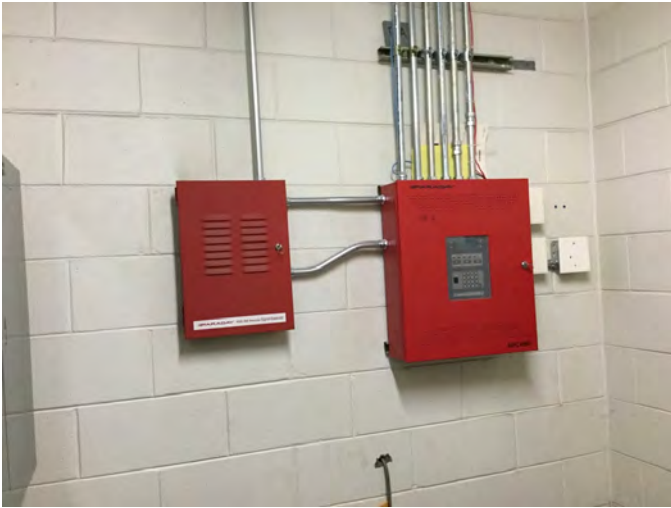
**System: D5030910 - Fire Alarm Systems**

**Location:** Throughout the Building  
**Distress:** Beyond Service Life  
**Category:** Deferred Maintenance  
**Priority:** 3 - Necessary/Not Yet Critical (Years 2-5)  
**Correction:** Renew System  
**Qty:** 16,956.00  
**Unit of Measure:** S.F.  
**Estimate:** \$61,737.00  
**Assessor Name:** Eduardo Lopez  
**Date Created:** 01/19/2017

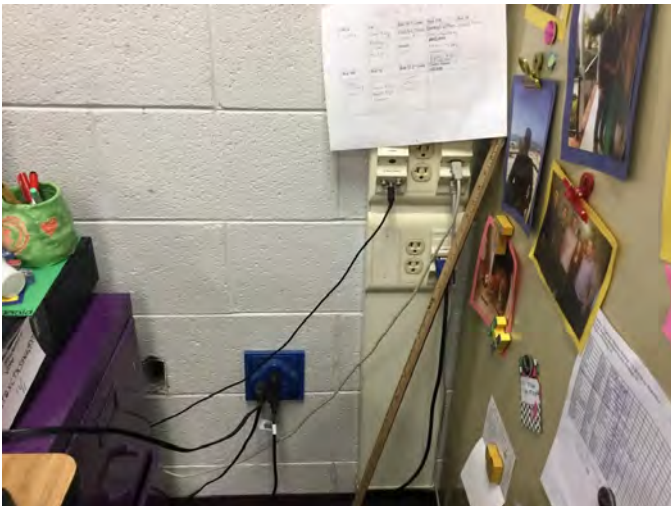
**System: D5030920 - Data Communication**

**Location:** Throughout the Building  
**Distress:** Beyond Service Life  
**Category:** Deferred Maintenance  
**Priority:** 3 - Necessary/Not Yet Critical (Years 2-5)  
**Correction:** Renew System  
**Qty:** 16,956.00  
**Unit of Measure:** S.F.  
**Estimate:** \$80,202.00  
**Assessor Name:** Eduardo Lopez  
**Date Created:** 01/19/2017

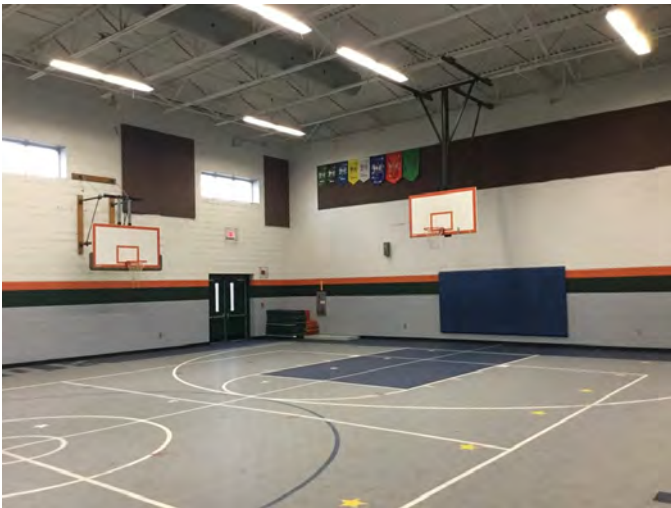
**System: E1090 - Other Equipment**

**Location:** Throughout the Building  
**Distress:** Beyond Service Life  
**Category:** Deferred Maintenance  
**Priority:** 3 - Necessary/Not Yet Critical (Years 2-5)  
**Correction:** Renew System  
**Qty:** 16,956.00  
**Unit of Measure:** S.F.  
**Estimate:** \$34,692.00  
**Assessor Name:** Eduardo Lopez  
**Date Created:** 01/19/2017

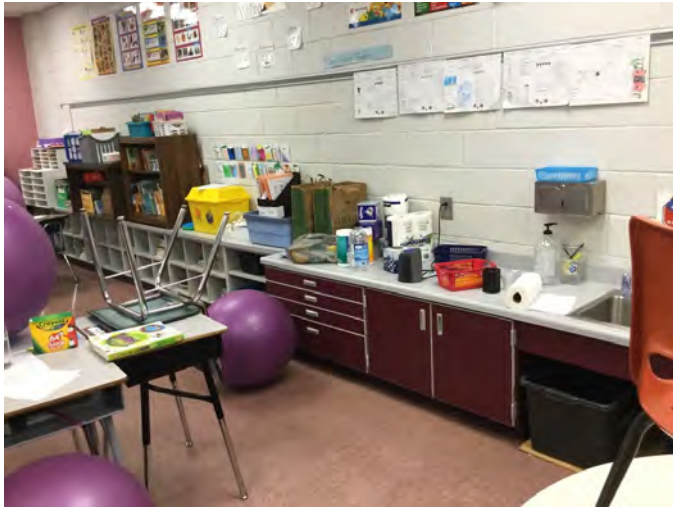
**System: E2010 - Fixed Furnishings**

**Location:** Throughout the Building  
**Distress:** Beyond Service Life  
**Category:** Deferred Maintenance  
**Priority:** 3 - Necessary/Not Yet Critical (Years 2-5)  
**Correction:** Renew System  
**Qty:** 16,956.00  
**Unit of Measure:** S.F.  
**Estimate:** \$106,687.00  
**Assessor Name:** Eduardo Lopez  
**Date Created:** 01/19/2017
