NC School District/400 Greene County/Elementary School

Snow Hill Primary

Campus Assessment Report

March 13, 2017

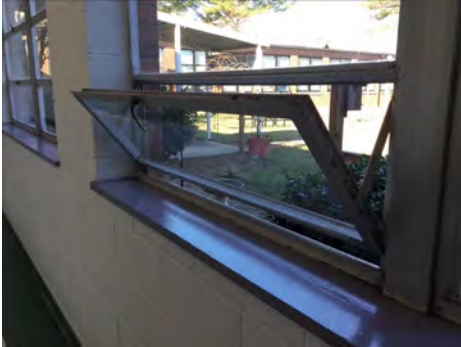
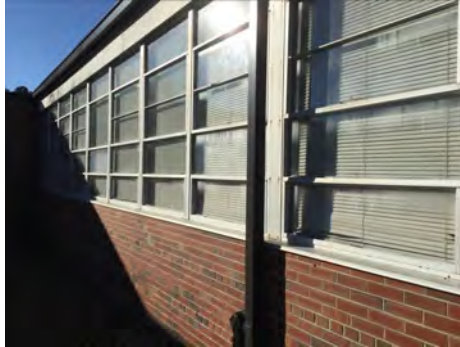
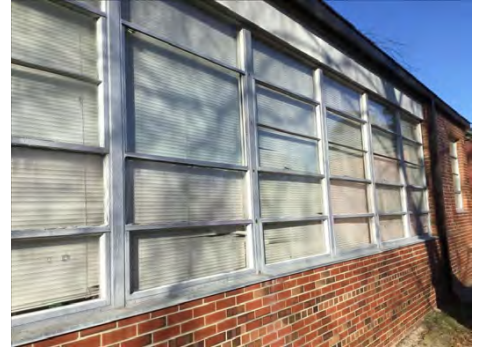
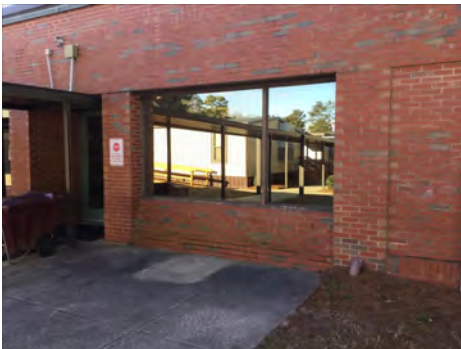
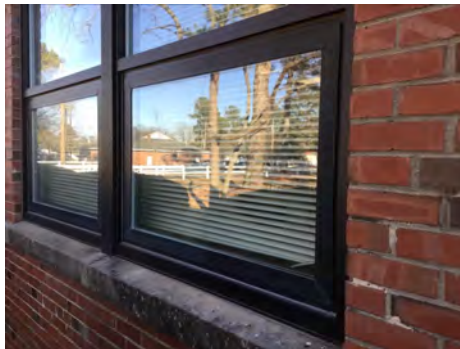
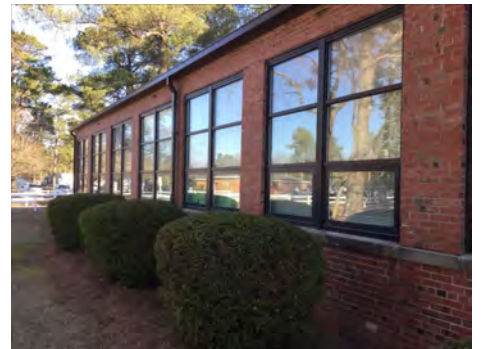
System: B2020 - Exterior Windows

Note: 20% of the windows need replacing.

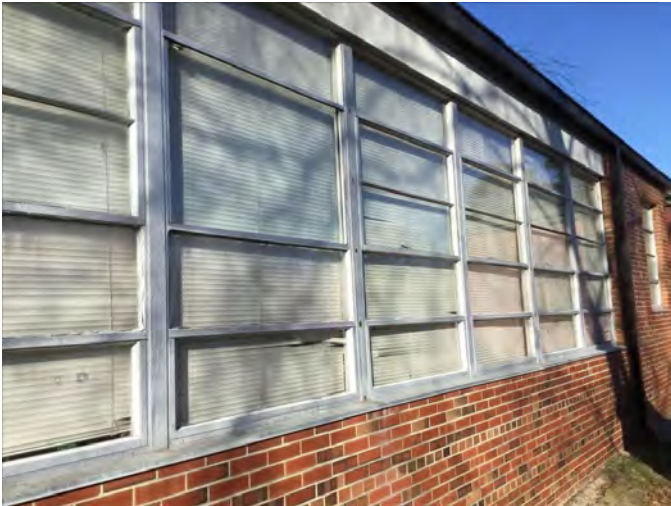
System: B2020 - Exterior Windows

Location: Exterior
Distress: Beyond Service Life
Category: Deferred Maintenance
Priority: 3 - Necessary/Not Yet Critical (Years 2-5)
Correction: Renew System
Qty: 52,079.00
Unit of Measure: S.F.
Estimate: \$537,924.00
Assessor Name: Eduardo Lopez
Date Created: 02/10/2017

Notes: The original metal frame, single pane, operable windows are aged, worn, inefficient and should be replaced.

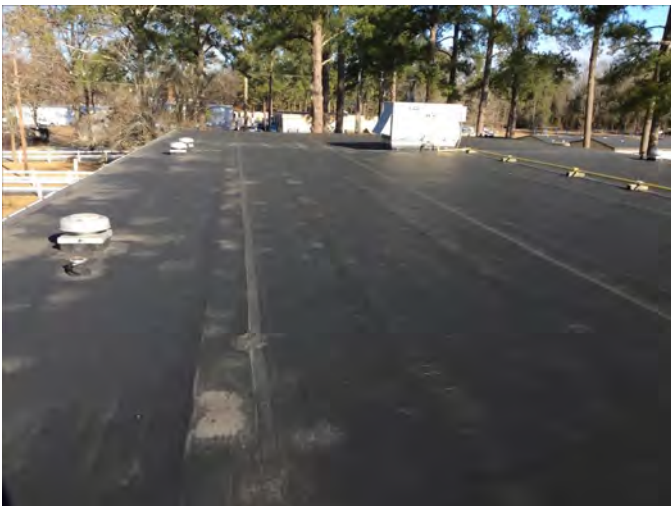
System: B3010120 - Single Ply Membrane

Location: Roof
Distress: Beyond Service Life
Category: Deferred Maintenance
Priority: 3 - Necessary/Not Yet Critical (Years 2-5)
Correction: Renew System
Qty: 36,790.00
Unit of Measure: S.F.
Estimate: \$385,191.00
Assessor Name: Eduardo Lopez
Date Created: 02/22/2017

Notes: There are no reported or observed leaks, but the rate of repairs are increasing. The roof covering should be replaced.

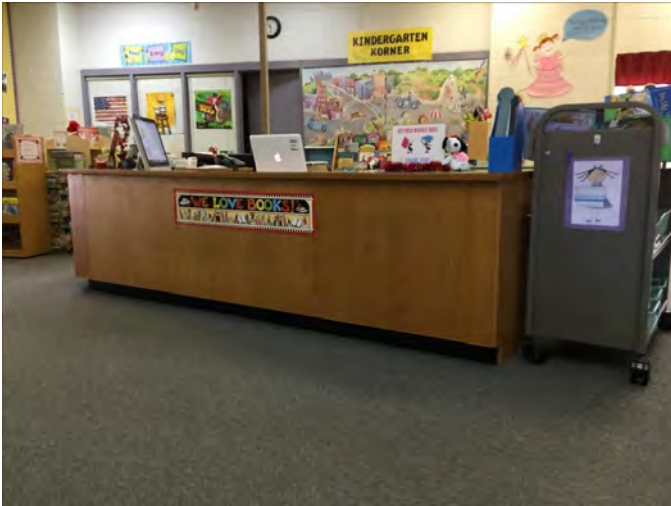
System: C3020 - Floor Finishes

Location: Office
Distress: Damaged
Category: Deferred Maintenance
Priority: 3 - Necessary/Not Yet Critical (Years 2-5)
Correction: Replace carpet with pad
Qty: 130.00
Unit of Measure: S.Y.
Estimate: \$3,706.56
Assessor Name: Eduardo Lopez
Date Created: 02/21/2017

Notes: The carpet is old and need to be replaced.

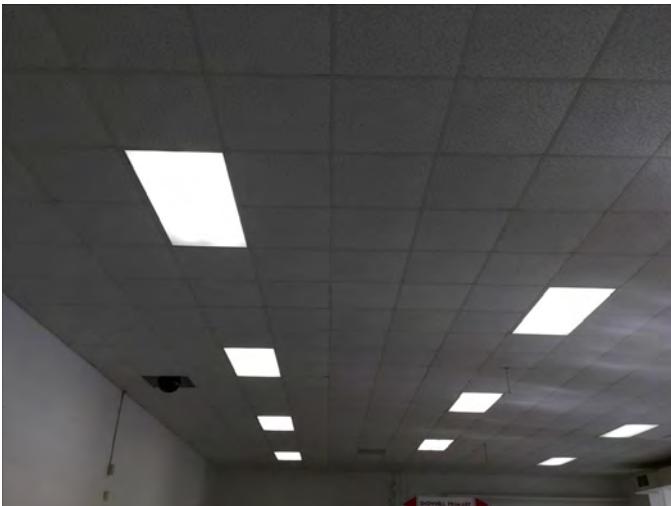
System: C3030 - Ceiling Finishes

Location: Throughout the building
Distress: Beyond Service Life
Category: Deferred Maintenance
Priority: 3 - Necessary/Not Yet Critical (Years 2-5)
Correction: Renew System
Qty: 52,079.00
Unit of Measure: S.F.
Estimate: \$628,437.00
Assessor Name: Eduardo Lopez
Date Created: 02/15/2017

Notes: The acoustical ceiling tiles and grid system is aged, and should be replaced.

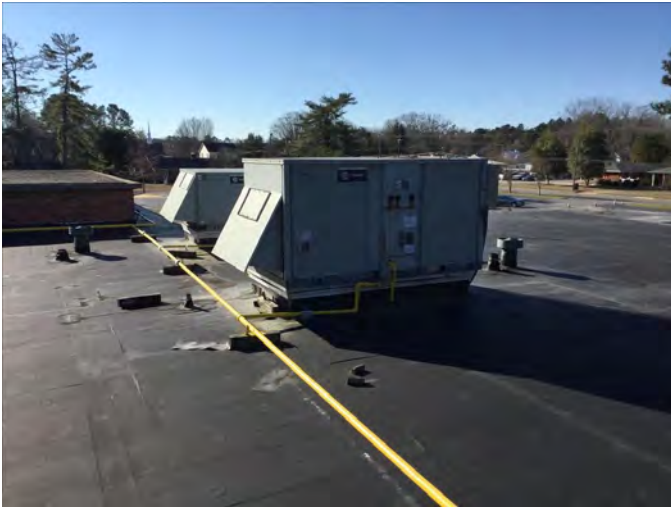
System: D3050 - Terminal & Package Units

Location: Roof
Distress: Beyond Service Life
Category: Deferred Maintenance
Priority: 3 - Necessary/Not Yet Critical (Years 2-5)
Correction: Renew System
Qty: 52,079.00
Unit of Measure: S.F.
Estimate: \$765,926.00
Assessor Name: Eduardo Lopez
Date Created: 02/10/2017

Notes: The roof mounted AC units are aged and should be scheduled for replacement.

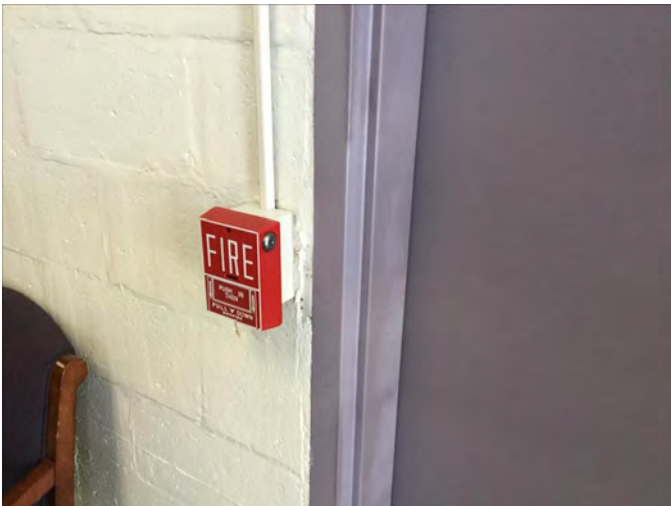
System: D5030910 - Fire Alarm Systems

Location: Throughout the building
Distress: Beyond Service Life
Category: Building Code Compliance
Priority: 3 - Necessary/Not Yet Critical (Years 2-5)
Correction: Renew System
Qty: 52,079.00
Unit of Measure: S.F.
Estimate: \$194,203.00
Assessor Name: Eduardo Lopez
Date Created: 02/10/2017

Notes: The original fire alarm system operating as designed, but is beyond its service life and should be replaced.

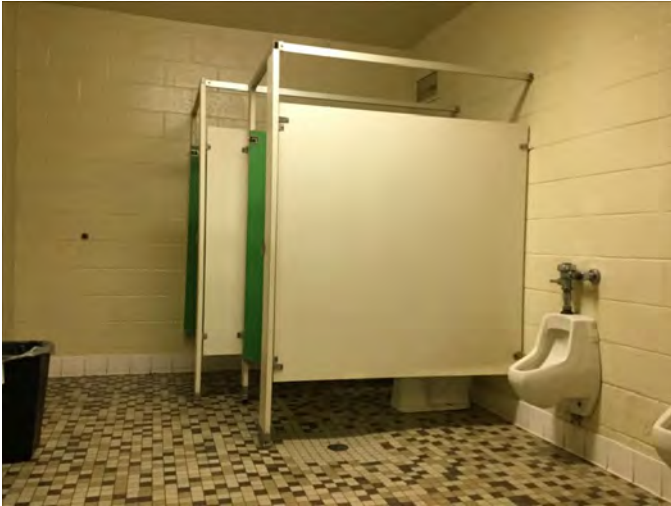
System: C1030 - Fittings

Location: Throughout the building
Distress: Beyond Service Life
Category: Deferred Maintenance
Priority: 4 - Recommended (Years 6-10)
Correction: Renew System
Qty: 52,079.00
Unit of Measure: S.F.
Estimate: \$557,974.00
Assessor Name: Eduardo Lopez
Date Created: 02/22/2017

Notes: The fittings are aged, worn, damaged and should be replaced.

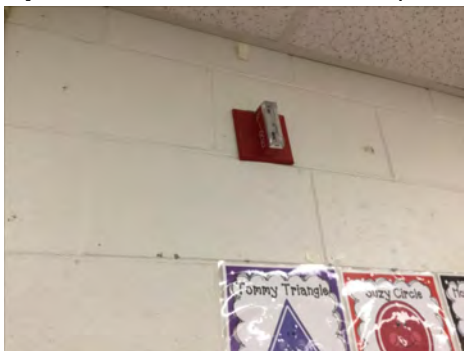
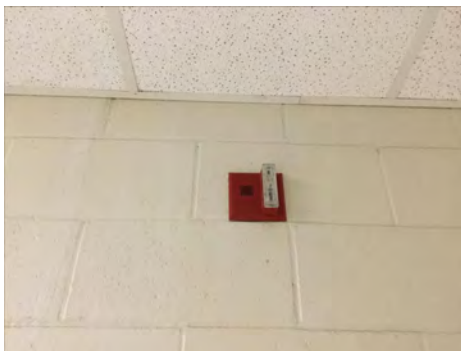
System: D5030910 - Fire Alarm Systems

Note: Connected to main panel.

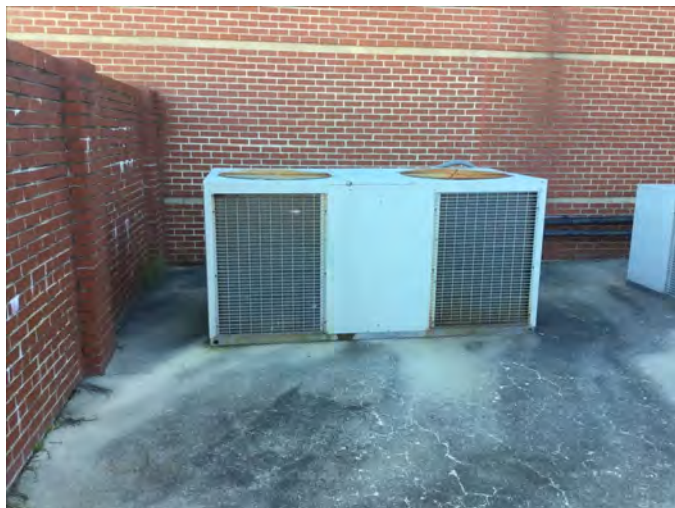
System: D3050 - Terminal & Package Units

Location: Exterior
Distress: Beyond Service Life
Category: Deferred Maintenance
Priority: 3 - Necessary/Not Yet Critical (Years 2-5)
Correction: Renew System
Qty: 21,414.00
Unit of Measure: S.F.
Estimate: \$195,274.00
Assessor Name: Eduardo Lopez
Date Created: 02/10/2017

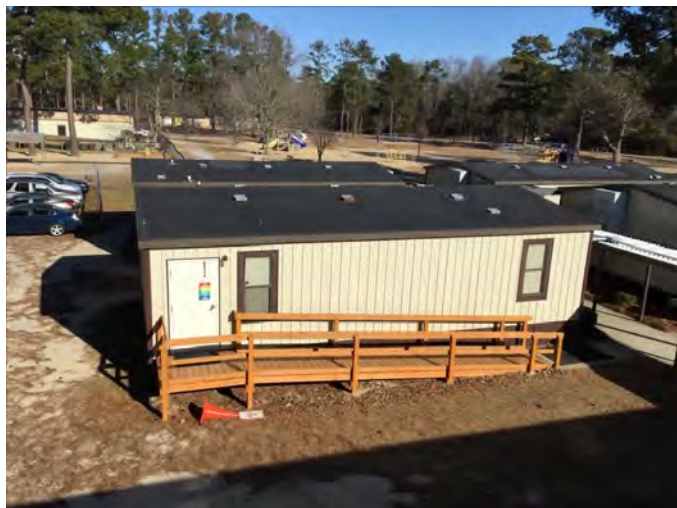
System: B3010120 - Single Ply Membrane

Location: Roof
Distress: Failing
Category: Deferred Maintenance
Priority: 3 - Necessary/Not Yet Critical (Years 2-5)
Correction: Renew System
Qty: 1,000.00
Unit of Measure: S.F.
Estimate: \$10,470.00
Assessor Name: Eduardo Lopez
Date Created: 02/01/2017

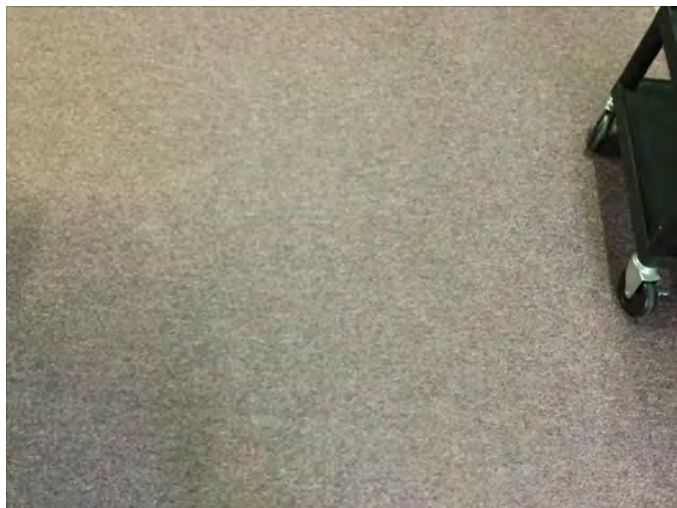
System: C3020 - Floor Finishes

Location: Throughout the building
Distress: Damaged
Category: Deferred Maintenance
Priority: 3 - Necessary/Not Yet Critical (Years 2-5)
Correction: Renew System
Qty: 1,000.00
Unit of Measure: S.F.
Estimate: \$12,760.00
Assessor Name: Eduardo Lopez
Date Created: 03/01/2017

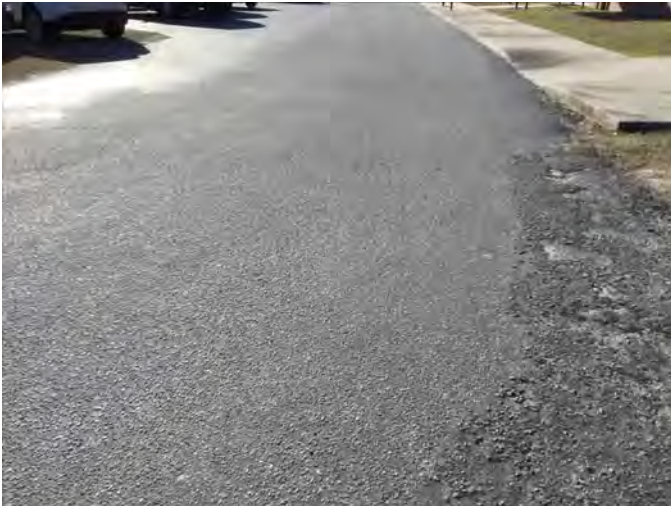
System: G2010 - Roadways

Location: Site
Distress: Beyond Service Life
Category: Deferred Maintenance
Priority: 3 - Necessary/Not Yet Critical (Years 2-5)
Correction: Renew System
Qty: 90,283.00
Unit of Measure: S.F.
Estimate: \$378,376.00
Assessor Name: Terence Davis
Date Created: 03/01/2017

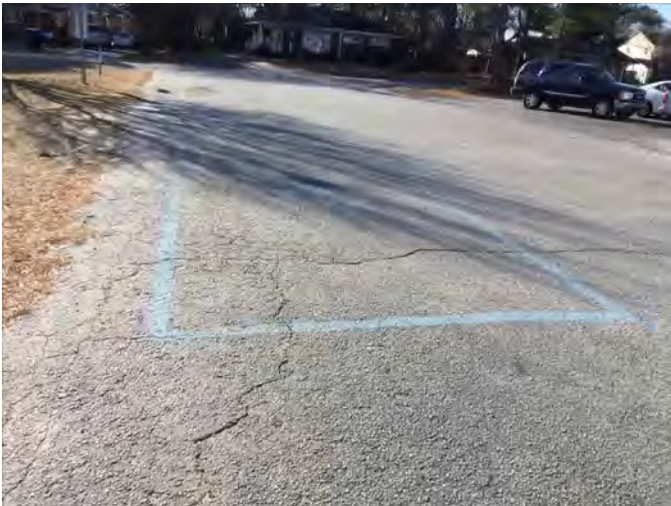
System: G2020 - Parking Lots

Location: Site
Distress: Beyond Service Life
Category: Deferred Maintenance
Priority: 3 - Necessary/Not Yet Critical (Years 2-5)
Correction: Renew System
Qty: 90,283.00
Unit of Measure: S.F.
Estimate: \$132,084.00
Assessor Name: Terence Davis
Date Created: 02/22/2017
