NC School District/400 Greene County/Middle School

# Greene County Middle

## Campus Assessment Report

March 13, 2017

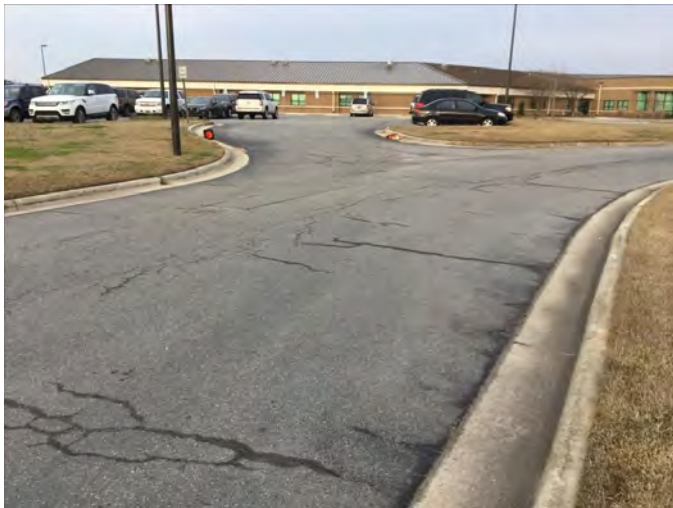
#### System: G2010 - Roadways

**Location:** Site  
**Distress:** Damaged  
**Category:** Deferred Maintenance  
**Priority:** 3 - Necessary/Not Yet Critical (Years 2-5)  
**Correction:** Renew System  
**Qty:** 128,452.00  
**Unit of Measure:** S.F.  
**Estimate:** \$596,274.00  
**Assessor Name:** Terence Davis  
**Date Created:** 02/28/2017

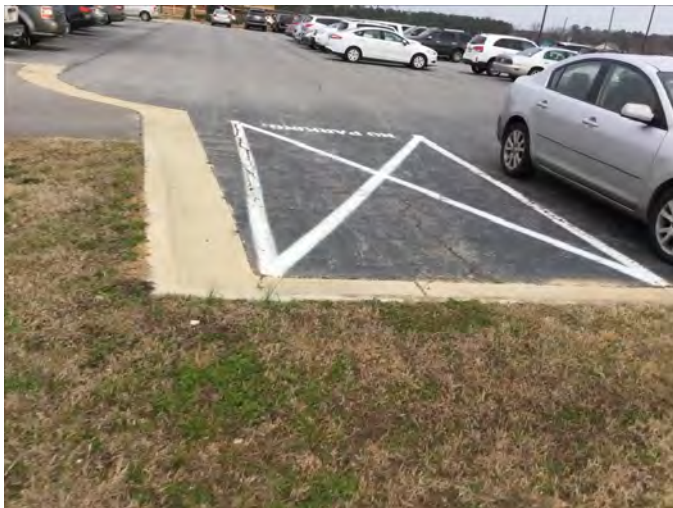
#### System: G2020 - Parking Lots

**Location:** Site  
**Distress:** Damaged  
**Category:** Deferred Maintenance  
**Priority:** 3 - Necessary/Not Yet Critical (Years 2-5)  
**Correction:** Renew System  
**Qty:** 128,452.00  
**Unit of Measure:** S.F.  
**Estimate:** \$196,403.00  
**Assessor Name:** Terence Davis  
**Date Created:** 02/28/2017
