NC School District/430 Harnett County/High School

Overhills High

Campus Assessment Report

March 11, 2017

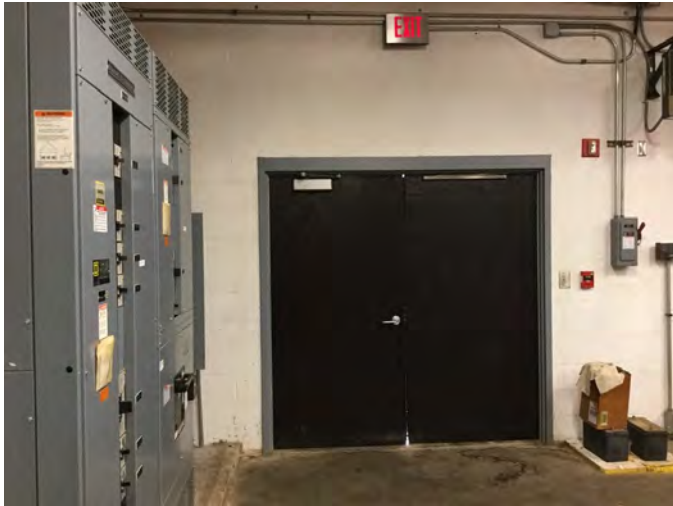
System: B2030 - Exterior Doors

Location: Exterior Door
Distress: Missing
Category: Building Code Compliance
Priority: 2 - Potentially Critical (Year 1)
Correction: Add panic hardware to exit door
Qty: 2.00
Unit of Measure: Ea.
Estimate: \$3,102.00
Assessor Name: Eduardo Lopez
Date Created: 12/09/2016

Notes: The electrical room exit access door doesn't have a panic hardware device installed and should be provided per Building Code compliance.

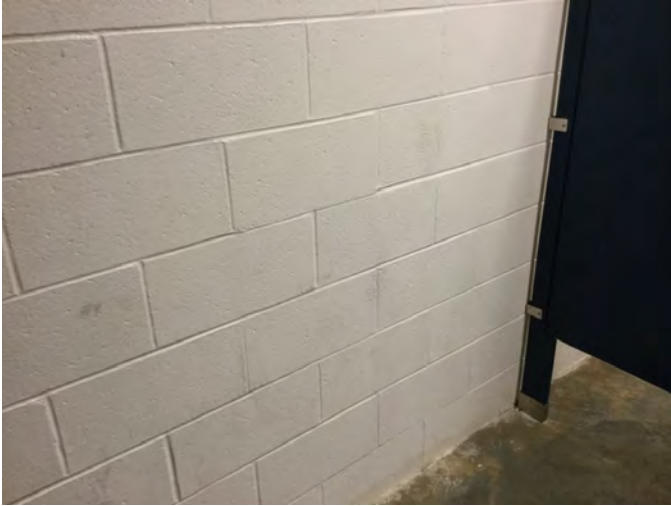
System: C3010 - Wall Finishes

Location: Throughout the building
Distress: Beyond Service Life
Category: Deferred Maintenance
Priority: 3 - Necessary/Not Yet Critical (Years 2-5)
Correction: Renew System
Qty: 2,172.00
Unit of Measure: S.F.
Estimate: \$17,823.00
Assessor Name: Eduardo Lopez
Date Created: 12/09/2016

Notes: The wall finishes are aged, scuffed, fading, stained, and should be replaced.

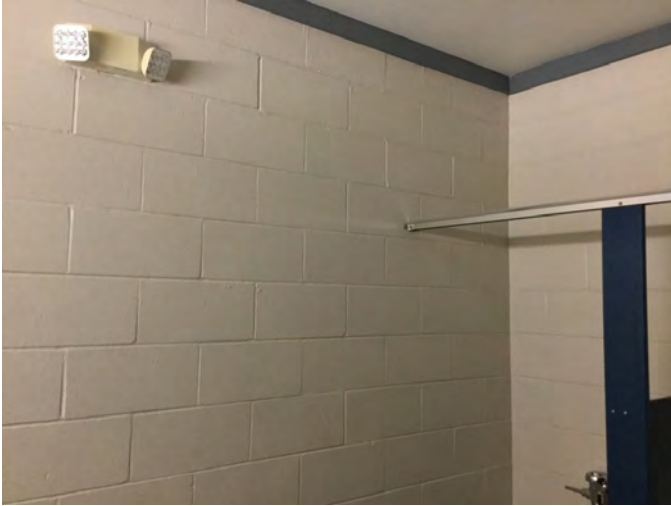
System: C3010 - Wall Finishes

Location: Throughout the building
Distress: Beyond Service Life
Category: Deferred Maintenance
Priority: 3 - Necessary/Not Yet Critical (Years 2-5)
Correction: Renew System
Qty: 1,248.00
Unit of Measure: S.F.
Estimate: \$10,241.00
Assessor Name: Eduardo Lopez
Date Created: 12/09/2016

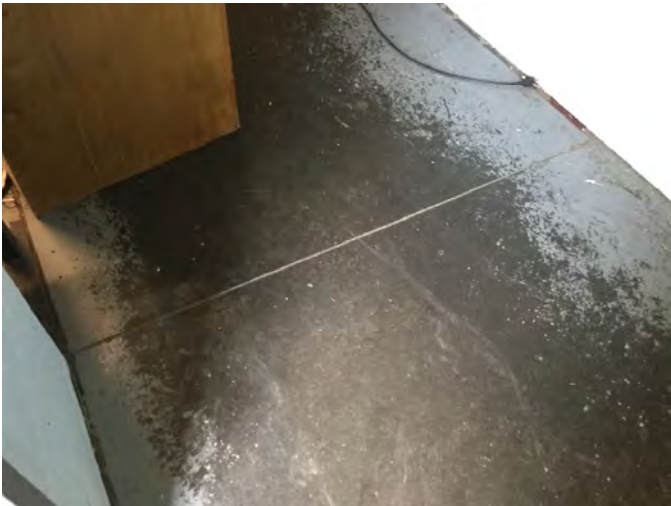
System: C3020 - Floor Finishes

Location: Throughout the building
Distress: Beyond Service Life
Category: Deferred Maintenance
Priority: 3 - Necessary/Not Yet Critical (Years 2-5)
Correction: Renew System
Qty: 4,558.00
Unit of Measure: S.F.
Estimate: \$63,876.00
Assessor Name: Eduardo Lopez
Date Created: 12/09/2016

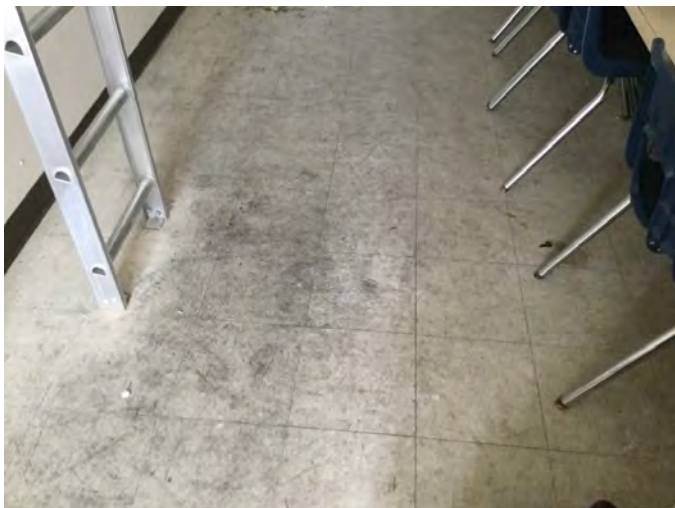
System: C3020 - Floor Finishes

Location: Throughout the building
Distress: Beyond Service Life
Category: Deferred Maintenance
Priority: 3 - Necessary/Not Yet Critical (Years 2-5)
Correction: Renew System
Qty: 286.00
Unit of Measure: S.F.
Estimate: \$3,892.00
Assessor Name: Eduardo Lopez
Date Created: 12/09/2016

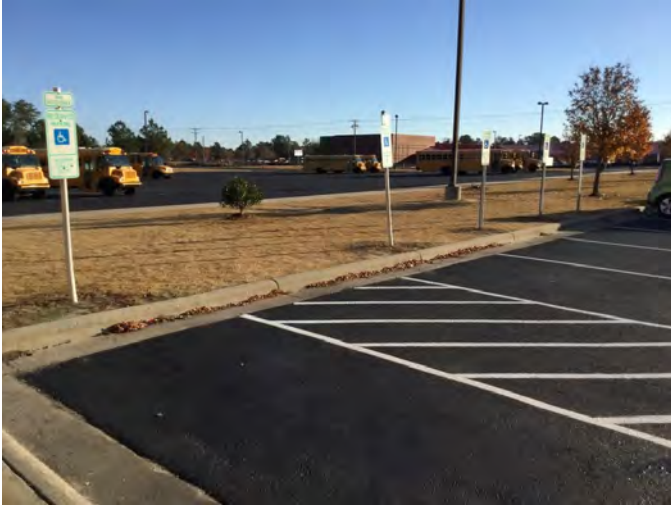
System: G2020 - Parking Lots

Location: Parking Lots
Distress: Missing
Category: Accessibility Code Compliance
Priority: 2 - Potentially Critical (Year 1)
Correction: Add handicap parking symbol
Qty: 16.00
Unit of Measure: Ea.
Estimate: \$1,475.36
Assessor Name: Somnath Das
Date Created: 12/10/2016
