NC School District/995 Yancey County/Elementary School

Burnsville Elementary

Campus Assessment Report

March 12, 2017

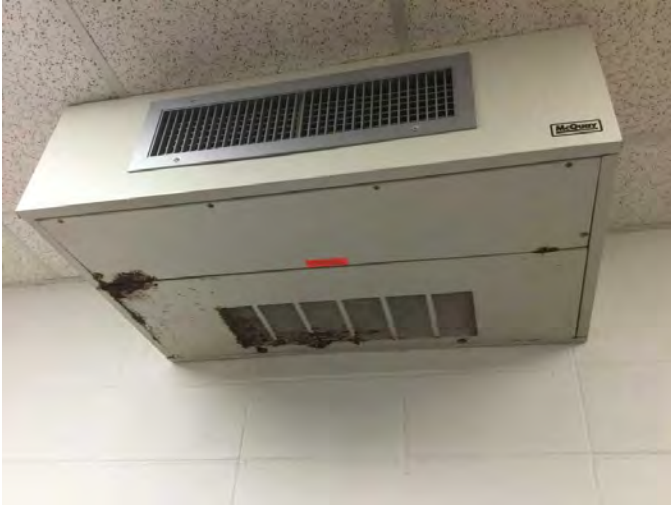
System: D3040 - Distribution Systems

Location: Throughout
Distress: Beyond Service Life
Category: Deferred Maintenance / Energy
Priority: 2 - Potentially Critical (Year 1)
Correction: Renew System
Qty: 63,578.00
Unit of Measure: S.F.
Estimate: \$421,014.00
Assessor Name: Matt Mahaffey
Date Created: 03/01/2017

Notes: The air distribution system is aged, becoming logistically unsupportable, and should be replaced.

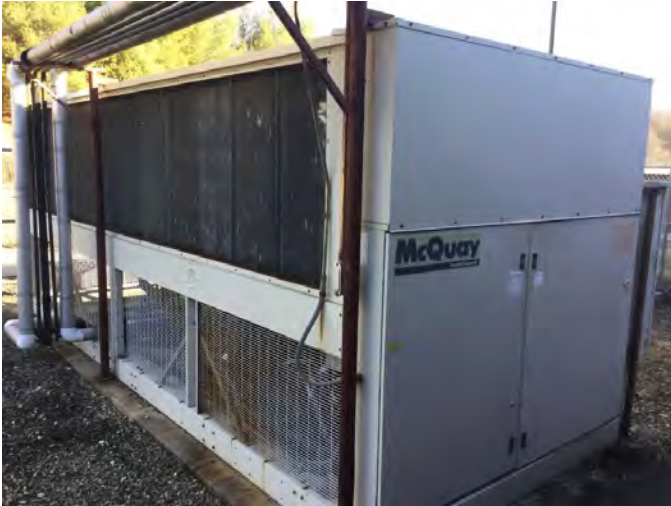
System: D3030 - Cooling Generating Systems

Location: Exterior
Distress: Beyond Service Life
Category: Deferred Maintenance / Energy
Priority: 3 - Necessary/Not Yet Critical (Years 2-5)
Correction: Renew System
Qty: 63,578.00
Unit of Measure: S.F.
Estimate: \$360,869.00
Assessor Name: Matt Mahaffey
Date Created: 01/27/2017

Notes: Chiller is aging and logistically unsupportable, and should be replaced with an energy efficient model.

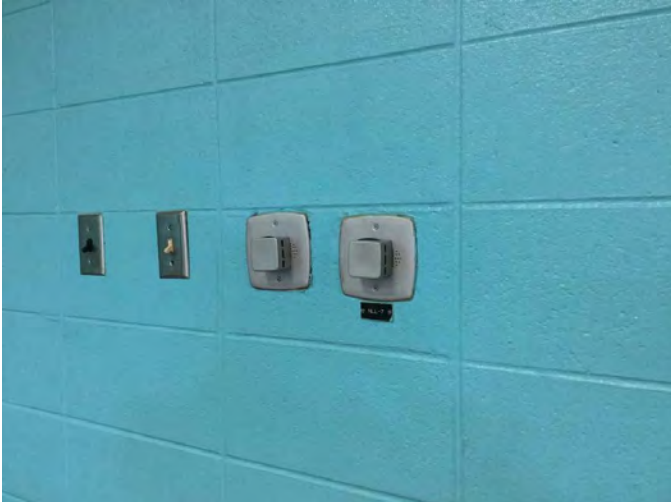
System: D3060 - Controls & Instrumentation

Location: Throughout
Distress: Beyond Service Life
Category: Deferred Maintenance / Energy
Priority: 3 - Necessary/Not Yet Critical (Years 2-5)
Correction: Renew System
Qty: 63,578.00
Unit of Measure: S.F.
Estimate: \$133,577.00
Assessor Name: Matt Mahaffey
Date Created: 01/27/2017

Notes: The HVAC controls are aged, becoming logistically unsupportable, and should be replaced.

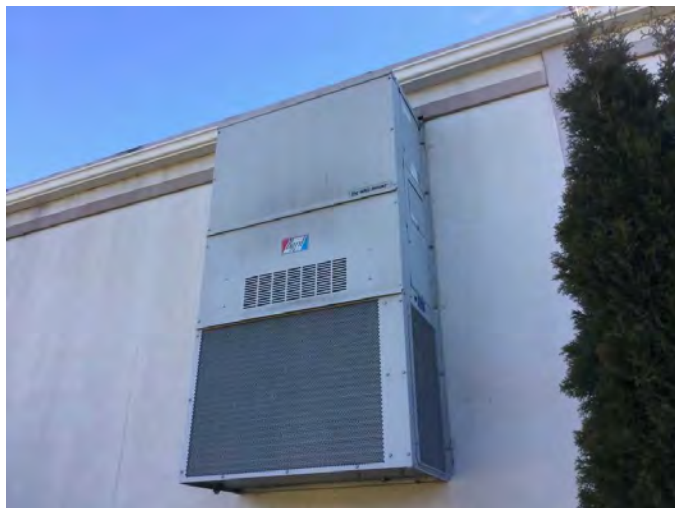
System: D3050 - Terminal & Package Units

Location: Throughout
Distress: Beyond Service Life
Category: Deferred Maintenance / Energy
Priority: 3 - Necessary/Not Yet Critical (Years 2-5)
Correction: Renew System
Qty: 4,200.00
Unit of Measure: S.F.
Estimate: \$34,142.00
Assessor Name: Terence Davis
Date Created: 01/27/2017

Notes: The wall mounted DX condensers are aged, rusted, not energy efficient, and should be replaced.

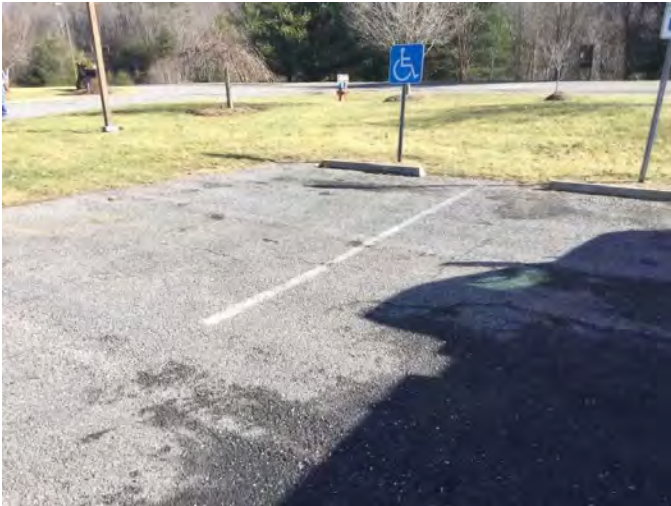
System: G2020 - Parking Lots

Location: Parking
Distress: Damaged
Category: Deferred Maintenance / Accessibility Code Compliance
Priority: 3 - Necessary/Not Yet Critical (Years 2-5)
Correction: Renew System
Qty: 67,778.00
Unit of Measure: S.F.
Estimate: \$99,159.00
Assessor Name: Matt Mahaffey
Date Created: 01/27/2017

Notes: The parking lot is aged, has many repairs and potholes, and should be replaced and re-striped. ADA signs height needs to be adjusted per minimum ADA standards.
