NC School District/040 Anson County/Elementary School

# Lilesville Elementary

## Campus Assessment Report

March 11, 2017

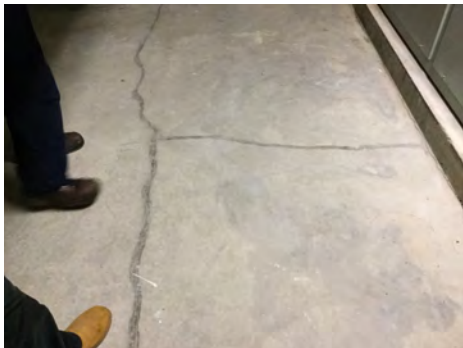
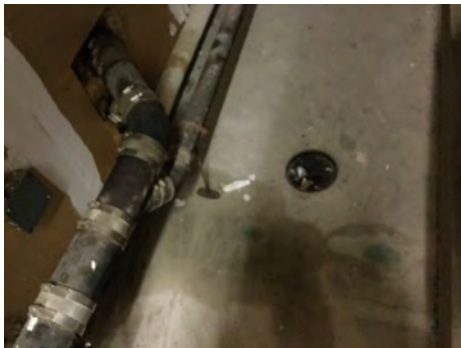
**System:** B1010 - Floor Construction

**Note:** Cracks in flooring reported by district personnel appear to be mostly located at construction control joints, or cracks in original construction. No distress in walls observed.

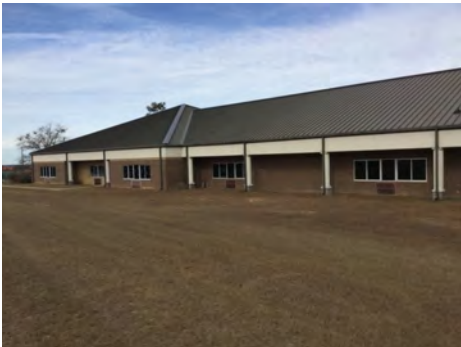
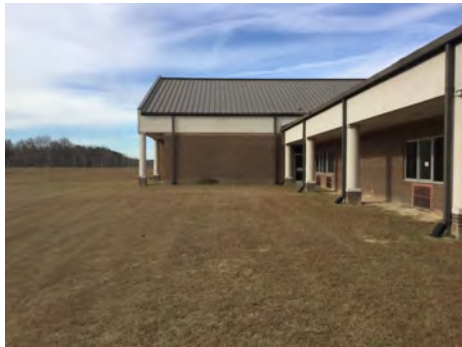
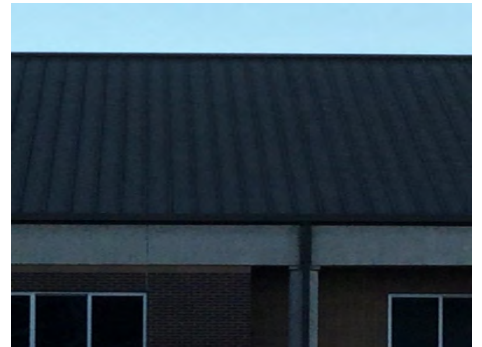
### System: B3010130 - Preformed Metal Roofing

**Location:** Roof  
**Distress:** Failing  
**Category:** Deferred Maintenance  
**Priority:** 2 - Potentially Critical (Year 1)  
**Correction:** Renew System  
**Qty:** 63,168.00  
**Unit of Measure:** S.F.  
**Estimate:** \$842,080.00  
**Assessor Name:** Eduardo Lopez  
**Date Created:** 02/09/2017

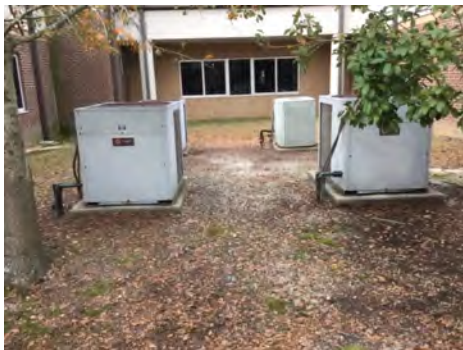
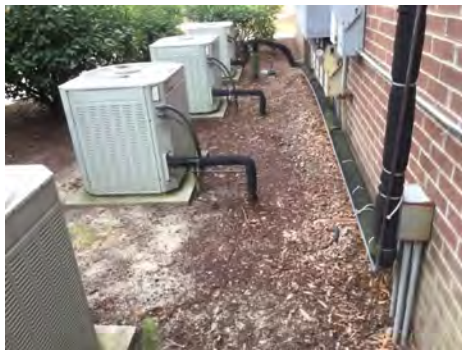
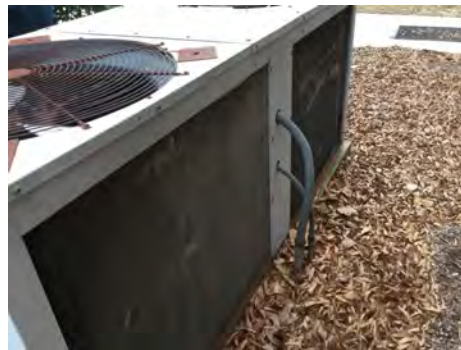
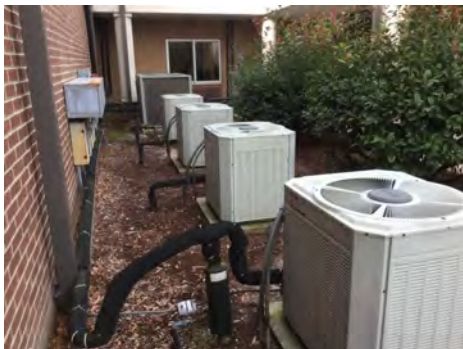
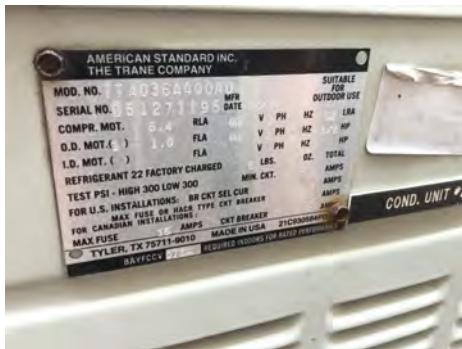
**System:** D3050 - Terminal & Package Units

**Notes:** Terminal and package units, mostly ground mounted condensers for the split systems and cabinet unit ventilators with compressors, have exceeded their expected useful life. Parts for the unit ventilators are difficult to obtain and valves are not functioning. Outside air dampers do not function correctly. Refrigeration lines to newer ground mount units are poorly routed. System renewal is recommended.

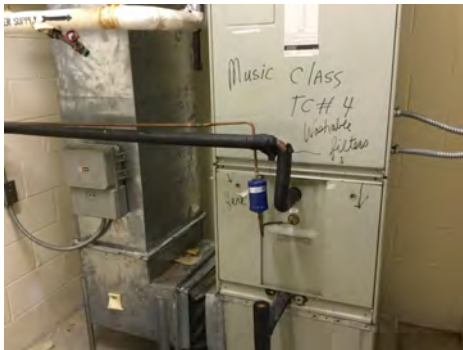
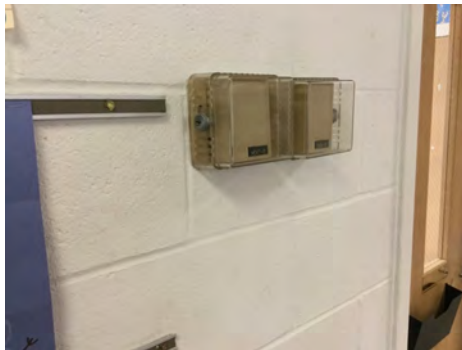
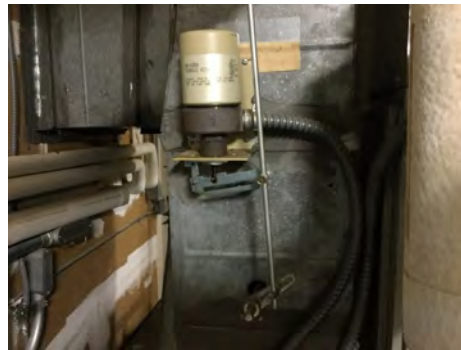
**System:** D3060 - Controls & Instrumentation

**Notes:** Building controls are typically original pneumatics. They are locally controlled. Installation of a modern digital system with remote monitoring and control capability for energy conservation is recommended.

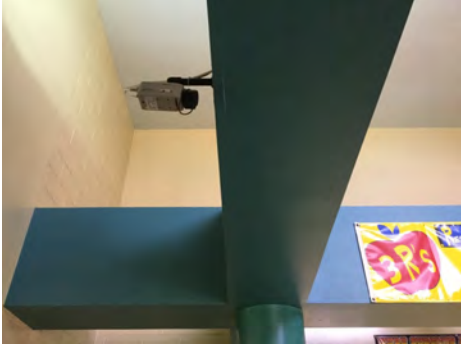
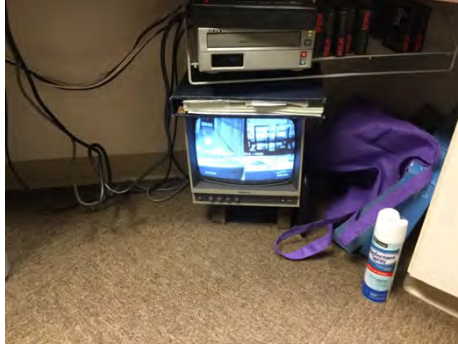
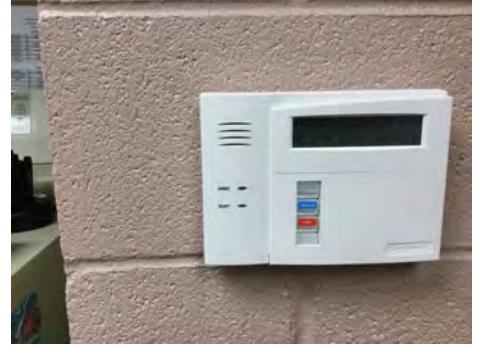
**System:** D5030810 - Security & Detection Systems

**Notes:** The security system is mostly original and beyond its expected life. There are areas inside and outside the building that aren't monitored. System renewal is recommended.

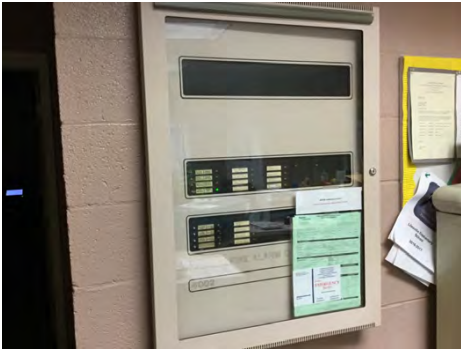
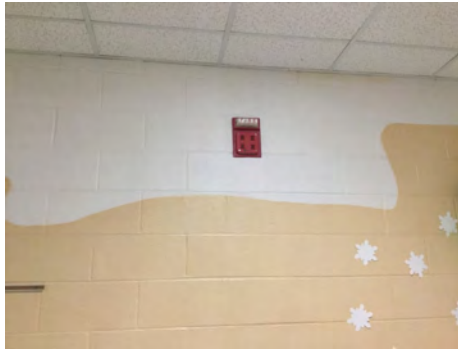
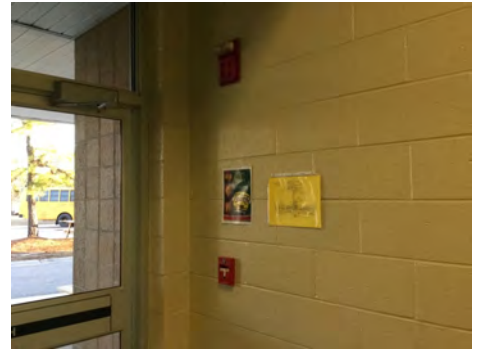
**System:** D5030910 - Fire Alarm Systems

**Notes:** The fire alarm system is original and beyond its expected life. System renewal is recommended to ensure reliability of this life safety system.

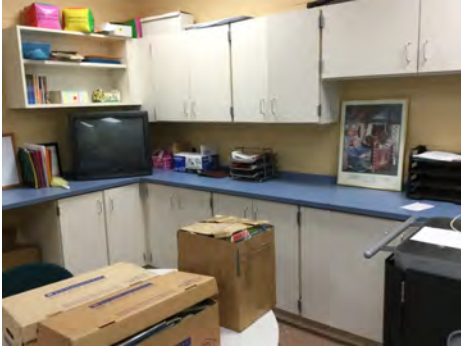
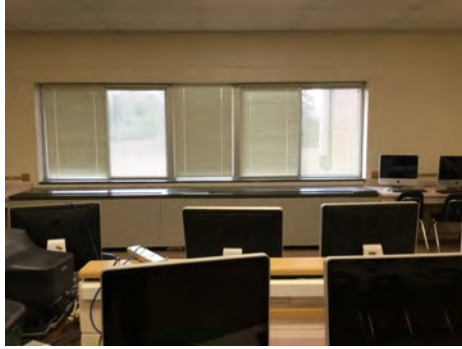
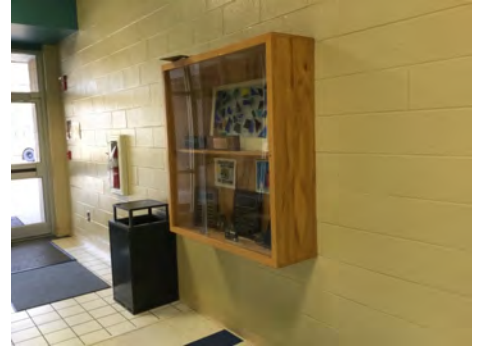
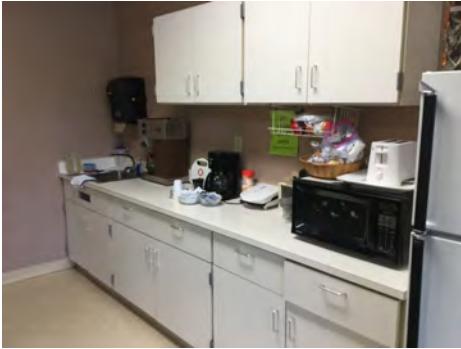
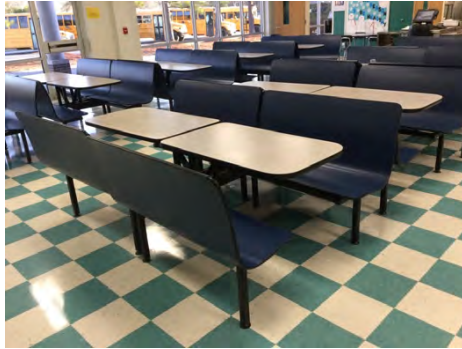
**System:** E2010 - Fixed Furnishings

**Notes:** Interior furnishings are beyond their expected life and are showing signs of wear and tear. Most classrooms do not have window blinds. System renewal is recommended.
