NC School District/040 Anson County/Elementary School

# Morven Elementary

## Campus Assessment Report

March 11, 2017

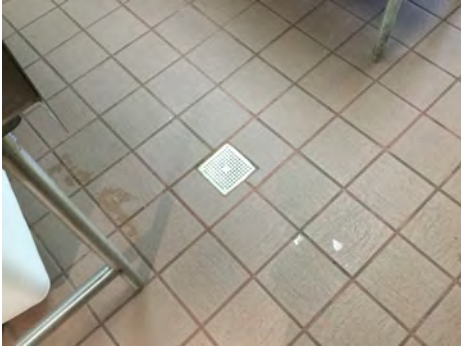
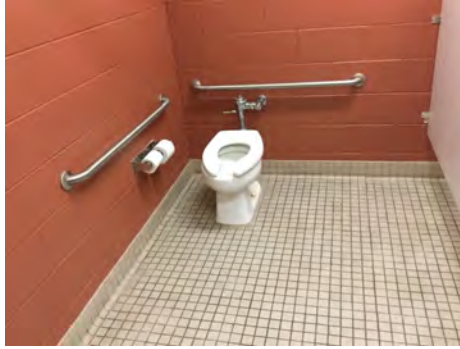
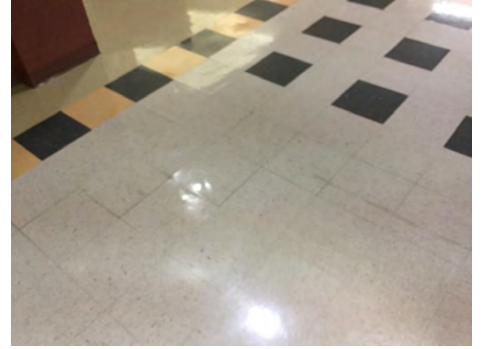
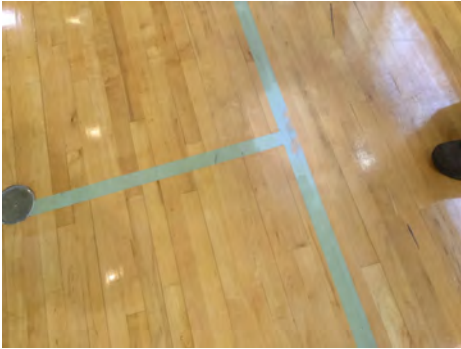
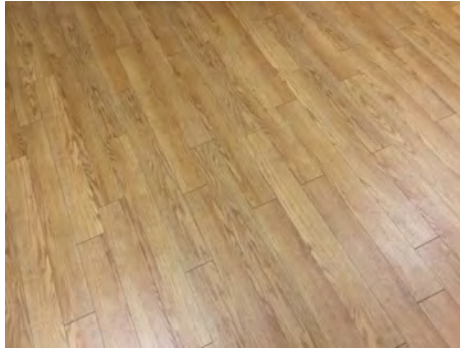
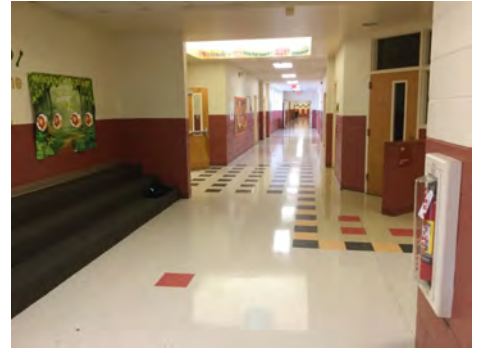
**System:** C3020 - Floor Finishes

**Note:** All carpet changed to VCT 2016.

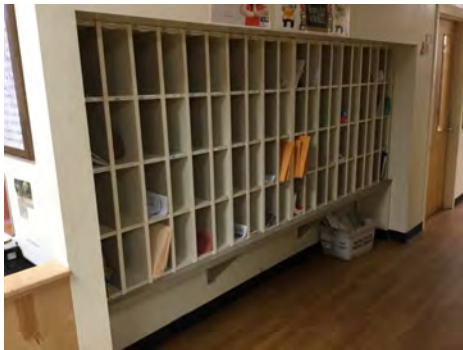
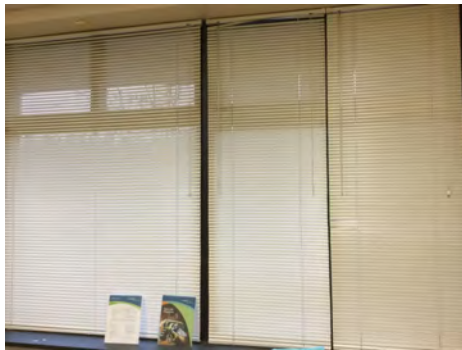
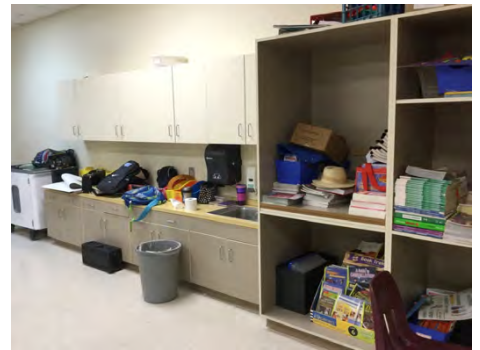
**System:** E2010 - Fixed Furnishings

**Notes:** Building fittings are typically original and beyond their expected life. In particular, there are still some chalkboards in the school, and many whiteboards are stained beyond cleaning. Lockers at the kitchen are beginning to rust. Signage is original.

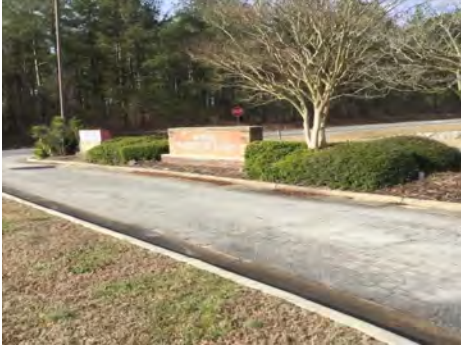
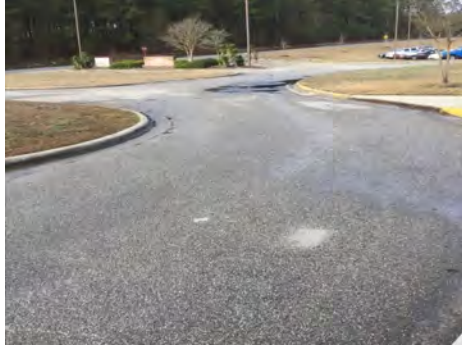
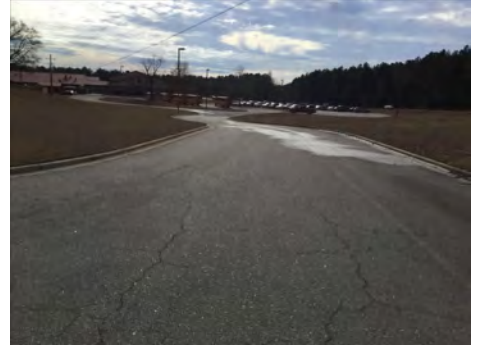
**System:** G2010 - Roadways

**Notes:** The asphalt roadway is beyond its expected life. It is aged with a worn surface and cracks. Provide Fire lane markings per Local Code requirements..

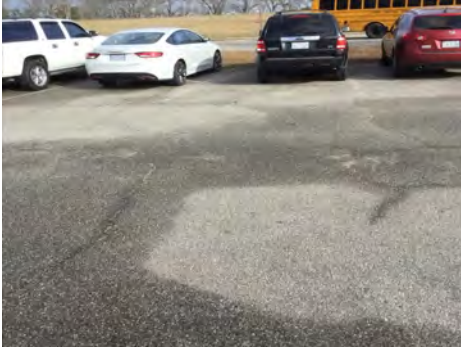
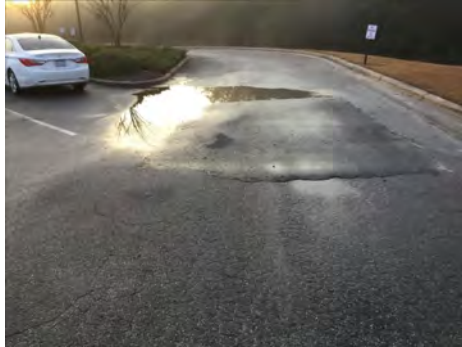
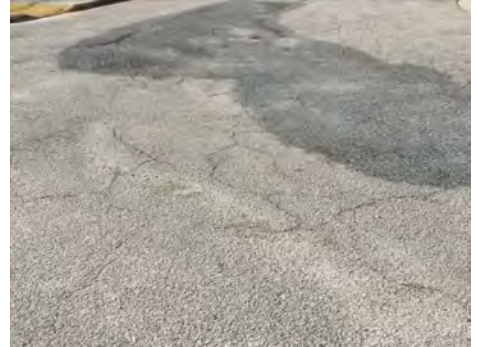
**System:** G2020 - Parking Lots

**Notes:** The parking lot is aged, has cracks, and a rough worn surface.with exposed aggregate. Patching as altered drainage pattern, creating ponding. Replace / resurface paving. Re-stripe parking spaces and provide pavement markings. ADA signs need to be adjusted per minimum ADA standards.

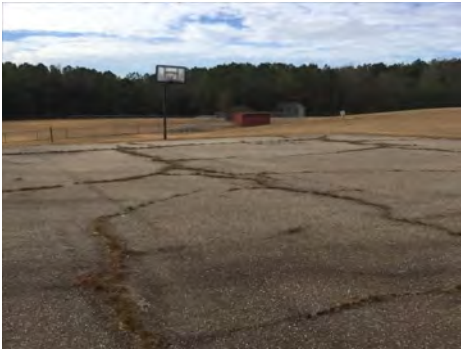
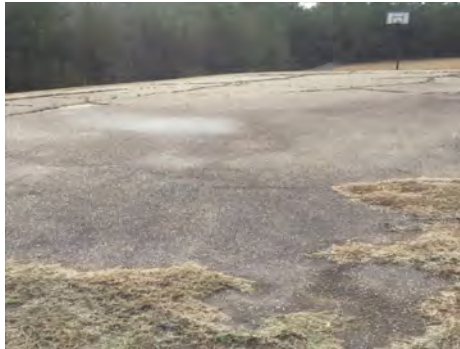
**System:** G2040950 - Hard Surface Play Area

**Notes:** The asphalt surfaced basketball court is in poor condition, creating a safety hazard, and/or an unusable asset. Replacement is recommended. In addition, the basketball backstops are in weathered condition and should be upgraded.

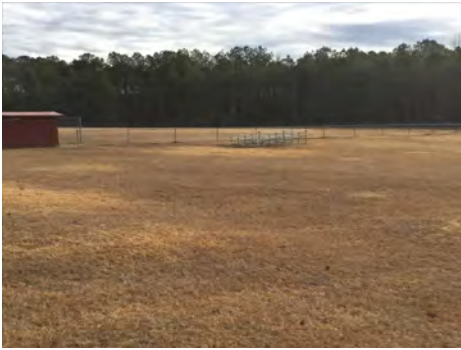
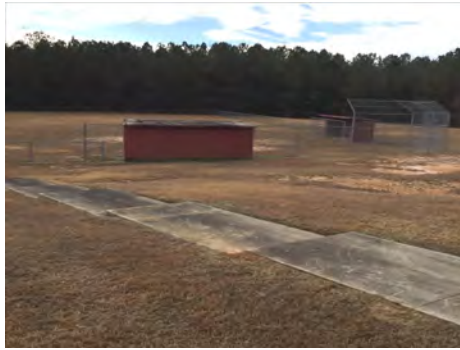
**System:** G2040950 - Playing Field

**Notes:** The steep slopes above the playing field are eroded, creating a safety concern for students and maintenance personnel. Repairs are recommended.
