NC School District/040 Anson County/Elementary School

Peachland-Polkton Elementary

Campus Assessment Report

March 11, 2017

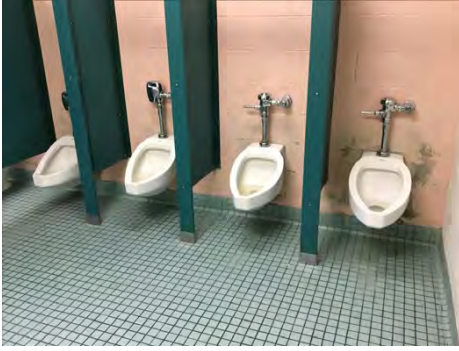
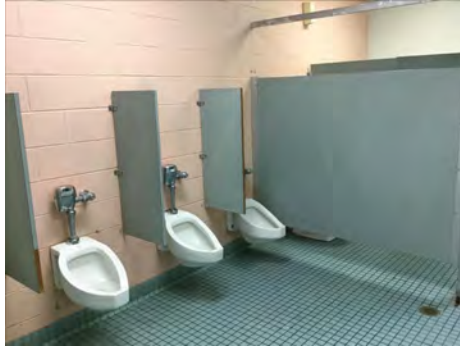
System: C1030 - Fittings

Note: The toilet partition and the signages throughout the school needs to be replaced.

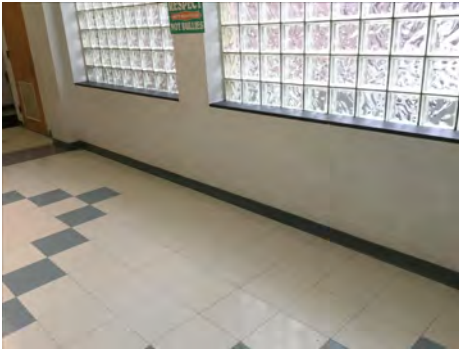
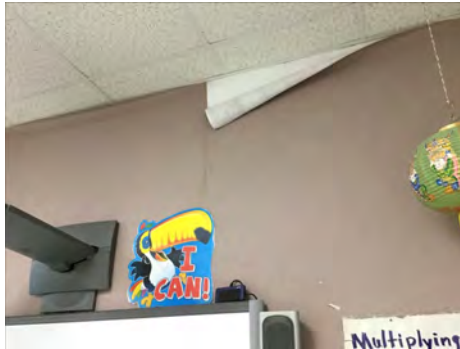
System: C3010 - Wall Finishes

Note: The paint is beyond its service life and should be replaced.

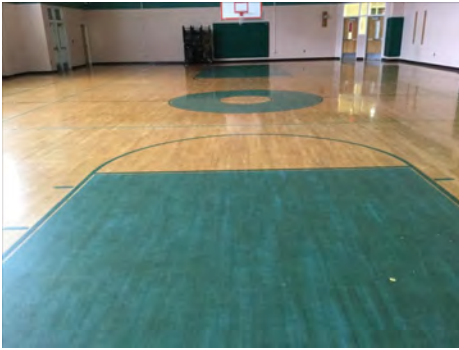
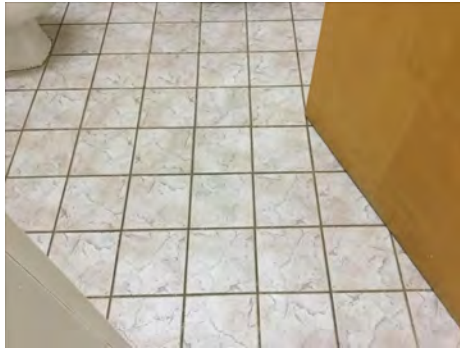
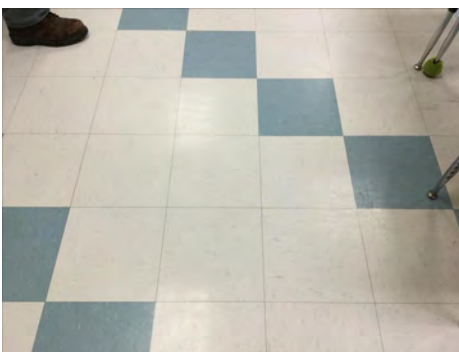
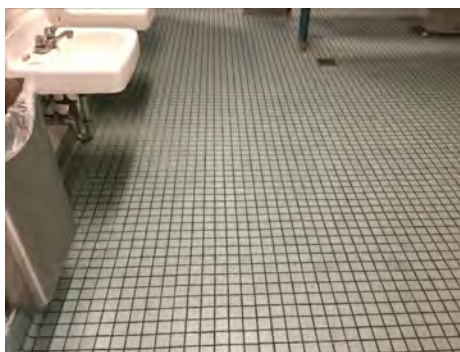
System: C3020 - Floor Finishes

Note: The carpet and portion of the VCT needs to be replaced.

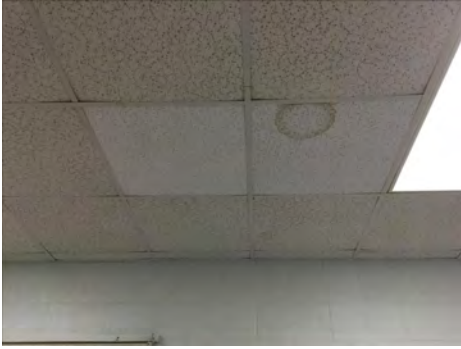
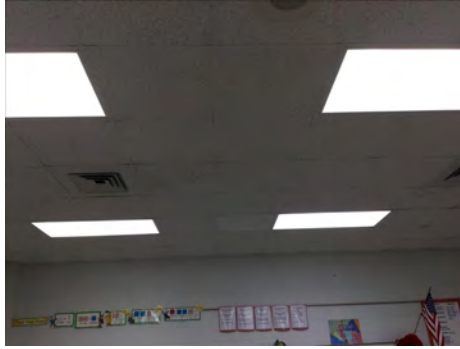
System: C3030 - Ceiling Finishes

Note: The acoustical ceiling tiles are beyond their service life and should be replaced.

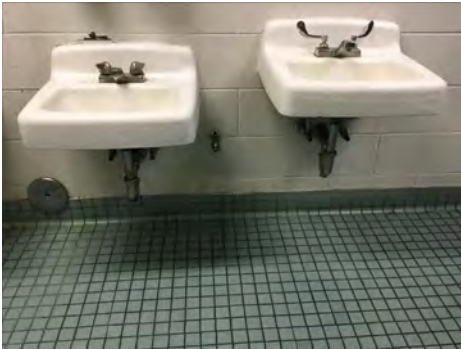
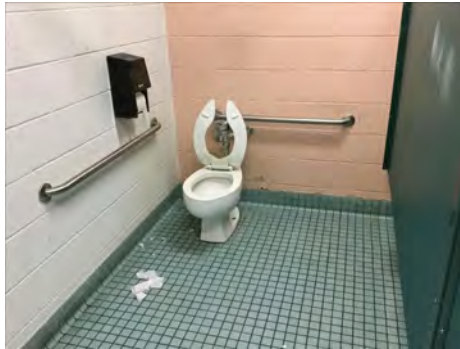
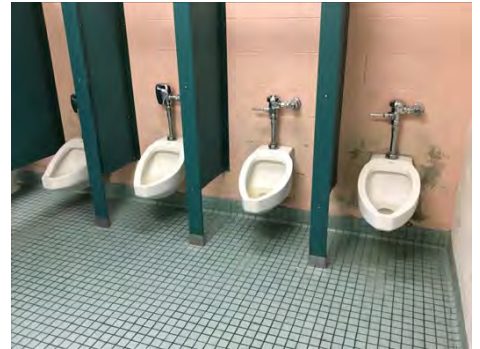
System: D2010 - Plumbing Fixtures

Note: The plumbing fixtures are beyond their service life and should be replaced.

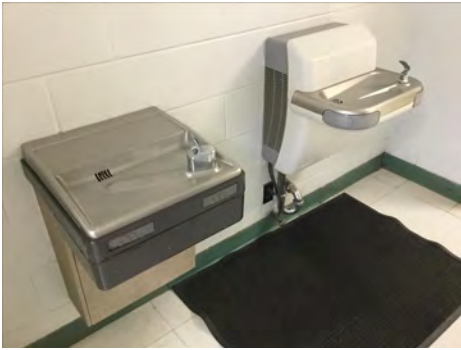
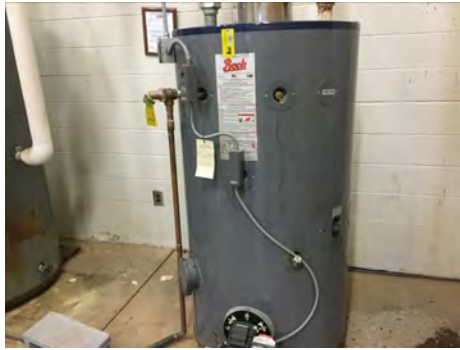
System: D2020 - Domestic Water Distribution

Note: The domestic water distribution system is beyond its service life and should be replaced.

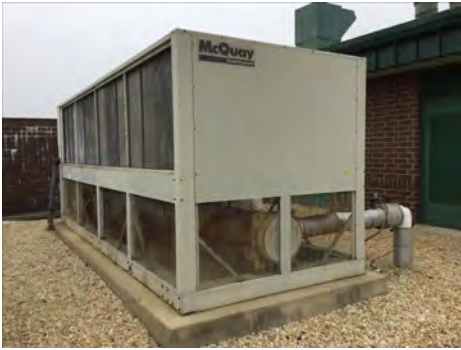
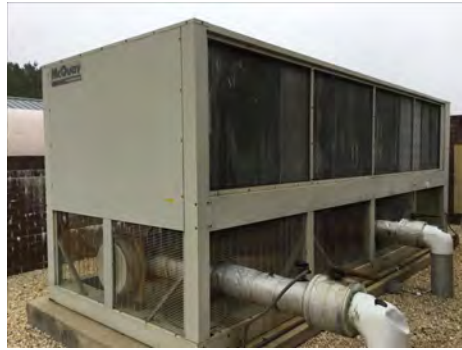
System: D3030 - Cooling Generating Systems

Note: The cooling system is beyond its service life and should be replaced.

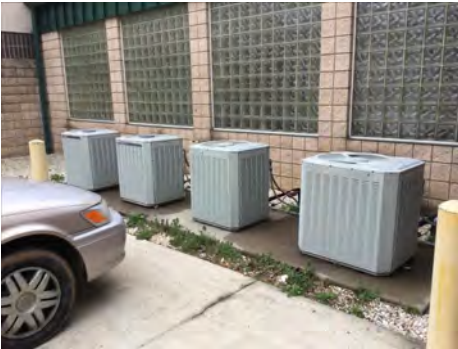
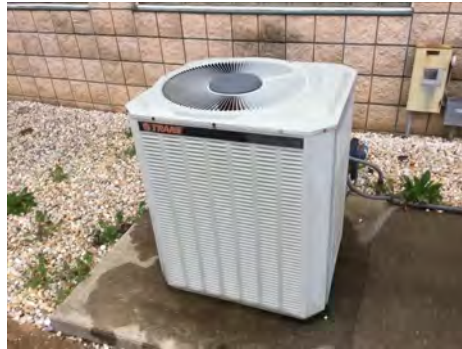
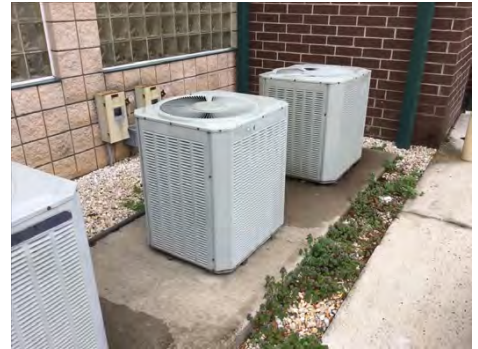
System: D3050 - Terminal & Package Units

Note: The terminal and package units are beyond their service life and should be replaced.

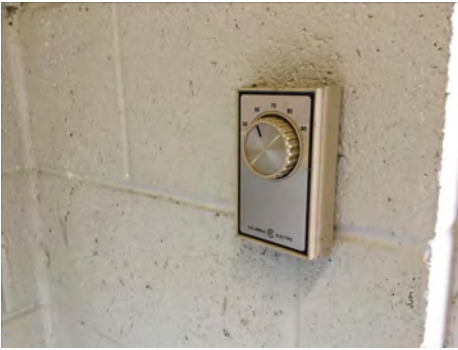
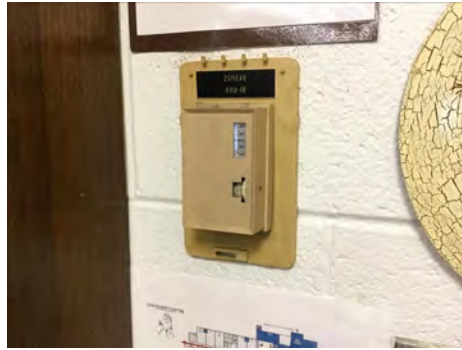
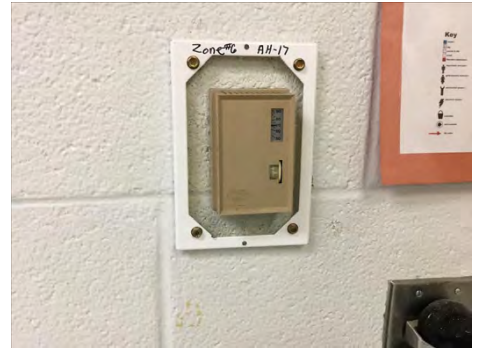
System: D3060 - Controls & Instrumentation

Note: The controls and instrumentation are beyond its service life and should be replaced.

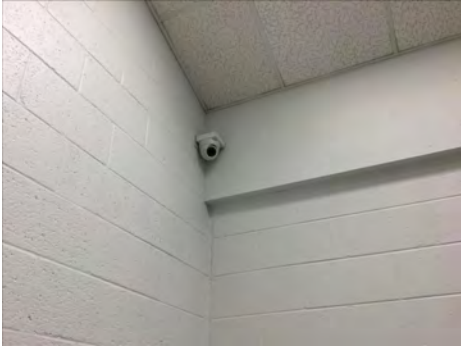
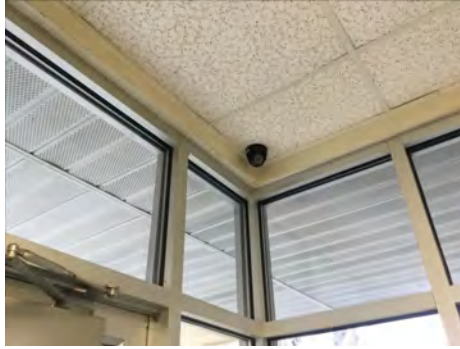
System: D5030810 - Security & Detection Systems

Note: The security and detection system is beyond its service life and should be replaced.

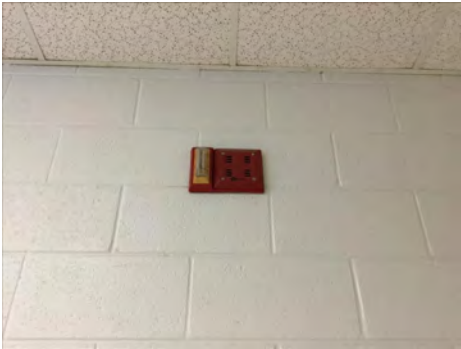
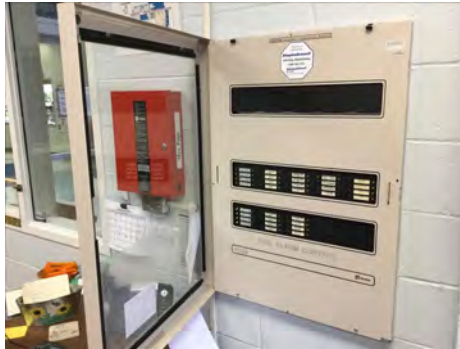
System: D5030910 - Fire Alarm Systems

Note: The fire alarm system is beyond its service life and should be replaced.

Notes: The fire alarm system is beyond its service life and should be replaced.

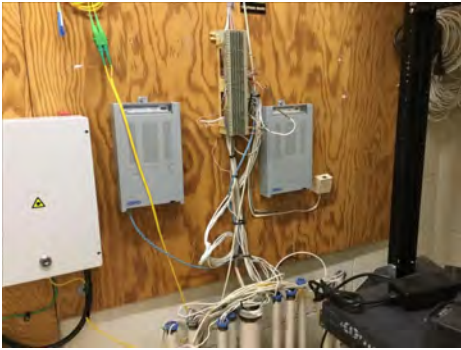
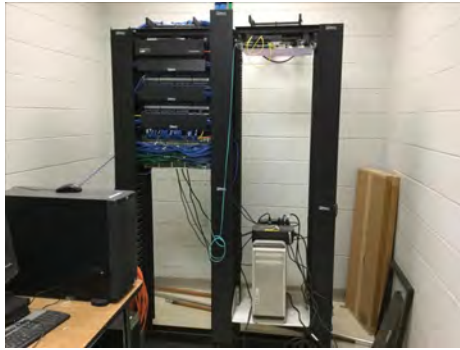
System: D5030920 - Data Communication

Note: The data communication is beyond its service life and should be replaced.

Notes: The data communication is beyond its service life and should be replaced.

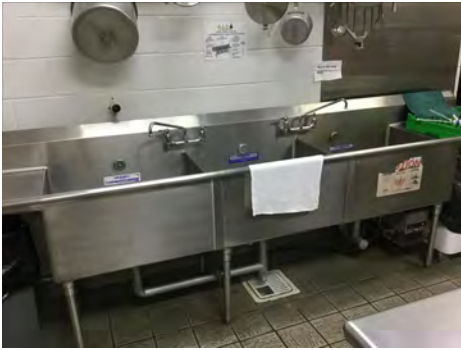
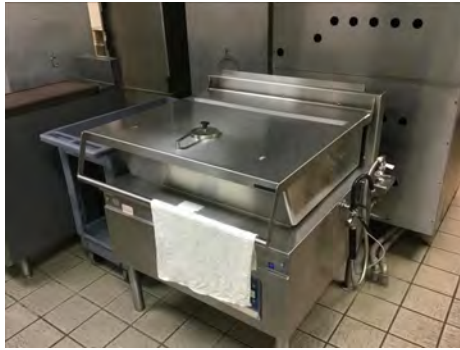
System: E1090 - Other Equipment

Note: The kitchen equipment is beyond its service life and should be replaced.

Notes: The kitchen equipment is beyond its service life and should be replaced.

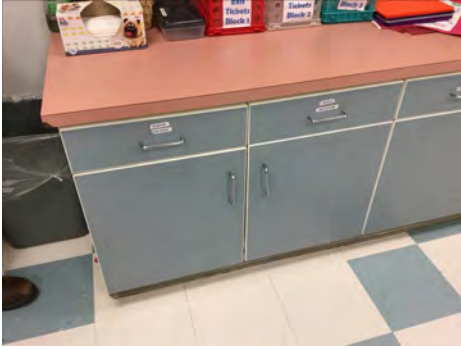
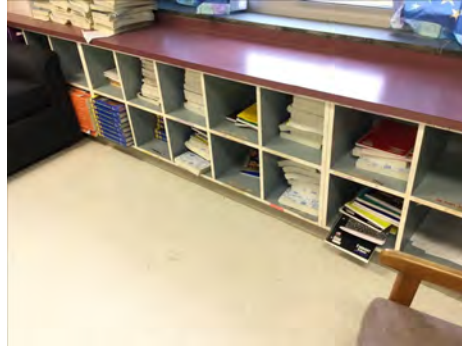
System: E2010 - Fixed Furnishings

Note: The fixed furnishings are beyond their service life and should be replaced.

Notes: The fixed furnishings are beyond their service life and should be replaced.

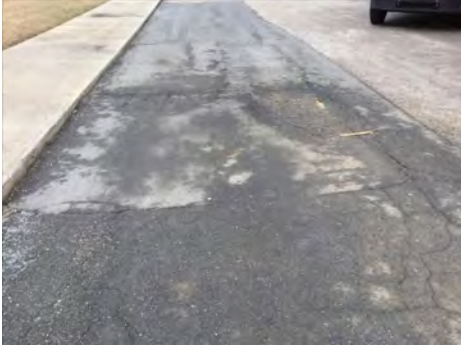
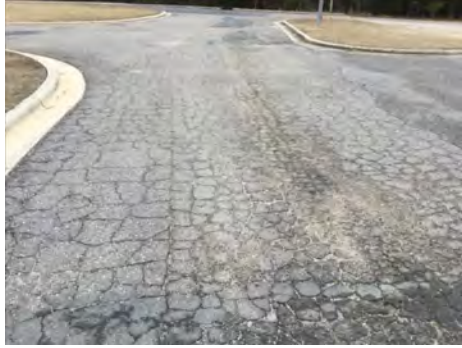
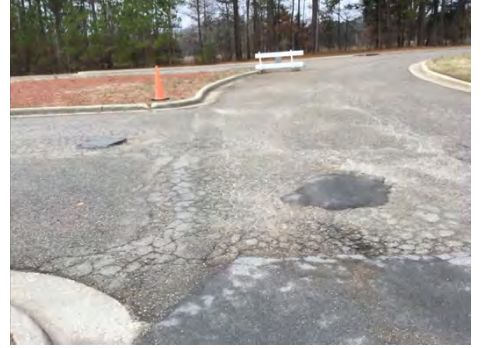
System: G2010 - Roadways

Note: The roadways are in poor condition and should be repaved.

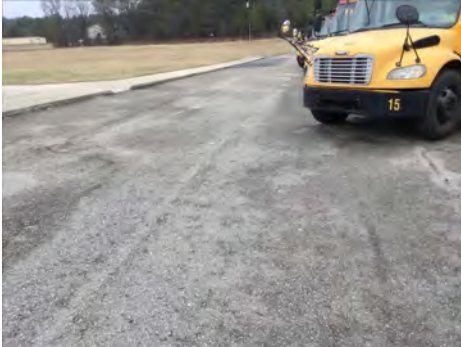
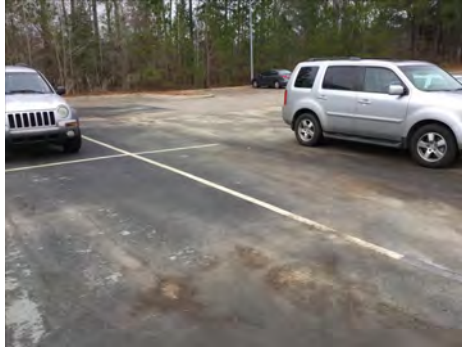
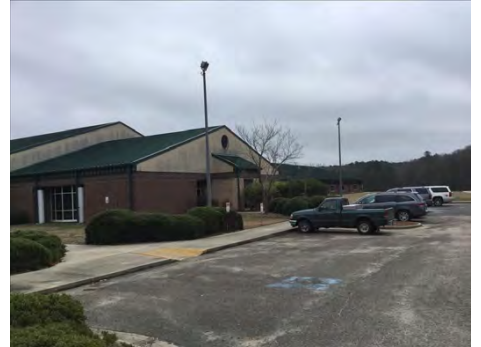
System: G2020 - Parking Lots

Note: The parking lot needs to be repaved, resealed, and restriped. The ADA parking needs to be brought up to the current codes.

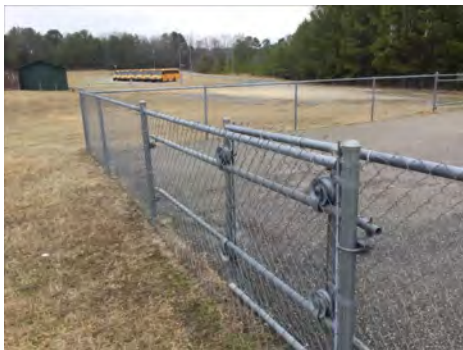
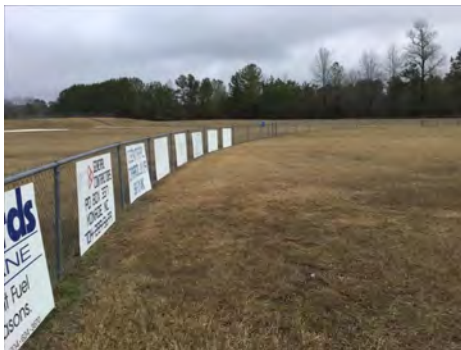
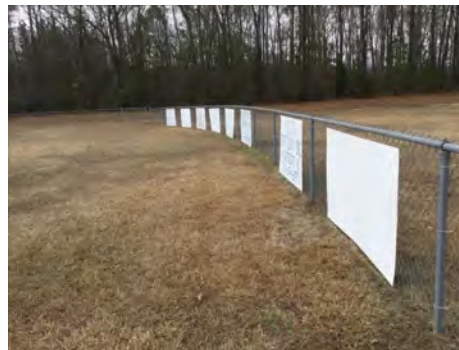
System: G2040105 - Fence & Guardrails

Note: The site does not have a site boundary fencing.

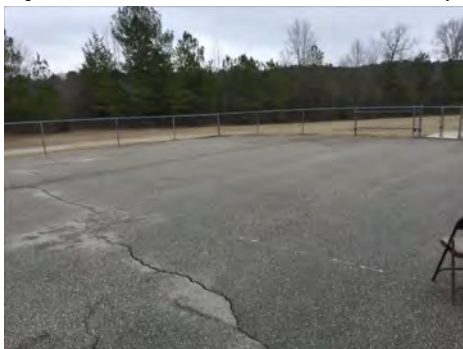
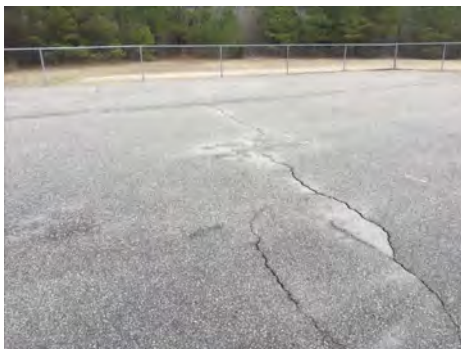
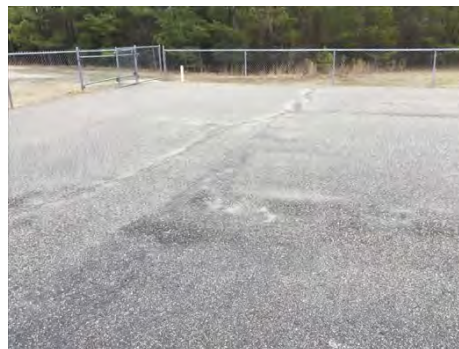
System: G2040950 - Hard Surface Play Area

Note: The hard surface play area is beyond its service life and should be replaced.

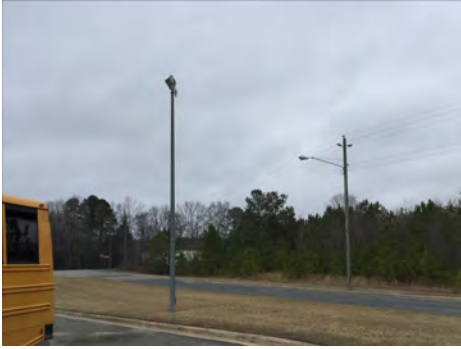
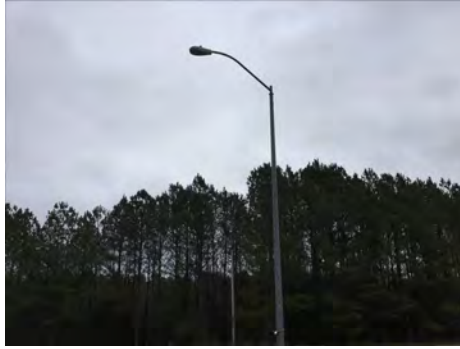
System: G4020 - Site Lighting

Note: The exterior lighting is considered inadequate and more lighting should be installed.

Location: Site
Distress: Inadequate
Category: Safety
Priority: 3 - Necessary/Not Yet Critical (Years 2-5)
Correction: Renew System
Qty: 66,179.00
Unit of Measure: S.F.
Estimate: \$107,011.00
Assessor Name: Eduardo Lopez
Date Created: 01/19/2017

Notes: The exterior lighting is considered inadequate and more lighting should be installed.

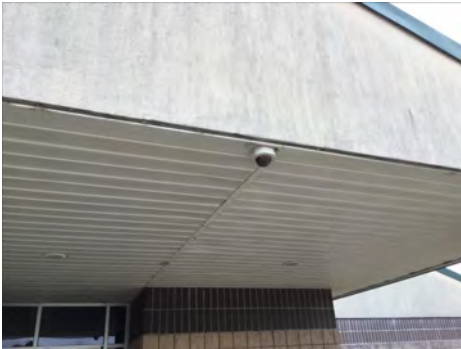
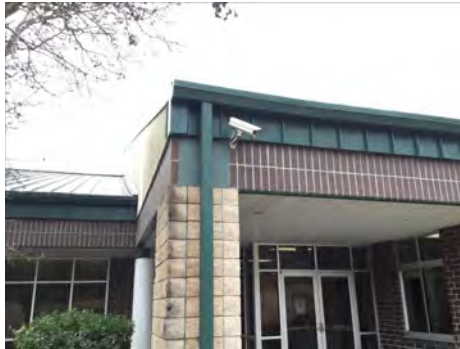
System: G4030 - Site Communications & Security

Note: The site security system is beyond its service life and should be replaced.

Notes: The site security system is beyond its service life and should be replaced.
