NC School District/040 Anson County/Elementary School

Wadesboro Elementary

Campus Assessment Report

March 11, 2017

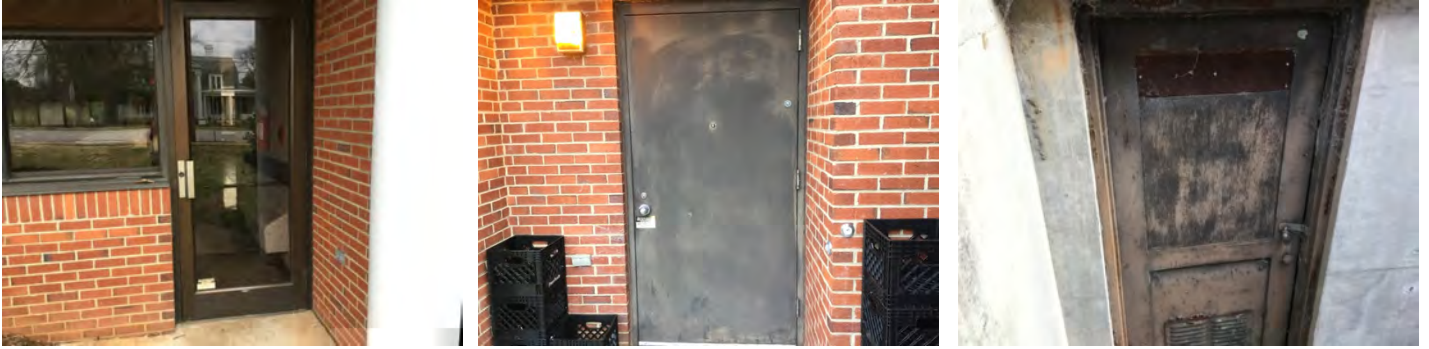
System: B2030 - Exterior Doors

Notes: Exterior doors have exceeded their useful life and are in fair to poor condition. Renewal is recommended.

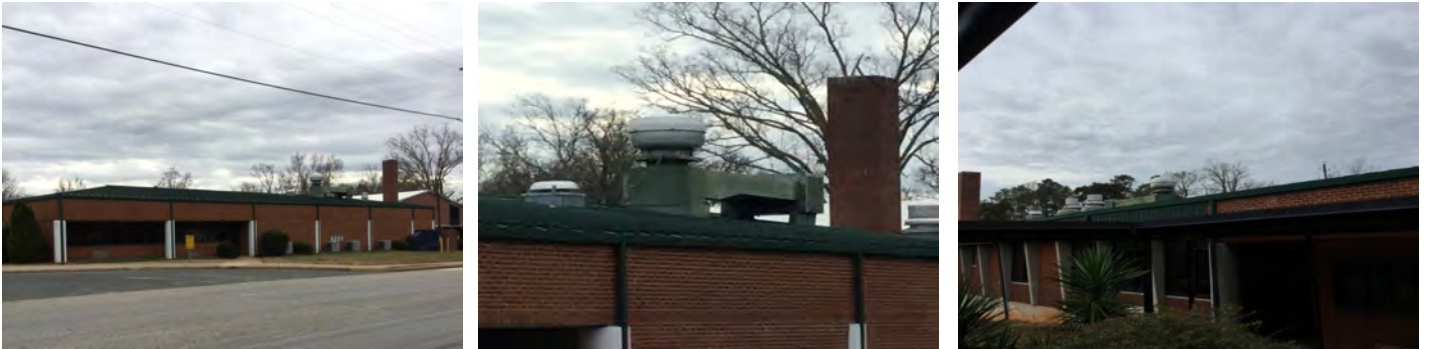
System: B3010130 - Preformed Metal Roofing

Notes: The roof has exceeded its expected life. System renewal is recommended.

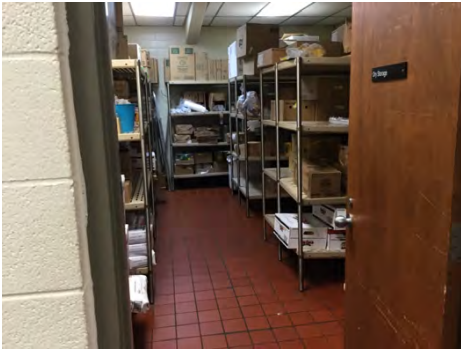
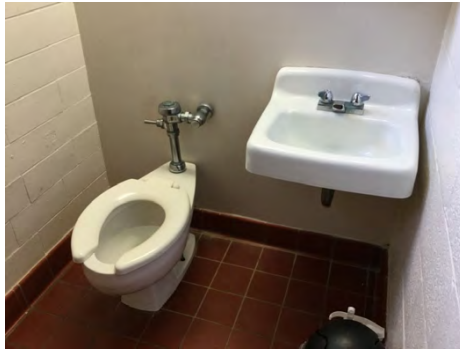
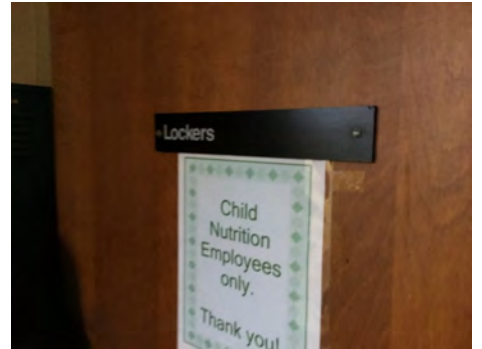
System: C1030 - Fittings

Notes: Fittings have exceed their expected useful life. Signage s not up to code. Toilet room is not ADA compliant. System renewal is recommended.

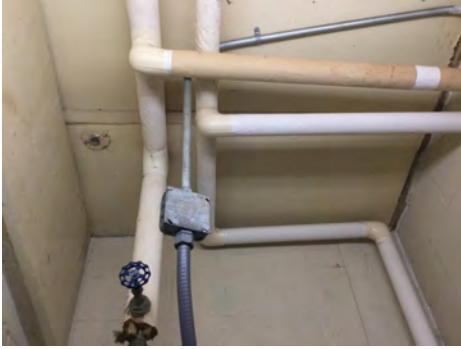
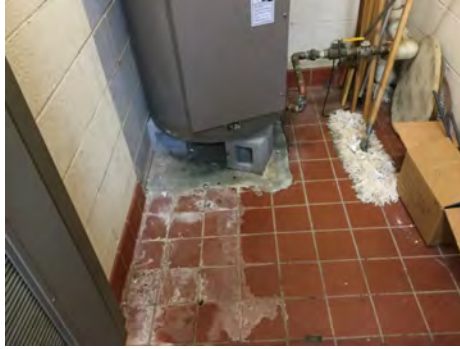
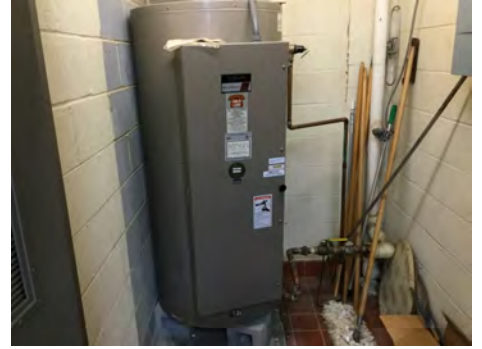
System: D2020 - Domestic Water Distribution

Notes: The domestic water system has exceeded its useful life. There is no backflow prevention on the water supply. system renewal is recommended.

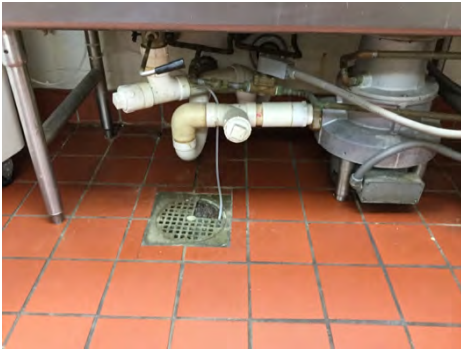
System: D2030 - Sanitary Waste

Notes: The sanitary sewer system has exceeded its expected useful life. System renewal is recommended.

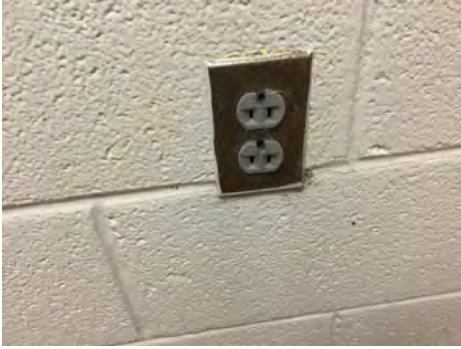
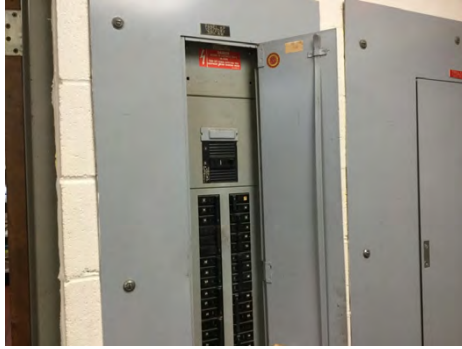
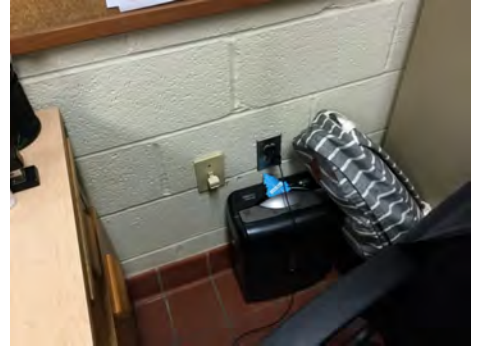
System: D5020 - Branch Wiring

Notes: The branch wiring system has exceeded its useful life. System renewal is recommended.

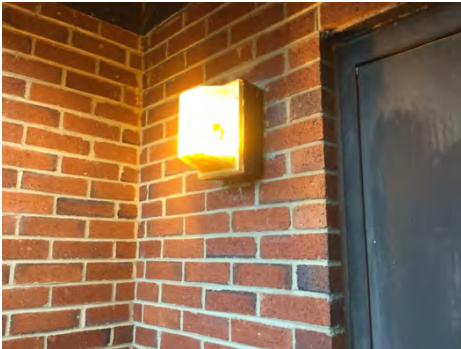
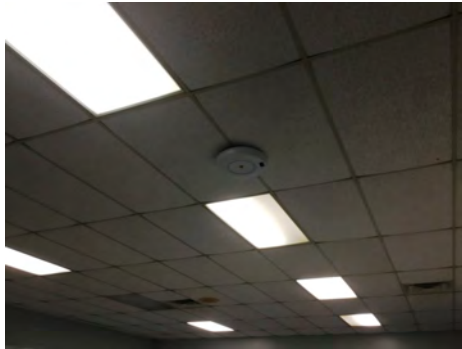
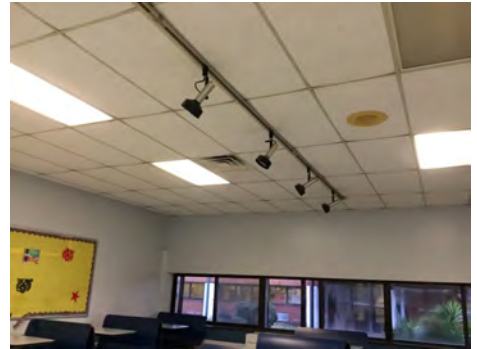
System: D5020 - Lighting

Notes: Lighting systems in the building are beyond their expected life and should be replaced.

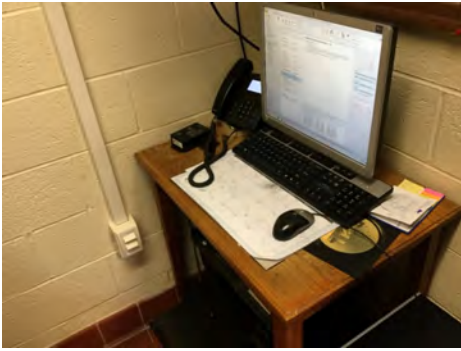
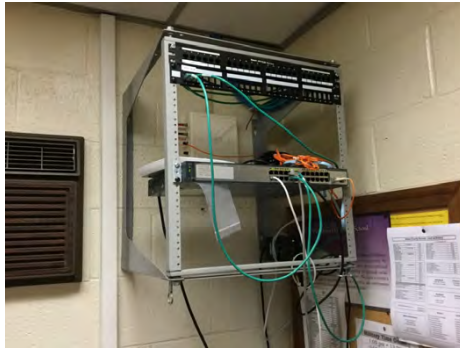
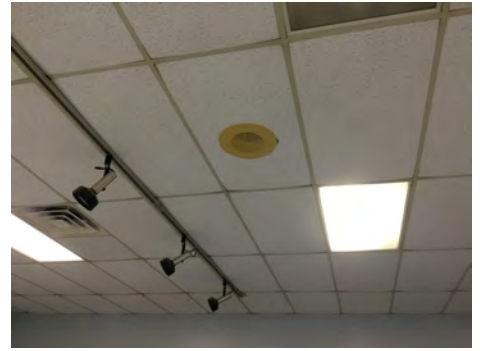
System: D5030920 - Data Communication

Notes: Data and communications systems are beyond their expected life. System renewal is recommended.

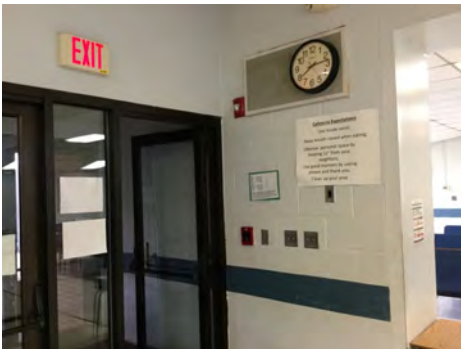
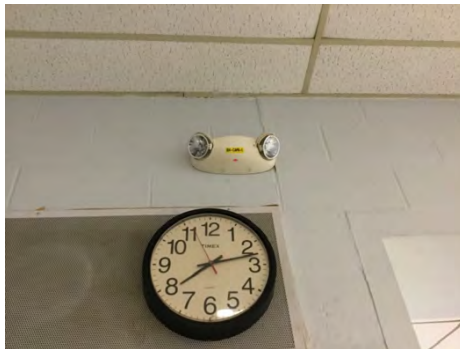
System: D5090 - Other Electrical Systems

Notes: Emergency lighting and illuminated exit signage is beyond its expected useful life. System renewal is recommended.

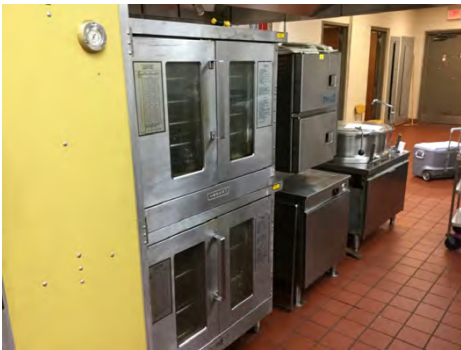
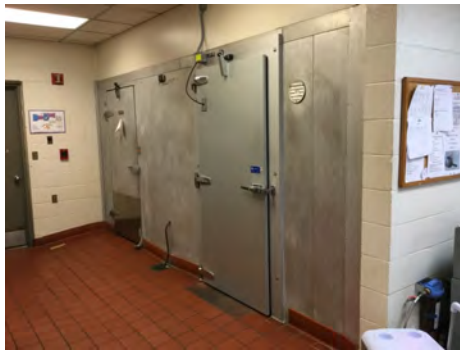
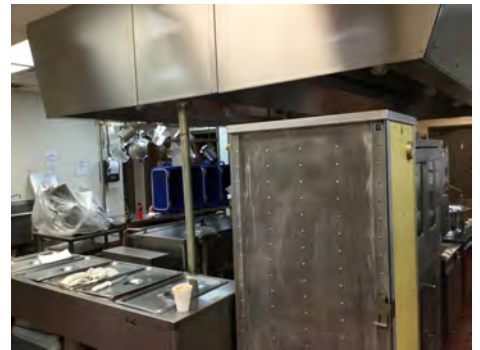
System: E1090 - Other Equipment

Note: Kitchen equipment is generally well beyond its expected useful life. System renewal is recommended.

Notes: Kitchen equipment is generally well beyond its expected useful life. System renewal is recommended.

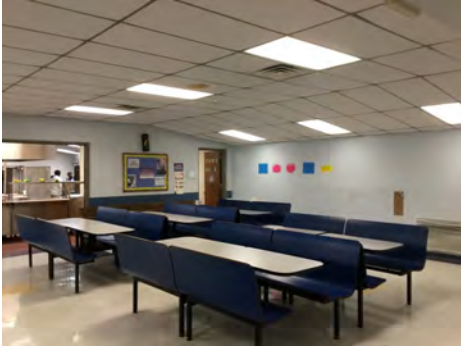
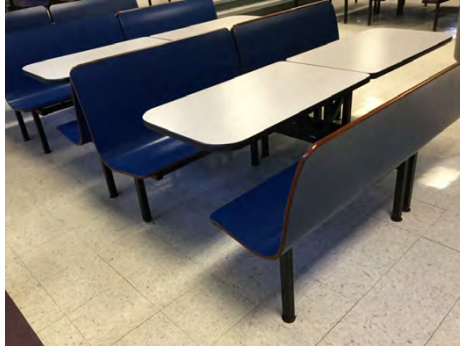
System: E2010 - Fixed Furnishings

Notes: Fixed furnishing have exceeded their useful life. System renewal is recommended.

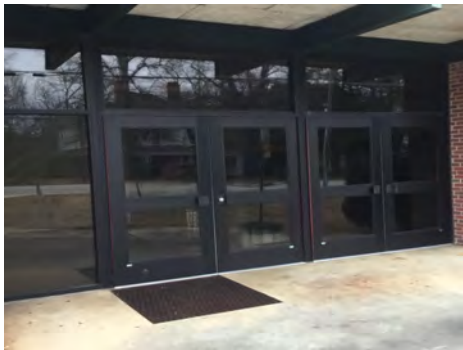
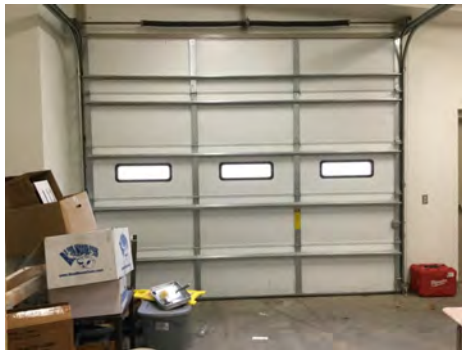
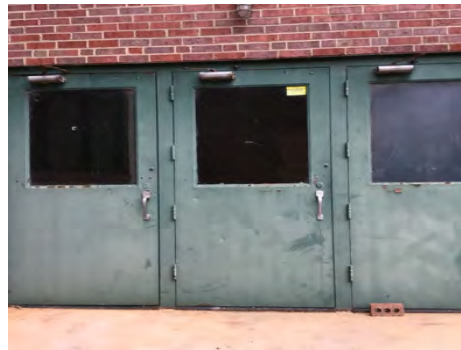
System: B2030 - Exterior Doors

Note: Front entrance doors replaced. Hardware on 6 rear doors replaced 2012.

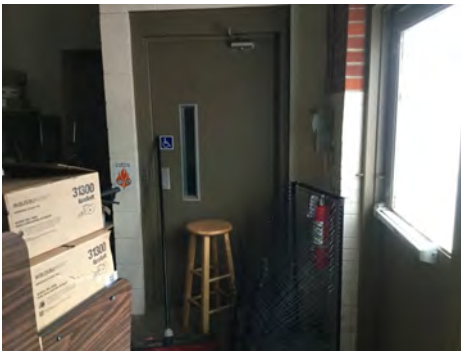
System: D1010 - Elevators and Lifts

Note: Elevator was locked and not in operation at time of visit.

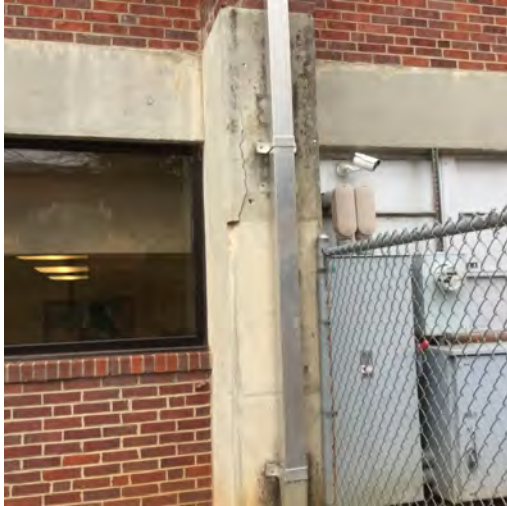
System: B2010 - Exterior Walls

Location: Exterior columns
Distress: Damaged
Category: Deferred Maintenance / Safety
Priority: 1 - Currently Critical (Immediate)
Correction: Engineering Study-2016-11-15 17:41:59
Qty: 1.00
Unit of Measure: Ea.
Estimate: \$13,200.00
Assessor Name: Somnath Das
Date Created: 02/10/2017

Notes: Exposed exterior concrete columns and beams have some spalling of concrete and cracking. It appears that some repairs have already been made in some places. Evaluation by a structural engineer is recommended. The correction does not include the cost of repairs.

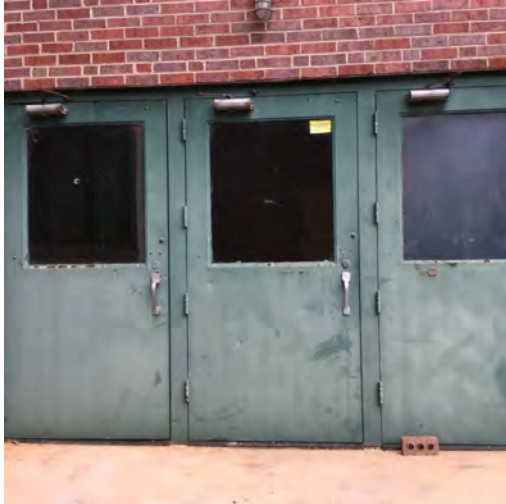
System: B2030 - Exterior Doors

Location: Exit doors.
Distress: Beyond Service Life
Category: Deferred Maintenance
Priority: 3 - Necessary/Not Yet Critical (Years 2-5)
Correction: Renew System
Qty: 24,682.00
Unit of Measure: S.F.
Estimate: \$27,693.00
Assessor Name: Somnath Das
Date Created: 02/09/2017

Notes: Academy front door replaced circa 2010. Front entrance doors replaced 2012 Anson. Hardware only on 6 rear exit doors replaced 2012. Doors and frames are in very poor condition. Other miscellaneous exterior doors are in poor condition. System renewal is recommended.

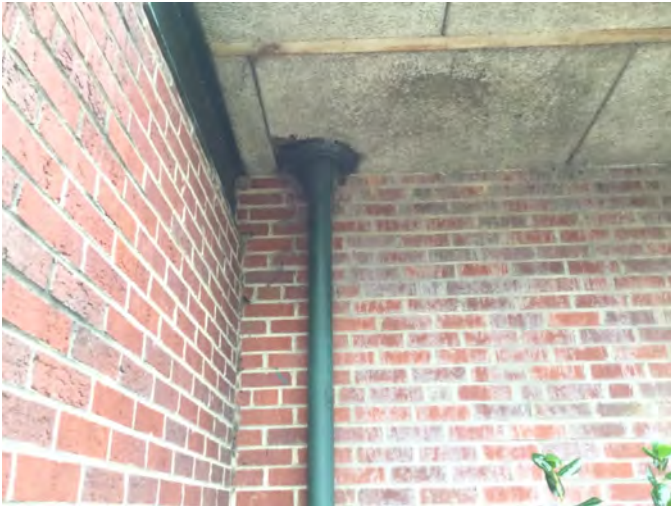
System: D2040 - Rain Water Drainage

Location: At front entry roof
Distress: Beyond Service Life
Category: Deferred Maintenance
Priority: 3 - Necessary/Not Yet Critical (Years 2-5)
Correction: Renew System
Qty: 24,682.00
Unit of Measure: S.F.
Estimate: \$12,489.00
Assessor Name: Somnath Das
Date Created: 02/09/2017

Notes: Rainwater drainage system is presumed original, is beyond its expected life, and should be renewed.

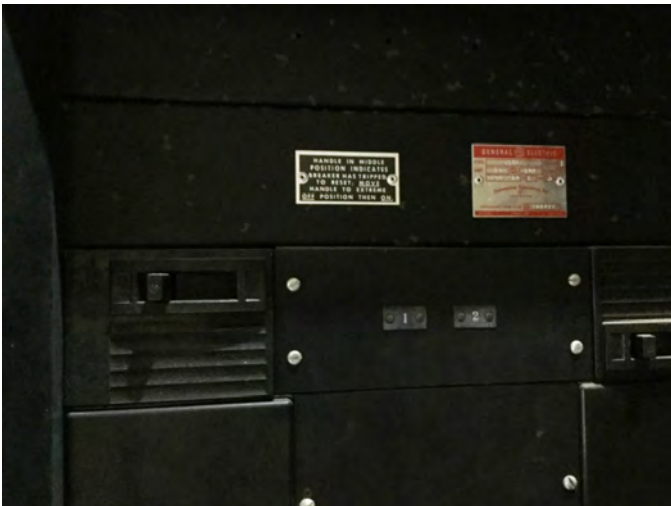
System: D5010 - Electrical Service/Distribution

Location: Electric service room
Distress: Beyond Service Life
Category: Deferred Maintenance
Priority: 3 - Necessary/Not Yet Critical (Years 2-5)
Correction: Renew System
Qty: 24,682.00
Unit of Measure: S.F.
Estimate: \$44,798.00
Assessor Name: Somnath Das
Date Created: 12/20/2016

Notes: The original electric service is well beyond its expected life. It shares space with the boiler. System renewal is recommended.

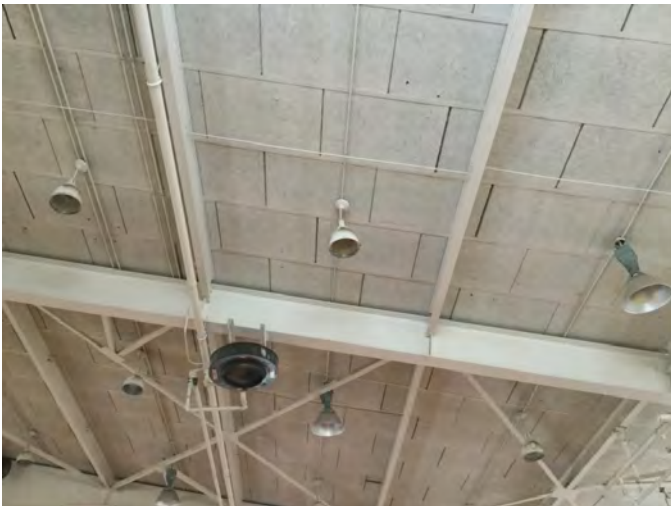
System: D5020 - Lighting

Location: Upper level and lower level ancillary spaces
Distress: Beyond Service Life
Category: Deferred Maintenance
Priority: 3 - Necessary/Not Yet Critical (Years 2-5)
Correction: Renew System
Qty: 24,682.00
Unit of Measure: S.F.
Estimate: \$316,028.00
Assessor Name: Somnath Das
Date Created: 12/20/2016

Notes: With the exception of Anson Academy, lighting is old and in poor condition. System renewal is recommended.

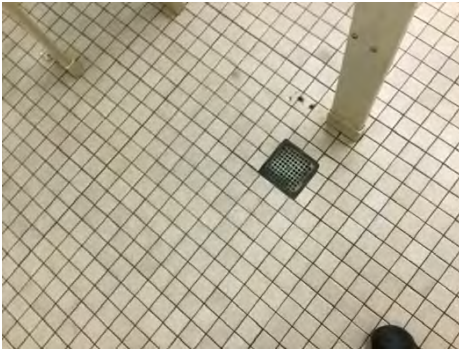
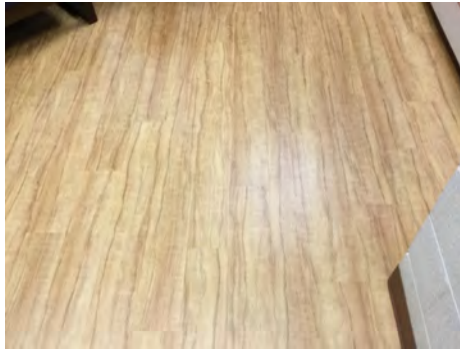
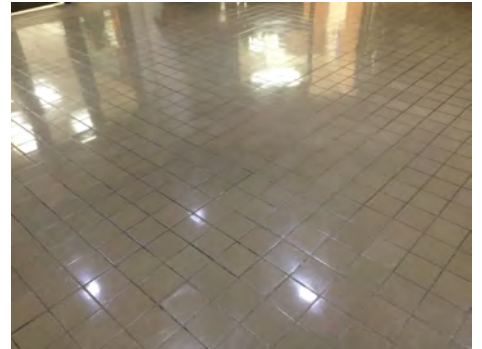
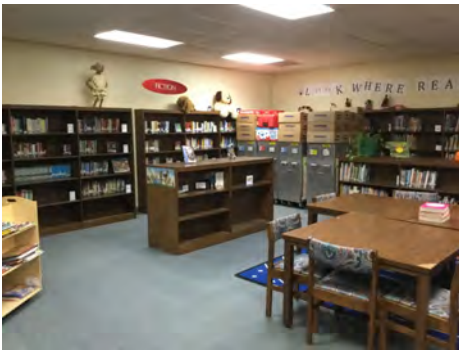
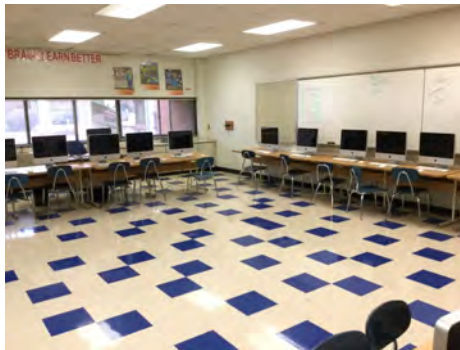
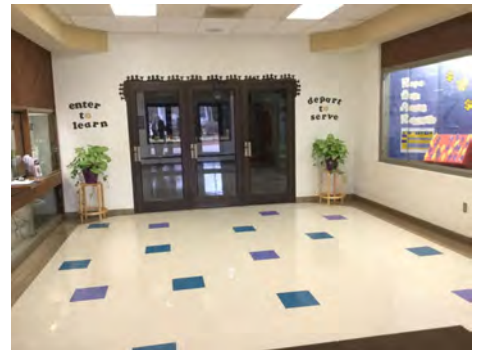
System: C3020 - Floor Finishes

Note: Ongoing project to replace floor tile in corridors and carpet with floor tile in classrooms.

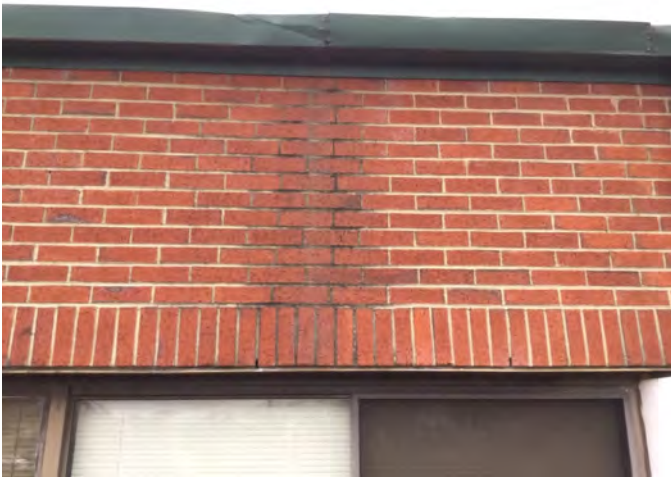
System: B2010 - Exterior Walls

Location: Exterior walls
Distress: Damaged
Category: Deferred Maintenance
Priority: 3 - Necessary/Not Yet Critical (Years 2-5)
Correction: Point clay brick wall, 1st floor
Qty: 80.00
Unit of Measure: C.S.F.
Estimate: \$120,172.80
Assessor Name: Eduardo Lopez
Date Created: 02/10/2017

Notes: Exterior walls need to be maintained with pointing where there is loss of mortar and repair of cracked brick at areas of minor settlement.

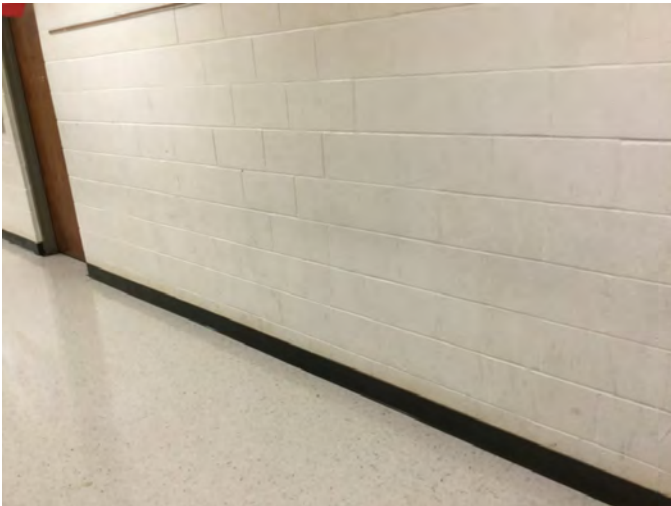
System: C3010 - Wall Finishes

Location: Throughout the building
Distress: Beyond Service Life
Category: Deferred Maintenance
Priority: 3 - Necessary/Not Yet Critical (Years 2-5)
Correction: Renew System
Qty: 41,625.00
Unit of Measure: S.F.
Estimate: \$125,000.00
Assessor Name: Eduardo Lopez
Date Created: 12/19/2016

Notes: Wall finishes are in need of renewal.

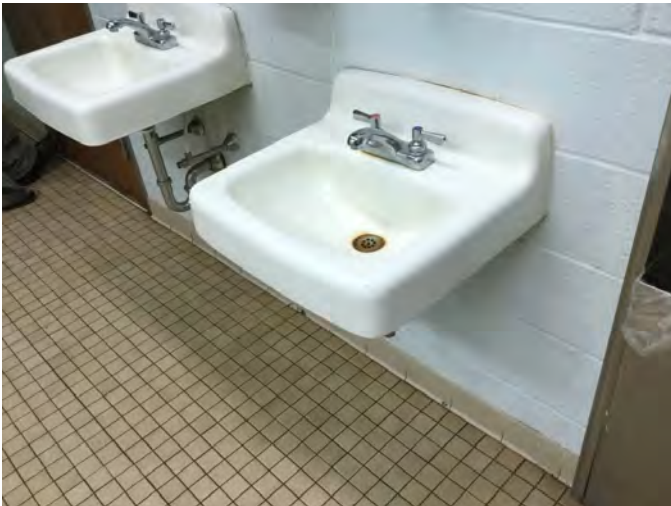
System: D2010 - Plumbing Fixtures

Location: Throughout the building
Distress: Beyond Service Life
Category: Deferred Maintenance
Priority: 3 - Necessary/Not Yet Critical (Years 2-5)
Correction: Renew System
Qty: 41,625.00
Unit of Measure: S.F.
Estimate: \$515,567.00
Assessor Name: Eduardo Lopez
Date Created: 12/19/2016

Notes: Plumbing fixtures are beyond their expected life. Classroom sinks are in poor condition. Most fixtures are not low-flow type. Fixtures and toilet room configurations are not ADA compliant.

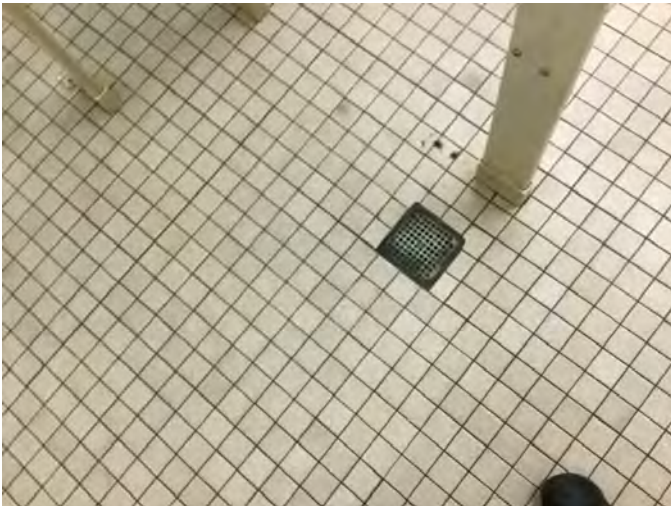
System: D2030 - Sanitary Waste

Location: Throughout the building
Distress: Beyond Service Life
Category: Deferred Maintenance
Priority: 3 - Necessary/Not Yet Critical (Years 2-5)
Correction: Renew System
Qty: 41,625.00
Unit of Measure: S.F.
Estimate: \$69,597.00
Assessor Name: Eduardo Lopez
Date Created: 12/19/2016

Notes: The sanitary waste system has exceeded its expected useful life. System renewal is recommended.

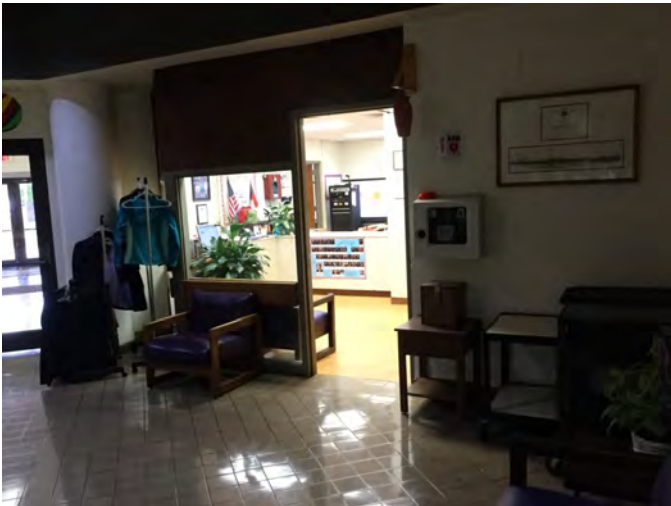
System: D5020 - Lighting

Location: Throughout the building
Distress: Beyond Service Life
Category: Deferred Maintenance
Priority: 3 - Necessary/Not Yet Critical (Years 2-5)
Correction: Renew System
Qty: 41,625.00
Unit of Measure: S.F.
Estimate: \$532,967.00
Assessor Name: Eduardo Lopez
Date Created: 12/19/2016

Notes: Lighting throughout the building is beyond its expected life. The lobby and is particularly dark. System renewal is recommended.

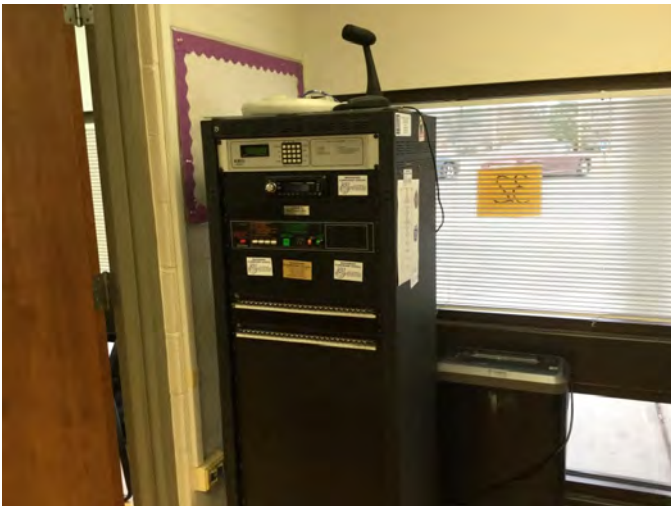
System: D5030920 - Data Communication

Location: Throughout the building
Distress: Beyond Service Life
Category: Deferred Maintenance
Priority: 3 - Necessary/Not Yet Critical (Years 2-5)
Correction: Renew System
Qty: 41,625.00
Unit of Measure: S.F.
Estimate: \$196,886.00
Assessor Name: Eduardo Lopez
Date Created: 02/10/2017

Notes: The PA system is outdated and needs to be replaced. System renewal is recommended.

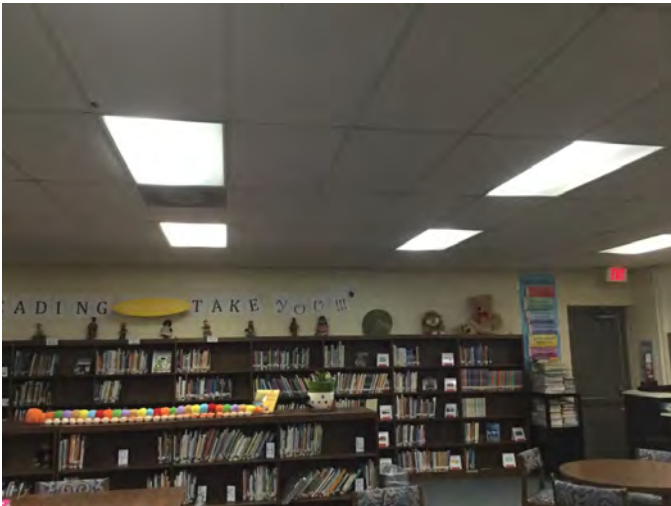
System: F1020 - Institutional Equipment

Location: Media Center
Distress: Beyond Service Life
Category: Deferred Maintenance
Priority: 3 - Necessary/Not Yet Critical (Years 2-5)
Correction: Renew System
Qty: 41,625.00
Unit of Measure: S.F.
Estimate: \$13,736.00
Assessor Name: Eduardo Lopez
Date Created: 12/19/2016

Notes: Library and other institutional equipment is original and beyond its expected life. System renewal is recommended.

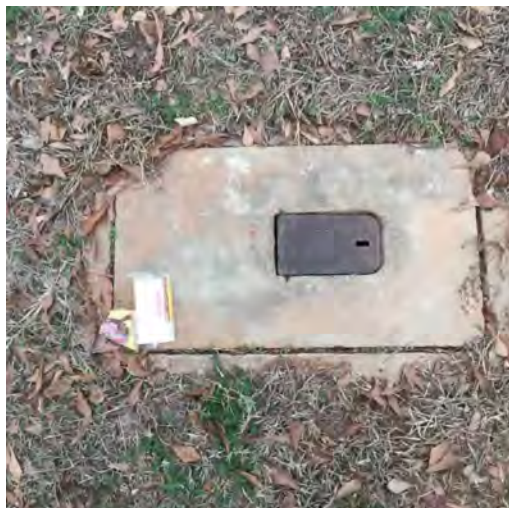
System: G3010 - Water Supply

Location: Site
Distress: Inadequate
Category: Deferred Maintenance
Priority: 2 - Potentially Critical (Year 1)
Correction: Renew System
Qty: 72,992.00
Unit of Measure: S.F.
Estimate: \$187,881.00
Assessor Name: Ann Buerger Linden
Date Created: 02/10/2017

Notes: The City water supply does not provide sufficient water flow at all times for the campus. There is no backflow preventer on the supply. System renewal is recommended.

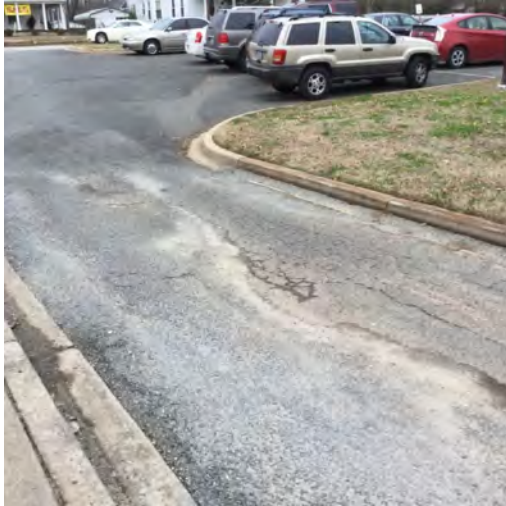
System: G2010 - Roadways

Location: Site
Distress: Beyond Service Life
Category: Deferred Maintenance
Priority: 3 - Necessary/Not Yet Critical (Years 2-5)
Correction: Renew System
Qty: 72,992.00
Unit of Measure: S.F.
Estimate: \$305,909.00
Assessor Name: Ann Buerger Linden
Date Created: 02/09/2017

Notes: Entrance drives are cracked and the surface is grainy, it is beyond its scheduled life expectancy. System renewal is recommended.

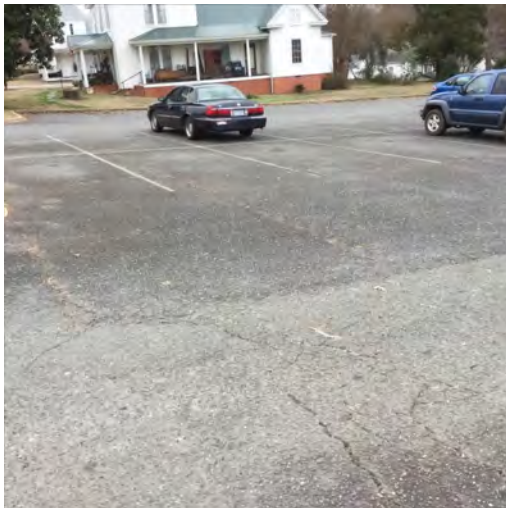
System: G2020 - Parking Lots

Location: Site
Distress: Beyond Service Life
Category: Deferred Maintenance
Priority: 3 - Necessary/Not Yet Critical (Years 2-5)
Correction: Renew System
Qty: 72,992.00
Unit of Measure: S.F.
Estimate: \$106,787.00
Assessor Name: Ann Buerger Linden
Date Created: 02/09/2017

Notes: The upper parking lot has cracks and the surface is grainy. It is past its expected life. The lower lot serving Anson Academy is unpaved. System renewal is recommended.

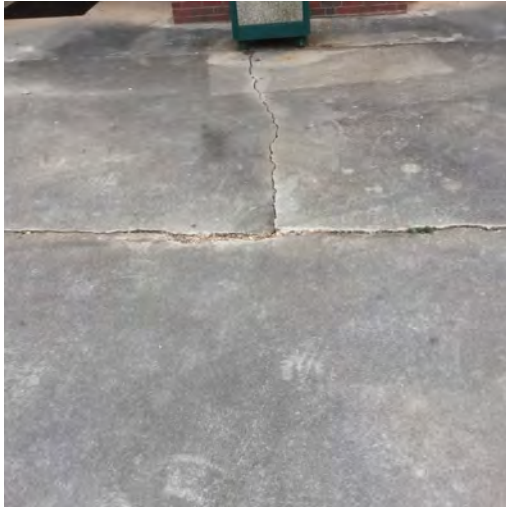
System: G2030 - Pedestrian Paving

Location: Site
Distress: Beyond Service Life
Category: Deferred Maintenance / Safety
Priority: 3 - Necessary/Not Yet Critical (Years 2-5)
Correction: Renew System
Qty: 72,992.00
Unit of Measure: S.F.
Estimate: \$153,356.00
Assessor Name: Ann Buerger Linden
Date Created: 02/09/2017

Notes: Site sidewalks are in fair condition with some cracking. The city sidewalk used to access the gym building is adjacent to a high traffic street and a path closer to the building should be built. Exterior stairs behind the gym do not have handrails. System renewal is recommended.

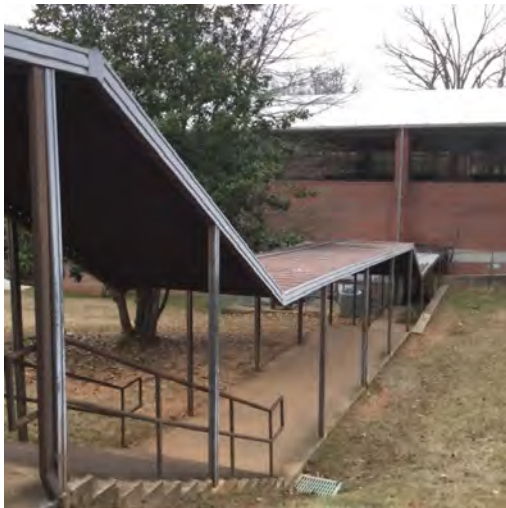
System: G2040950 - Covered Walkways

Location: Main to Gym and Main to Cafeteria
Distress: Beyond Service Life
Category: Deferred Maintenance
Priority: 3 - Necessary/Not Yet Critical (Years 2-5)
Correction: Renew System
Qty: 72,992.00
Unit of Measure: S.F.
Estimate: \$122,043.00
Assessor Name: Ann Buerger Linden
Date Created: 02/09/2017

Notes: Covered walkways are beyond their expected life. Lighting is not present on the walkway to the gym building. Lighting between the building and the cafeteria is yellowed and expired.

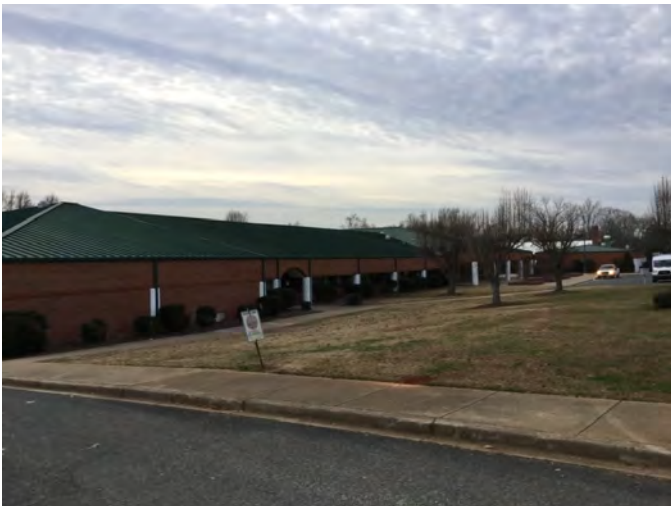
System: G4020 - Site Lighting

Location: Site
Distress: Beyond Service Life
Category: Deferred Maintenance / Safety
Priority: 3 - Necessary/Not Yet Critical (Years 2-5)
Correction: Renew System
Qty: 72,992.00
Unit of Measure: S.F.
Estimate: \$118,028.00
Assessor Name: Ann Buerger Linden
Date Created: 02/09/2017

Notes: Site lighting is beyond its expected life where it exists. There is insufficient lighting at the front of the building, at the rear of the building, and at the lower parking lot. System renewal is recommended.
