NC School District/040 Anson County/Elementary School

Wadesboro Primary

Campus Assessment Report

March 10, 2017

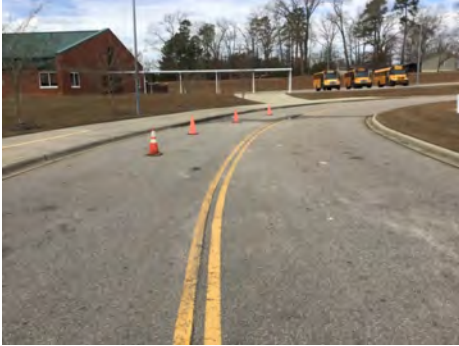
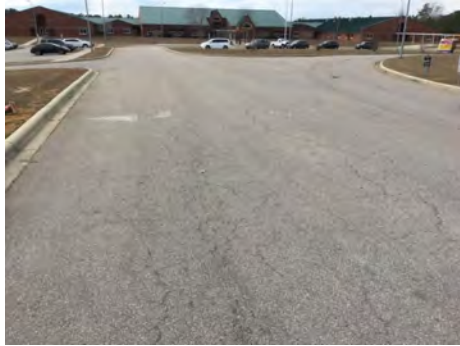
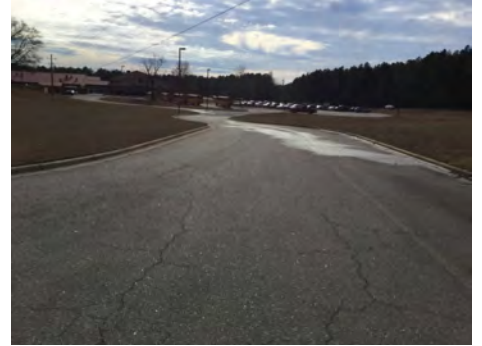
System: G2010 - Roadways

Location: Site roadways
Distress: Failing
Category: Deferred Maintenance
Priority: 3 - Necessary/Not Yet Critical (Years 2-5)
Correction: Resurface the roadway
Qty: 2,500.00
Unit of Measure: L.F.
Estimate: \$106,128.00
Assessor Name: Somnath Das
Date Created: 02/08/2017

Notes: Roads are alligatored and grainy. Crack sealing and sealing is recommended to prolong system life.

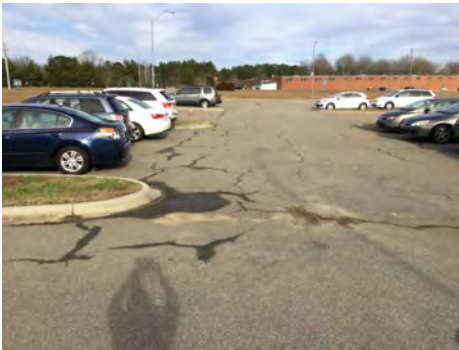
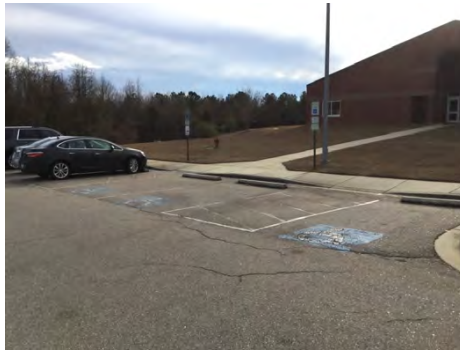
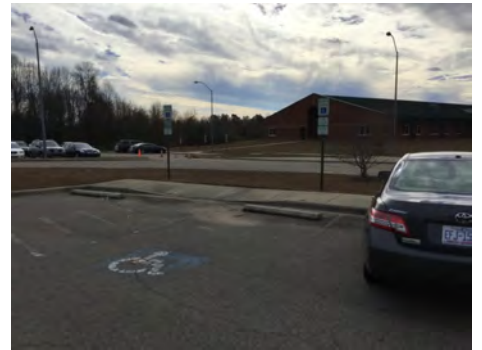
System: G2020 - Parking Lots

Location: Parking lots
Distress: Failing
Category: Deferred Maintenance
Priority: 3 - Necessary/Not Yet Critical (Years 2-5)
Correction: Parking lot repair and sealcoating
Qty: 35.00
Unit of Measure: M.S.F.
Estimate: \$30,906.41
Assessor Name: Somnath Das
Date Created: 02/08/2017

Notes: Parking lots show some alligatoring and asphalt is grainy. Striping and pavement markings are faded. Crack fill and seal pavements. Re-stripe lots.

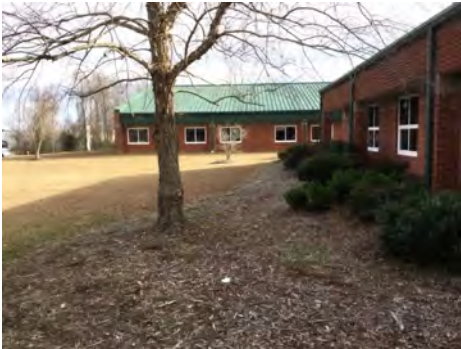
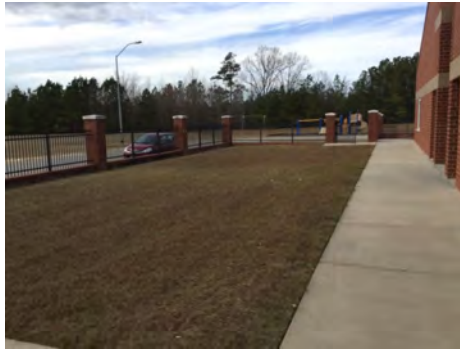
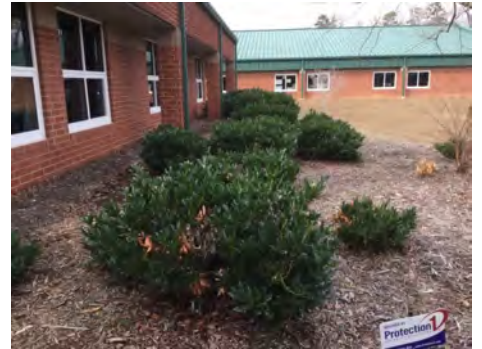
System: G2050 - Landscaping

Location: Near bus driveway
Distress: Inadequate
Category: Deferred Maintenance / Safety
Priority: 3 - Necessary/Not Yet Critical (Years 2-5)
Correction: Grading study
Qty: 1.00
Unit of Measure: Ea.
Estimate: \$6,600.00
Assessor Name: Somnath Das
Date Created: 02/09/2017

Notes: The steep slope north of the bus drive area spills runoff and debris onto the pavement, creating icy conditions in winter. Regrading is recommended.
