NC School District/220 Clay County/Elementary School

# Hayesville Elementary

## Campus Assessment Report

March 13, 2017

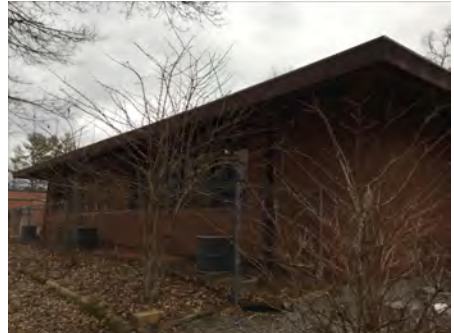
3). North Elevation - Jan 23, 2017
